**Report  
of  
Preliminary Ecological Bat Survey**

**Street Buildings North End Road  
Yapton**

**30<sup>th</sup> June 2017**

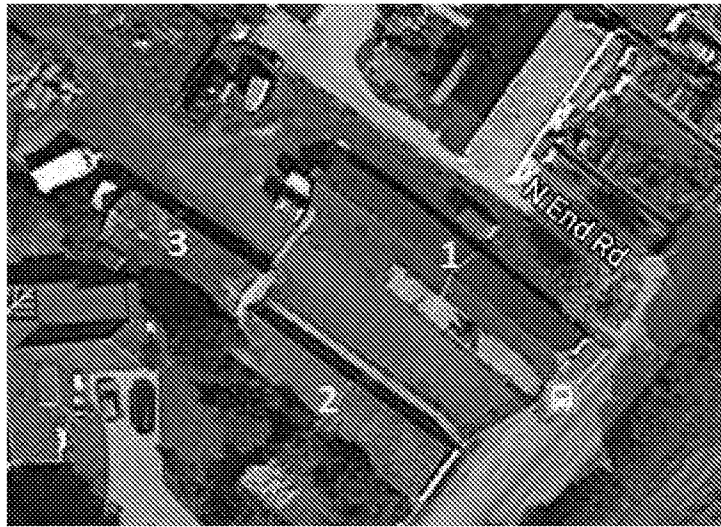
Aerial photo of buildings from Google maps. The buildings have been numbered 1-3 for the purposes of this report only

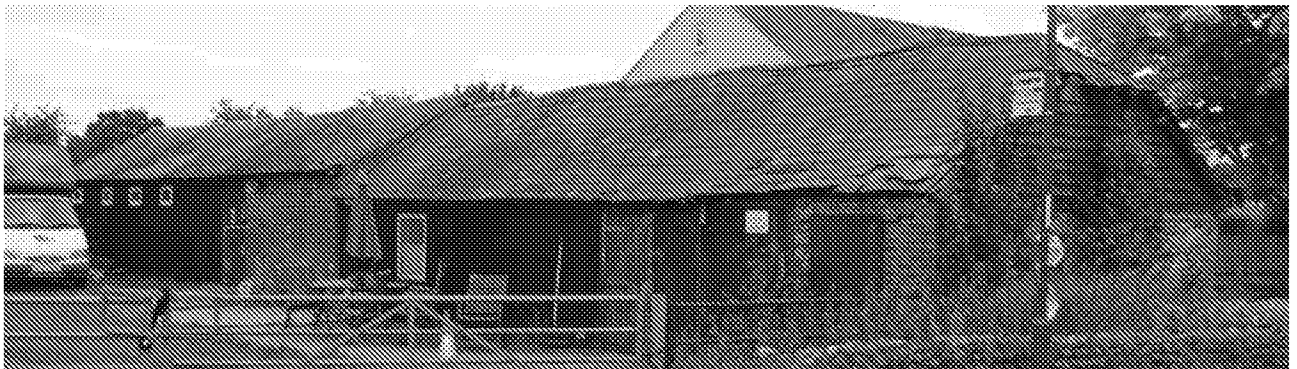
South west facing frontage

The building was divided internally into two large open areas and two smaller areas. Windows were fitted into the long south west facing frontage allowing high levels of light passing into parts of the building.

The rear and end walls were a mix of brick and flint. The long south west facing wall was largely of corrugated sheeting with some brick and the remainder of the wall made up of timber doors. A small area of unlined timber cladding lay on the southern end by the roadside. There was no roosting opportunities to bats in the walls. An birds nest was seen in the eaves on the east side.

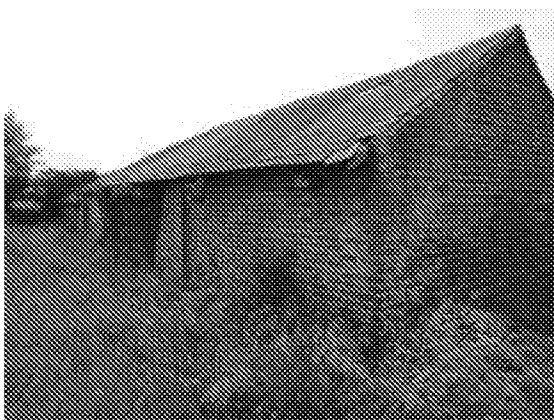
North east facing rear showing mixture of brick and flint walls

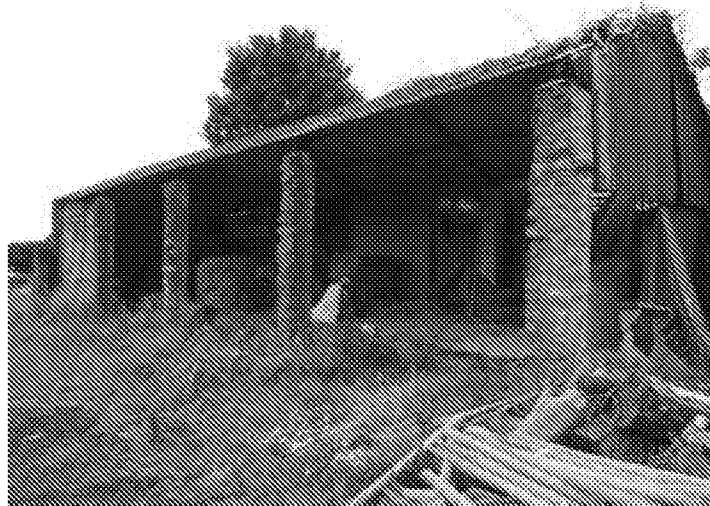
North east facing frontage

The simple four bay barn had a pitched roof covered with corrugated panels. There was no potential for bats to roost in this very open light building.
