Our ref: GE18875/LD01/200228

**RE: Land at Stakers Farm, North End Road, Yapton, Arundel, West Sussex, BN18 0DU – BRE 365 Soakage Testing**

We are pleased to present the results of the soakage testing undertaken at the above site. The soakage tests were undertaken in accordance with BRE Digest 365 'Soakaway Design' BRE, 2016.

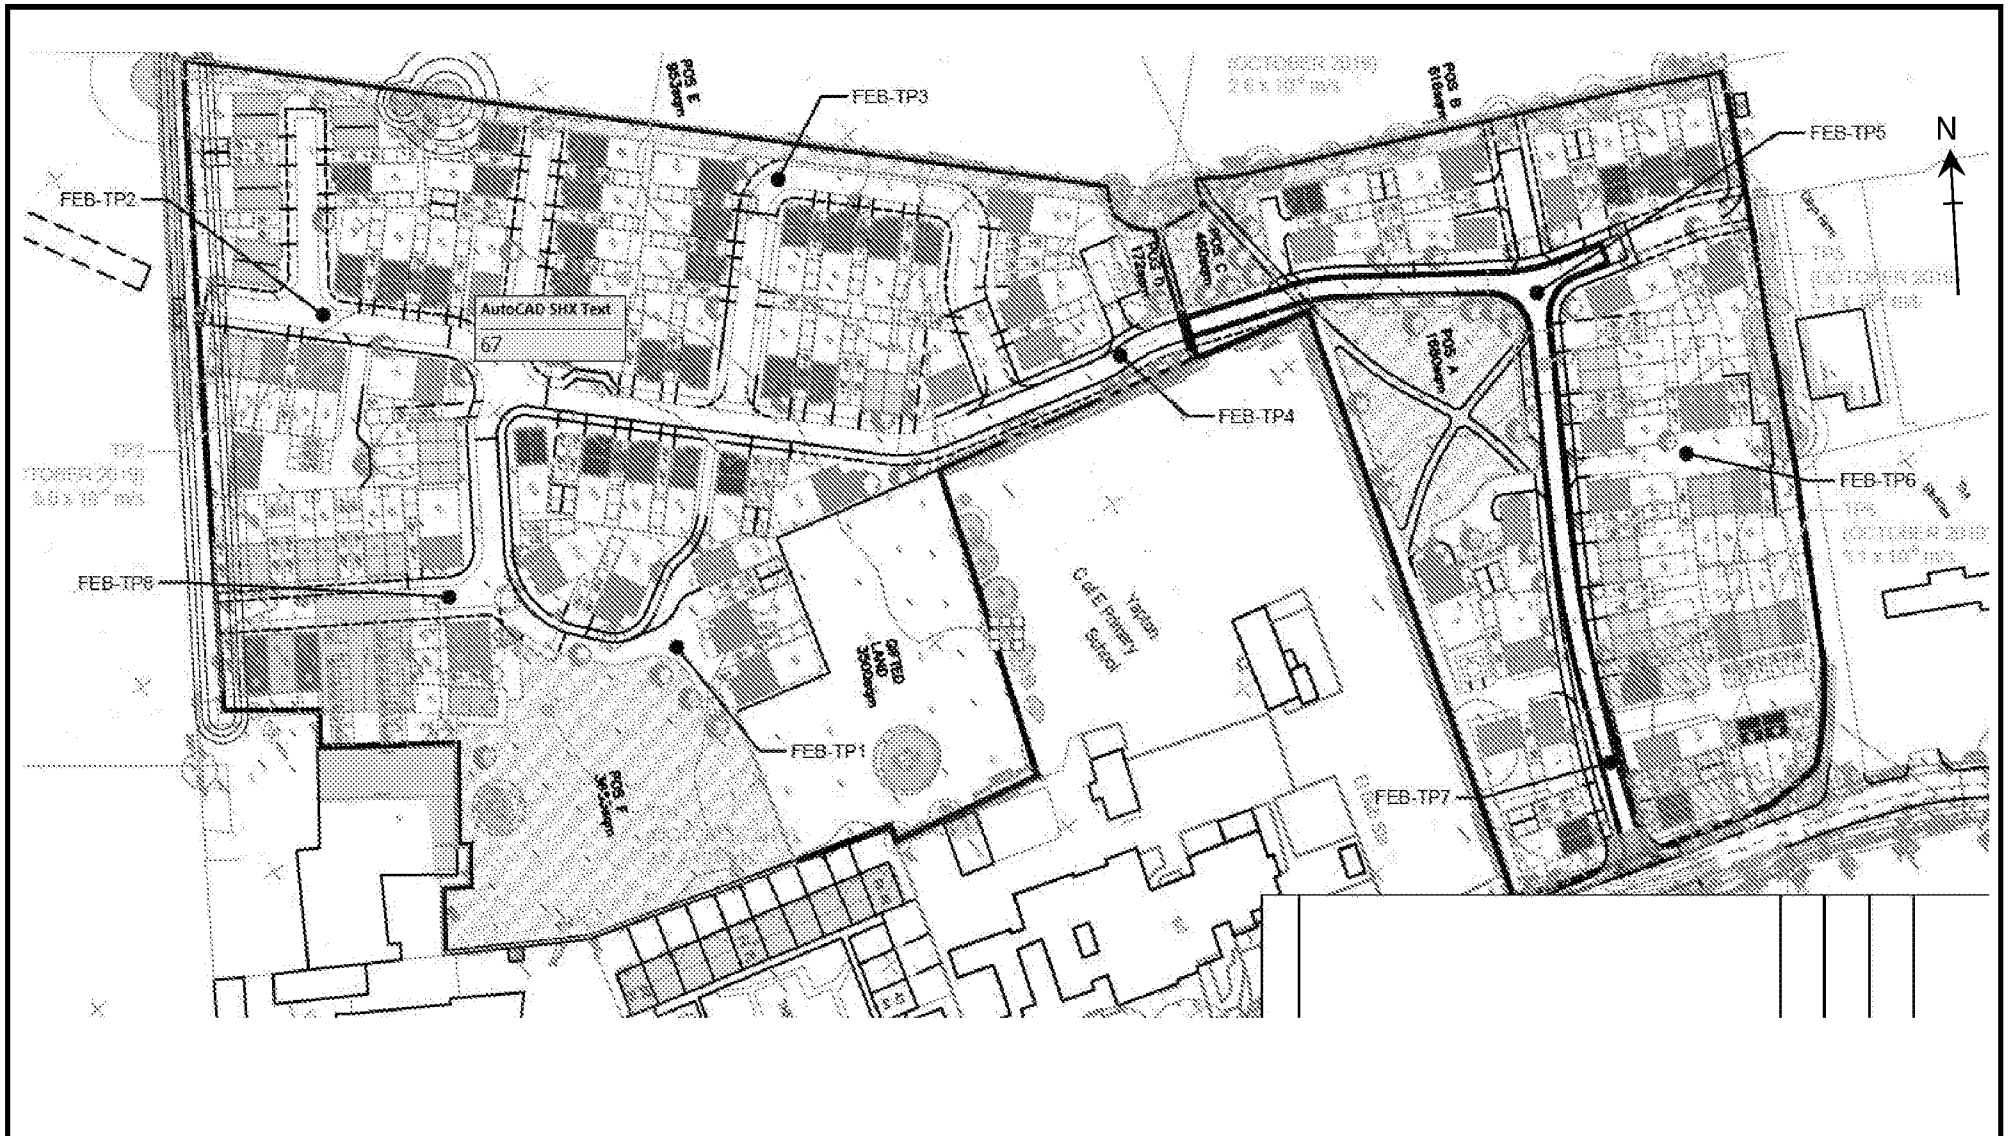
A total of eight soakage tests were undertaken within eight separate trial pits at locations specified by the Client's drainage Engineer, which targeted the proposed locations of the soakaways. The locations of these trial pits are presented in Figure 2.

Soakage tests were undertaken at eight locations (FEB-TP1 to FEB-TP8) in accordance with BRE Digest 365, primarily to inform the design of a SUDS scheme, with the depth of the tests being specified by the Client's drainage engineer. Three soakage runs were undertaken within each position was commenced on the 24<sup>th</sup> February 2020 and was left to run over night with the final readings being collected on the 27<sup>th</sup> February 2020. However, there was insufficient fall in head to calculate an infiltration rate within FEB-TP1 and FEB-TP8. Table 1 summarises the soakage rates, which were calculated based on the results of the soakage testing:
