# Yapton Scrap Metal Yard, Yapton

Tree Survey Report

Report Number J20438\_Arb\_Rev\_A

Tree Protection Plan      20438\_Arb\_TPP\_Rev\_A

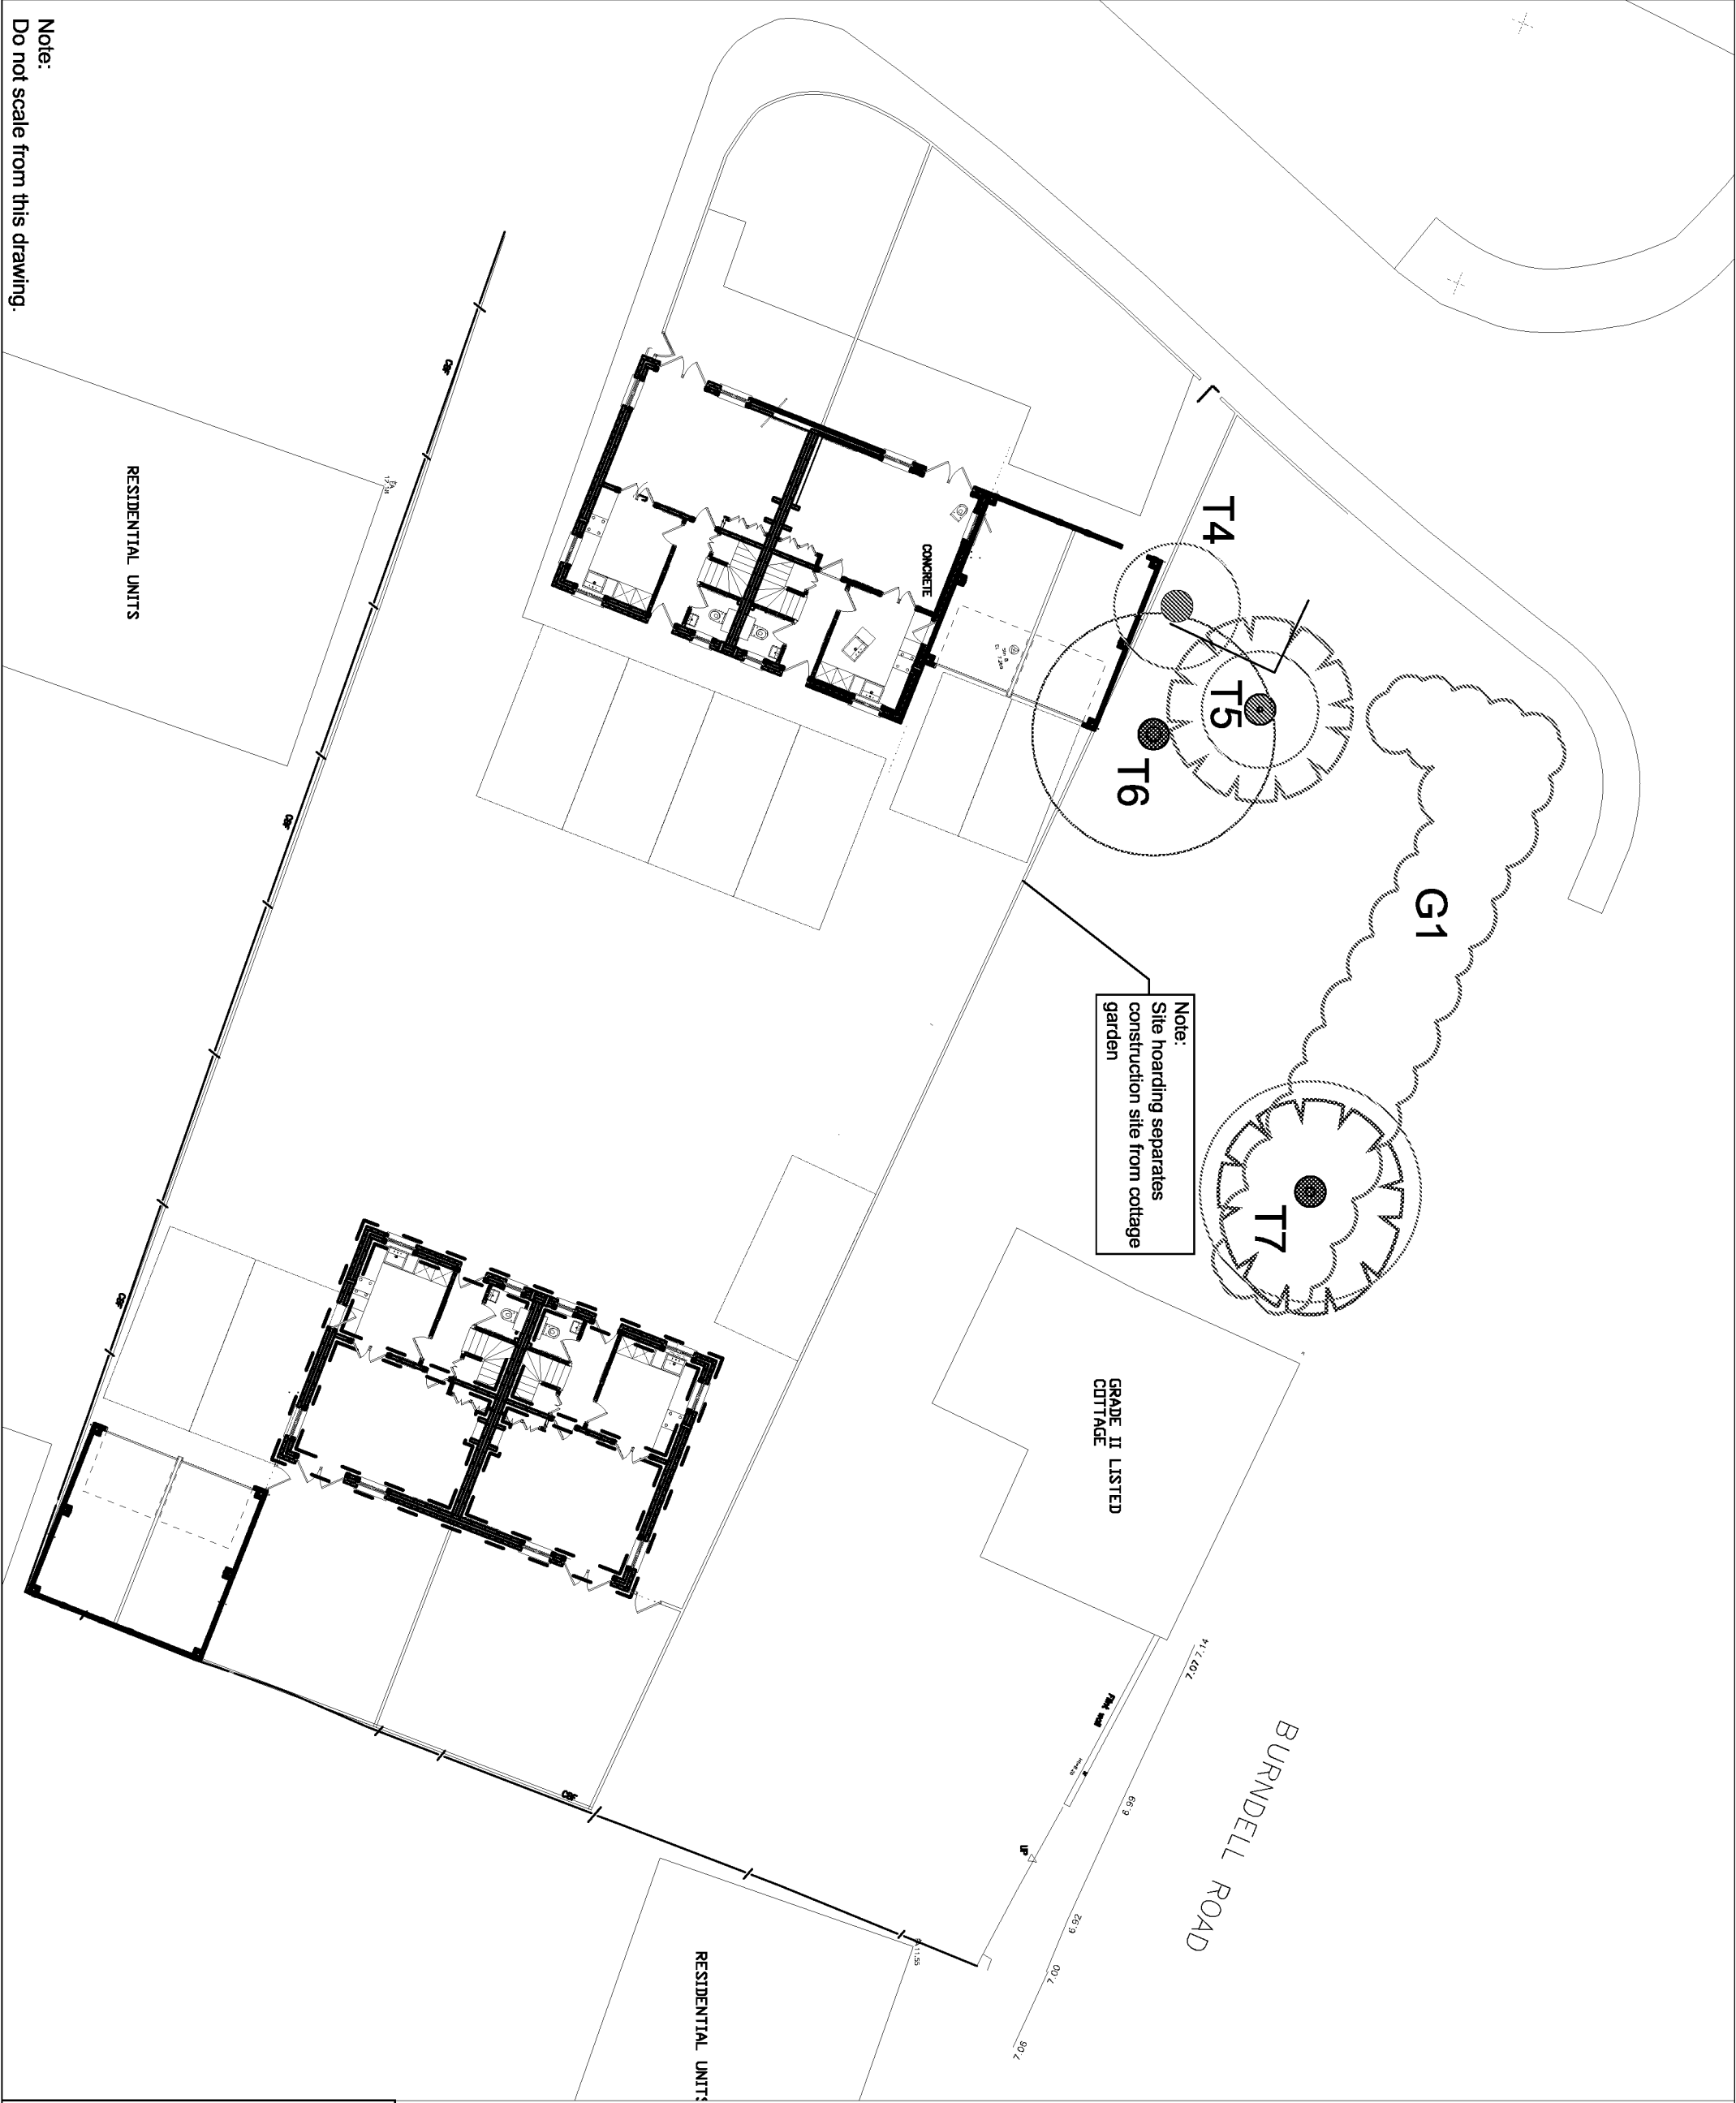
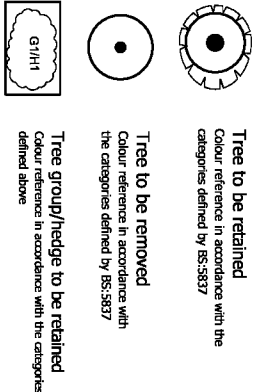
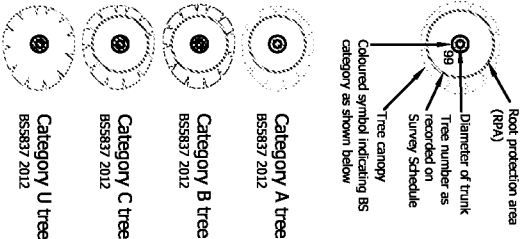
Drawing Reference : J20438\_Arb\_TPP\_A

- 5.1.2 The quality and relative importance of each tree is illustrated as a coloured polygon. The colour used relates to the BS categories as follows: A - green, B - blue, C - grey and R - red (see accompanying drawing reference J20438\_Arb\_TPP). In general the design process will try to retain A and B category trees. Proposed construction will therefore normally be excluded from the RPA of A and B category trees. Red trees are discounted as they are recommended for removal.

- 5.1.3 Details of the trees surveyed are given in the TSS (Appendix 1). The juxtaposition of the proposed development in relation to existing tree locations are shown on the accompanying TPP drawing, reference J20438\_Arb\_TPP.

Drawing Title  
Tree Protection Plan

- 5.2.1 Refer to the accompanying TPP, drawing, reference J20438\_Arb\_TPP, for the relationship between the proposed development and the trees on and adjacent to the site
- ✧ The following tree should be removed for arboricultural reasons:  
T4
  - ✧ The following trees and groups of trees have been removed as part of the preparations of the site:  
T1-T3, T9-T19 and G2
  - ✧ Following the dimensions being checked on site, the following trees will be removed to enable the approved development:  
T6 to enable the construction of a garage
  - ✧ There will be no demolition or construction within the RPA of a retained tree.

- 6.5.1 The retained trees are within the garden of the cottage which is separated from the construction site by site hoarding. As such, no tree protection measures will be required.
