**Report issued:**  
16 January 2014

# Bat Survey Report

Hobbs Farm  
Bilsham Road  
Yapton  
Nr Arundel  
West Sussex  
BN18 0JY

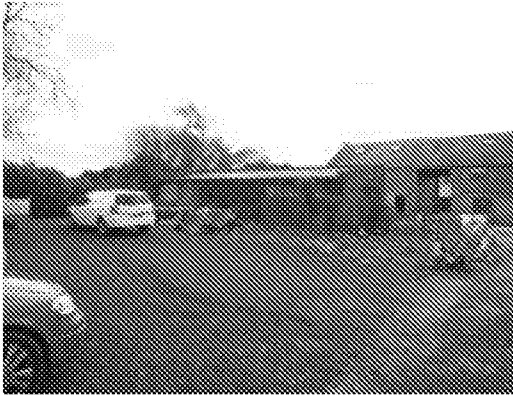
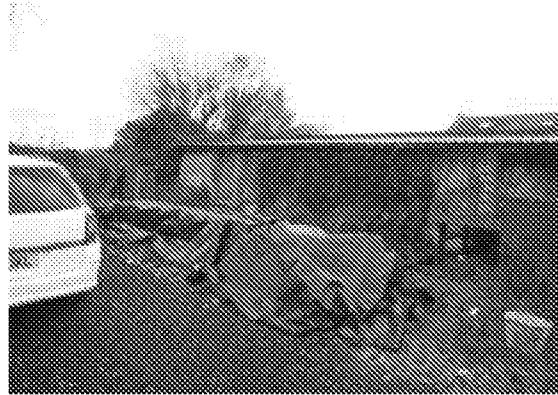
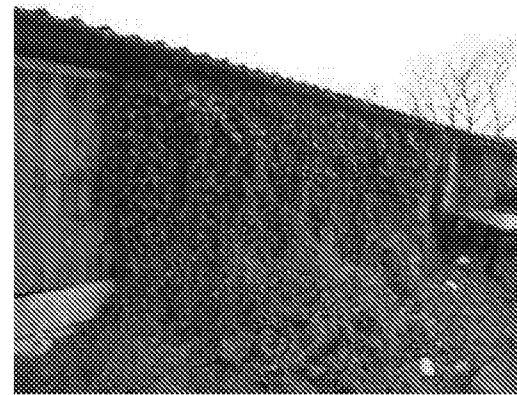
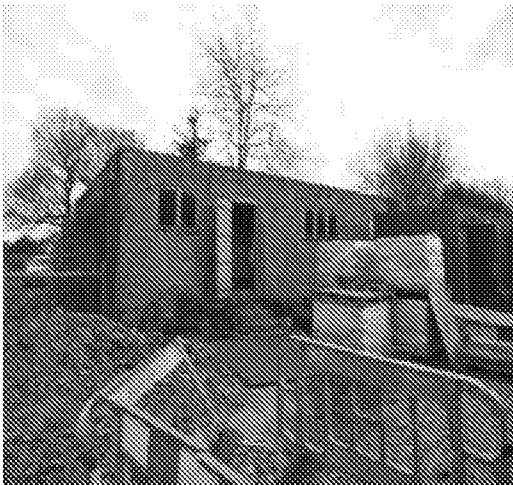
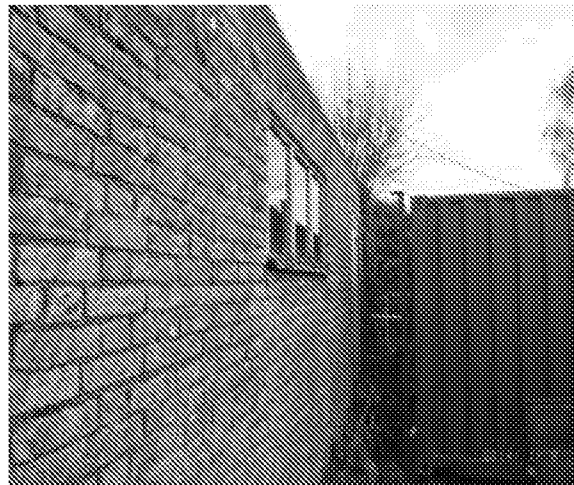
## Appendix 2: Photographs of development site

The outbuilding is a former piggery which is single storey and built of brick and timber panels. The roof is flat with no roof void and covered by corrugated roofing sheets. The internal part of the building is currently boarded forming a ceiling.

The external inspection found potential bat access points between the roof parts and the wall.

Inspection of the walls floor and roof found no evidence of bats, either of live animals or droppings.

The building assessment considered the outbuilding unlikely to support roosting bats due in part to the design of the building and the lack of any roof void or potential roost sites.

No evidence was found of bats using the outbuilding. In addition, the building was assessed as having no real potential to support roosting bats. This was based mainly on the construction and design of the building, and the fact that the building had no features that bats usually prefer for roosting.

**It is therefore considered that a European Protected Species licence for bats (EPS), will not be required from Natural England.**

In addition no further survey or mitigation work is required relating to bats and the development of the building.
