Our ref: GE18965/LD01/200331

**RE: Land at Stakers Farm, North End Road, Yapton, Arundel, West Sussex, BN18 0DU – BRE 365 Soakage Testing**

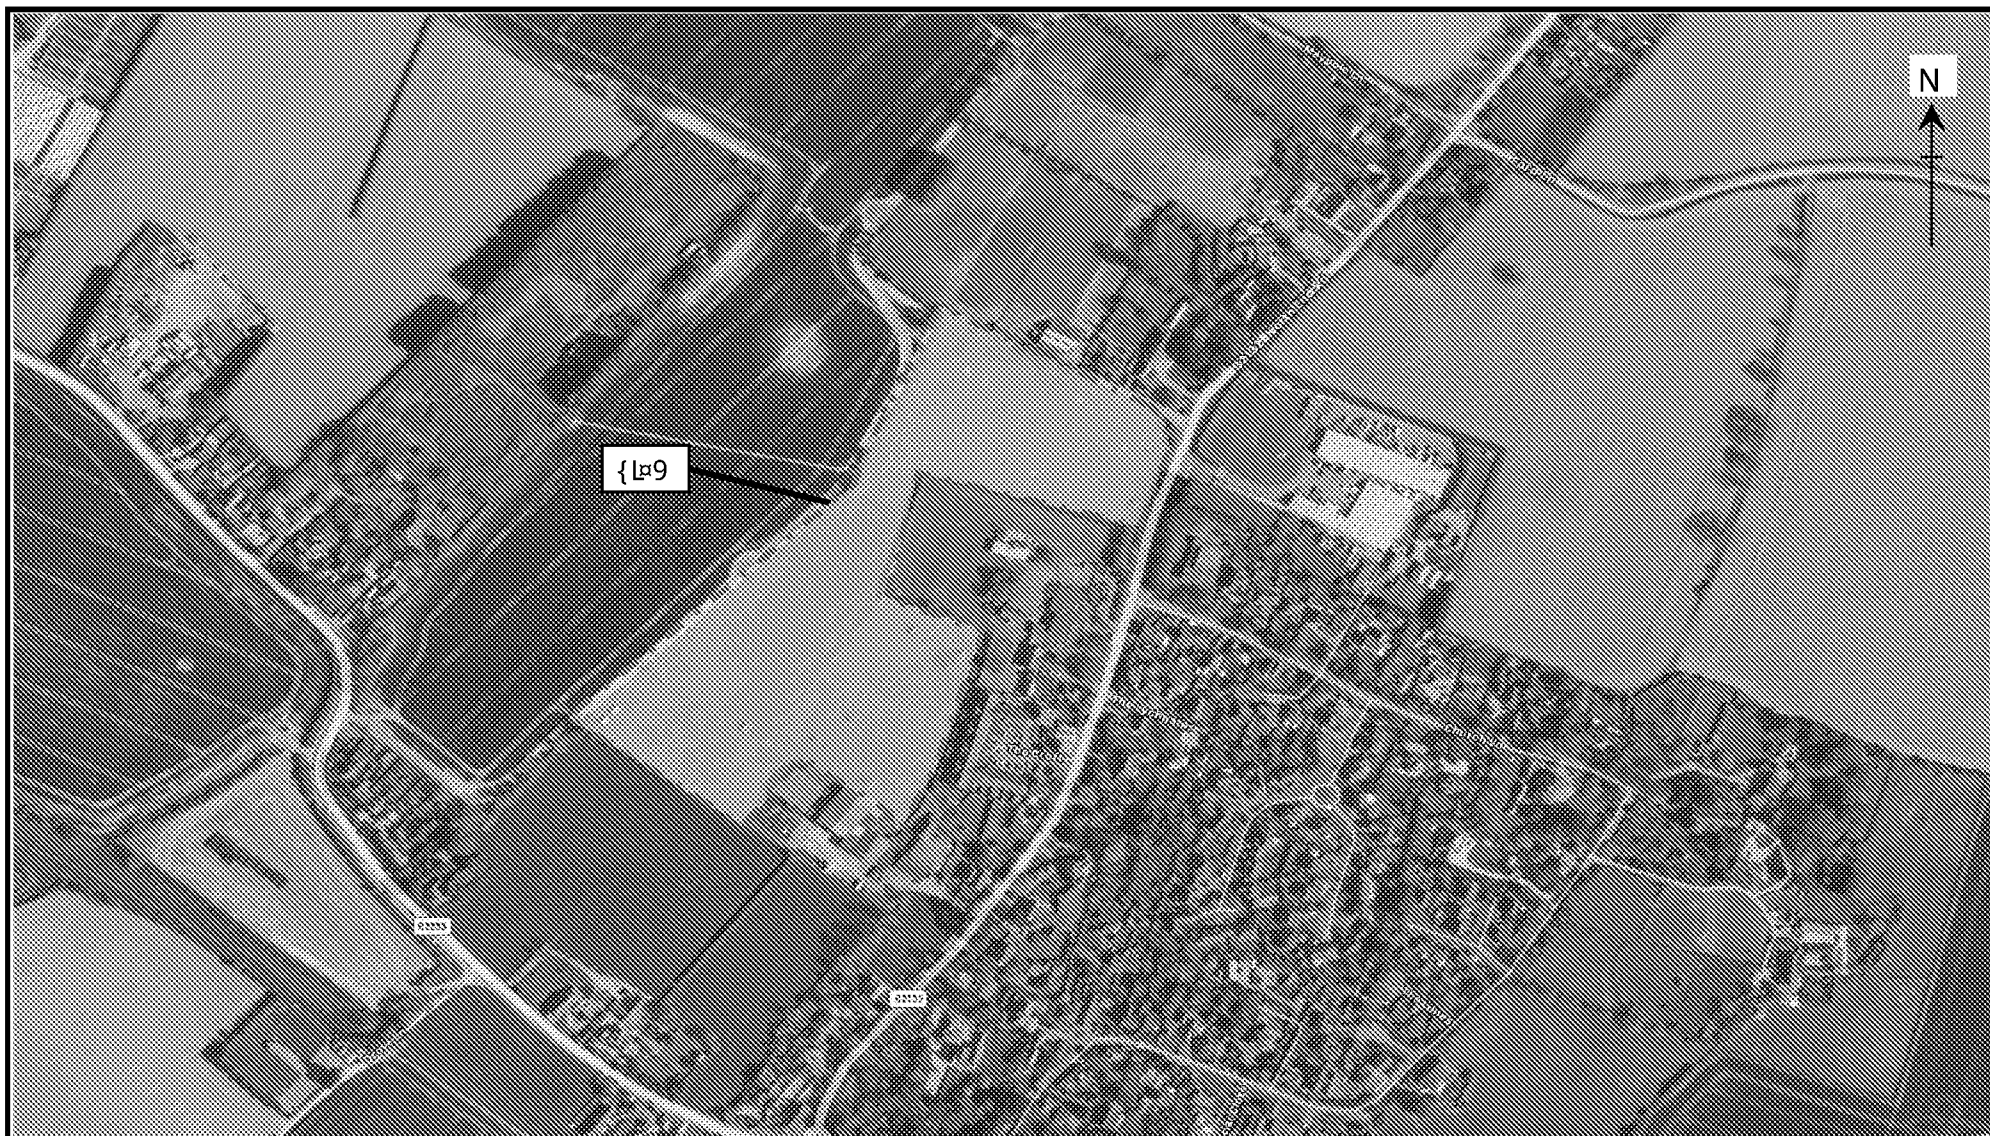
A total of eight BRE365 soakage tests within eight separate trial pits and one cable percussive borehole were undertaken at locations specified by the Client's Drainage Engineer, which targeted the proposed locations of the soakaways. The locations of the exploratory holes are presented in Figure 2.

Enc    Figure 1        – Locations Plan  
      Figure 2        – Exploratory Hole Locations Plan  
      Appendix A    – Exploratory Hole Logs
