**GROUND INVESTIGATION REPORT**

**STAKERS FARM, NORTHERN END ROAD (B2132),**

**DANDARA LIMITED**

| <b>Reference:</b> | <b>GE18621-GIR-NOV19</b> |

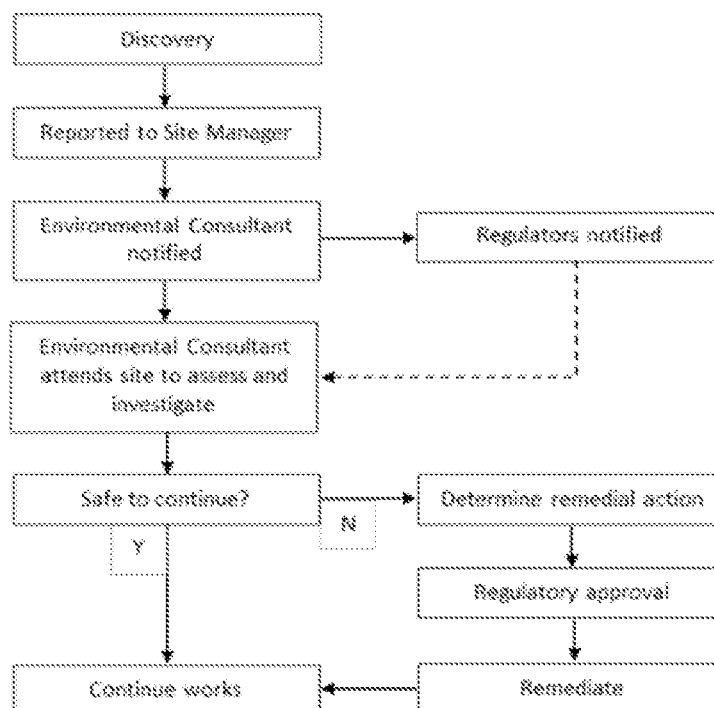
**Discovery Strategy Process**

Should previously undiscovered contamination be encountered during construction by the ground workers, this should be reported to the Site Manager immediately in order that any necessary inspection may be made. Records should be kept and samples submitted for analysis where conditions encountered are not as anticipated. The results of any such testing should be sent to the authorities for consultation.

The process is shown below

A copy of the discovery strategy should be lodged on site and provisions made to ensure that all workers are made aware of their responsibility to observe, report and act on any potentially suspicious or contaminated materials they may encounter.

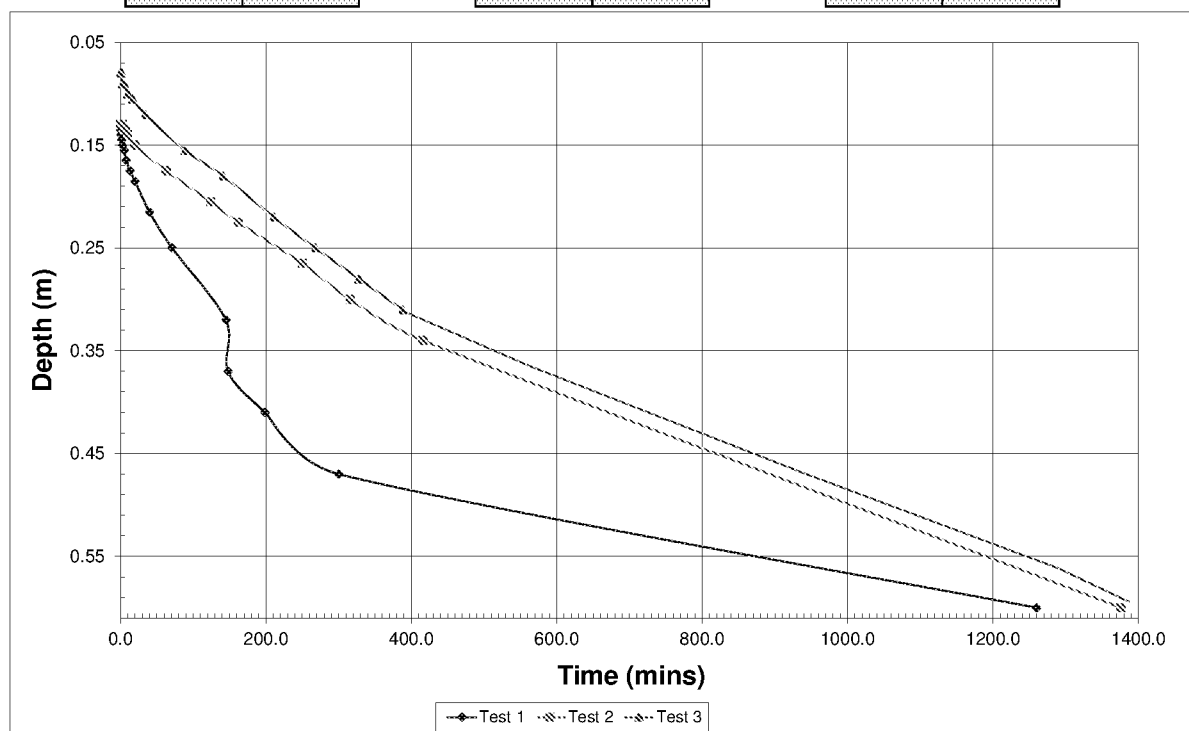
| Soil infiltration rate (m/s) | 6.0E-06 | 2.5E-06 | 2.6E-06 |
| Soil infiltration rate (mm/hr) | 2.17E+01 | 9.11E+00 | 9.18E+00 |

Based on the above results and ground conditions encountered on site, it is considered that conventional soakaways may locally be suitable for discharging storm water run-off to the ground. However, the storage capacity of any soakaway may be limited by the presence of groundwater, particularly during the wetter winter months, and it is likely that some allowance for on-site storage and attenuation of peak storm flow with discharge to the drainage ditch network, possible at greenfield run-off rate would be required, under an extension of riparian rights.

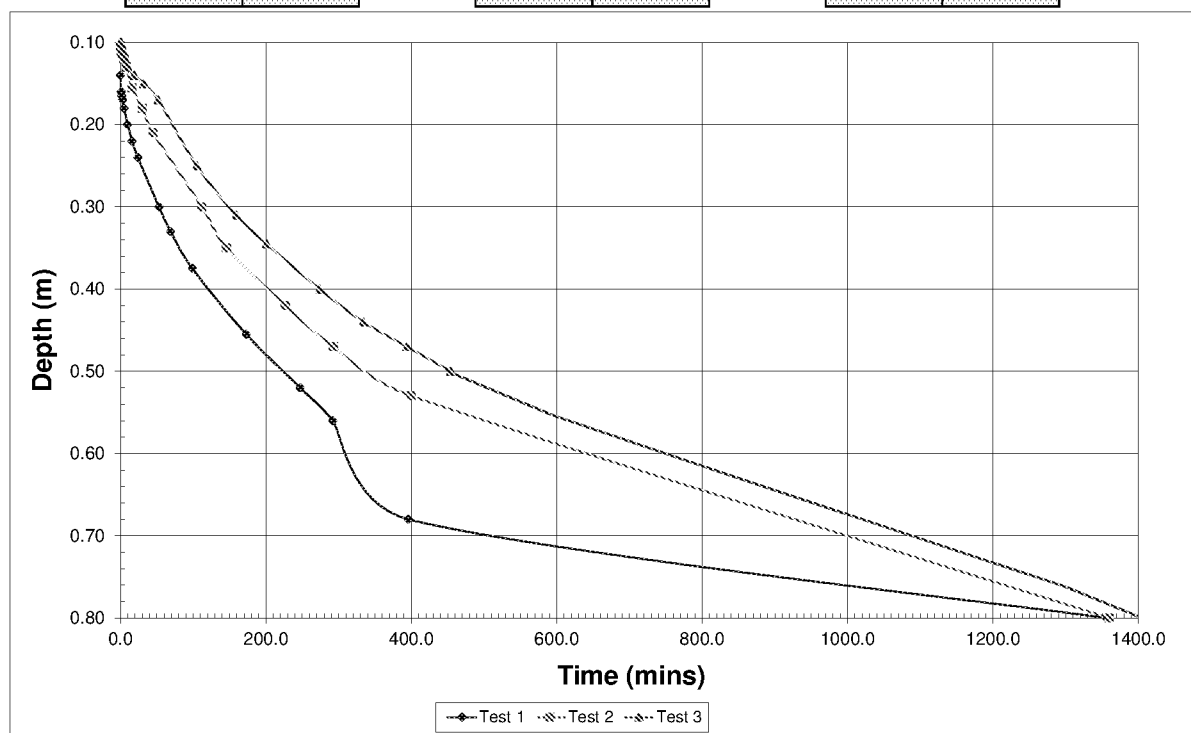
| Soil infiltration rate (m/s) | 7.5E-06 | 3.3E-06 | 3.0E-06 |
| Soil infiltration rate (mm/hr) | 2.69E+01 | 1.21E+01 | 1.08E+01 |

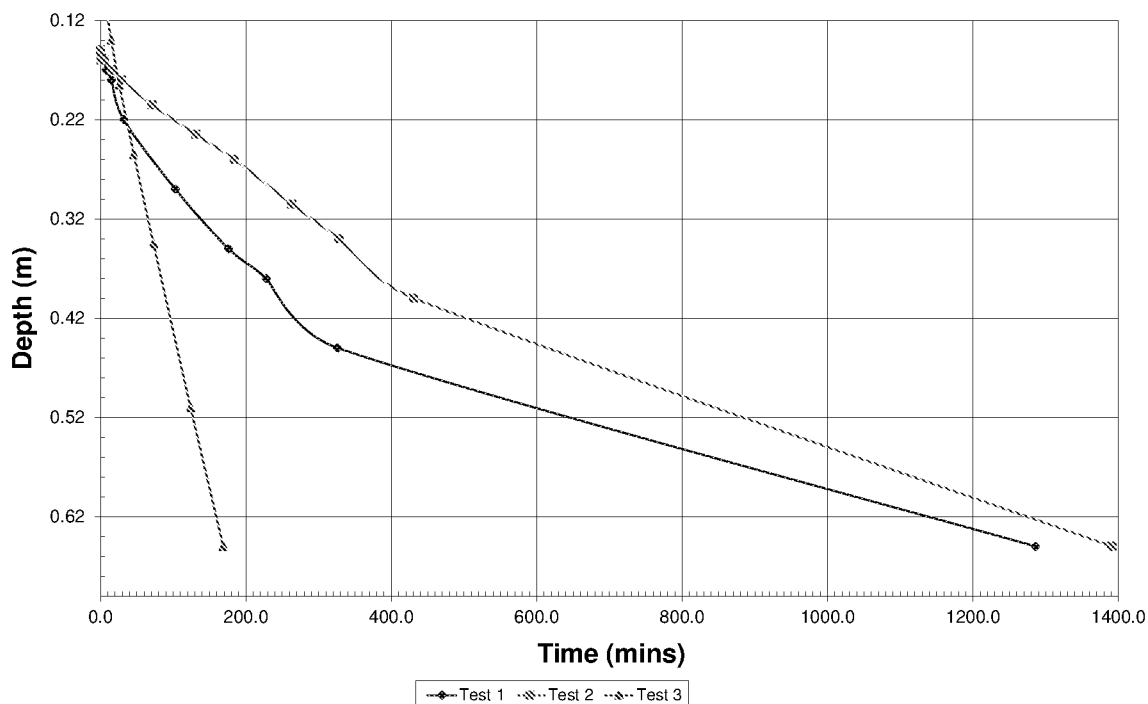
| Soil infiltration rate (m/s) | 3.2E-06 | 2.7E-06 | 2.5E-05 |
| Soil infiltration rate (mm/hr) | 1.14E+01 | 9.69E+00 | 8.91E+01 |

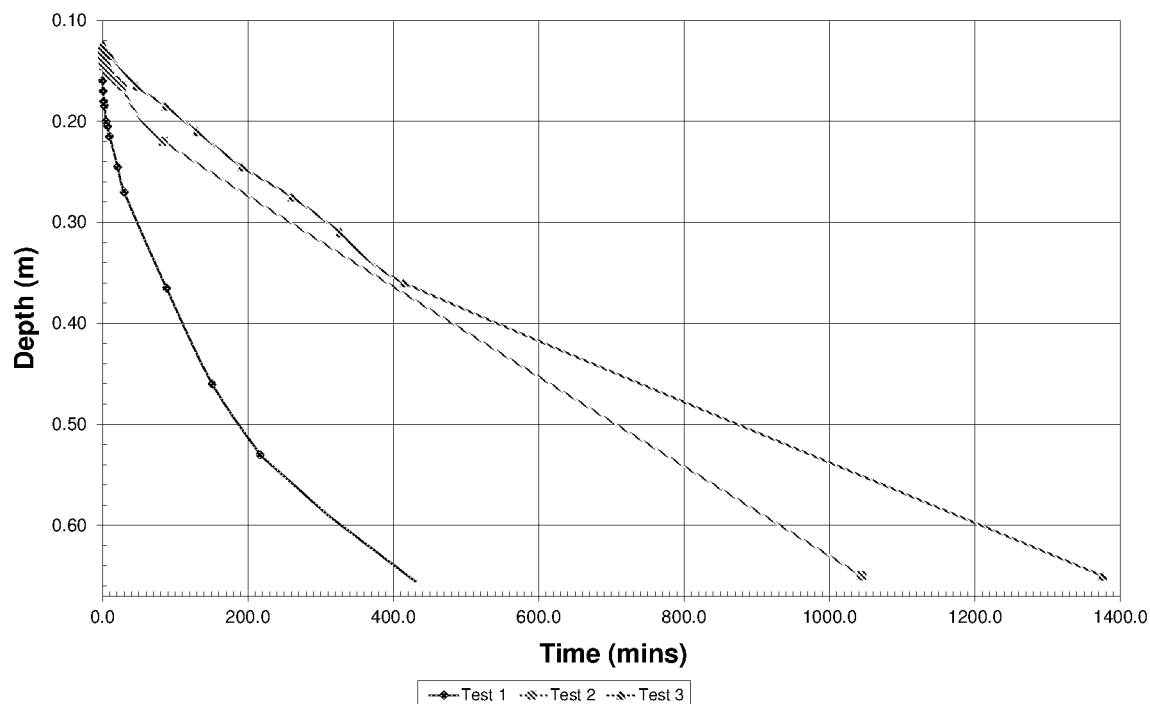
| Soil infiltration rate (m/s) | 1.0E-05 | 3.2E-06 | 2.6E-06 |
| Soil infiltration rate (mm/hr) | 3.66E+01 | 1.15E+01 | 9.33E+00 |

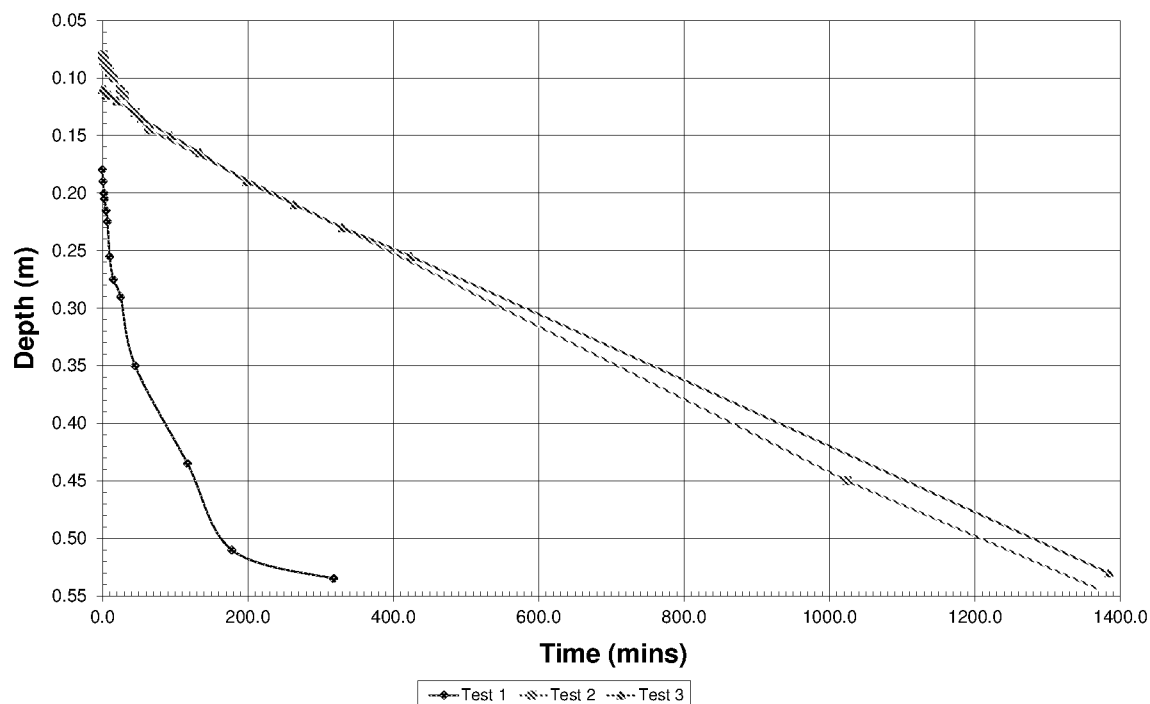
| Soil infiltration rate (m/s) | 3.4E-06 | 2.4E-06 | 2.4E-06 |
| Soil infiltration rate (mm/hr) | 1.24E+01 | 8.81E+00 | 8.66E+00 |

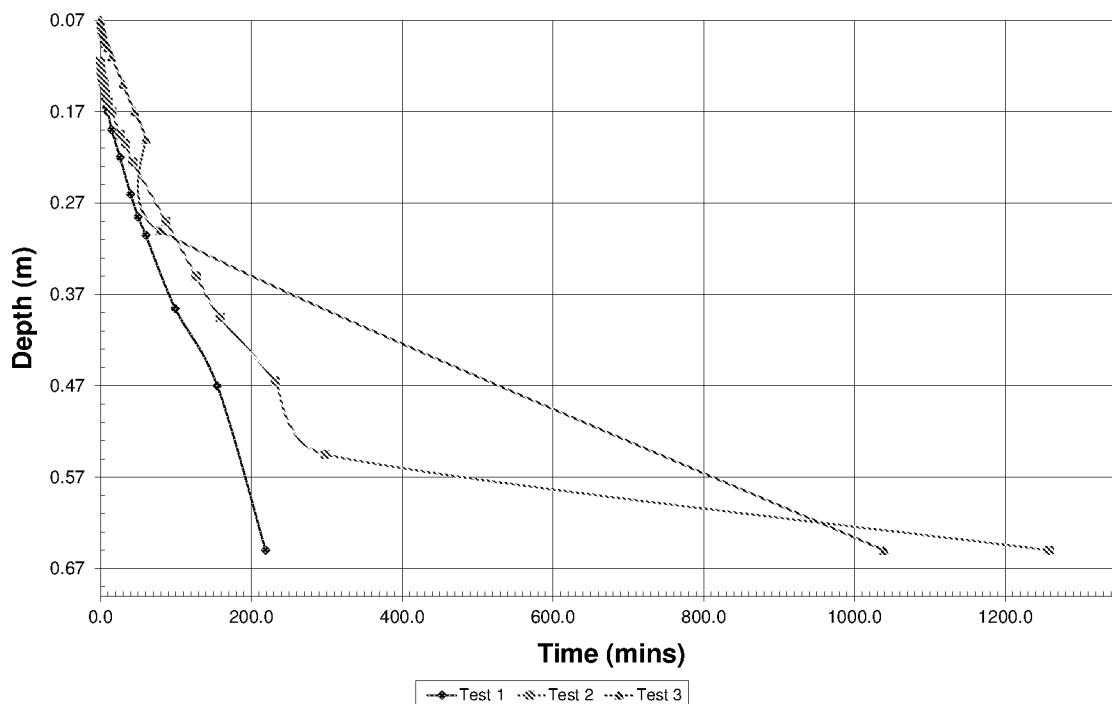
| Soil infiltration rate (m/s) | 1.3E-05 | 8.4E-06 | 3.1E-06 |
| Soil infiltration rate (mm/hr) | 4.60E+01 | 3.04E+01 | 1.11E+01 |

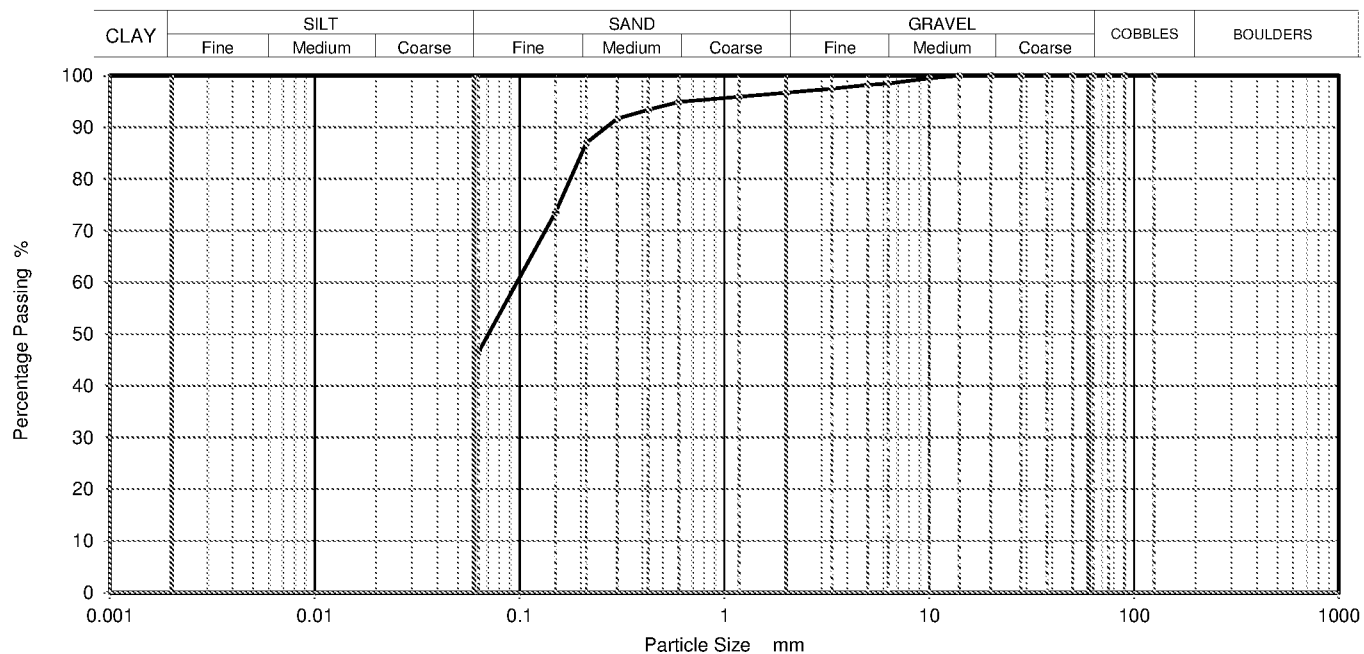
| Soil Description | Brown slightly gravelly silty sandy CLAY (gravel is fm and sub-angular) | | |
| Test Method | BS1377:Part 2: 1990, clause 9.0 | | |

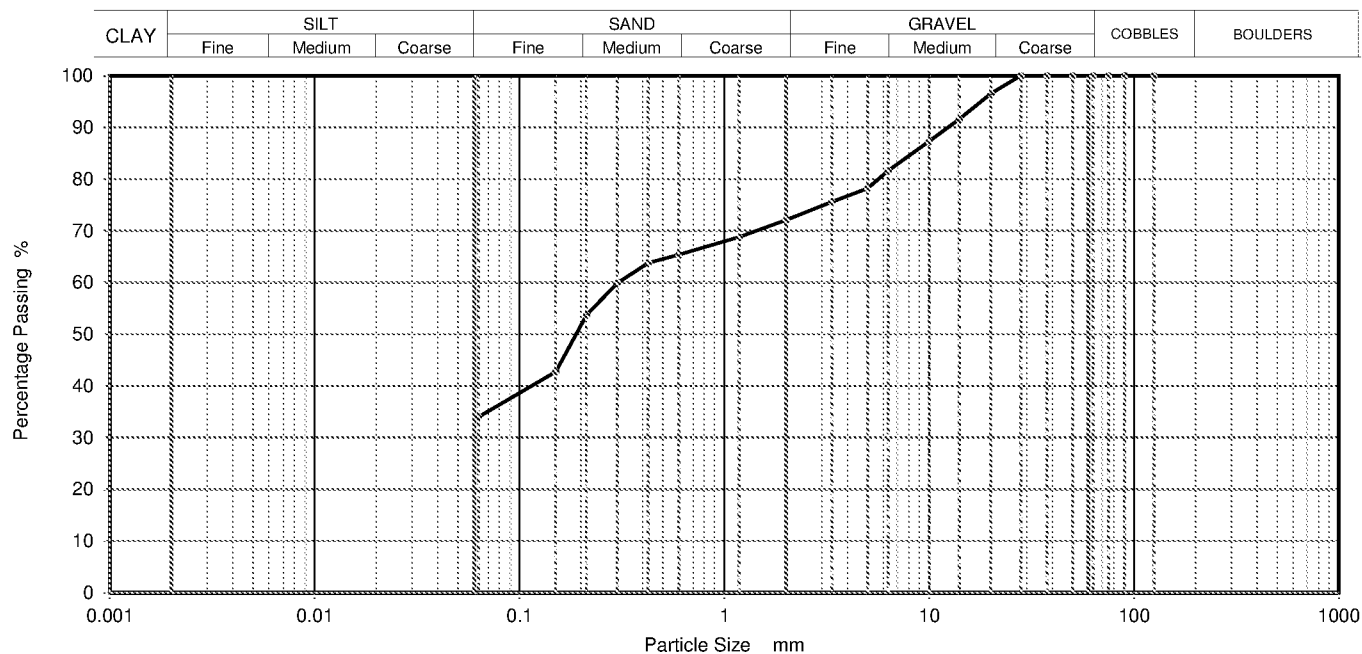
| Soil Description | Light brown clayey silty gravelly SAND with occasional fmc intact chalk fragments (gravel is fm and sub-angular to angular) | | |
| Test Method | BS1377:Part 2: 1990, clause 9.0 | | |

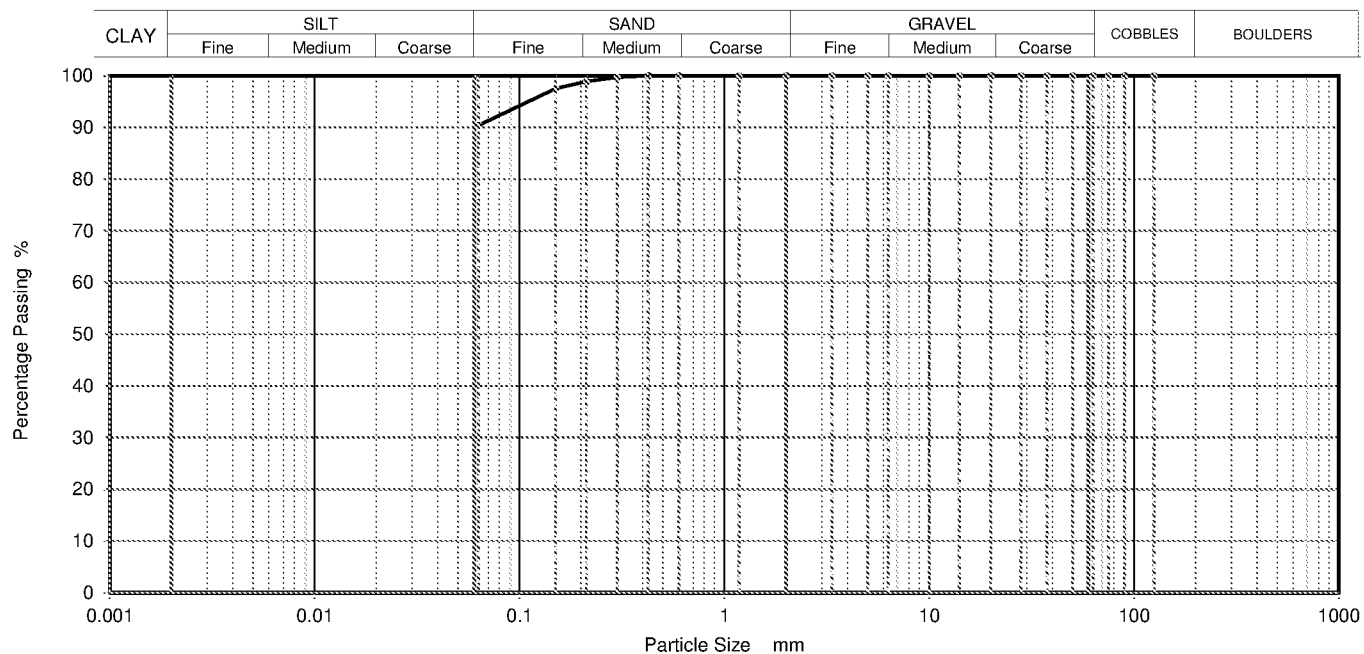
| Soil Description | Brown slightly sandy silty CLAY with scattered dark grey flecks | | |
| Test Method | BS1377:Part 2: 1990, clause 9.0 | | |

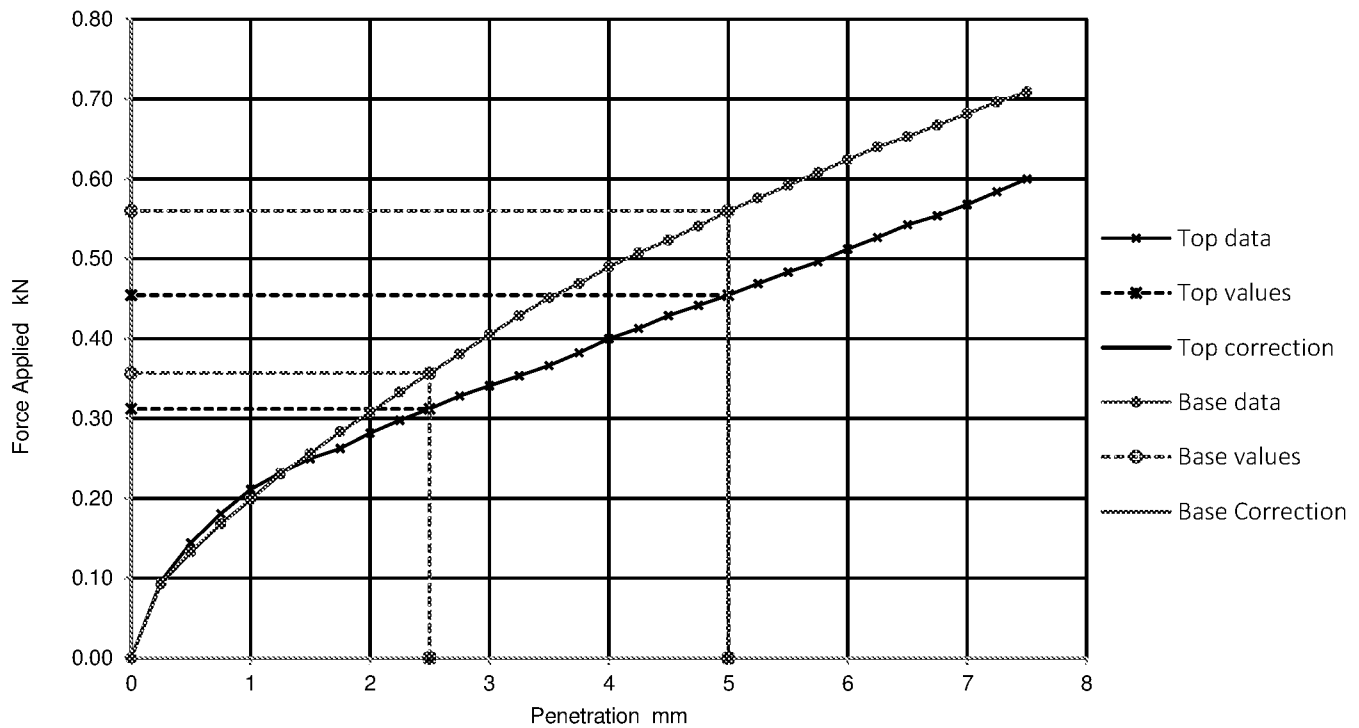
### Force v Penetration Plots

Moisture content 22 %

In addition, six soaked CBR tests were carried out in accordance with BS1377: Part 4:1990 using a 2.5kg rammer compaction method. A maximum dry unit weight of 17.2kN/m<sup>3</sup> (TP107) and natural moisture contents ranged from 10% to 22% with soaked CBR values ranging from 1.5 to 5.7%.

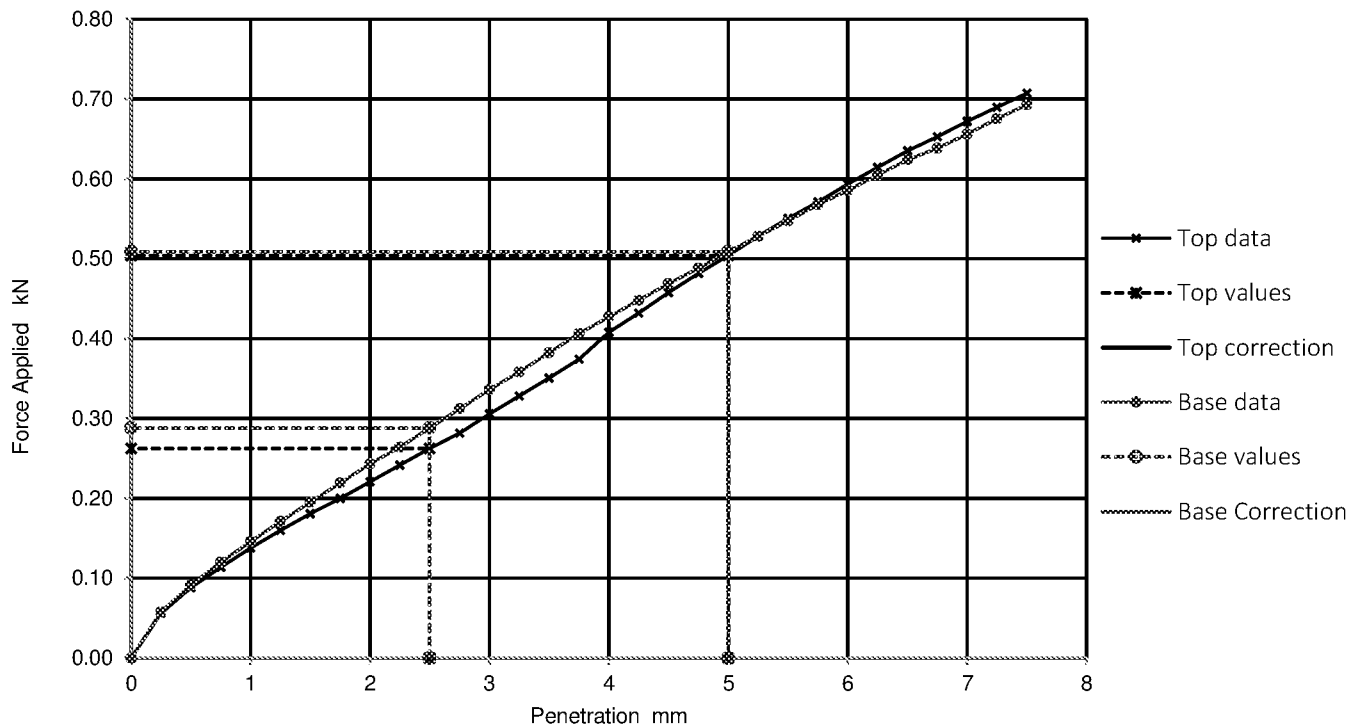
Force v Penetration Plots

Initial Specimen details Bulk density 2.02 Mg/m<sup>3</sup> Surcharge applied 6 kg  
Dry density 1.68 Mg/m<sup>3</sup> 4 kPa  
Moisture content 21 %

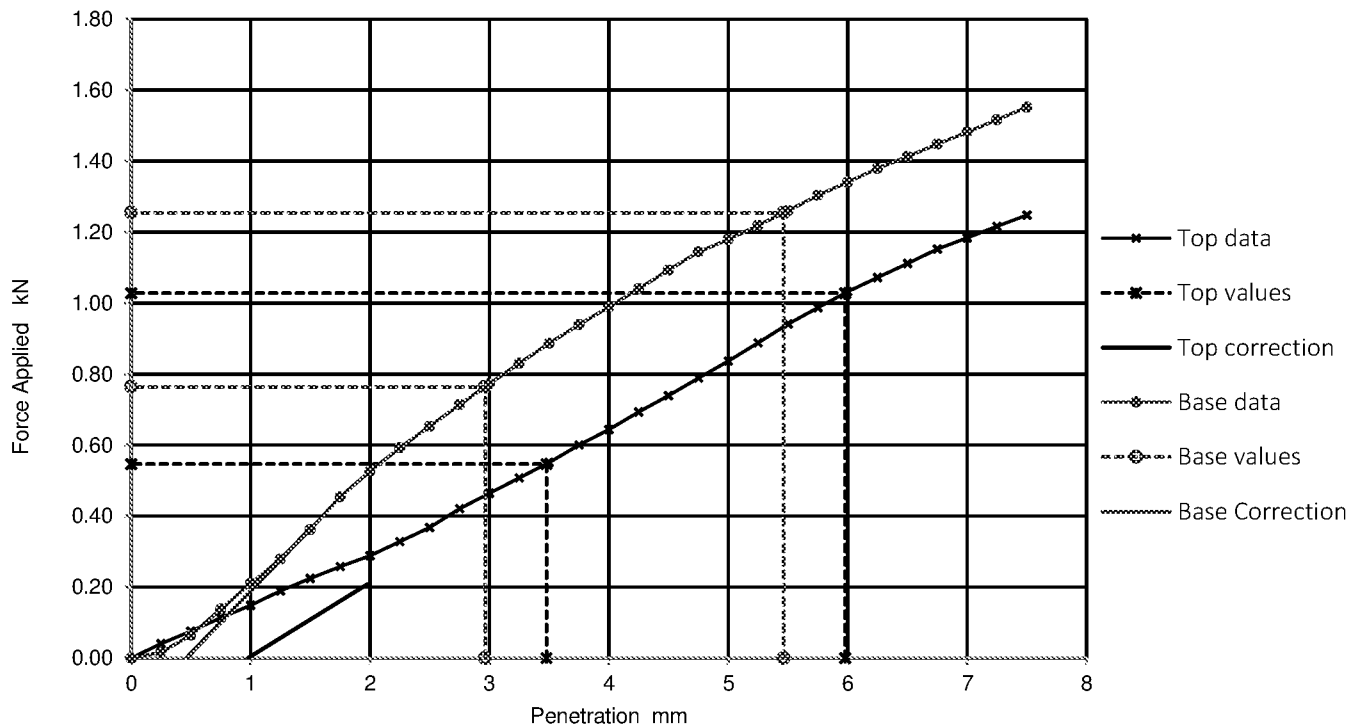
### Force v Penetration Plots

Moisture content 18 %

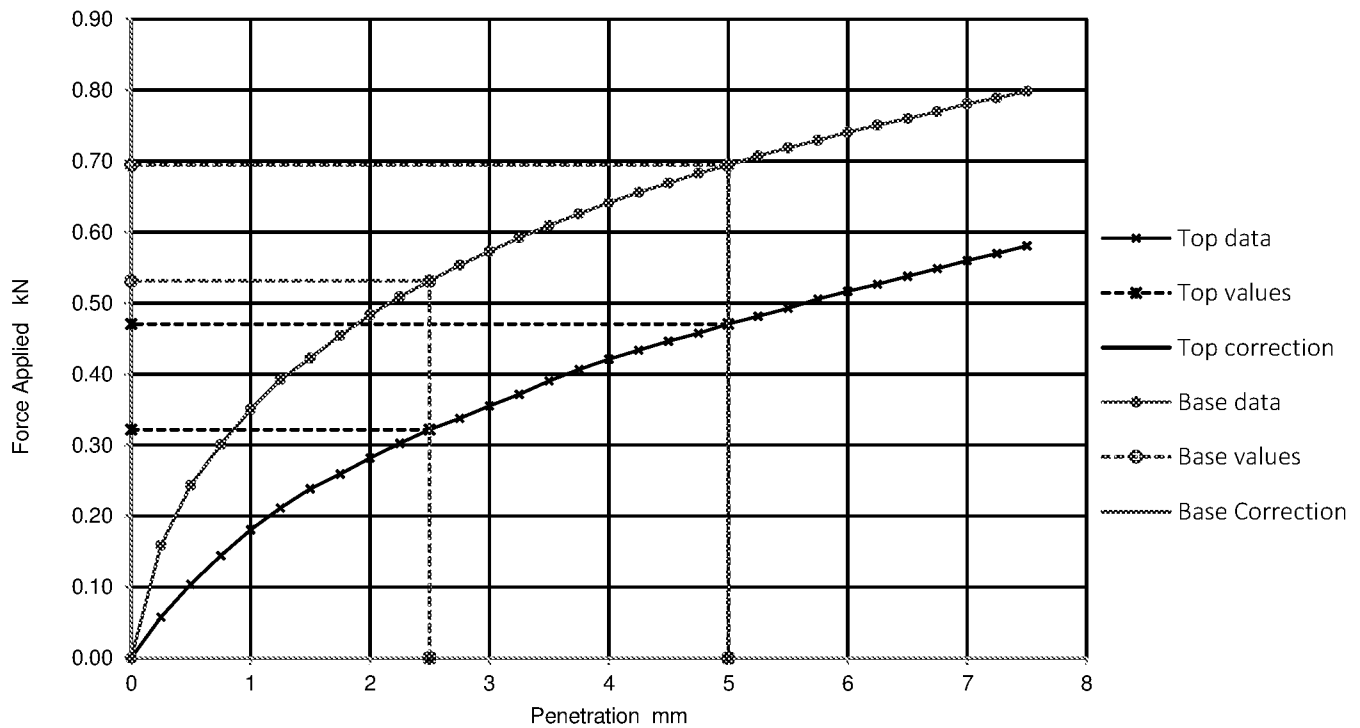
Force v Penetration Plots

Initial Specimen details Bulk density 1.76 Mg/m<sup>3</sup> Surcharge applied 6 kg  
Dry density 1.56 Mg/m<sup>3</sup> 4 kPa  
Moisture content 13 %

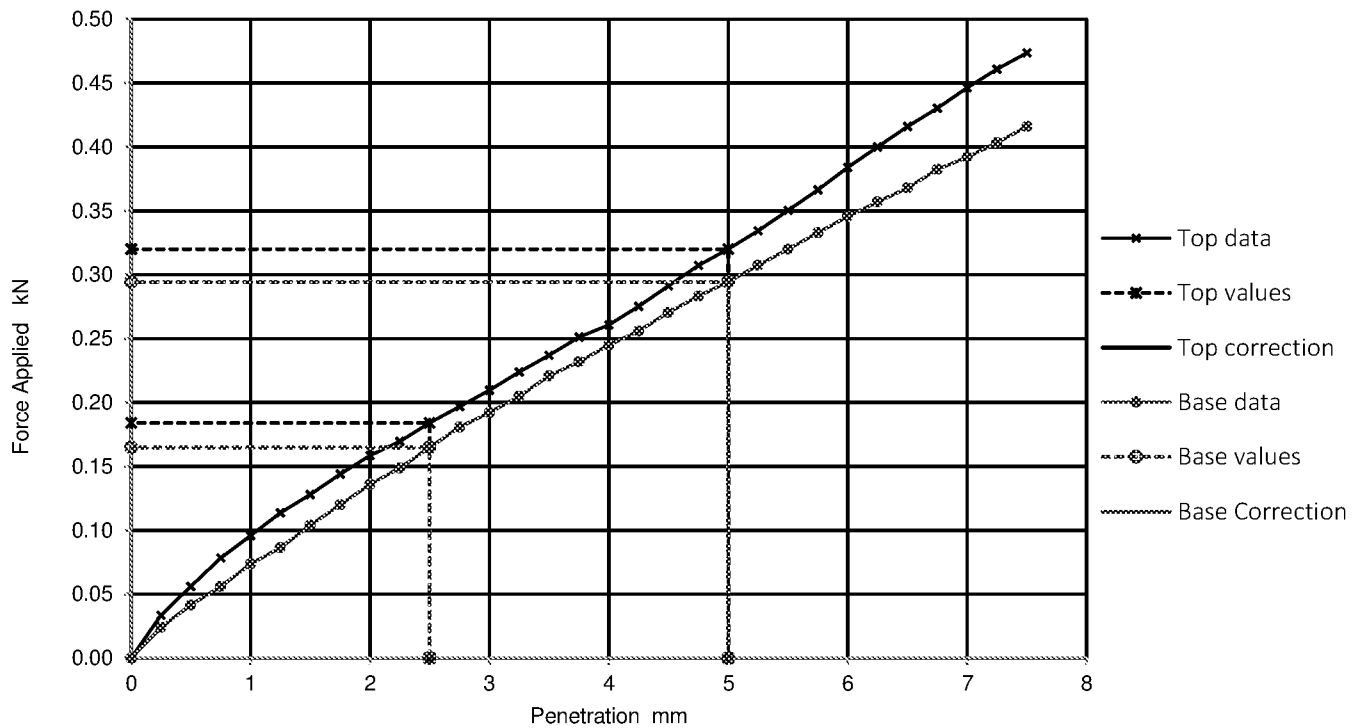
Force v Penetration Plots

Initial Specimen details Bulk density 2.06 Mg/m<sup>3</sup> Surcharge applied 6 kg  
Dry density 1.71 Mg/m<sup>3</sup> 4 kPa  
Moisture content 20 %

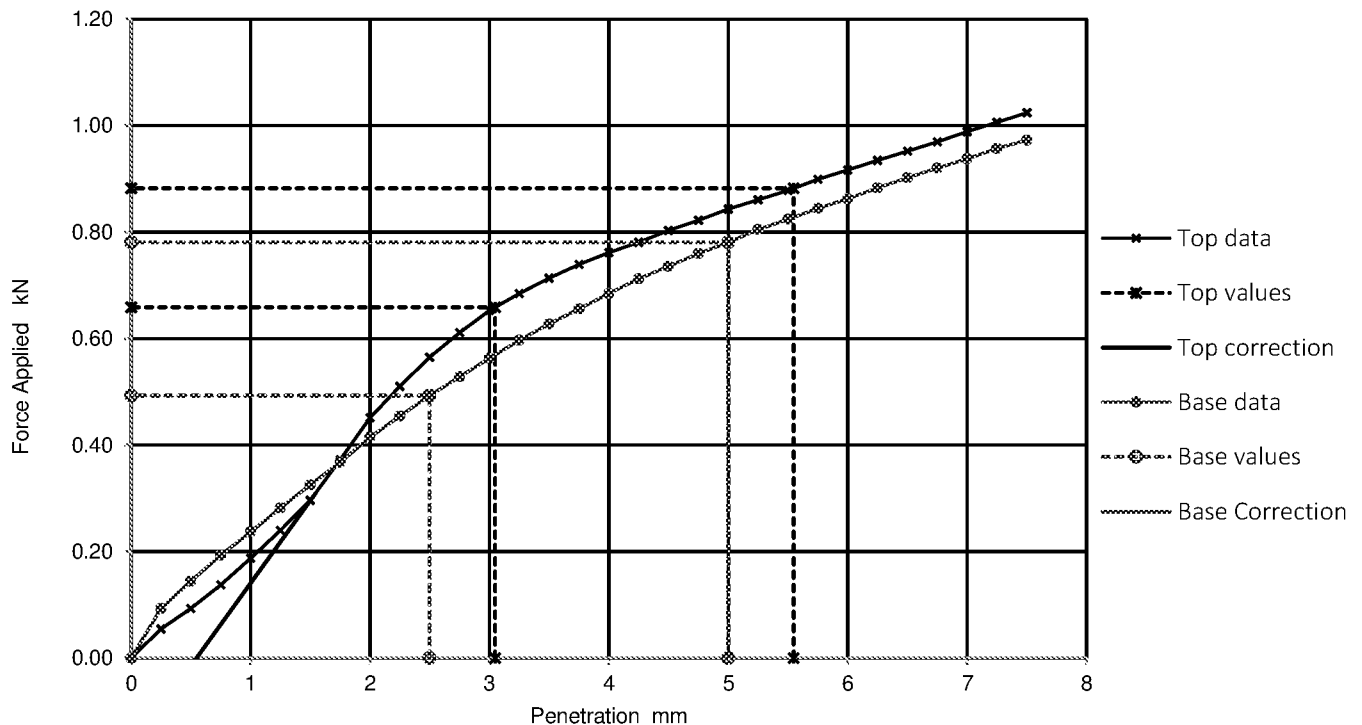
Force v Penetration Plots

| | Moisture content | 10 | % | | | |
