## Bat Survey Report

For proposed development at:

Hobbs Farm house  
Bilsham Road  
Yapton  
Arundel  
BN18 0JY

| Tony Hargreaves BSc AIEMA<br>Director | Project Ref: 17186 |

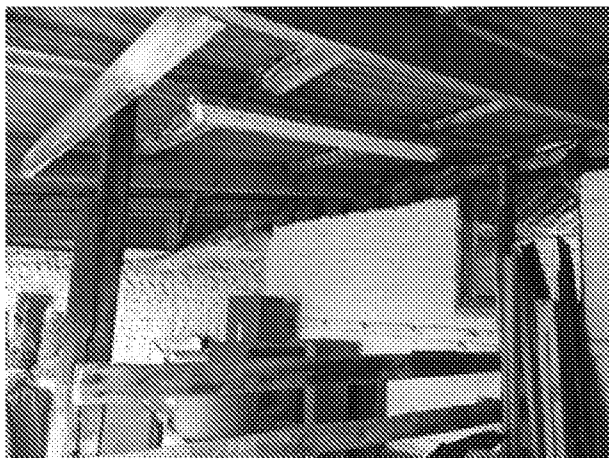
Interior of side (east) lean to.

- 4.1.5. The lean to either side, one is finished in a corrugated sheet tin roof the other in a corrugated cement sheet roof. Neither of these offer suitable opportunities for bats and there were no signs of bats within these sections.

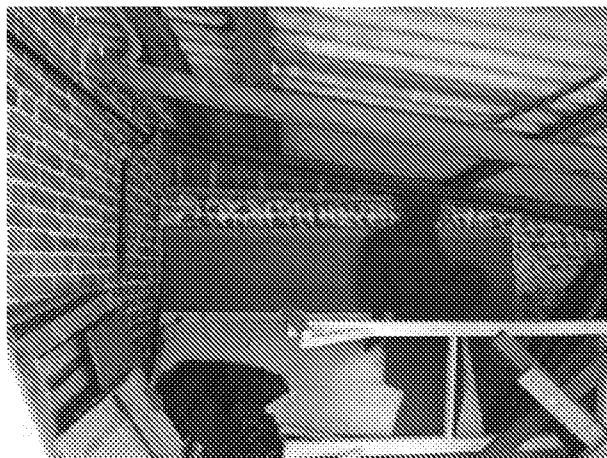
Interior of side (west) lean to

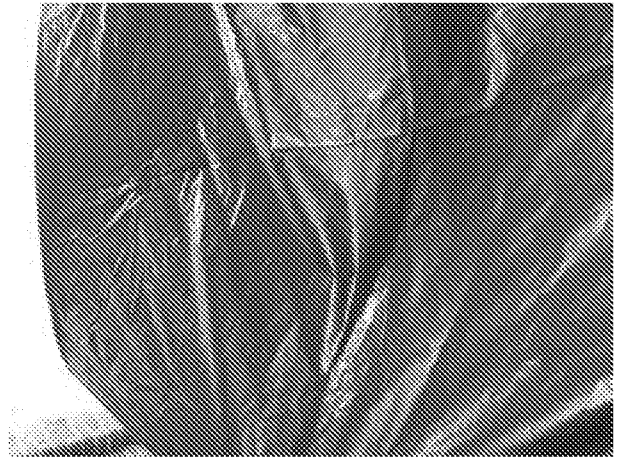
Scattering of small number of droppings on car cover.

- 4.1.1. There is a scattering of bat droppings throughout the outbuilding. These were of a smooth appearance and fine particle characteristic of Pipistrelle species confirmed as Soprano Pipistrelle through DNA analysis (see appendix C)

- 4.1.4. The main concentration of bat droppings was at the eastern end of the property. Where a small cavity could be seen around the ridge beam into the ridge tile cavity. This is considered likely to be a site of bat roosting.

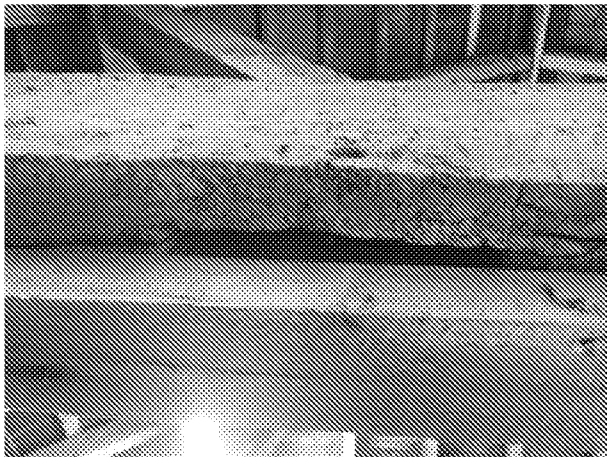
Old mortice tenon joint partly obstructed by modern timber.

- 4.1.3. The timbers on the most part do not offer suitable cavities however, there are cross timbers which have traditional mortice joints within them although several of these are largely covered by modern timbers. However, they were clear on the most part of cobwebs indicating that they maybe being disturbed, although no droppings are present to indicate they are used by bats.

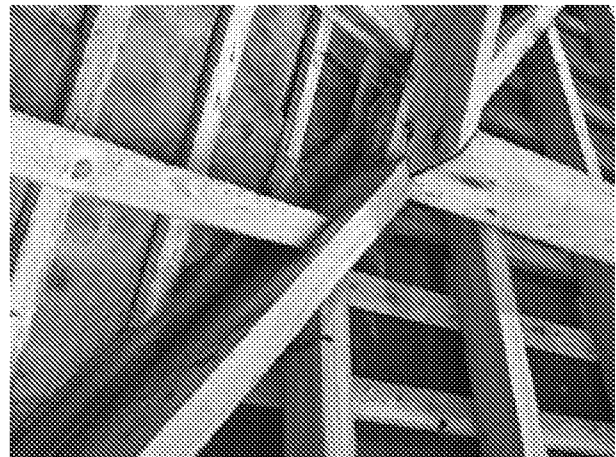
Bird nest on purlin timber.

- 4.1.8. A bird nest was identified on purlin timbers, currently unoccupied.

8.1.4. To prevent harm to birds it is recommended that works commence outside of the bird breeding season (1st March to 31st August). If this is not possible then a pre-works inspection for any nesting activity should be carried out, should any nesting activity be identified works in those areas must wait until the nesting season is over and the birds have fledged.
