# Arboricultural Impact Assessment

Land at:  
Yapton road  
Yapton  
West Sussex

16<sup>th</sup> November 2017

PJC ref: 4698/17-02

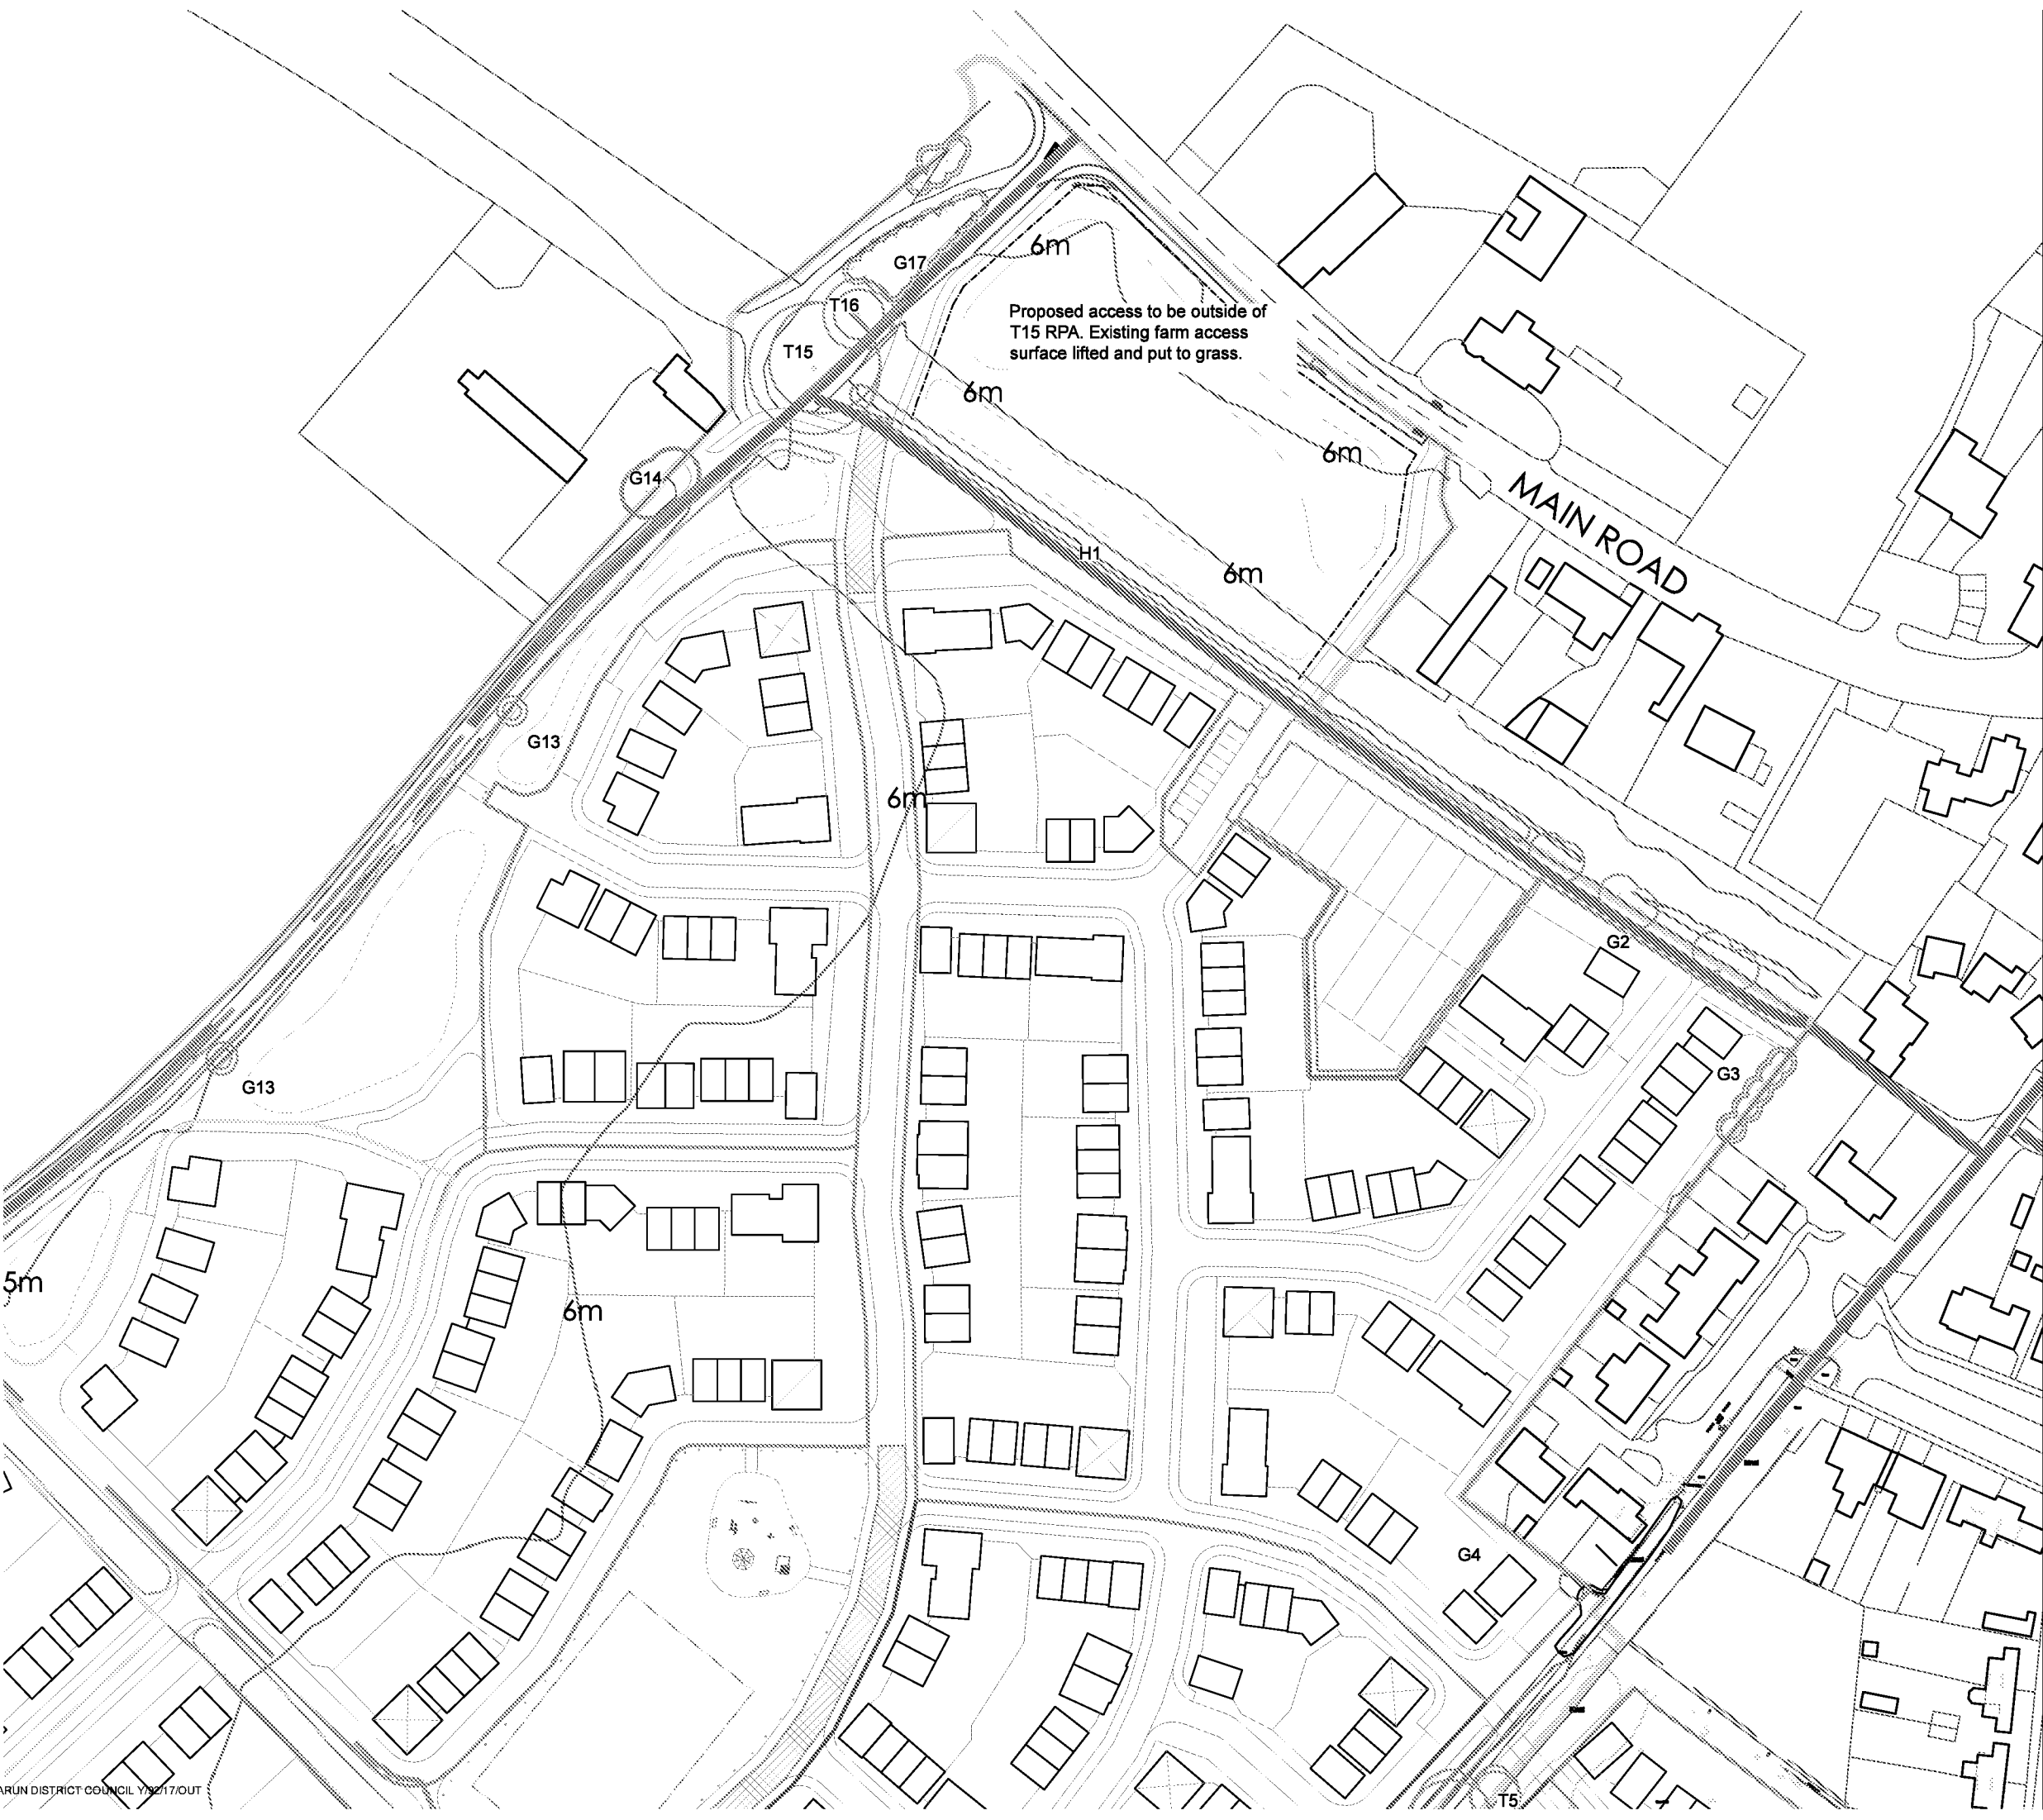
| Drawing title: Tree Retention Plan | | | | |

**4.1 Tree removals:** All category A, B and C trees are shown to be retained on the current layout. Trees will be protected during the proposed development to maintain standards of local visual amenity.

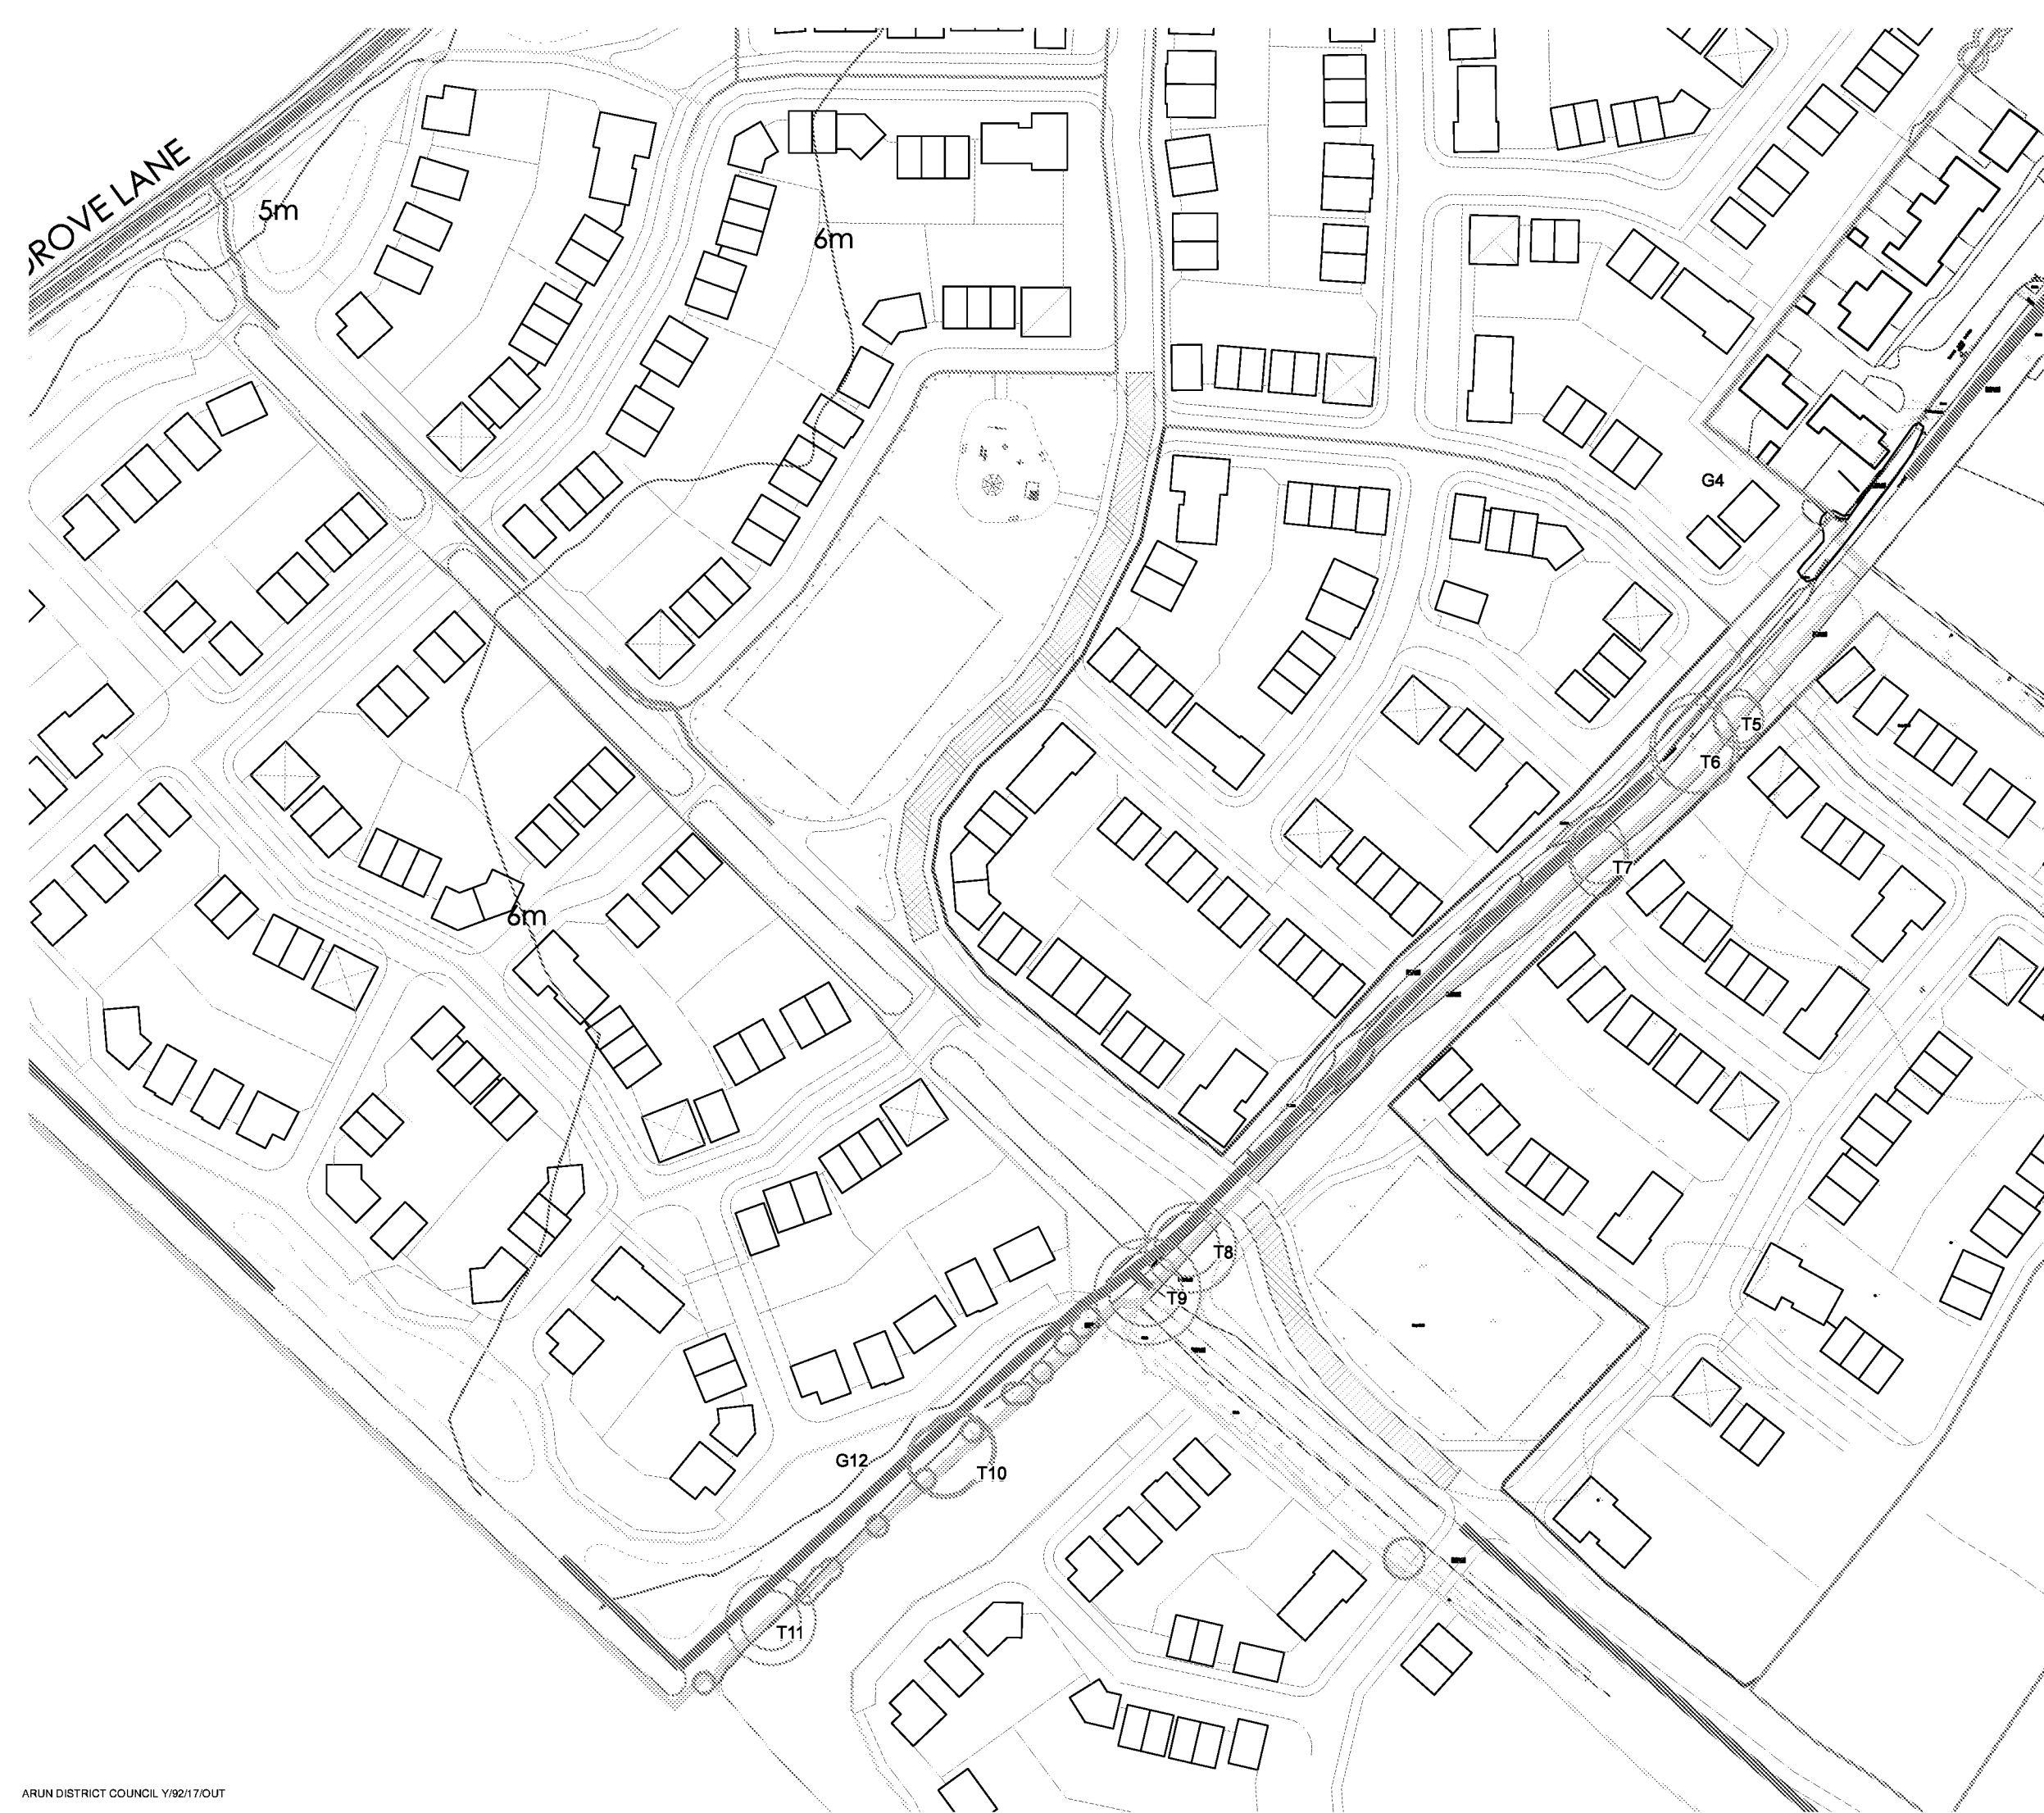
Drawing title: Tree Retention Plan

**4.3 Works within root protection areas:** The southern road link to the adjacent proposed development passes across the RPA of T8. This is a minor encroachment and is not thought to represent a significant threat to the potential future retention of the tree, however it is advised that at reserved matters stage, the design seeks to avoid this encroachment therefore reducing the potential for damage. The existing shared access from Yapton Road to the north of the site consists of a set concrete slab. This surface passes within 2m of the stem of T15. The proposal seeks to lift the existing road creating the new access outside of RPAs. Detailed methodologies for working in the RPA of T15 should be put forward as part of an arboricultural method statement at detailed planning permission.

5.2 The proposed site layout involves construction of a small quantity of surfacing in the RPA of T8. Final layouts should seek to remove this encroachment entirely if possible even though it is unlikely to represent a significant impact to the trees potential for future retention.
