# Management of Japanese knotweed, *Fallopia japonica*

Project:  
2793 Burndell Road, Yapton.

## Project Brief

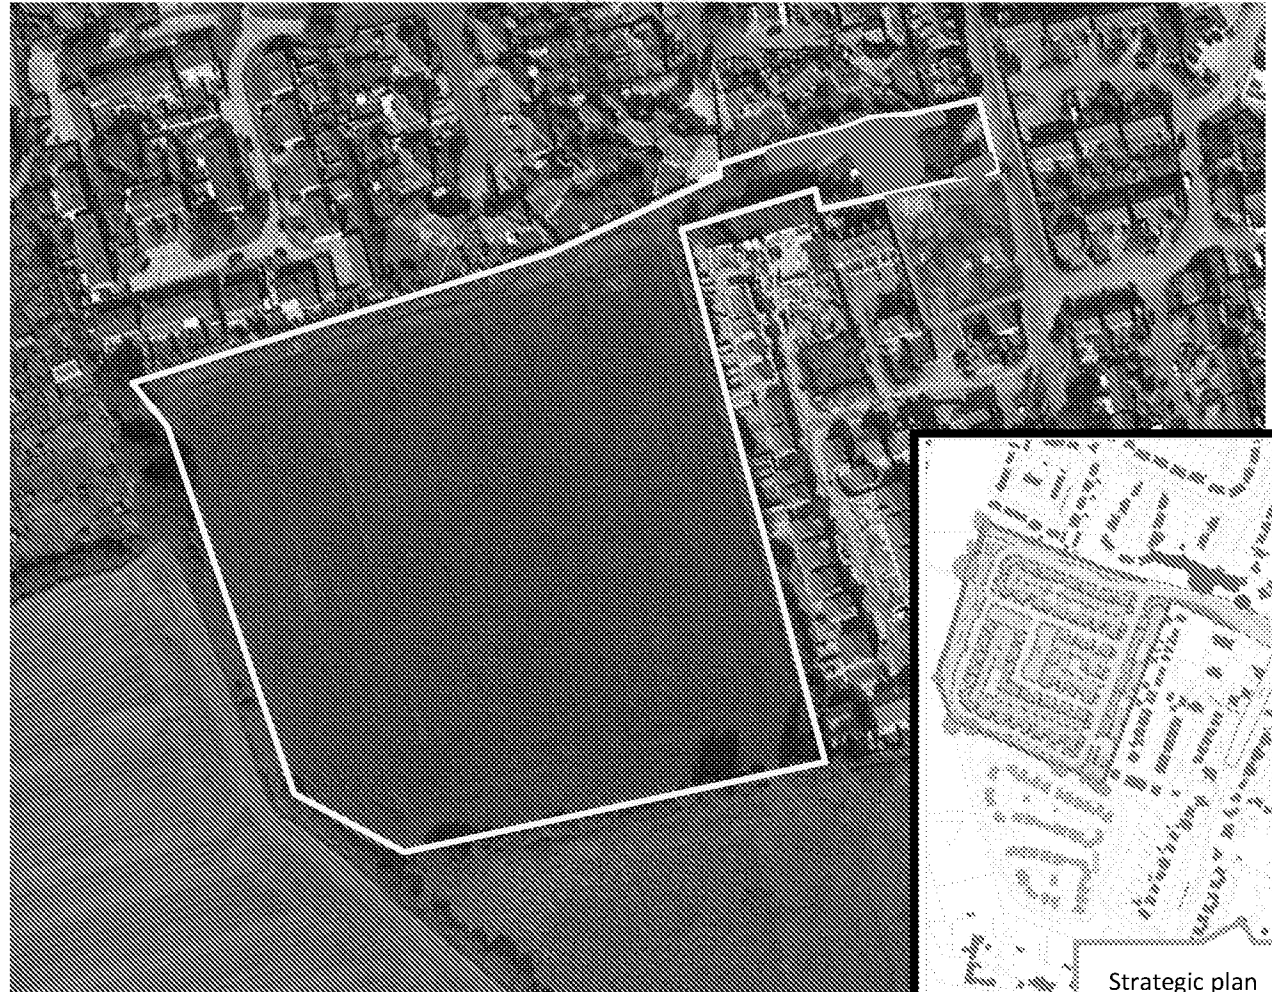
## Site Survey plan

Approximate survey area.

\*Approximate Japanese Knotweed affected areas.

Area requiring further survey which was not accessible on the day. (not part of site but to be used as access).

\*Mapping the site would allow us to accurately cite the current visible Japanese Knotweed extent and potential extent of the underground rhizome system.

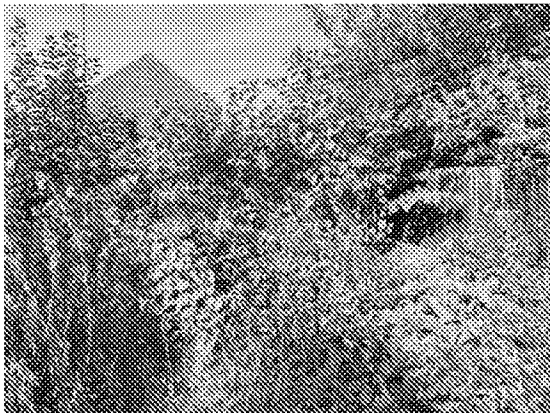
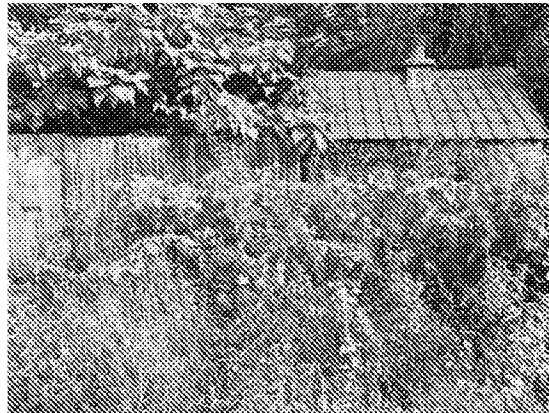
## Site Photographs – JK area 1.

Japanese Knotweed observed here within adjacent property (derelict cottages garden)

Japanese Knotweed located on site boundary with adjacent property and highway.

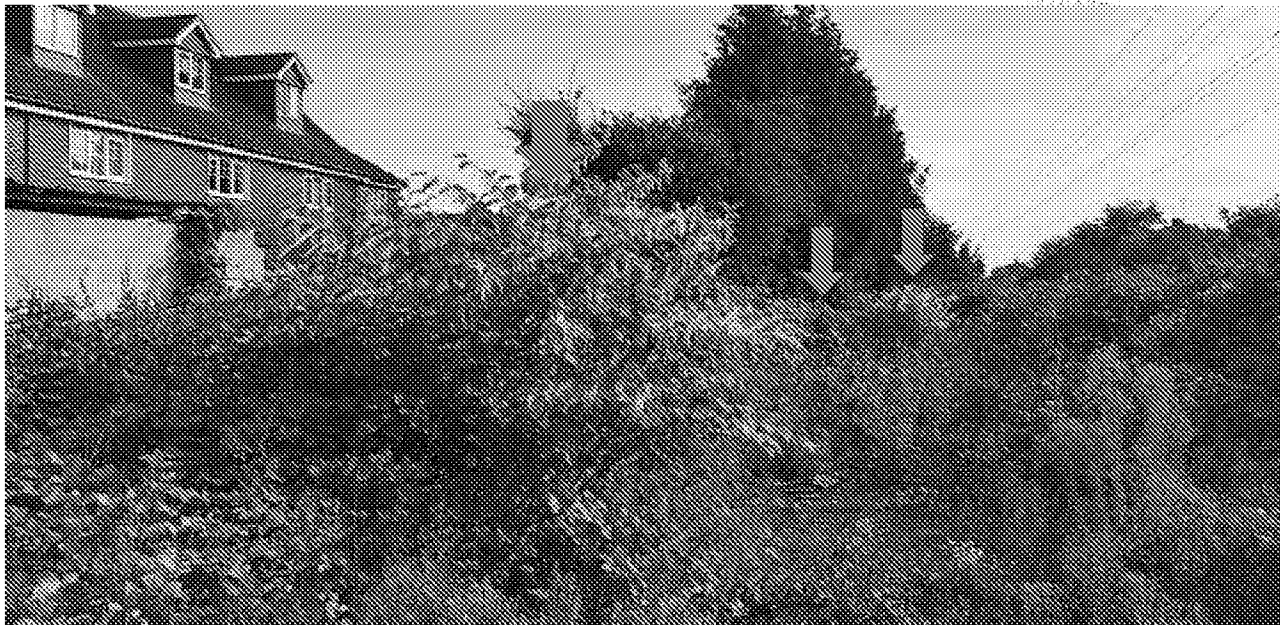
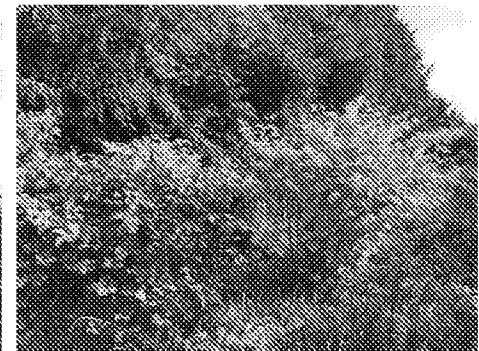
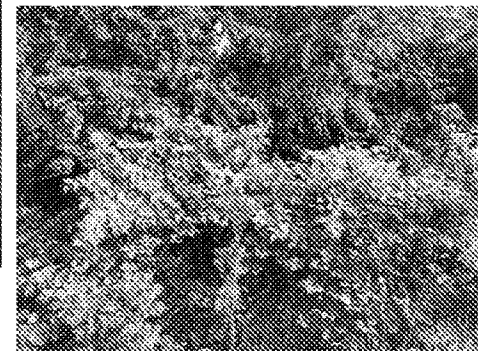
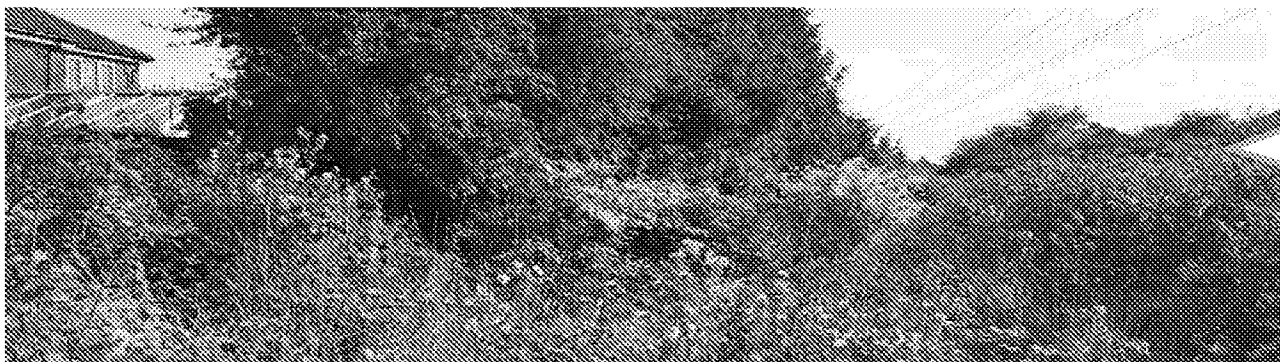
## Site Photographs — JK area 2

Japanese Knotweed located within 7m  
of site boundary.

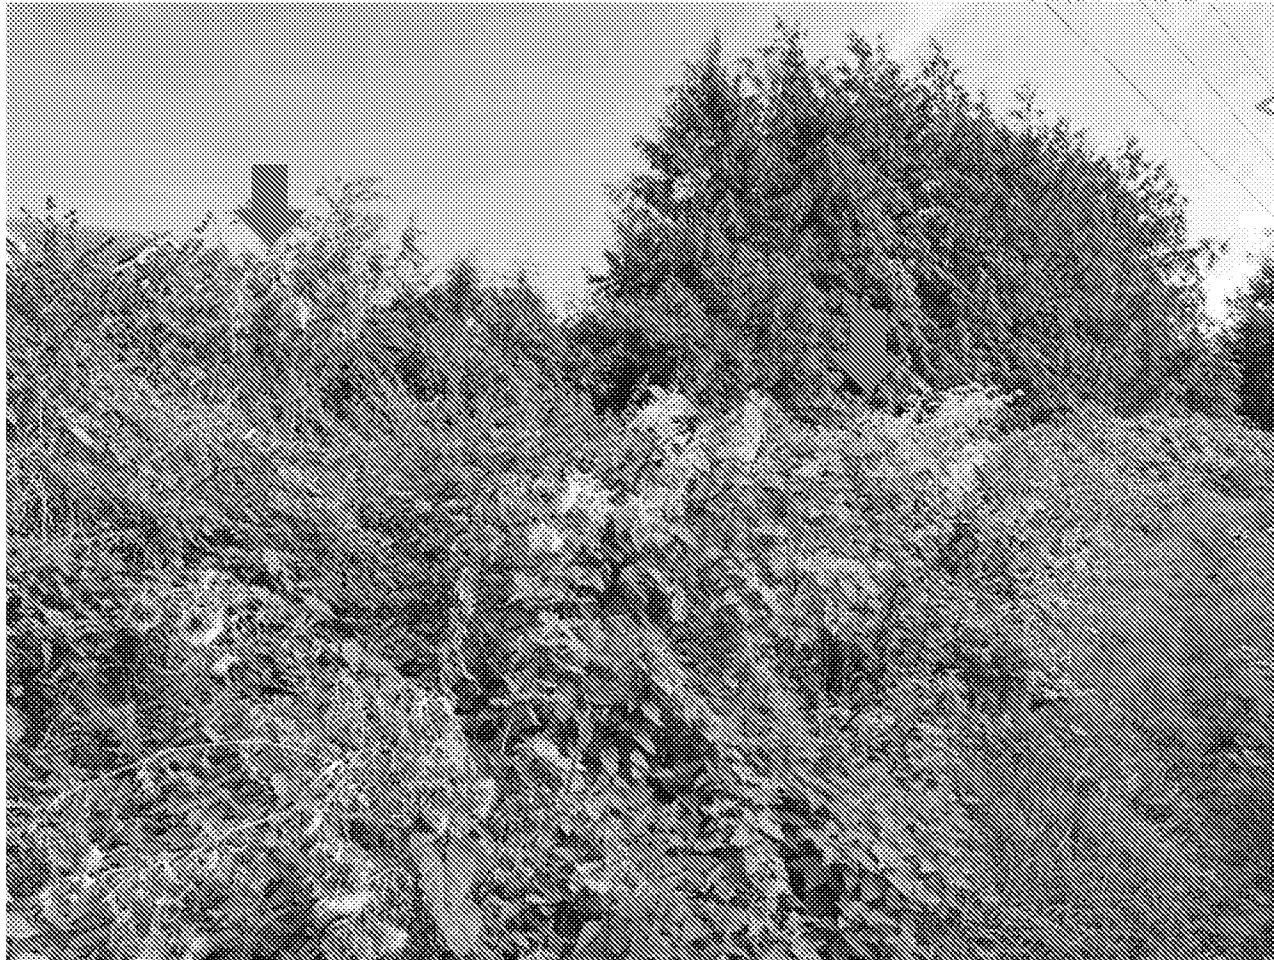
## Site Photographs – JK area 3

In several locations, the Japanese Knotweed was growing amongst dense thickets of brambles. It is possible that this dense vegetation is masking the extent of the infestation.

- ✧ Dense thickets of bramble have the potential to mask the full extent of the infestation.
- ✧ The Japanese Knotweed is widespread within the critical development area.

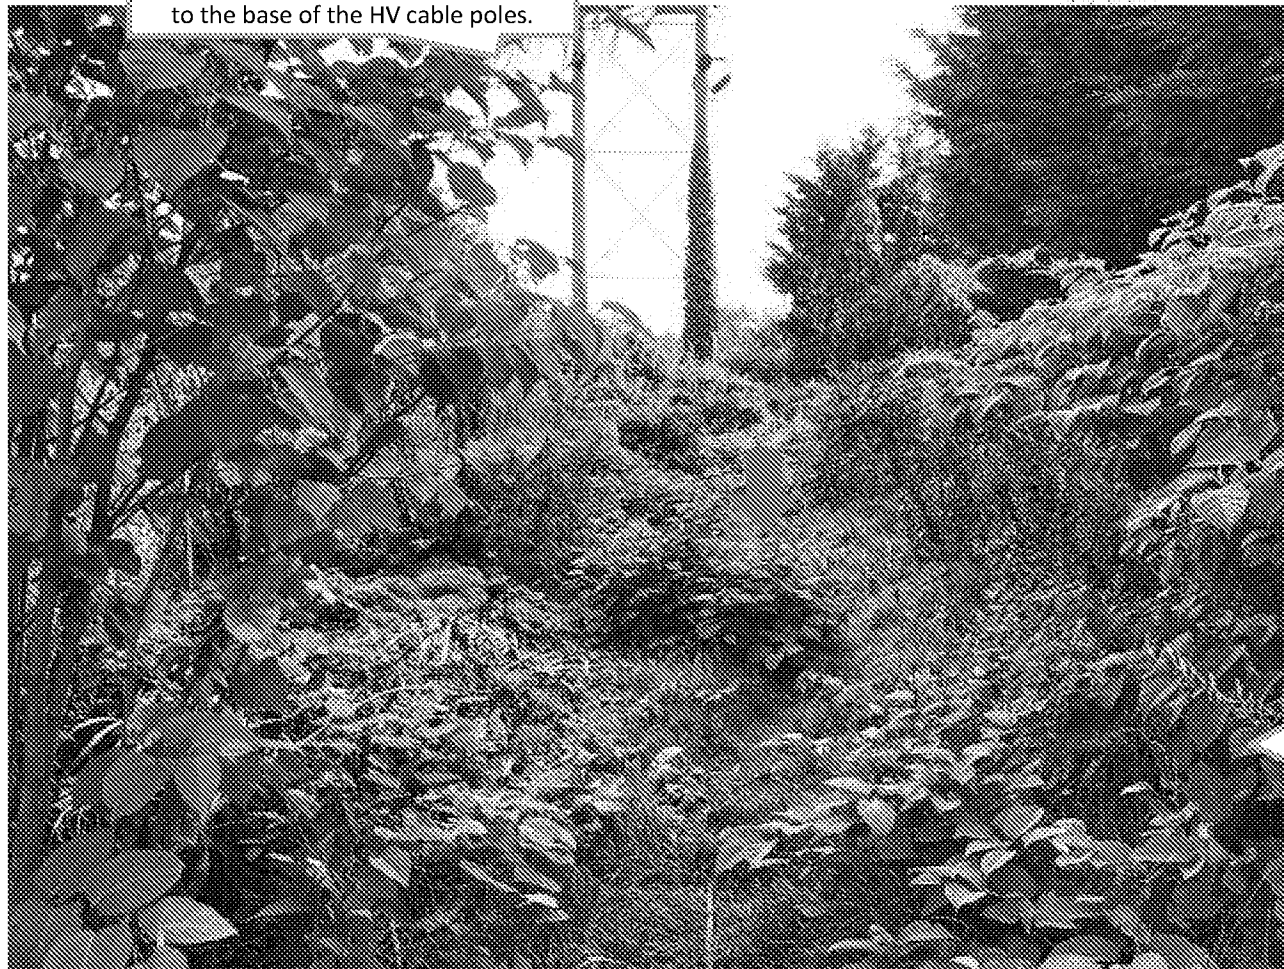
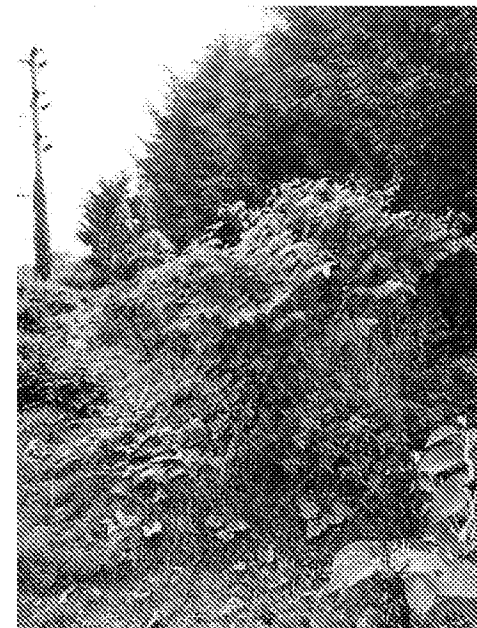
## Site Photographs — JK area 3

Japanese Knotweed established close to the base of the HV cable poles.

In other areas, around the foot path and rear entrances to properties located adjacent, the Japanese Knotweed has been cut back resulting in smaller sporadic stands of Japanese Knotweed.

- ✧ Japanese Knotweed is located on or within 7m of the site boundary within a number of locations.
- ✧ The plant is also located within 7m of the poles supporting the overhead HV cables.

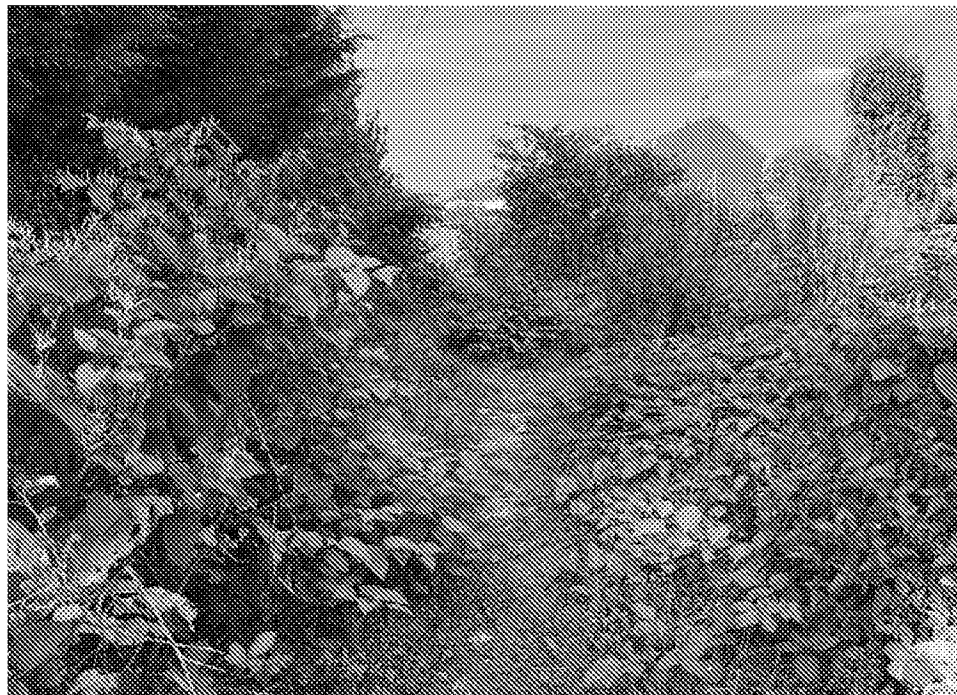
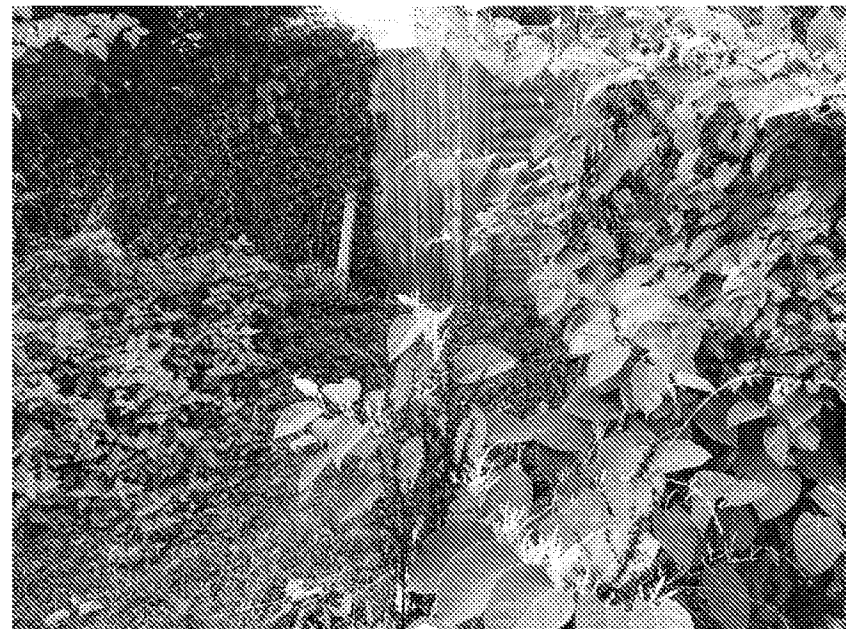
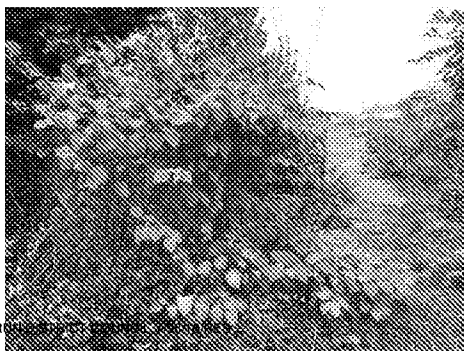
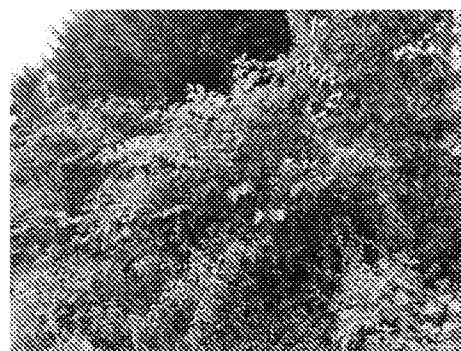
## Site Photographs — JK area 3

In other areas, around the foot path and rear entrances to properties located adjacent, the Japanese Knotweed has been cut back resulting in smaller sporadic stands of Japanese Knotweed.

Japanese Knotweed frequently observed on and within 7m of site boundary.

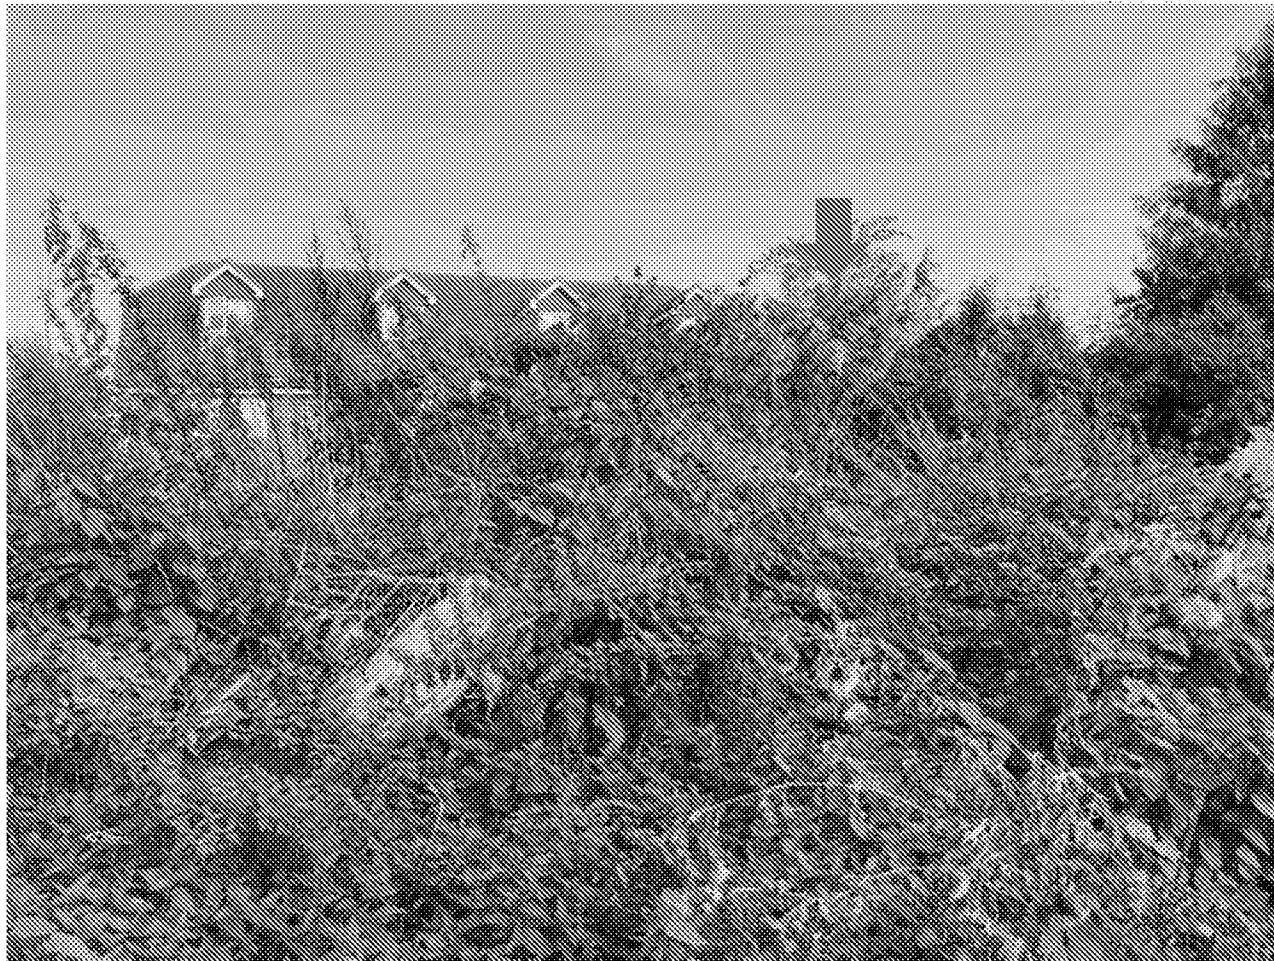
## Site Photographs – JK area 4

A small stand of Japanese Knotweed was found to be growing on top of a vegetated bund located within this part of the site. The bund appeared to contain scraped up vegetation, soils and logs, likely resulting from previous clearances of the area. See historic satellite images.

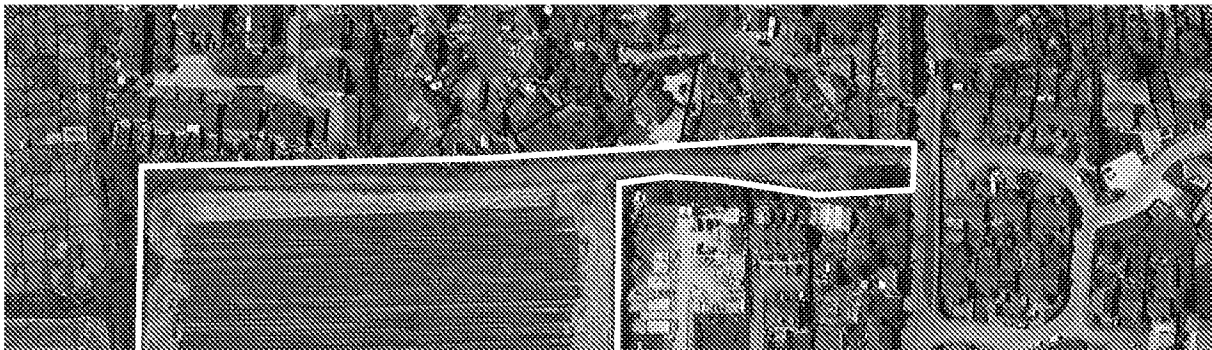
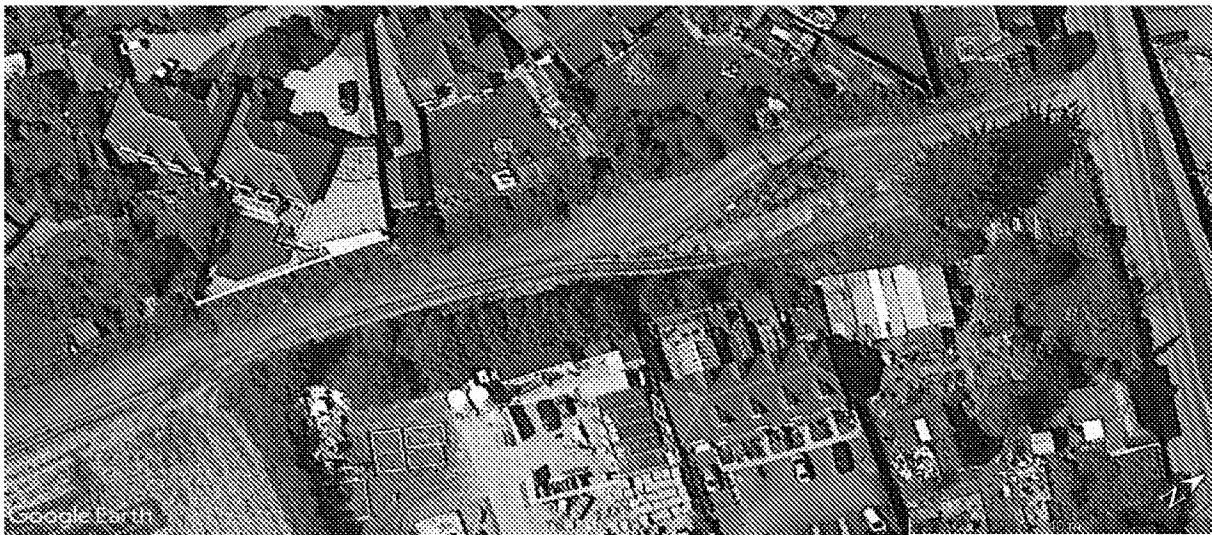
## Site Photographs — JK area 4

Historic images captured on 22.04.15 show that the area affected by the Japanese Knotweed was subject to extensive clearance.

It may have been during these works that the Japanese Knotweed was imported onto site, however it is considered more likely that the infestation was already present and that these activities resulted in the widespread distribution of the plant and the sporadic nature now observed,

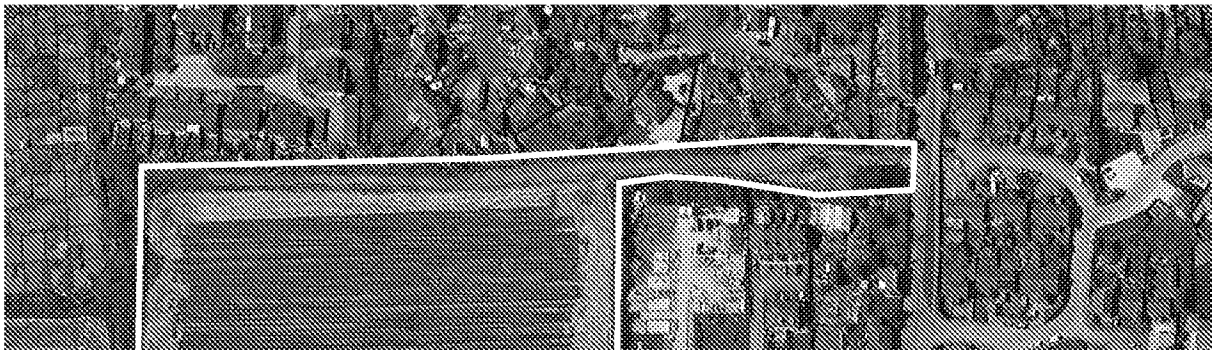
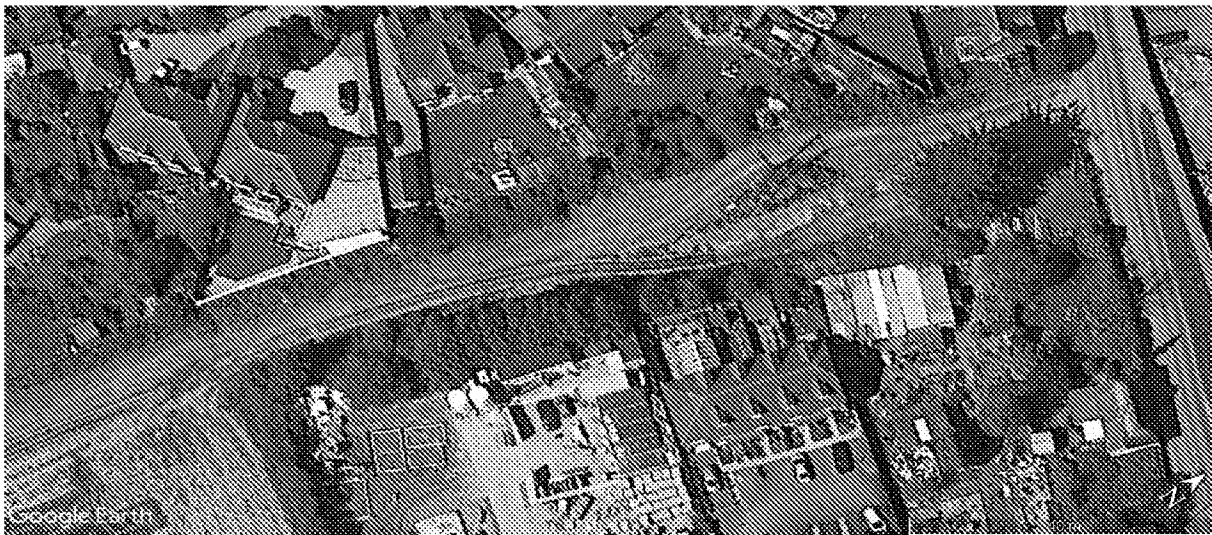
## Site Photographs – Historic uncontrolled works

Historic images captured on 22.04.15 show that the area affected by the Japanese Knotweed was subject to extensive clearance.

It may have been during these works that the Japanese Knotweed was imported onto site, or, it is considered more likely that the infestation was already present and that these activities resulted in the widespread distribution of the plant and the sporadic nature now observed.

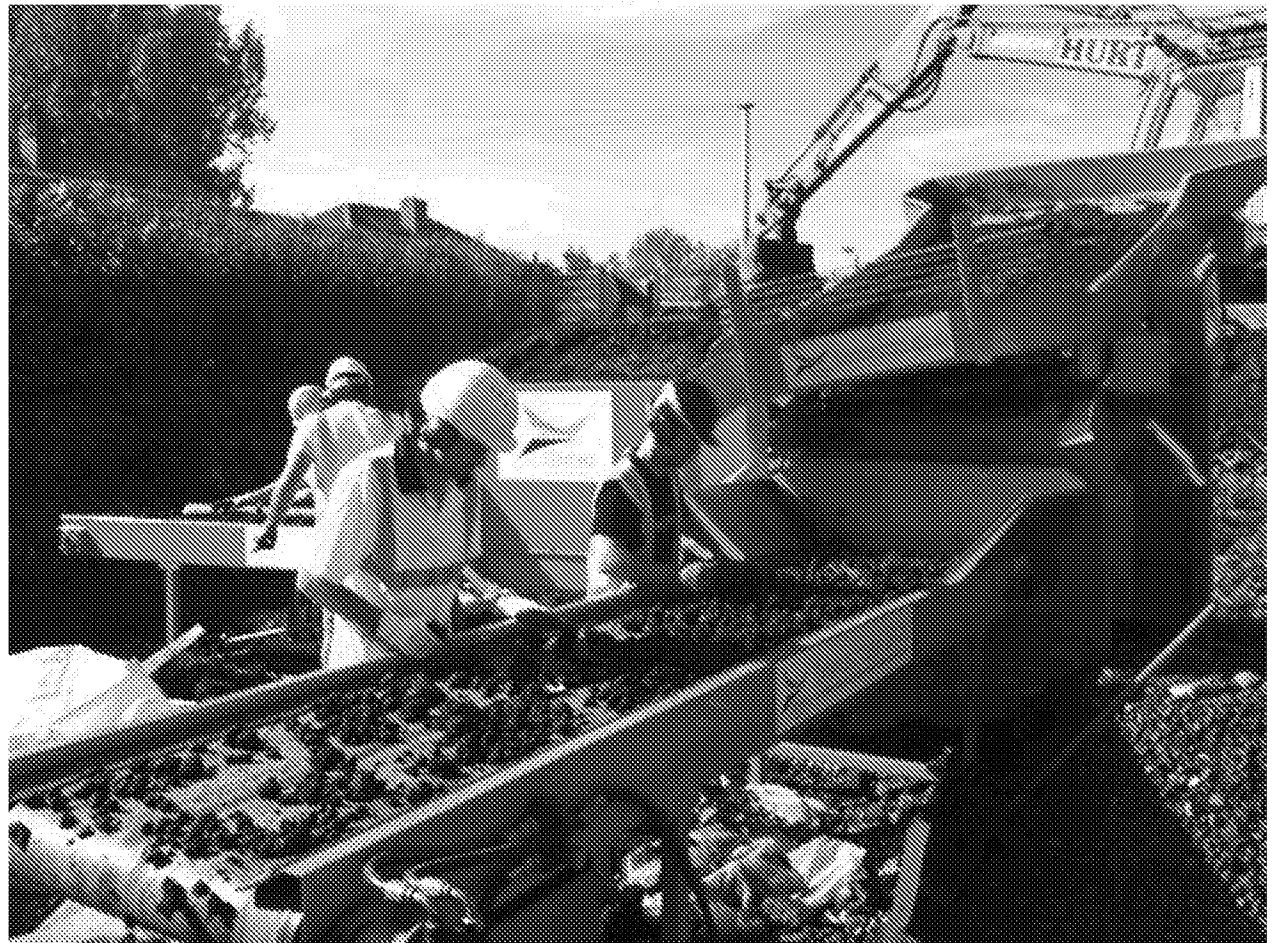
## ENVIROSCREEN 20-20

The system sees material which contains Japanese knotweed rhizomes processed through a mechanical soil separation unit and then manually picked to further remove knotweed. Upon completion only the Japanese knotweed material (Typically <1%) is removed from site, with the three sized processed material being re-engineered into the site. Re engineering works to be undertaken by the client under Ebsford supervision / consultation.

Once the operation begins the screened material will be split in to 3 separate stockpiles, the method of reuse is detailed below:

- **Stockpile 1:** Predominately oversized material such as brick, large stones and concrete blocks. This stockpile might require crushing before reuse on site. Estimated quantity will be 15% - 20% of the total volume screened. **Once processed this material can be reused anywhere on site without restriction.**

- **Stockpile 2:** Material varying in size up to 75-90mm (with small amounts of soil) which will have been handpicked to remove 99.9% of the rhizome material. This processed material will be stockpiled and can be reused on site. **This material can also be reused on site in any location. Estimated quantity of 40% - 50% of volume screened.**

- **Stockpile 3:** Material which will closely resemble topsoil < 20mm in size. There will be small fragments of rhizome, smaller than a biro pen within this material which usually results in a requirement for a cap of 500mm. The rhizome which remains in the material will not be viable from this depth and will simply rot away.
