# Geo-Environmental Site Investigation

## Burndell Road, Yapton

Report Reference: **BRD2484-OR2-A**

Date: **December 2015**

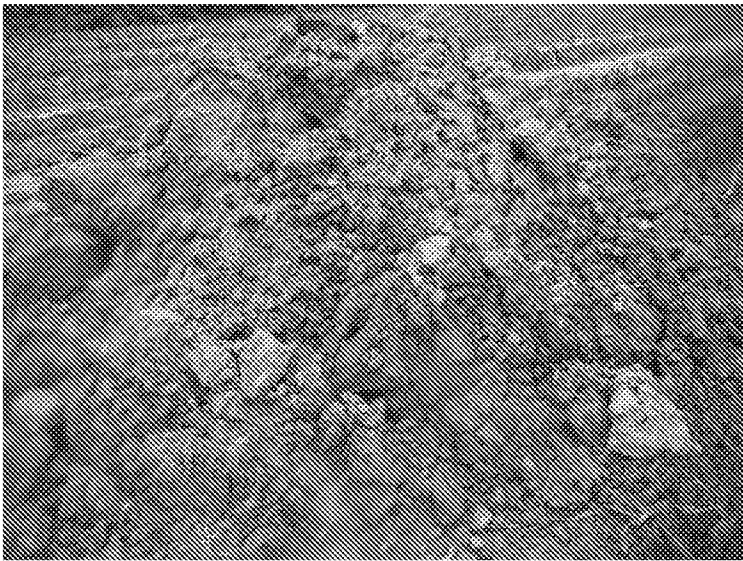
| AEOLIAN DEPOSITS | | | |
|---|---|---|---|
| | GROUNDWATER | Groundwater was observed in this stratum in the boreholes as moist soils, and in TP07 and TP08 as seepages at the base of the pits. | |
