Asbestos Demolition Survey Report

HMP Ford, Ford Road, Arundel, West Sussex, BN18 0BX

Title: HMP Ford - Demolition Surveys of Accommodation Buildings (Batch 3)

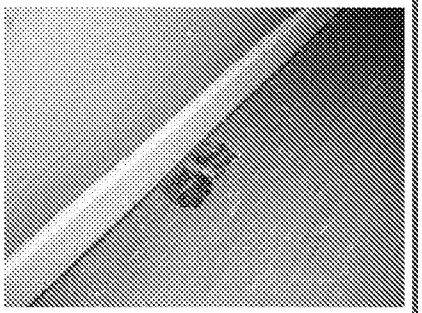
Building	Level	Location	Item / Product Examined	Sample No.	Material Description	Fibre Type	Material Score	Extent	Risk Level Assessment	Initial Control Recommendation	Photograph
Accommodation Hut G1	0	001/ corridor	Subfloor	472686-3	Asbestos-containing bitumen adhesive	Chrysotile	3	24 Sqm.	R3	Remove	
Accommodation Hut G1	0	002/ bedroom	Subfloor	472686-3	Asbestos-containing bitumen adhesive	Chrysotile	3	6 Sqm.	R3	Remove	
Accommodation Hut G1	0	003/ bedroom	Subfloor	472686-3	Asbestos-containing bitumen adhesive	Chrysotile	3	6 Sqm.	R3	Remove

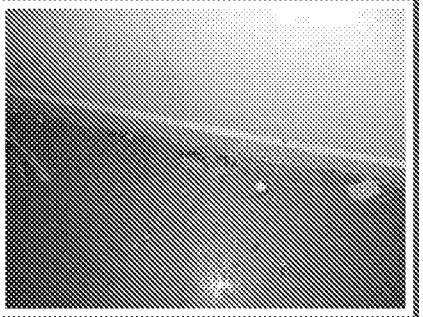
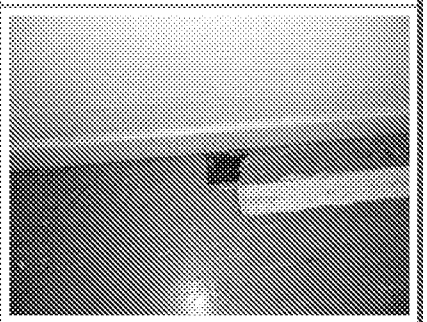
Building	Level	Location	Item / Product Examined	Sample No.	Material Description	Fibre Type	Material Score	Extent	Risk Level Assessment	Initial Control Recommendation	Photograph
Accommodation Hut G1	0	004/ bedroom	Subfloor	472686-3	Asbestos-containing bitumen adhesive	Chrysotile	3	6 Sqm.	R3	Remove	
Accommodation Hut G1	0	005/ bedroom	Subfloor	472686-3	Asbestos-containing bitumen adhesive	Chrysotile	3	6 Sqm.	R3	Remove	
Accommodation Hut G1	0	006/ bedroom	Subfloor	472686-3	Asbestos-containing bitumen adhesive	Chrysotile	3	6 Sqm.	R3	Remove

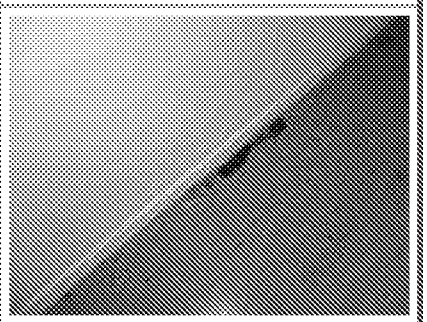
Building	Level	Location	Item / Product Examined	Sample No.	Material Description	Fibre Type	Material Score	Extent	Risk Level Assessment	Initial Control Recommendation	Photograph
Accommodation Hut G1	0	007/ bedroom	Subfloor	472686-3	Asbestos-containing bitumen adhesive	Chrysotile	3	6 Sqm.	R3	Remove	
Accommodation Hut G1	0	008/ bedroom	Subfloor	472686-3	Asbestos-containing bitumen adhesive	Chrysotile	3	6 Sqm.	R3	Remove	
Accommodation Hut G1	0	009/ bedroom	Subfloor	472686-3	Asbestos-containing bitumen adhesive	Chrysotile	3	6 Sqm.	R3	Remove

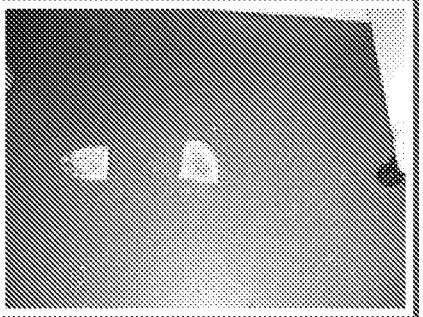
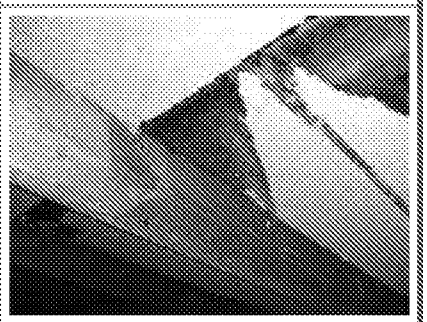
Building	Level	Location	Item / Product Examined	Sample No.	Material Description	Fibre Type	Material Score	Extent	Risk Level Assessment	Initial Control Recommendation	Photograph
Accommodation Hut G1	0	013/ kitchen	Subfloor	472686-3	Asbestos-containing bitumen adhesive	Chrysotile	3	8 Sqm.	R3	Remove	
Accommodation Hut G1	1	001/loft space	Slaters felt	472686-8	Asbestos-containing bituminous product	Chrysotile	3	100 Sqm.	R3	Remove	
Accommodation Hut G1	9	999/ externals	Wall panels with textured coating in porch	472686-11	Asbestos-containing insulating board	Amosite, Chrysotile	6	6 Sqm.	R2	Remove

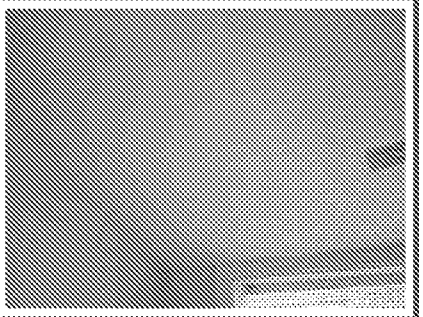
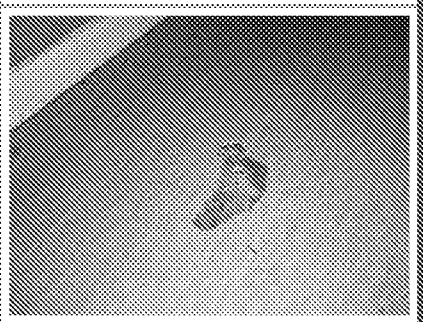
Building	Level	Location	Item / Product Examined	Sample No.	Material Description	Fibre Type	Material Score	Extent	Risk Level Assessment	Initial Control Recommendation	Photograph
Accommodation Hut G1	9	999/ externals	Ceiling panels with textured coating in porch	472686-10	Asbestos-containing insulating board	Amosite, Chrysotile	6	2 Sqm.	R3	Remove	
Accommodation Hut G2	0	001/ corridor	Subfloor	472686-14	Asbestos-containing bitumen adhesive	Chrysotile	3	21 Sqm.	R3	Remove	
Accommodation Hut G2	0	002/plant room	Floor covering	472686-14	Asbestos-containing bitumen adhesive	Chrysotile	3	4 Sqm.	R3	Remove

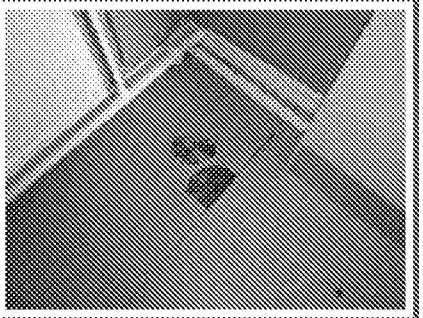
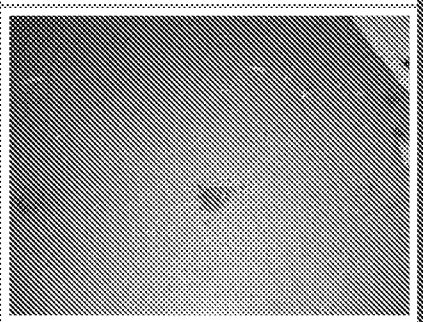
Building	Level	Location	Item / Product Examined	Sample No.	Material Description	Fibre Type	Material Score	Extent	Risk Level Assessment	Initial Control Recommendation	Photograph
Accommodation Hut G2	0	005/ kitchen	Subfloor	472686-14	Asbestos-containing bitumen adhesive	Chrysotile	3	6 Sqm.	R3	Remove	
Accommodation Hut G2	0	006/ bedroom	Subfloor	472686-14	Asbestos-containing bitumen adhesive	Chrysotile	3	6 Sqm.	R3	Remove	
Accommodation Hut G2	0	007/ bedroom	Subfloor	472686-14	Asbestos-containing bitumen adhesive	Chrysotile	3	6 Sqm.	R3	Remove

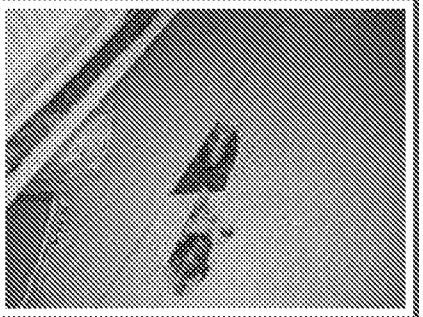
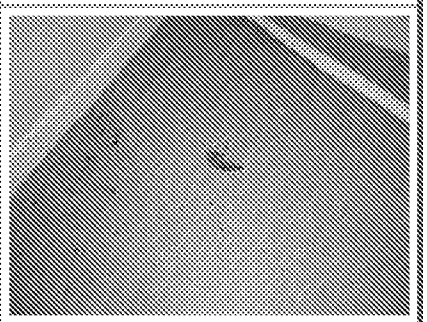
Building	Level	Location	Item / Product Examined	Sample No.	Material Description	Fibre Type	Material Score	Extent	Risk Level Assessment	Initial Control Recommendation	Photograph
Accommodation Hut G2	0	008/ bedroom	Subfloor	472686-14	Asbestos-containing bitumen adhesive	Chrysotile	3	6 Sqm.	R3	Remove	
Accommodation Hut G2	0	009/ bedroom	Subfloor	472686-14	Asbestos-containing bitumen adhesive	Chrysotile	3	6 Sqm.	R3	Remove	
Accommodation Hut G2	0	010/ bedroom	Subfloor	472686-14	Asbestos-containing bitumen adhesive	Chrysotile	3	6 Sqm.	R3	Remove

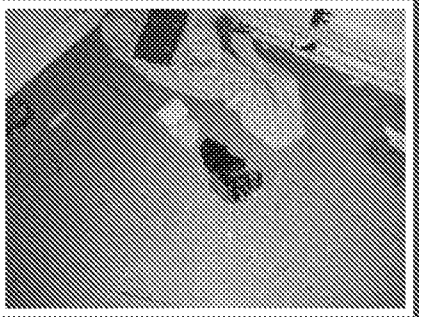
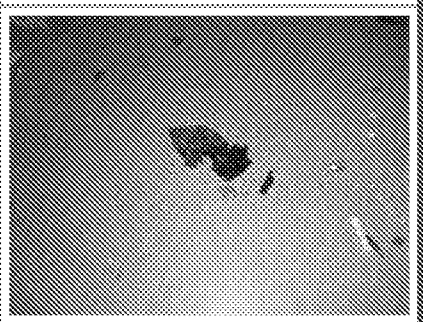
Building	Level	Location	Item / Product Examined	Sample No.	Material Description	Fibre Type	Material Score	Extent	Risk Level Assessment	Initial Control Recommendation	Photograph
Accommodation Hut G2	0	011/ bedroom	Subfloor	472686-14	Asbestos-containing bitumen adhesive	Chrysotile	3	6 Sqm.	R3	Remove	
Accommodation Hut G2	0	012/ bedroom	Subfloor	472686-14	Asbestos-containing bitumen adhesive	Chrysotile	3	6 Sqm.	R3	Remove	
Accommodation Hut G2	0	013/ bedroom	Subfloor	472686-14	Asbestos-containing bitumen adhesive	Chrysotile	3	6 Sqm.	R3	Remove

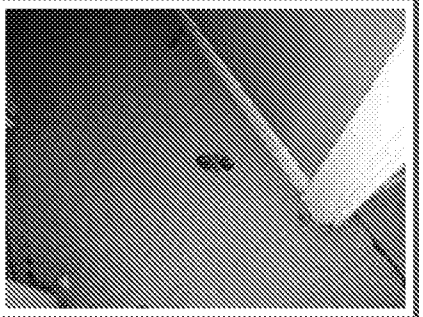
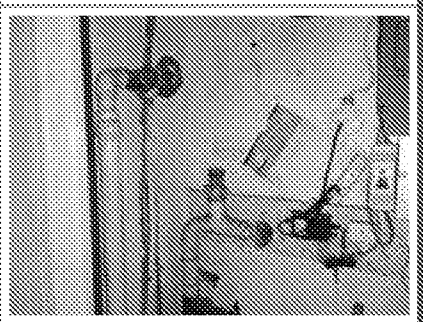
Building	Level	Location	Item / Product Examined	Sample No.	Material Description	Fibre Type	Material Score	Extent	Risk Level Assessment	Initial Control Recommendation	Photograph
Accommodation Hut H1	0	001/ corridor	Subfloor	472686-79	Asbestos-containing bitumen adhesive	Chrysotile	3	21 Sqm.	R3	Remove	
Accommodation Hut H1	0	002/plant room	Lining panels to walls in electrical area	472686-84	Asbestos-containing cement	Chrysotile	4	4 Sqm.	R3	Remove	
Accommodation Hut H1	0	002/plant room	Floor covering	472686-79	Asbestos-containing bitumen adhesive	Chrysotile	3	4 Sqm.	R3	Remove

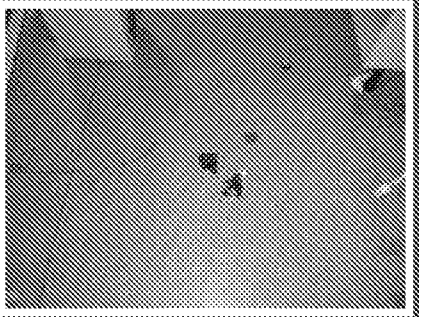
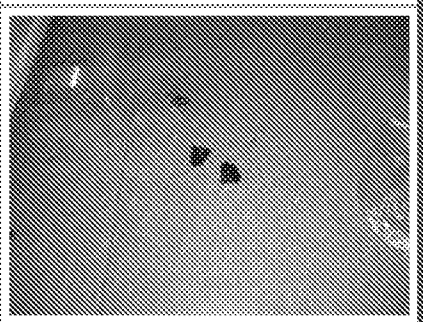
Building	Level	Location	Item / Product Examined	Sample No.	Material Description	Fibre Type	Material Score	Extent	Risk Level Assessment	Initial Control Recommendation	Photograph
Accommodation Hut H1	0	005/ kitchen	Subfloor	472686-79	Asbestos-containing bitumen adhesive	Chrysotile	3	6 Sqm.	R3	Remove	
Accommodation Hut H1	0	006/ bedroom	Subfloor	472686-79	Asbestos-containing bitumen adhesive	Chrysotile	3	6 Sqm.	R3	Remove	
Accommodation Hut H1	0	007/ bedroom	Subfloor	472686-79	Asbestos-containing bitumen adhesive	Chrysotile	3	6 Sqm.	R3	Remove

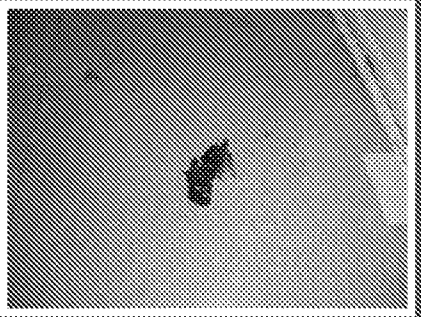
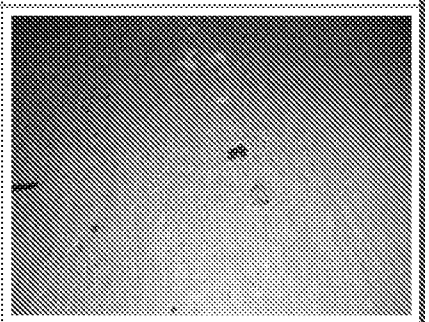
Building	Level	Location	Item / Product Examined	Sample No.	Material Description	Fibre Type	Material Score	Extent	Risk Level Assessment	Initial Control Recommendation	Photograph
Accommodation Hut H1	0	008/ bedroom	Subfloor	472686-79	Asbestos-containing bitumen adhesive	Chrysotile	3	6 Sqm.	R3	Remove	
Accommodation Hut H1	0	009/ bedroom	Subfloor	472686-79	Asbestos-containing bitumen adhesive	Chrysotile	3	6 Sqm.	R3	Remove	
Accommodation Hut H1	0	010/ bedroom	Subfloor	472686-79	Asbestos-containing bitumen adhesive	Chrysotile	3	6 Sqm.	R3	Remove

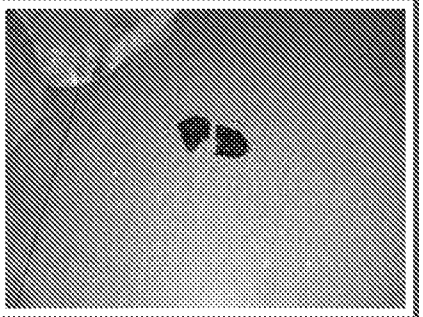
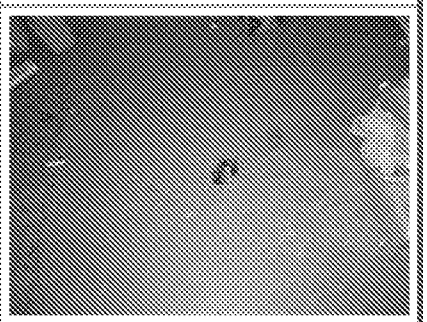
Building	Level	Location	Item / Product Examined	Sample No.	Material Description	Fibre Type	Material Score	Extent	Risk Level Assessment	Initial Control Recommendation	Photograph
Accommodation Hut H1	0	011/ bedroom	Subfloor	472686-79	Asbestos-containing bitumen adhesive	Chrysotile	3	6 Sqm.	R3	Remove	
Accommodation Hut H1	0	012/ bedroom	Subfloor	472686-79	Asbestos-containing bitumen adhesive	Chrysotile	3	6 Sqm.	R3	Remove	
Accommodation Hut H1	0	013/ bedroom	Subfloor	472686-79	Asbestos-containing bitumen adhesive	Chrysotile	3	6 Sqm.	R3	Remove

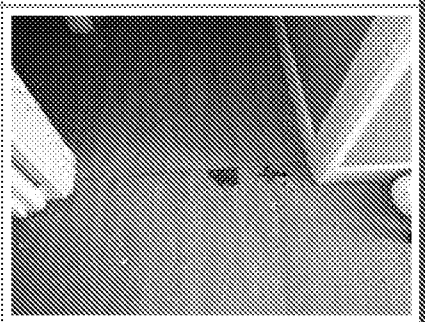
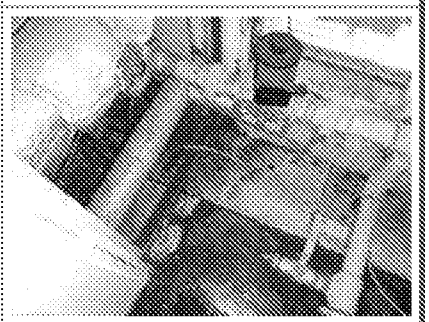
Building	Level	Location	Item / Product Examined	Sample No.	Material Description	Fibre Type	Material Score	Extent	Risk Level Assessment	Initial Control Recommendation	Photograph
Accommodation Hut H1	1	001/loft space	Slaters felt	472686-86	Asbestos-containing bituminous product	Chrysotile	3	100 Sqm.	R3	Remove	
Accommodation Hut H2	0	001/ corridor	Subfloor	472686-91	Asbestos-containing bitumen adhesive	Chrysotile	3	21 Sqm.	R3	Remove	
Accommodation Hut H2	0	002/plant room	Floor covering on duct cover and in electrical area	472686-96	Asbestos-containing floor tile with bitumen adhesive	Chrysotile	3	0.5 Sqm.	R3	Remove

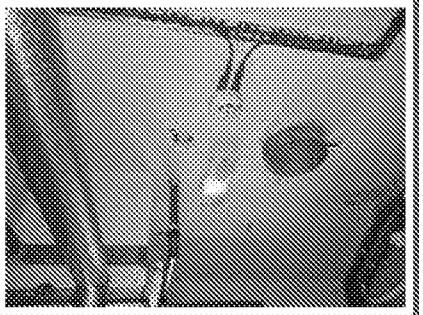
Building	Level	Location	Item / Product Examined	Sample No.	Material Description	Fibre Type	Material Score	Extent	Risk Level Assessment	Initial Control Recommendation	Photograph
Accommodation Hut H2	0	002/plant room	Floor covering	472686-91	Asbestos-containing bitumen adhesive	Chrysotile	3	4 Sqm.	R3	Remove	
Accommodation Hut H2	0	002/plant room	Walls	472686-93	Asbestos-containing cement panels with textured coating	Chrysotile	4	10 Sqm.	R3	Remove	
Accommodation Hut H2	0	002/plant room	Ceiling	472686-92	Asbestos-containing cement panels with textured coating	Chrysotile	4	4 Sqm.	R3	Remove

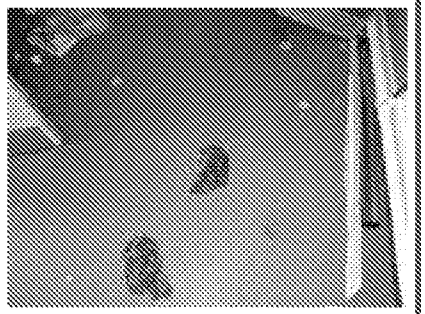
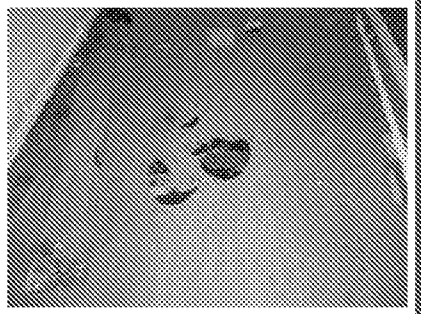
Building	Level	Location	Item / Product Examined	Sample No.	Material Description	Fibre Type	Material Score	Extent	Risk Level Assessment	Initial Control Recommendation	Photograph
Accommodation Hut H2	0	005/ kitchen	Subfloor	472686-91	Asbestos-containing bitumen adhesive	Chrysotile	3	6 Sqm.	R3	Remove	
Accommodation Hut H2	0	006/ bedroom	Subfloor	472686-91	Asbestos-containing bitumen adhesive	Chrysotile	3	6 Sqm.	R3	Remove	
Accommodation Hut H2	0	007/ bedroom	Subfloor	472686-91	Asbestos-containing bitumen adhesive	Chrysotile	3	6 Sqm.	R3	Remove

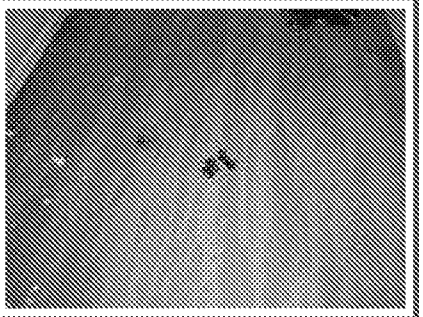
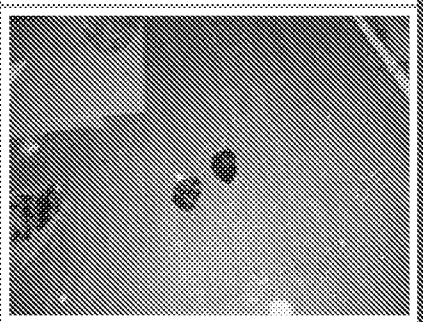
Building	Level	Location	Item / Product Examined	Sample No.	Material Description	Fibre Type	Material Score	Extent	Risk Level Assessment	Initial Control Recommendation	Photograph
Accommodation Hut H2	0	008/ bedroom	Subfloor	472686-91	Asbestos-containing bitumen adhesive	Chrysotile	3	6 Sqm.	R3	Remove	
Accommodation Hut H2	0	009/ bedroom	Subfloor	472686-91	Asbestos-containing bitumen adhesive	Chrysotile	3	6 Sqm.	R3	Remove	
Accommodation Hut H2	0	010/ bedroom	Subfloor	472686-91	Asbestos-containing bitumen adhesive	Chrysotile	3	6 Sqm.	R3	Remove

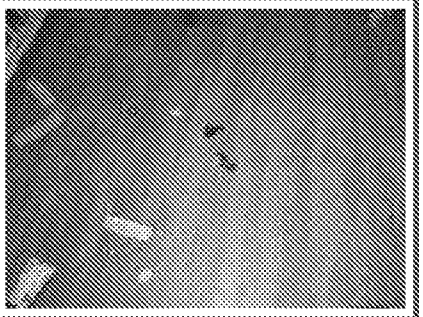
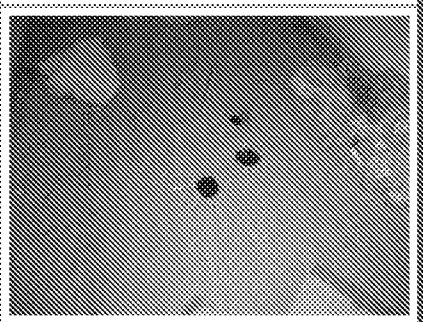
Building	Level	Location	Item / Product Examined	Sample No.	Material Description	Fibre Type	Material Score	Extent	Risk Level Assessment	Initial Control Recommendation	Photograph
Accommodation Hut H2	0	011/ bedroom	Subfloor	472686-91	Asbestos-containing bitumen adhesive	Chrysotile	3	6 Sqm.	R3	Remove	
Accommodation Hut H2	0	012/ bedroom	Subfloor	472686-91	Asbestos-containing bitumen adhesive	Chrysotile	3	6 Sqm.	R3	Remove	
Accommodation Hut H2	0	013/ bedroom	Subfloor	472686-91	Asbestos-containing bitumen adhesive	Chrysotile	3	6 Sqm.	R3	Remove

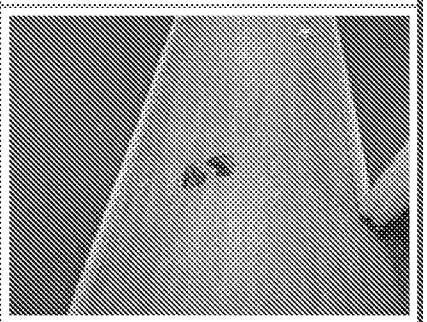
Building	Level	Location	Item / Product Examined	Sample No.	Material Description	Fibre Type	Material Score	Extent	Risk Level Assessment	Initial Control Recommendation	Photograph
Accommodation Hut H2	1	001/loft space	Cement floor to boiler room below	472686-99	Asbestos-containing cement	Chrysotile	4	4 Sqm.	R3	Remove	
Accommodation Hut I1	0	001/ corridor	Subfloor	472686-104	Asbestos-containing bitumen adhesive	Chrysotile	3	21 Sqm.	R3	Remove	
Accommodation Hut I1	0	001/ corridor	Floor covering on duct cover	472686-106	Asbestos-containing floor tile with bitumen adhesive	Chrysotile	3	0.5 Sqm.	R3	Remove

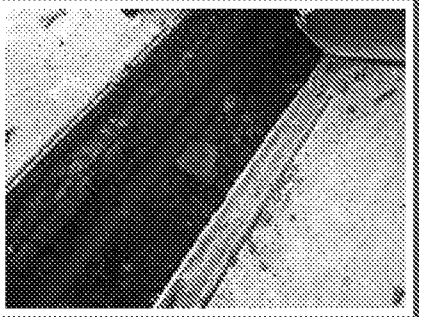
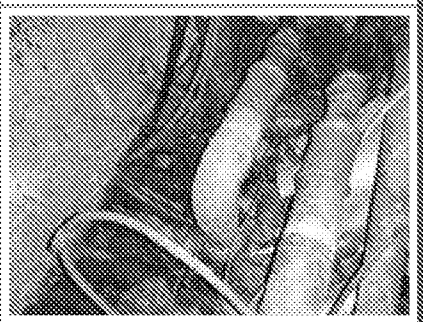
Building	Level	Location	Item / Product Examined	Sample No.	Material Description	Fibre Type	Material Score	Extent	Risk Level Assessment	Initial Control Recommendation	Photograph
Accommodation Hut I1	0	001/ corridor	Cement debris in duct	472686-107	Asbestos-containing cement	Chrysotile	8	0.1 Sqm.	R2	Remove	
Accommodation Hut I1	0	002/plant room	Cement debris in floor duct	472686-107	Asbestos-containing cement	Chrysotile	8	0.1 Sqm.	R2	Remove	
Accommodation Hut I1	0	002/plant room	Lining panels to walls in electrical area	472686-112	Asbestos-containing cement	Chrysotile	4	4 Sqm.	R3	Remove

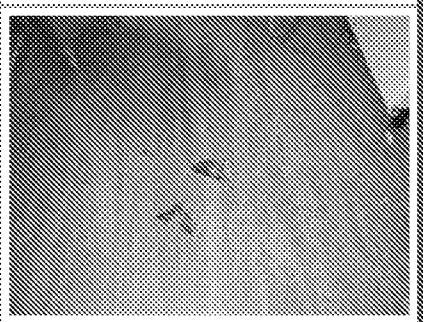
Building	Level	Location	Item / Product Examined	Sample No.	Material Description	Fibre Type	Material Score	Extent	Risk Level Assessment	Initial Control Recommendation	Photograph
Accommodation Hut I1	0	002/plant room	Floor covering	472686-109	Asbestos-containing floor tile with bitumen adhesive	Chrysotile	3	4 Sqm.	R3	Remove	
Accommodation Hut I1	0	005/ kitchen	Subfloor	472686-104	Asbestos-containing bitumen adhesive	Chrysotile	3	6 Sqm.	R3	Remove	
Accommodation Hut I1	0	006/ bedroom	Subfloor	472686-104	Asbestos-containing bitumen adhesive	Chrysotile	3	6 Sqm.	R3	Remove

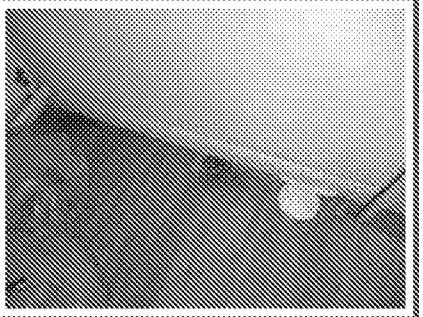
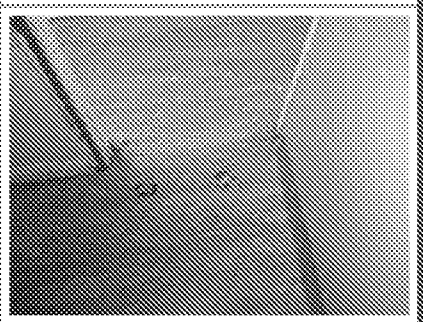
Building	Level	Location	Item / Product Examined	Sample No.	Material Description	Fibre Type	Material Score	Extent	Risk Level Assessment	Initial Control Recommendation	Photograph
Accommodation Hut I1	0	007/ bedroom	Subfloor	472686-104	Asbestos-containing bitumen adhesive	Chrysotile	3	6 Sqm.	R3	Remove	
Accommodation Hut I1	0	008/ bedroom	Subfloor	472686-104	Asbestos-containing bitumen adhesive	Chrysotile	3	6 Sqm.	R3	Remove	
Accommodation Hut I1	0	009/ bedroom	Subfloor	472686-104	Asbestos-containing bitumen adhesive	Chrysotile	3	6 Sqm.	R3	Remove

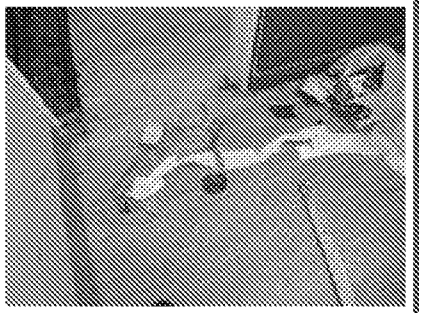
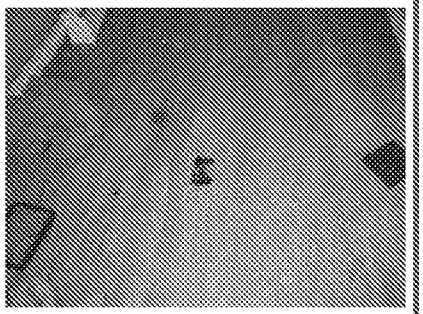
Building	Level	Location	Item / Product Examined	Sample No.	Material Description	Fibre Type	Material Score	Extent	Risk Level Assessment	Initial Control Recommendation	Photograph
Accommodation Hut I1	0	010/ bedroom	Subfloor	472686-104	Asbestos-containing bitumen adhesive	Chrysotile	3	6 Sqm.	R3	Remove	
Accommodation Hut I1	0	011/ bedroom	Subfloor	472686-104	Asbestos-containing bitumen adhesive	Chrysotile	3	6 Sqm.	R3	Remove	
Accommodation Hut I1	0	012/ bedroom	Subfloor	472686-104	Asbestos-containing bitumen adhesive	Chrysotile	3	6 Sqm.	R3	Remove

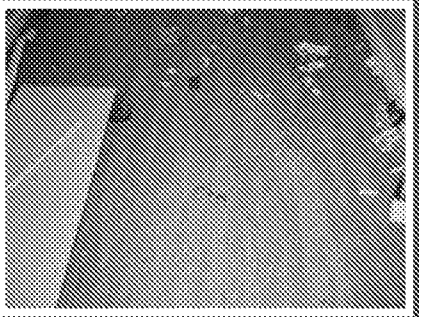
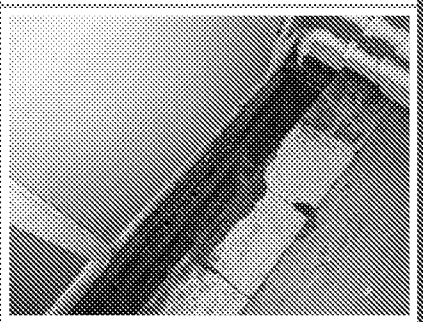
Building	Level	Location	Item / Product Examined	Sample No.	Material Description	Fibre Type	Material Score	Extent	Risk Level Assessment	Initial Control Recommendation	Photograph
Accommodation Hut I1	0	013/ bedroom	Subfloor	472686-104	Asbestos-containing bitumen adhesive	Chrysotile	3	6 Sqm.	R3	Remove	
Accommodation Hut I2	0	001/ corridor	Cement debris in duct	472686-121	Asbestos-containing cement	Chrysotile	6	0.1 Sqm.	R2	Remove	
Accommodation Hut I2	0	001/ corridor	Floor covering on duct cover	472686-120	Asbestos-containing floor tile with bitumen adhesive	Chrysotile	3	0.5 Sqm.	R3	Remove

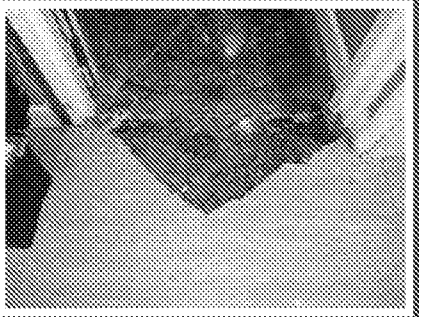
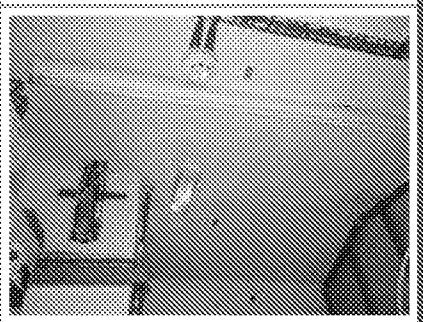
Building	Level	Location	Item / Product Examined	Sample No.	Material Description	Fibre Type	Material Score	Extent	Risk Level Assessment	Initial Control Recommendation	Photograph
Accommodation Hut I2	0	001/ corridor	Subfloor	472686-118	Asbestos-containing bitumen adhesive	Chrysotile	3	21 Sqm.	R3	Remove	
Accommodation Hut I2	0	002/plant room	Ceiling	472686-122	Asbestos-containing cement with textured coating	Chrysotile	4	4 Sqm.	R3	Remove	
Accommodation Hut I2	0	002/plant room	Floor covering on duct cover	472686-120	Asbestos-containing floor tile with bitumen adhesive	Chrysotile	3	0.3 Sqm.	R3	Remove

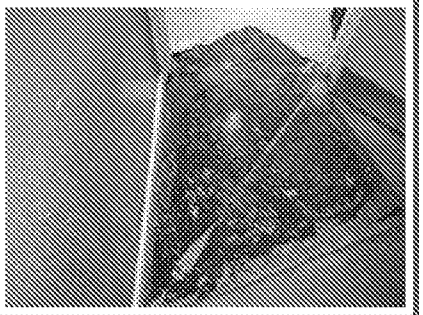
Building	Level	Location	Item / Product Examined	Sample No.	Material Description	Fibre Type	Material Score	Extent	Risk Level Assessment	Initial Control Recommendation	Photograph
Accommodation Hut I2	0	002/plant room	Floor covering	472686-118	Asbestos-containing bitumen adhesive	Chrysotile	3	4 Sqm.	R3	Remove	
Accommodation Hut I2	0	002/plant room	Walls	472686-123	Asbestos-containing cement with textured coating	Chrysotile	4	14 Sqm.	R3	Remove	
Accommodation Hut I2	0	005/ kitchen	Subfloor	472686-118	Asbestos-containing bitumen adhesive	Chrysotile	3	6 Sqm.	R3	Remove

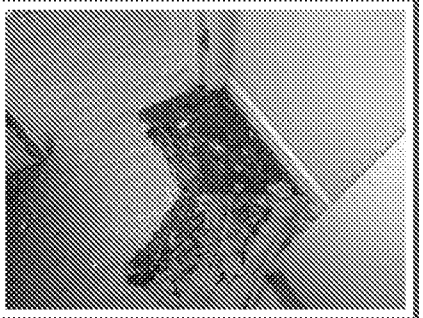
Building	Level	Location	Item / Product Examined	Sample No.	Material Description	Fibre Type	Material Score	Extent	Risk Level Assessment	Initial Control Recommendation	Photograph
Accommodation Hut I2	0	006/ bedroom	Subfloor	472686-118	Asbestos-containing bitumen adhesive	Chrysotile	3	6 Sqm.	R3	Remove	
Accommodation Hut I2	0	007/ bedroom	Subfloor	472686-118	Asbestos-containing bitumen adhesive	Chrysotile	3	6 Sqm.	R3	Remove	
Accommodation Hut I2	0	008/ bedroom	Subfloor	472686-118	Asbestos-containing bitumen adhesive	Chrysotile	3	6 Sqm.	R3	Remove

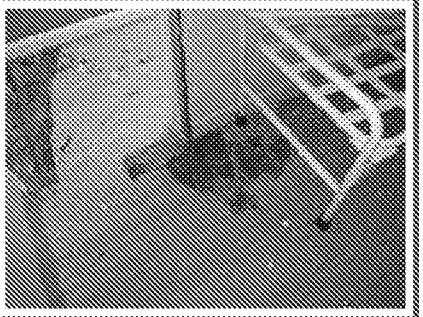
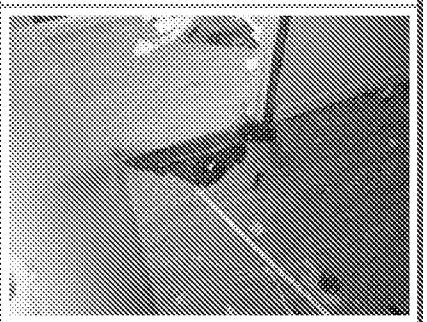
Building	Level	Location	Item / Product Examined	Sample No.	Material Description	Fibre Type	Material Score	Extent	Risk Level Assessment	Initial Control Recommendation	Photograph
Accommodation Hut I2	0	009/ bedroom	Subfloor	472686-118	Asbestos-containing bitumen adhesive	Chrysotile	3	6 Sqm.	R3	Remove	
Accommodation Hut I2	0	010/ bedroom	Subfloor	472686-118	Asbestos-containing bitumen adhesive	Chrysotile	3	6 Sqm.	R3	Remove	
Accommodation Hut I2	0	011/ bedroom	Subfloor	472686-118	Asbestos-containing bitumen adhesive	Chrysotile	3	6 Sqm.	R3	Remove

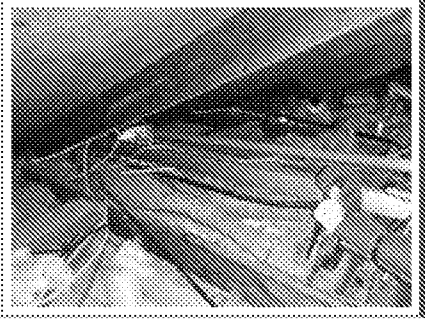
Building	Level	Location	Item / Product Examined	Sample No.	Material Description	Fibre Type	Material Score	Extent	Risk Level Assessment	Initial Control Recommendation	Photograph
Accommodation Hut I2	0	012/ bedroom	Subfloor	472686-118	Asbestos-containing bitumen adhesive	Chrysotile	3	6 Sqm.	R3	Remove	
Accommodation Hut I2	0	013/ bedroom	Subfloor	472686-118	Asbestos-containing bitumen adhesive	Chrysotile	3	6 Sqm.	R3	Remove	
Accommodation Hut I2	1	001/loft space	Cement panels to ceiling below	472686-128	Asbestos-containing cement	Chrysotile	4	4 Sqm.	R3	Remove

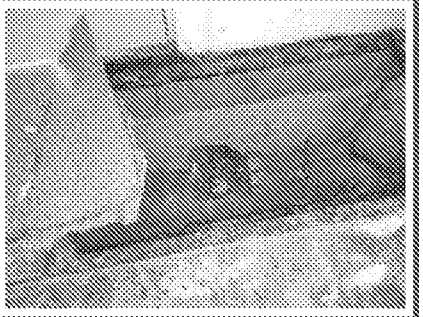
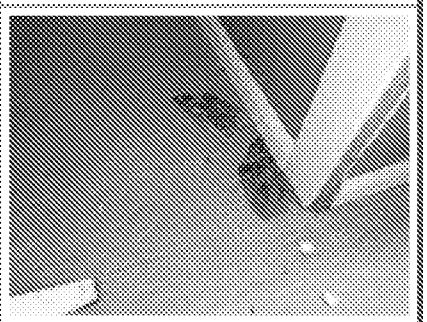
Building	Level	Location	Item / Product Examined	Sample No.	Material Description	Fibre Type	Material Score	Extent	Risk Level Assessment	Initial Control Recommendation	Photograph
Accommodation Hut O1	0	001/ corridor	Felt debris in floor ducts	472686-50	Asbestos-containing bituminous product	Chrysotile	8	0.1 Sqm.	R2	Remove	
Accommodation Hut O1	0	001/ corridor	Subfloor	472686-48	Asbestos-containing bitumen adhesive	Chrysotile	3	21 Sqm.	R3	Remove	
Accommodation Hut O1	0	002/plant room	Floor covering on duct cover	472686-55	Asbestos-containing floor tile with bitumen adhesive	Chrysotile	3	0.5 Sqm.	R3	Remove

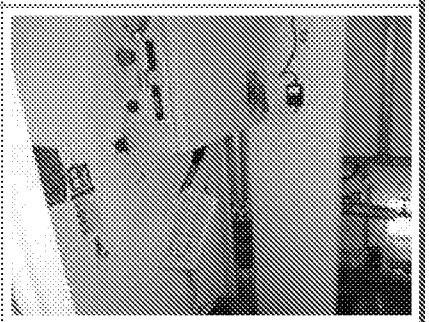
Building	Level	Location	Item / Product Examined	Sample No.	Material Description	Fibre Type	Material Score	Extent	Risk Level Assessment	Initial Control Recommendation	Photograph
Accommodation Hut O1	0	002/plant room	Floor covering	472686-48	Asbestos-containing bitumen adhesive	Chrysotile	3	4 Sqm.	R3	Remove	
Accommodation Hut O1	0	002/plant room	Floor tiles & adhesive	472686-52	Asbestos-containing cement panels with textured coating	Chrysotile	4	10 Sqm.	R3	Remove	
Accommodation Hut O1	0	002/plant room	Cement lining to walls & ceiling	472686-51	Asbestos-containing cement panels with textured coating	Chrysotile	4	4 Sqm.	R3	Remove

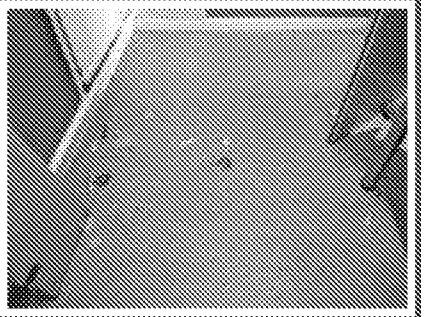
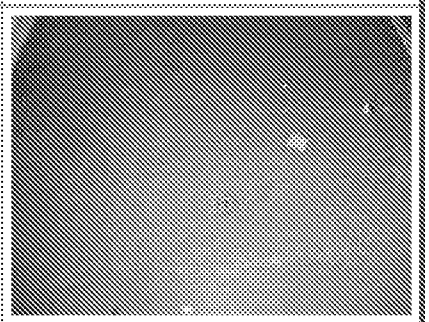
Building	Level	Location	Item / Product Examined	Sample No.	Material Description	Fibre Type	Material Score	Extent	Risk Level Assessment	Initial Control Recommendation	Photograph
Accommodation Hut O1	0	005/ kitchen	Subfloor	472686-48	Asbestos-containing bitumen adhesive	Chrysotile	3	6 Sqm.	R3	Remove	
Accommodation Hut O1	0	006/ bedroom	Subfloor	472686-48	Asbestos-containing bitumen adhesive	Chrysotile	3	6 Sqm.	R3	Remove	
Accommodation Hut O1	0	007/ bedroom	Subfloor	472686-48	Asbestos-containing bitumen adhesive	Chrysotile	3	6 Sqm.	R3	Remove

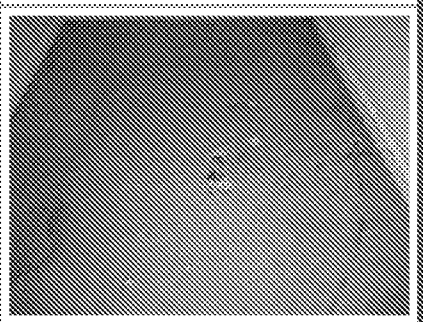
Building	Level	Location	Item / Product Examined	Sample No.	Material Description	Fibre Type	Material Score	Extent	Risk Level Assessment	Initial Control Recommendation	Photograph
Accommodation Hut O1	0	008/ bedroom	Subfloor	472686-48	Asbestos-containing bitumen adhesive	Chrysotile	3	6 Sqm.	R3	Remove	
Accommodation Hut O1	0	009/ bedroom	Subfloor	472686-48	Asbestos-containing bitumen adhesive	Chrysotile	3	6 Sqm.	R3	Remove	
Accommodation Hut O1	0	010/ bedroom	Subfloor	472686-48	Asbestos-containing bitumen adhesive	Chrysotile	3	6 Sqm.	R3	Remove

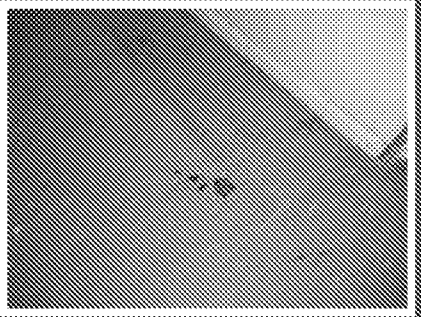
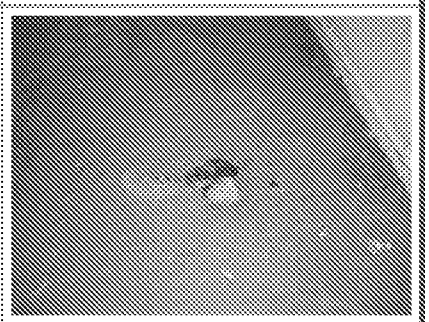
Building	Level	Location	Item / Product Examined	Sample No.	Material Description	Fibre Type	Material Score	Extent	Risk Level Assessment	Initial Control Recommendation	Photograph
Accommodation Hut O1	0	011/ bedroom	Subfloor	472686-48	Asbestos-containing bitumen adhesive	Chrysotile	3	6 Sqm.	R3	Remove	
Accommodation Hut O1	0	012/ bedroom	Subfloor	472686-48	Asbestos-containing bitumen adhesive	Chrysotile	3	6 Sqm.	R3	Remove	
Accommodation Hut O1	0	013/ bedroom	Subfloor	472686-48	Asbestos-containing bitumen adhesive	Chrysotile	3	6 Sqm.	R3	Remove

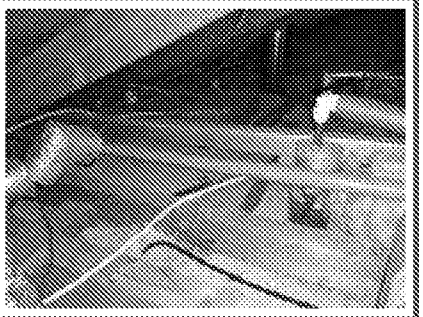
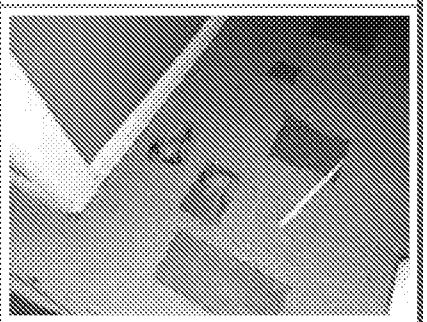
Building	Level	Location	Item / Product Examined	Sample No.	Material Description	Fibre Type	Material Score	Extent	Risk Level Assessment	Initial Control Recommendation	Photograph
Accommodation Hut O1	1	001/loft space	Cement floor to boiler room below	472686-58	Asbestos-containing cement	Chrysotile	4	4 Sqm.	R3	Remove	
Accommodation Hut O2	0	001/ corridor	Subfloor	472686-64	Asbestos-containing bitumen adhesive	Chrysotile	3	21 Sqm.	R3	Remove	
Accommodation Hut O2	0	002/plant room	Floor covering on duct cover	472686-70	Asbestos-containing floor tile with bitumen adhesive	Chrysotile	3	0.5 Sqm.	R3	Remove

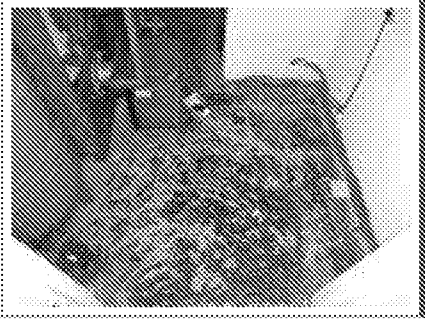
Building	Level	Location	Item / Product Examined	Sample No.	Material Description	Fibre Type	Material Score	Extent	Risk Level Assessment	Initial Control Recommendation	Photograph
Accommodation Hut O2	0	002/plant room	Walls	472686-67	Asbestos-containing cement panels with textured coating	Chrysotile	4	10 Sqm.	R3	Remove	
Accommodation Hut O2	0	002/plant room	Ceiling	472686-66	Asbestos-containing cement panels with textured coating	Chrysotile	4	4 Sqm.	R3	Remove	
Accommodation Hut O2	0	002/plant room	Floor covering	472686-64	Asbestos-containing bitumen adhesive	Chrysotile	3	4 Sqm.	R3	Remove

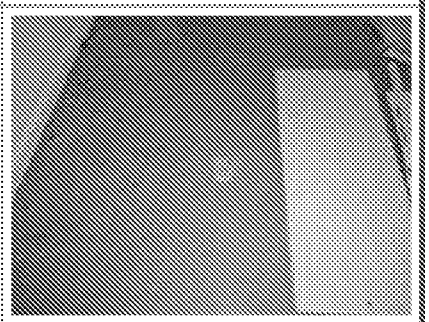
Building	Level	Location	Item / Product Examined	Sample No.	Material Description	Fibre Type	Material Score	Extent	Risk Level Assessment	Initial Control Recommendation	Photograph
Accommodation Hut O2	0	005/ kitchen	Subfloor	472686-64	Asbestos-containing bitumen adhesive	Chrysotile	3	6 Sqm.	R3	Remove	
Accommodation Hut O2	0	006/ bedroom	Subfloor	472686-64	Asbestos-containing bitumen adhesive	Chrysotile	3	6 Sqm.	R3	Remove	
Accommodation Hut O2	0	007/ bedroom	Subfloor	472686-64	Asbestos-containing bitumen adhesive	Chrysotile	3	6 Sqm.	R3	Remove

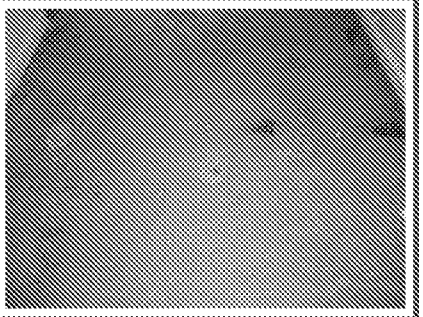
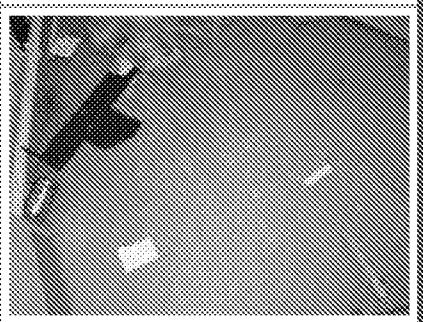
Building	Level	Location	Item / Product Examined	Sample No.	Material Description	Fibre Type	Material Score	Extent	Risk Level Assessment	Initial Control Recommendation	Photograph
Accommodation Hut O2	0	008/ bedroom	Subfloor	472686-64	Asbestos-containing bitumen adhesive	Chrysotile	3	6 Sqm.	R3	Remove	
Accommodation Hut O2	0	009/ bedroom	Subfloor	472686-64	Asbestos-containing bitumen adhesive	Chrysotile	3	6 Sqm.	R3	Remove	
Accommodation Hut O2	0	010/ bedroom	Subfloor	472686-64	Asbestos-containing bitumen adhesive	Chrysotile	3	6 Sqm.	R3	Remove

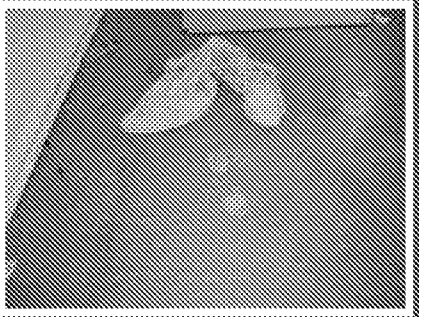
Building	Level	Location	Item / Product Examined	Sample No.	Material Description	Fibre Type	Material Score	Extent	Risk Level Assessment	Initial Control Recommendation	Photograph
Accommodation Hut O2	0	011/ bedroom	Subfloor	472686-64	Asbestos-containing bitumen adhesive	Chrysotile	3	6 Sqm.	R3	Remove	
Accommodation Hut O2	0	012/ bedroom	Subfloor	472686-64	Asbestos-containing bitumen adhesive	Chrysotile	3	6 Sqm.	R3	Remove	
Accommodation Hut O2	0	013/ bedroom	Subfloor	472686-64	Asbestos-containing bitumen adhesive	Chrysotile	3	6 Sqm.	R3	Remove

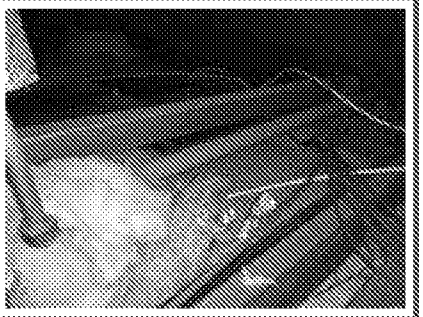
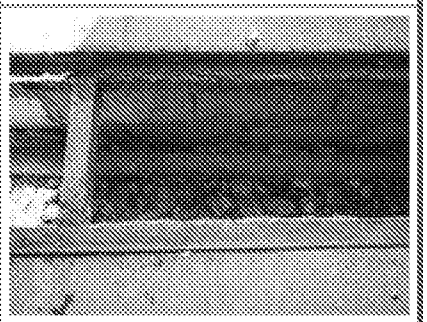
Building	Level	Location	Item / Product Examined	Sample No.	Material Description	Fibre Type	Material Score	Extent	Risk Level Assessment	Initial Control Recommendation	Photograph
Accommodation Hut O2	1	001/loft space	Cement floor to boiler room below	472686-73	Asbestos-containing cement	Chrysotile	4	4 Sqm.	R3	Remove	
Accommodation Hut P1	0	001/ corridor	Floor tiles debris in floor ducts	472686-25	Asbestos-containing floor tile with bitumen adhesive	Chrysotile	8	0.1 Sqm.	R2	Remove	
Accommodation Hut P1	0	001/ corridor	Subfloor	472686-24	Asbestos-containing bitumen adhesive	Chrysotile	3	21 Sqm.	R3	Remove

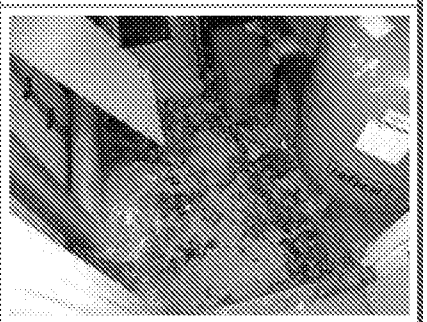
Building	Level	Location	Item / Product Examined	Sample No.	Material Description	Fibre Type	Material Score	Extent	Risk Level Assessment	Initial Control Recommendation	Photograph
Accommodation Hut P1	0	002/plant room	Floor covering on duct cover	472686-28	Asbestos-containing floor tile with bitumen adhesive	Chrysotile	3	0.5 Sqm.	R3	Remove	
Accommodation Hut P1	0	002/plant room	Floor covering	472686-24	Asbestos-containing bitumen adhesive	Chrysotile	3	4 Sqm.	R3	Remove	
Accommodation Hut P1	0	005/ kitchen	Subfloor	472686-24	Asbestos-containing bitumen adhesive	Chrysotile	3	6 Sqm.	R3	Remove

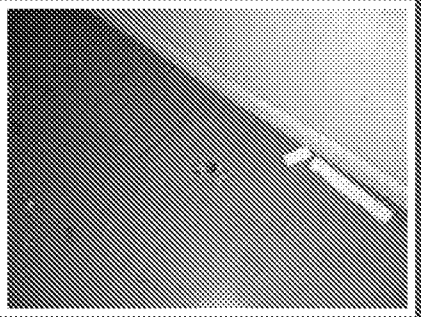
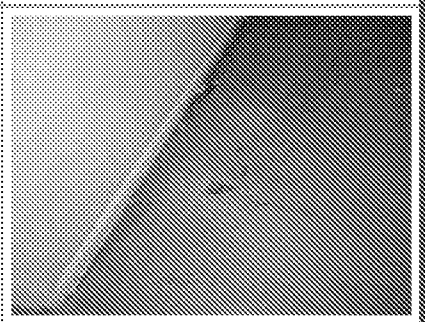
Building	Level	Location	Item / Product Examined	Sample No.	Material Description	Fibre Type	Material Score	Extent	Risk Level Assessment	Initial Control Recommendation	Photograph
Accommodation Hut P1	0	006/ bedroom	Subfloor	472686-24	Asbestos-containing bitumen adhesive	Chrysotile	3	6 Sqm.	R3	Remove	
Accommodation Hut P1	0	007/ bedroom	Subfloor	472686-24	Asbestos-containing bitumen adhesive	Chrysotile	3	6 Sqm.	R3	Remove	
Accommodation Hut P1	0	008/ bedroom	Subfloor	472686-24	Asbestos-containing bitumen adhesive	Chrysotile	3	6 Sqm.	R3	Remove

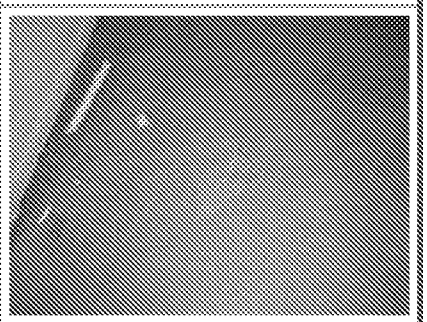
Building	Level	Location	Item / Product Examined	Sample No.	Material Description	Fibre Type	Material Score	Extent	Risk Level Assessment	Initial Control Recommendation	Photograph
Accommodation Hut P1	0	009/ bedroom	Subfloor	472686-24	Asbestos-containing bitumen adhesive	Chrysotile	3	6 Sqm.	R3	Remove	
Accommodation Hut P1	0	010/ bedroom	Subfloor	472686-24	Asbestos-containing bitumen adhesive	Chrysotile	3	6 Sqm.	R3	Remove	
Accommodation Hut P1	0	011/ bedroom	Subfloor	472686-24	Asbestos-containing bitumen adhesive	Chrysotile	3	6 Sqm.	R3	Remove

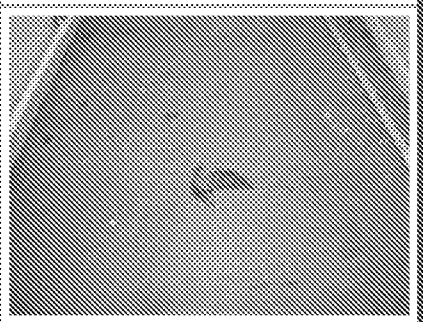
Building	Level	Location	Item / Product Examined	Sample No.	Material Description	Fibre Type	Material Score	Extent	Risk Level Assessment	Initial Control Recommendation	Photograph
Accommodation Hut P1	0	012/ bedroom	Subfloor	472686-24	Asbestos-containing bitumen adhesive	Chrysotile	3	6 Sqm.	R3	Remove	
Accommodation Hut P1	0	013/ bedroom	Subfloor	472686-24	Asbestos-containing bitumen adhesive	Chrysotile	3	6 Sqm.	R3	Remove	
Accommodation Hut P1	9	999/ externals	Wall panels with textured coating in porch	472686-34	Asbestos-containing insulating board	Chrysotile	5	6 Sqm.	R2	Remove

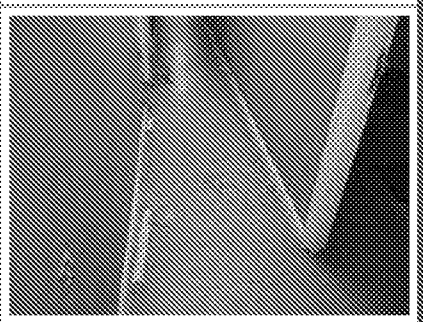
Building	Level	Location	Item / Product Examined	Sample No.	Material Description	Fibre Type	Material Score	Extent	Risk Level Assessment	Initial Control Recommendation	Photograph
Accommodation Hut P1	9	999/ externals	Ceiling panels with textured coating in porch	472686-33	Asbestos-containing insulating board	Chrysotile	5	2 Sqm.	R3	Remove	
Accommodation Hut P2	0	001/ corridor	Subfloor	472686-37	Asbestos-containing bitumen adhesive	Chrysotile	3	21 Sqm.	R3	Remove	
Accommodation Hut P2	0	002/plant room	Floor covering	472686-37	Asbestos-containing bitumen adhesive	Chrysotile	3	4 Sqm.	R3	Remove

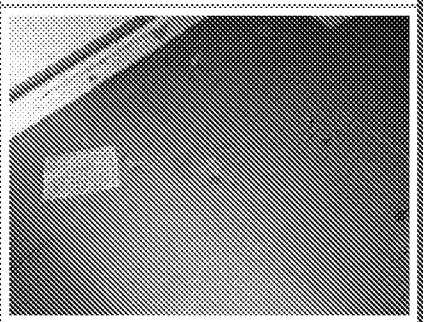
Building	Level	Location	Item / Product Examined	Sample No.	Material Description	Fibre Type	Material Score	Extent	Risk Level Assessment	Initial Control Recommendation	Photograph
Accommodation Hut P2	0	002/plant room	Floor covering on duct cover	472686-40	Asbestos-containing floor tile with bitumen adhesive	Chrysotile	3	0.5 Sqm.	R3	Remove	
Accommodation Hut P2	0	005/ kitchen	Subfloor	472686-37	Asbestos-containing bitumen adhesive	Chrysotile	3	6 Sqm.	R3	Remove	
Accommodation Hut P2	0	006/ bedroom	Subfloor	472686-37	Asbestos-containing bitumen adhesive	Chrysotile	3	6 Sqm.	R3	Remove

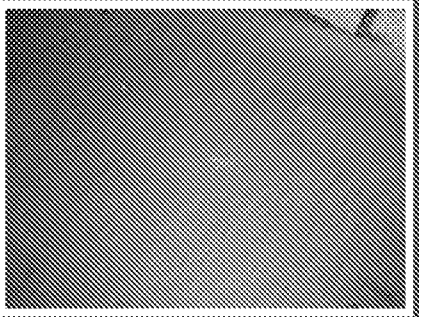
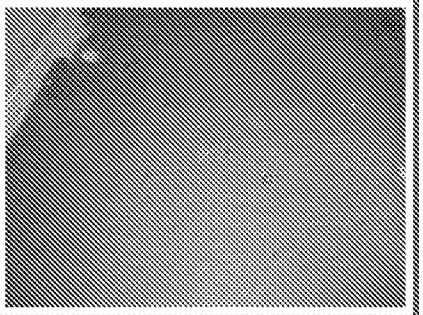
Building	Level	Location	Item / Product Examined	Sample No.	Material Description	Fibre Type	Material Score	Extent	Risk Level Assessment	Initial Control Recommendation	Photograph
Accommodation Hut P2	0	007/ bedroom	Subfloor	472686-37	Asbestos-containing bitumen adhesive	Chrysotile	3	6 Sqm.	R3	Remove	
Accommodation Hut P2	0	008/ bedroom	Subfloor	472686-37	Asbestos-containing bitumen adhesive	Chrysotile	3	6 Sqm.	R3	Remove	
Accommodation Hut P2	0	009/ bedroom	Subfloor	472686-37	Asbestos-containing bitumen adhesive	Chrysotile	3	6 Sqm.	R3	Remove

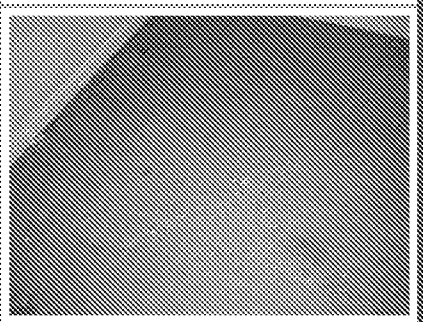
Building	Level	Location	Item / Product Examined	Sample No.	Material Description	Fibre Type	Material Score	Extent	Risk Level Assessment	Initial Control Recommendation	Photograph
Accommodation Hut P2	0	010/ bedroom	Subfloor	472686-37	Asbestos-containing bitumen adhesive	Chrysotile	3	6 Sqm.	R3	Remove	
Accommodation Hut P2	0	011/ bedroom	Subfloor	472686-37	Asbestos-containing bitumen adhesive	Chrysotile	3	6 Sqm.	R3	Remove	
Accommodation Hut P2	0	012/ bedroom	Subfloor	472686-37	Asbestos-containing bitumen adhesive	Chrysotile	3	6 Sqm.	R3	Remove

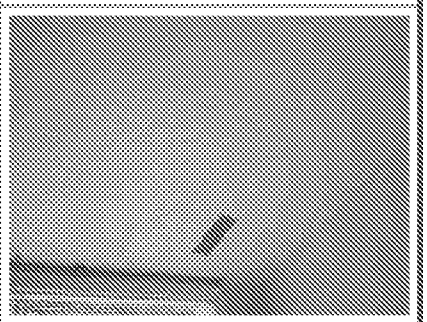
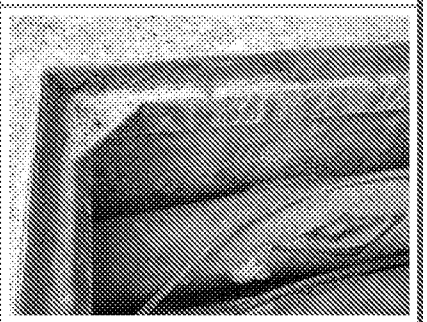
Building	Level	Location	Item / Product Examined	Sample No.	Material Description	Fibre Type	Material Score	Extent	Risk Level Assessment	Initial Control Recommendation	Photograph
Accommodation Hut P2	0	013/ bedroom	Subfloor	472686-37	Asbestos-containing bitumen adhesive	Chrysotile	3	6 Sqm.	R3	Remove	
Accommodation Hut P2	9	999/ externals	Ceiling panels with textured coating in porch	472686-44	Asbestos-containing insulating board	Chrysotile	5	2 Sqm.	R3	Remove	
Accommodation Hut P2	9	999/ externals	Wall panels with textured coating in porch	472686-45	Asbestos-containing insulating board	Chrysotile	5	6 Sqm.	R2	Remove

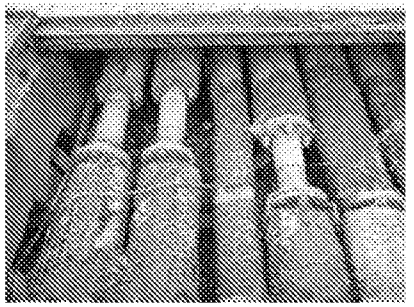
Building	Level	Location	Item / Product Examined	Accessibility	Surveyor Additional Comments At Time Of Survey	Photograph
external ducts for blocks P, G, H, O, I	9	999/externals ducts	***Entire Location***	Limited Access	reasons of health and safety	
				Due to services and depth of duct

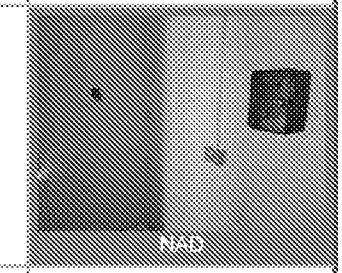
Building: Accommodation Hut G1 **Level: 0** **Location: 010/bedroom**

Item / Product Examined	Material Description	Sampling Strategy	Sample No.	Extent	Product Score	Material Condition	Surface Treatment	Friable	Material Score	Accessibility Score	Risk Level Assessment
Ceiling	Hardboard with textured coating	Cross Reference	472686-1								 NAD
Walls	Hardboard										
Wall covering	Textured coating	Cross Reference	472686-2								 NAD
Floor covering	Modern linoleum										
Floor	Concrete										
Door and frame	Wood										
Window frames	PVC and wood

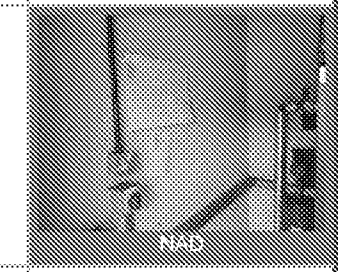
Building: Accommodation Hut G1 **Level: 0** **Location: 014/electrical cupboard**

Item / Product Examined	Material Description	Sampling Strategy	Sample No	Extent	Product Score	Material Condition	Surface Treatment	Friable	Material Score	Accessibility Score	Risk Level Assessment
Lining within cavity to external walls	Bituminous product	Cross Reference	472686-5								 N/AD
Door and frame	Wood										
Electrics	Modern										
Pipework insulation in floor duct	Insulation	Sample	472686-7								 N/AD

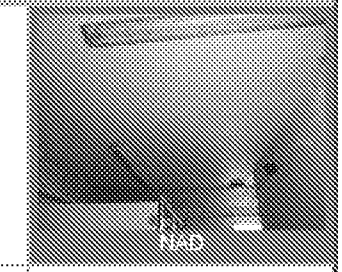
Building: Accommodation Hut G2 **Level: 0** **Location: 003/cupboard**

Item / Product Examined	Material Description	Sampling Strategy	Sample No	Extent	Product Score	Material Condition	Surface Treatment	Friability	Material Score	Accessibility Score	Risk Level Assessment
Ceiling	Wood										
Walls	Wood and hardboard										
Floor covering	Modern linoleum										
Floor	Concrete and ceramic										
Door and frame	Wood

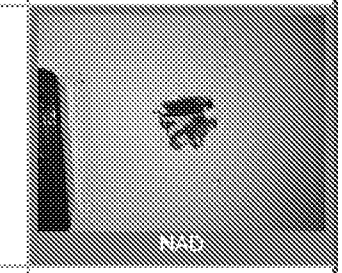
Building: Accommodation Hut G2 **Level: 0** **Location: 006/bedroom**

Item / Product Examined	Material Description	Sampling Strategy	Sample No	Extent	Product Score	Material Condition	Surface Treatment	Asbestos ID	Material Score	Accessibility Score	Risk Level Assessment
Ceiling	Hardboard with textured coating	Cross Reference	472686-12								
Walls	Hardboard

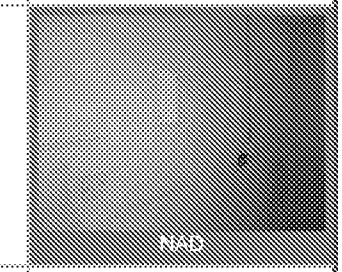
Building: Accommodation Hut G2 **Level: 0** **Location: 009/bedroom**

Item / Product Examined	Material Description	Sampling Strategy	Sample No.	Extent	Product Score	Material Condition	Surface Treatment	Fibre Id.	Material Score	Accessibility Score	Risk Level Assessment
Ceiling	Hardboard with textured coating	Cross Reference	472686-12								 N/A

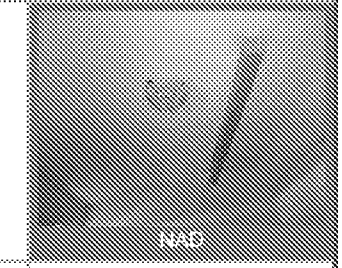
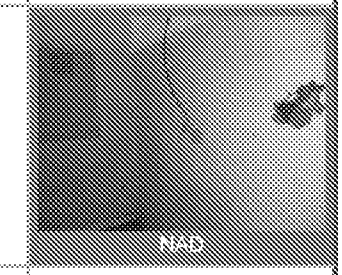
Building: Accommodation Hut G2 **Level: 0** **Location: 011/bedroom**

Item / Product Examined	Material Description	Sampling Strategy	Sample No.	Extent	Product Score	Material Condition	Surface Treatment	Friable	Material Score	Accessibility Score	Risk Level Assessment
Ceiling	Hardboard with textured coating	Cross Reference	472686-12								 NAD
Walls	Hardboard										
Wall covering	Textured coating	Cross Reference	472686-13								 NAD
Floor covering	Modern linoleum

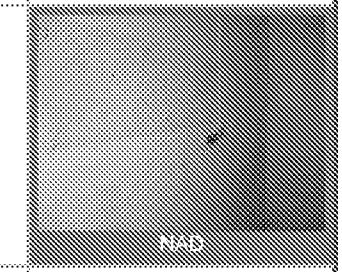
Building: Accommodation Hut G2 **Level: 0** **Location: 012/bedroom**

Item / Position Examined	Material Description	Sampling Strategy	Sample No.	Extent	Product Score	Material Condition	Surface Treatment	Fibre Id.	Material Score	Accessibility Score	Risk Level Assessment
Ceiling	Hardboard with textured coating	Cross Reference	472686-12								 N/A

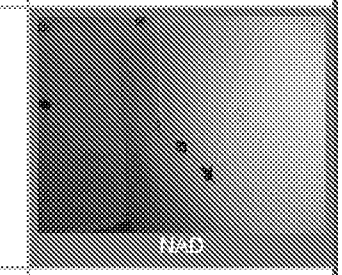
Building: Accommodation Hut H1 **Level: 0** **Location: 011/bedroom**

Item / Product Examined	Material Description	Sampling Strategy	Sample No	Extent	Product Score	Material Condition	Surface Treatment	Friable	Material Score	Accessibility Score	Risk Level Assessment
Ceiling	Hardboard with textured coating	Cross Reference	472686-77								 NAD
Walls	Hardboard										
Wall covering	Textured coating	Cross Reference	472686-78								 NAD
Floor covering	Modern linoleum

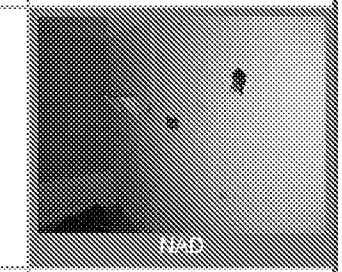
Building: Accommodation Hut H2 **Level: 0** **Location: 008/bedroom**

Item / Product Examined	Material Description	Sampling Strategy	Sample No	Extent	Product Score	Material Condition	Surface Treatment	Friable	Material Score	Accessibility Score	Risk Level Assessment
Ceiling	Hardboard with textured coating	Cross Reference	472686-89								 NAD
Walls	Hardboard										
Wall covering	Textured coating	Cross Reference	472686-90								 NAD
Floor covering	Modern linoleum

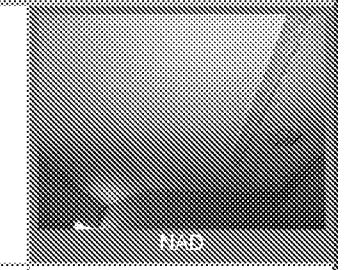
Building: Accommodation Hut I1 **Level: 0** **Location: 006/bedroom**

Item / Product Examined	Material Description	Sampling Strategy	Sample No.	Extent	Product Score	Material Condition	Surface Treatment	Fibre Id.	Material Score	Accessibility Score	Risk Level Assessment
Ceiling	Hardboard with textured coating	Cross Reference	472686-102								
Walls	Hardboard										
Wall covering	Textured coating	Cross Reference	472686-103								
Floor covering	Modern linoleum

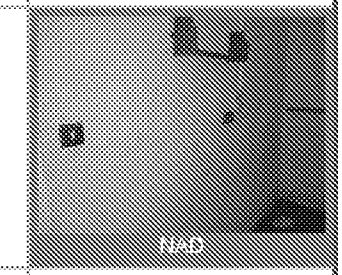
Building: Accommodation Hut I1 **Level: 0** **Location: 009/bedroom**

Item / Product Examined	Material Description	Sampling Strategy	Sample No.	Extent	Product Score	Material Condition	Surface Treatment	Fibre ID	Material Score	Accessibility Score	Risk Level Assessment
Ceiling	Hardboard with textured coating	Cross Reference	472686-102								 NAD
Walls	Hardboard										
Wall covering	Textured coating	Cross Reference	472686-103								 NAD
Floor covering	Modern linoleum

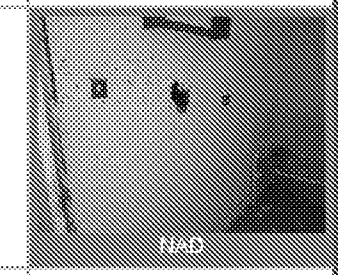
Building: Accommodation Hut I2 **Level: 0** **Location: 010/bedroom**

Item / Product Examined	Material Description	Sampling Strategy	Sample No.	Extent	Friable Score	Material Condition	Surface Treatment	Fibre ID	Material Score	Accessibility Score	Risk Level Assessment
Ceiling	Hardboard with textured coating	Cross Reference	472686-116								 NAD
Walls	Hardboard										
Wall covering	Textured coating	Cross Reference	472686-117								 NAD
Floor covering	Modern linoleum

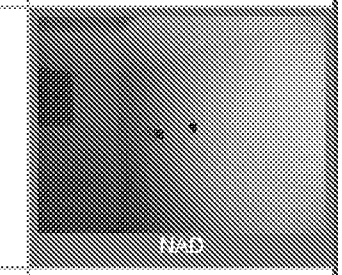
Building: Accommodation Hut O1 **Level: 0** **Location: 008/bedroom**

Item / Product Examined	Material Description	Sampling Strategy	Sample No	Extent	Product Score	Material Condition	Surface Treatment	Friable	Material Score	Accessibility Score	Risk Level Assessment
Ceiling	Hardboard with textured coating	Cross Reference	472686-46								
Walls	Hardboard										
Wall covering	Textured coating	Cross Reference	472686-47								
Floor covering	Modern linoleum

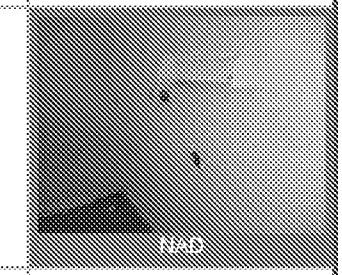
Building: Accommodation Hut O1 **Level: 0** **Location: 011/bedroom**

Item / Product Examined	Material Description	Sampling Strategy	Sample No	Extent	Product Score	Material Condition	Surface Treatment	Friable	Material Score	Accessibility Score	Risk Level Assessment
Ceiling	Hardboard with textured coating	Cross Reference	472686-46								 NAD
Walls	Hardboard										
Wall covering	Textured coating	Cross Reference	472686-47								 NAD
Floor covering	Modern linoleum

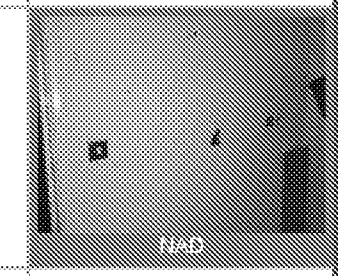
Building: Accommodation Hut O2 **Level: 0** **Location: 008/bedroom**

Item / Product Examined	Material Description	Sampling Strategy	Sample No	Extent	Product Score	Material Condition	Surface Treatment	Friable	Material Score	Accessibility Score	Risk Level Assessment
Ceiling	Hardboard with textured coating	Cross Reference	472686-62								 NAD
Walls	Hardboard										
Wall covering	Textured coating	Cross Reference	472686-63								 NAD
Floor covering	Modern linoleum

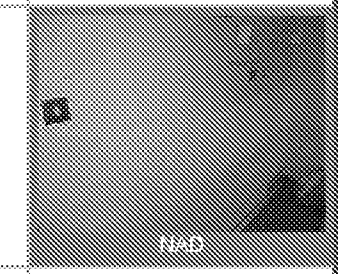
Building: Accommodation Hut O2 **Level: 0** **Location: 011/bedroom**

Item / Product Examined	Material Description	Sampling Strategy	Sample No	Extent	Product Score	Material Condition	Surface Treatment	Friable	Material Score	Accessibility Score	Risk Level Assessment
Ceiling	Hardboard with textured coating	Cross Reference	472686-62								 NAD
Walls	Hardboard										
Wall covering	Textured coating	Cross Reference	472686-63								 NAD
Floor covering	Modern linoleum
