Asbestos Demolition Survey Report

HMP Ford, Ford Road, Arundel, West Sussex, BN18 0BX

Title: HMP Ford - Demolition Surveys of Accommodation Buildings (Batch 3)

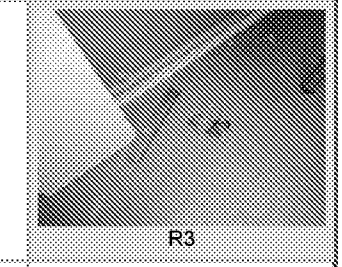
Building: Accommodation Hut P1 **Level: 0** **Location: 005/kitchen**

Item / Product Examined	Material Description	Sampling Strategy	Sample No	Extent	Product Score	Material Condition	Surface Treatment	Friable	Material Score	Accessibility Score	Risk Level Assessment
Ceiling	Hardboard with textured coating	Cross Reference	472686-22								
Walls	Hardboard										
Wall covering	Textured coating	Cross Reference	472686-23								
Floor covering	Modern linoleum										
Subfloor	Asbestos-containing bitumen adhesive	Cross Reference	472686-24	6 Sqm.	1	1	0	Chrysotile	3	2	
Floor	Concrete										
Door and frames	Wood										
Packers to door frames	Wood, card and hardboard										
Insulation within cavity walls	Man made mineral fibre

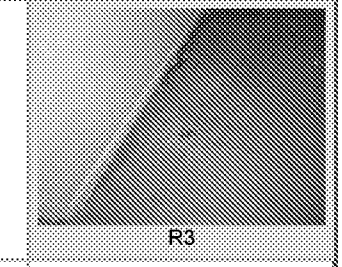
Building: Accommodation Hut P1 **Level: 0** **Location: 007/bedroom**

Item / Product Examined	Material Description	Sampling Strategy	Sample No	Extent	Friable Score	Material Condition	Surface Treatment	Asbestos Type	Material Score	Accessibility Score	Risk Level Assessment
Ceiling	Hardboard with textured coating	Cross Reference	472686-22								 NAD
Walls	Hardboard										
Wall covering	Textured coating	Cross Reference	472686-23								 NAD
Floor covering	Modern linoleum										
Subfloor	Asbestos-containing bitumen adhesive	Cross Reference	472686-24	6 Sqm.	1	1	0	Chrysotile	3	2	 R3
Floor	Concrete										
Door and frame	Wood										
Window frames	PVC and wood										
Radiator and pipework	Metal										
Insulation within cavity walls	Man made mineral fibre

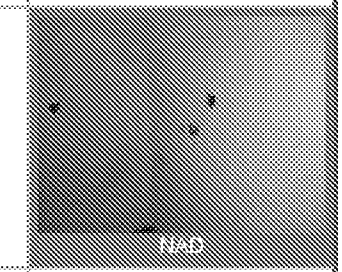
Building: Accommodation Hut P1 **Level: 0** **Location: 008/bedroom**

Item / Product Examined	Material Description	Sampling Strategy	Sample No	Extent	Product Score	Material Condition	Surface Treatment	Friable	Material Score	Accessibility Score	Risk Level Assessment
Ceiling	Hardboard with textured coating	Cross Reference	472686-22								 NAD
Walls	Hardboard										
Wall covering	Textured coating	Cross Reference	472686-23								 NAD
Floor covering	Modern linoleum

Item / Product Examined	Material Description	Sampling Strategy	Sample No.	Extent	Product Score	Material Condition	Surface Treatment	Fibre Id.	Material Score	Accessibility Score	Risk Level Assessment
Subfloor	Asbestos-containing bitumen adhesive	Cross Reference	472686-24	6 Sqm.	1	1	0	Chrysotile	3	2	 R3
Floor	Concrete										
Door and frame	Wood										
Window frames	PVC and wood										
Radiator and pipework	Metal										
Insulation within cavity walls	Man made mineral fibre										
Lining within cavity to external walls	Bituminous product	Cross Reference	472686-31								 N4D

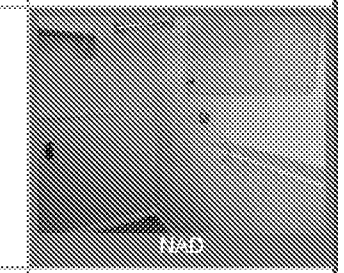
Building: Accommodation Hut P1 **Level: 0** **Location: 011/bedroom**

Item / Product Examined	Material Description	Sampling Strategy	Sample No	Extent	Product Score	Material Condition	Surface Treatment	Friable	Material Score	Accessibility Score	Risk Level Assessment
Ceiling	Hardboard with textured coating	Cross Reference	472686-22								 NAD
Walls	Hardboard										
Wall covering	Textured coating	Cross Reference	472686-23								 NAD
Floor covering	Modern linoleum

Item / Product Examined	Material Description	Sampling Strategy	Sample No.	Extent	Product Score	Material Condition	Surface Treatment	Fibre Id.	Material Score	Accessibility Score	Risk Level Assessment
Subfloor	Asbestos-containing bitumen adhesive	Cross Reference	472686-24	6 Sqm.	1	1	0	Chrysotile	3	2	 R3
Floor	Concrete										
Door and frame	Wood										
Window frames	PVC and wood										
Radiator and pipework	Metal										
Insulation within cavity walls	Man made mineral fibre										
Lining within cavity to external walls	Bituminous product	Cross Reference	472686-31								 N/AS

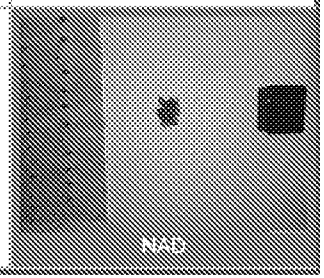
Building: Accommodation Hut P1 **Level: 0** **Location: 012/bedroom**

Item / Product Examined	Material Description	Sampling Strategy	Sample No.	Extent	Product Score	Material Condition	Surface Treatment	Fibre Id.	Material Score	Accessibility Score	Risk Level Assessment
Ceiling	Hardboard with textured coating	Cross Reference	472686-22								 N/AS
Walls	Hardboard

Item / Product Examined	Material Description	Sampling Strategy	Sample No	Extent	Product Score	Material Condition	Surface Treatment	Fibre Id	Material Score	Accessibility Score	Risk Level Assessment
Wall covering	Textured coating	Cross Reference	472686-23								 NAD
Floor covering	Modern linoleum										
Subfloor	Asbestos-containing bitumen adhesive	Cross Reference	472686-24	6 Sqm.	1	1	0	Chrysotile	3	2	 R3
Floor	Concrete										
Door and frame	Wood										
Window frames	PVC and wood										
Radiator and pipework	Metal										
Insulation within cavity walls	Man made mineral fibre										
Lining within cavity to external walls	Bituminous product	Cross Reference	472686-31								 NAD

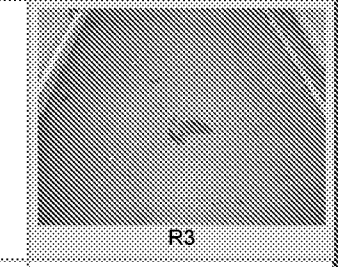
Building: Accommodation Hut P1 **Level: 0** **Location: 013/bedroom**

Item / Product / Component	Additional Description	Sampling Strategy	Sample No	Extent	Product Score	Material Condition	Surface Treatment	Asbestos Type	Material Score	Accessibility Score	Risk Level Assessment
Ceiling	Hardboard with textured coating	Cross Reference	472686-22								
Walls	Hardboard										
Wall covering	Textured coating	Cross Reference	472686-23								
Floor covering	Modern linoleum										
Subfloor	Asbestos-containing bitumen adhesive	Cross Reference	472686-24	6 Sqm.	1	1	0	Chrysotile	3	2	
Floor	Concrete										
Door and frame	Wood										
Window frames	PVC and wood										
Radiator and pipework	Metal										
Insulation within cavity walls	Man made mineral fibre

Item / Product Examined	Material Description	Sampling Strategy	Sample No	Extent	Product Score	Material Condition	Surface Treatment	Friable	Material Score	Accessibility Score	Risk Level Assessment
Lining within cavity to external walls	Bituminous product	Cross Reference	472686-31								 NAD

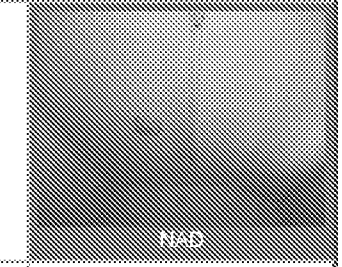
Building: Accommodation Hut P2 **Level: 0** **Location: 006/bedroom**

Item / Product Examined	Material Description	Sampling Strategy	Sample No	Extent	Product Score	Material Condition	Surface Treatment	Friable	Material Score	Accessibility Score	Risk Level Assessment
Ceiling	Hardboard with textured coating	Cross Reference	472686-35								 NAD
Walls	Hardboard										
Wall covering	Textured coating	Cross Reference	472686-36								 NAD
Floor covering	Modern linoleum

Item / Product Examined	Material Description	Sampling Strategy	Sample No.	Extent	Product Score	Material Condition	Surface Treatment	Fibre Id.	Material Score	Accessibility Score	Risk Level Assessment
Subfloor	Asbestos-containing bitumen adhesive	Cross Reference	472686-37	6 Sqm.	1	1	0	Chrysotile	3	2	 R3
Floor	Concrete										
Door and frame	Wood										
Window frames	PVC and wood										
Radiator and pipework	Metal										
Insulation within cavity walls	Man made mineral fibre										
Lining within cavity to external walls	Bituminous product	Cross Reference	472686-42								 NAD
