VERIFICATION REPORT

for PLOTS 16-23 (SOIL COVER SYSTEMS) &

ALL PLOTS (GROUND GAS) AT

CORNFIELD CLOSE, LITTLEHAMPTON,

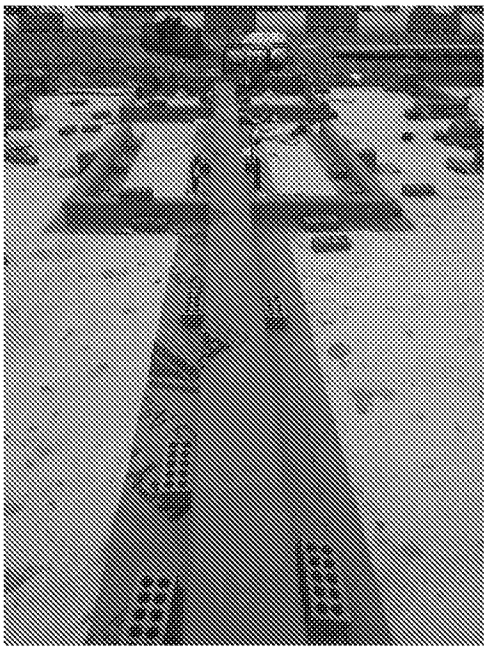
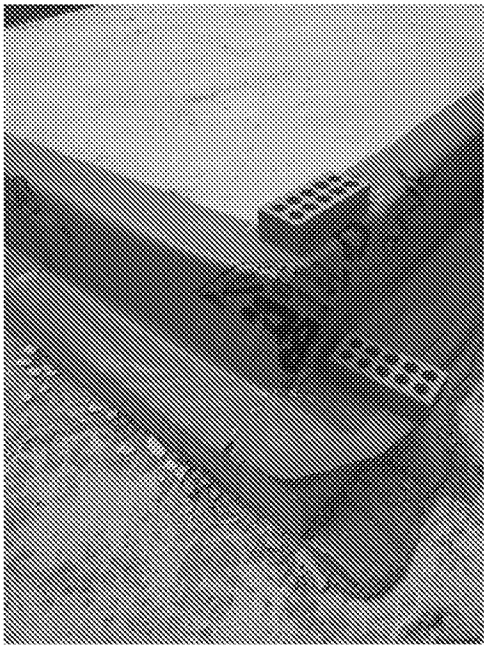
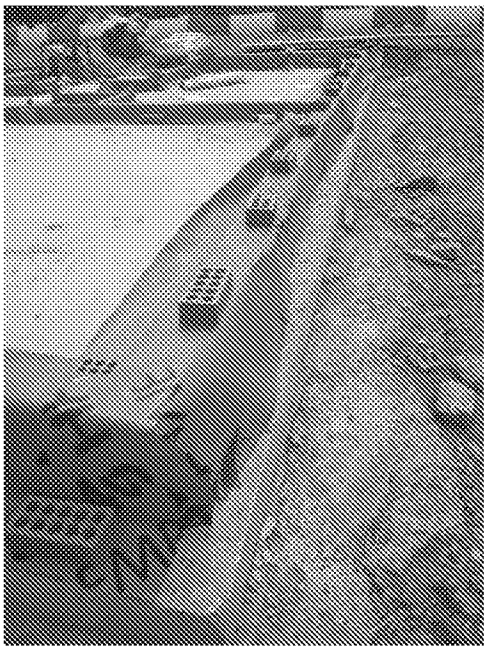
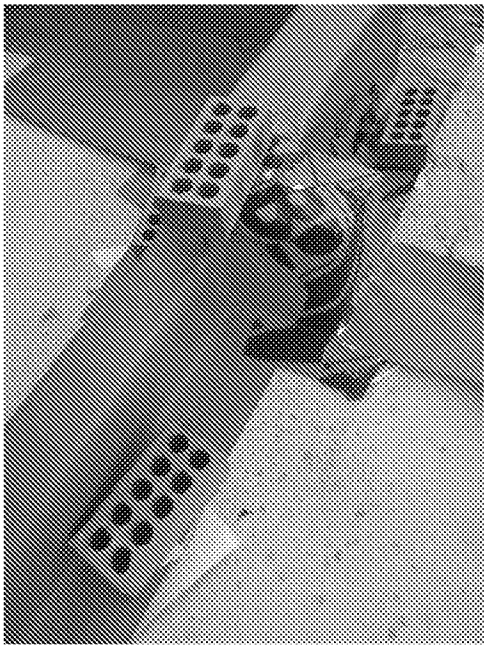
1.1 Condition of sub-grade and underside of membrane	Clean, recently swept flat concrete.
1.2 Gas membrane type	Keytec 400 HP - Self branded bought from Juta.
1.3 Gas membrane condition	Very good. No sign of previous repair or weakness.
Jointing tape product	Membrane cutouts used as principal joint tape. 301483 Foil Band 150mm width/ 1.5mm thickness/10m length - Aluminum heat weld membrane tape - used around service ducts.
1.5 Lapping design	Lapped >=50mm in all areas where achievable
1.6 Laps, welds and joints seals	Heat welded membrane used to seal joints.
1.7 Service seals	Seal with foil band weld membrane joining tape.

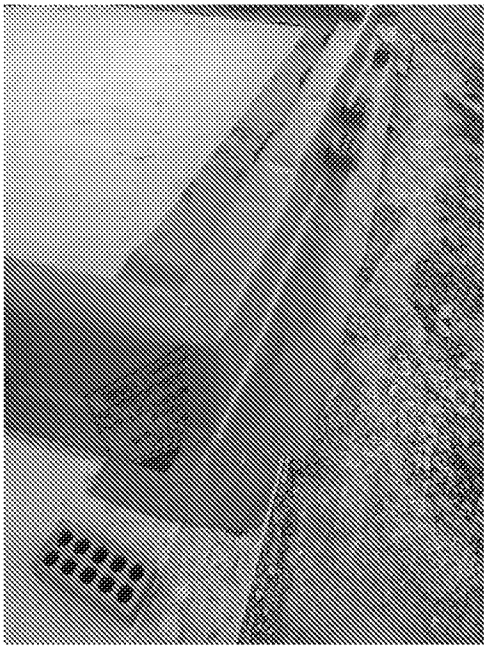
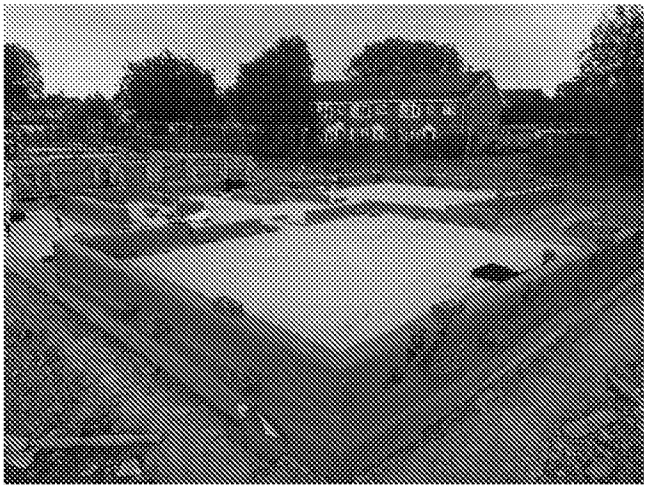
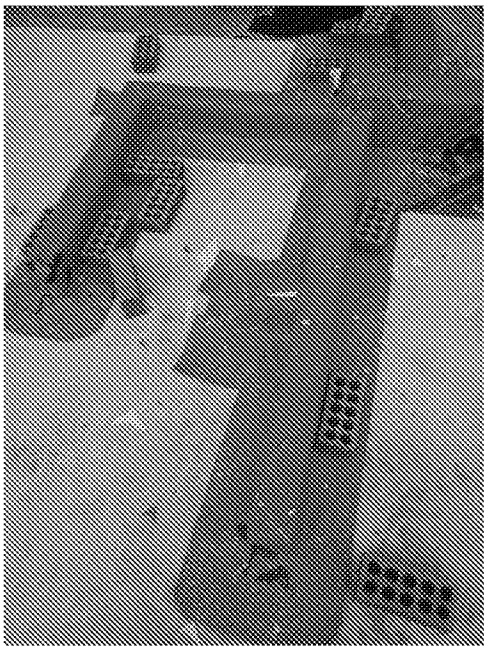
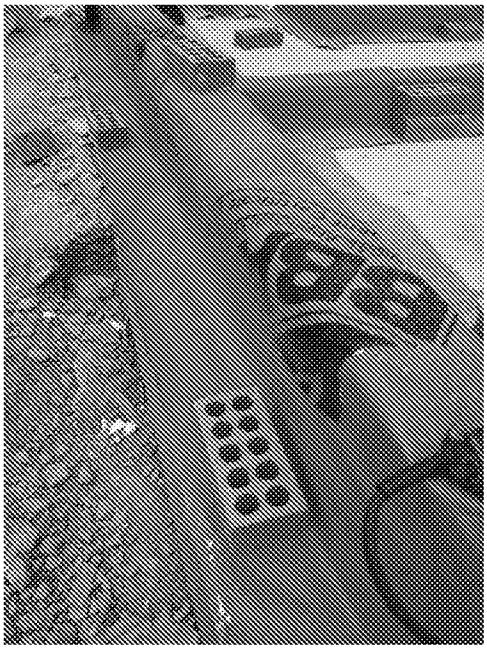
1.1 Condition of sub-grade and underside of membrane	Very clean, recently swept.
1.2 Gas membrane type	Keytec 400 HP - bought from Juta branded by Keytec. Red. Stored in van.

1.3 Gas membrane condition	No punctures, evidence of footprints, repairs or weakness. Joining tape will be used to protect membrane against wooden beam installation at later date
Jointing tape product	Membrane used as principal joint tape as opposed to membrane tape due to longer life span (25 years). Joining tape used on service ducts only. Brand:301483 Foil Band 150mm width/ 1.5mm thickness/10m length - Aluminum heat membrane tape - used around service ducts

1.7 Service seals	Services sealed with heat sealed tape

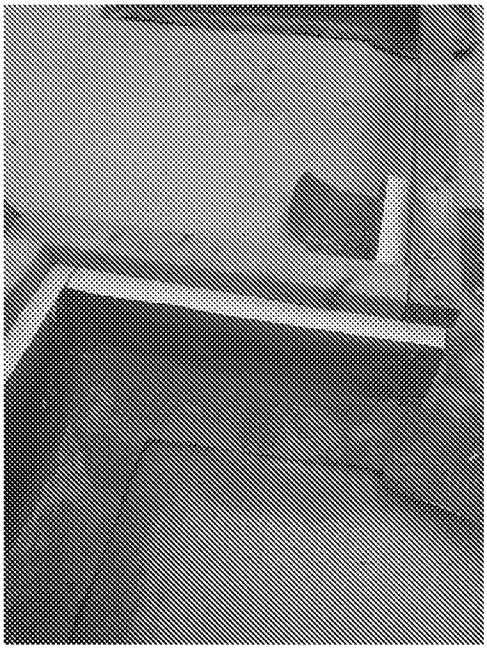
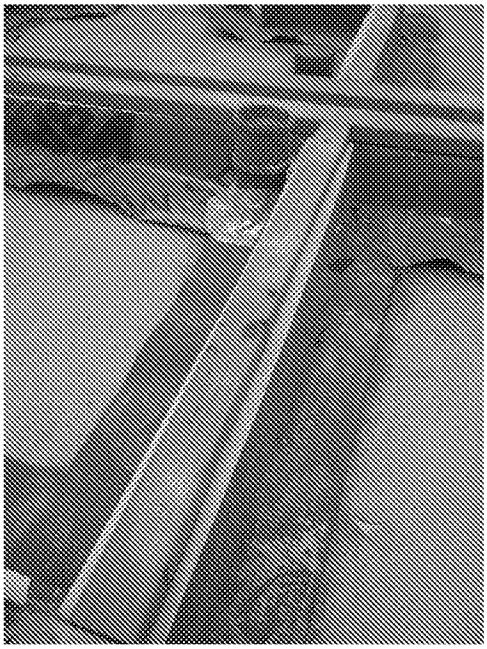
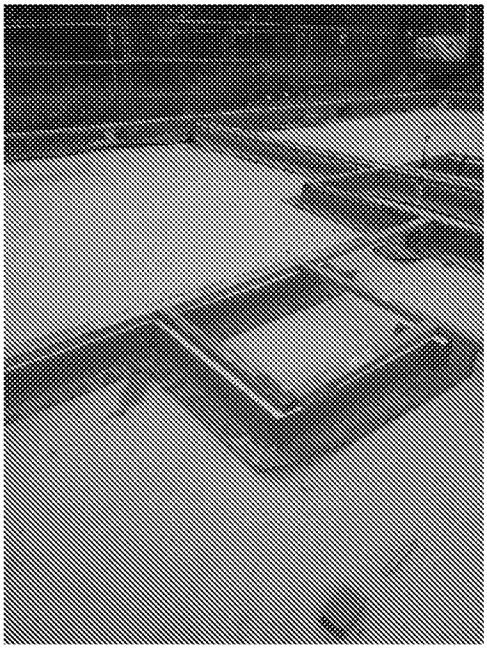
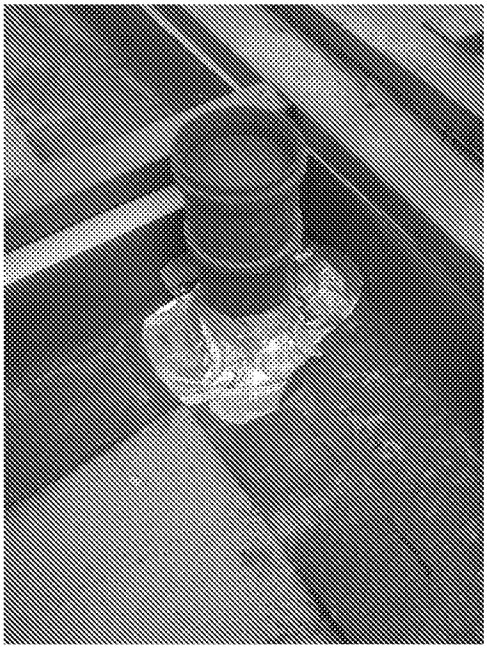
1.1 Condition of sub-grade and underside of membrane	Good condition, clean with no visible damage
1.2 Gas membrane type	Keytec gas resistant 400 membrane and on a few plots black juta unbranded gas resistant membrane
1.3 Gas membrane condition	Membrane in good condition some dust but well protected
Jointing tape product	Heat sealed, no tape
1.5 Lapping design	At least 100mm lap on all joins
1.6 Laps, welds and joints seals	All heat sealed and well sealed
1.7 Service seals	Site made seals around all services that fall within perimeter. Services outside perimeter yet to be sealed

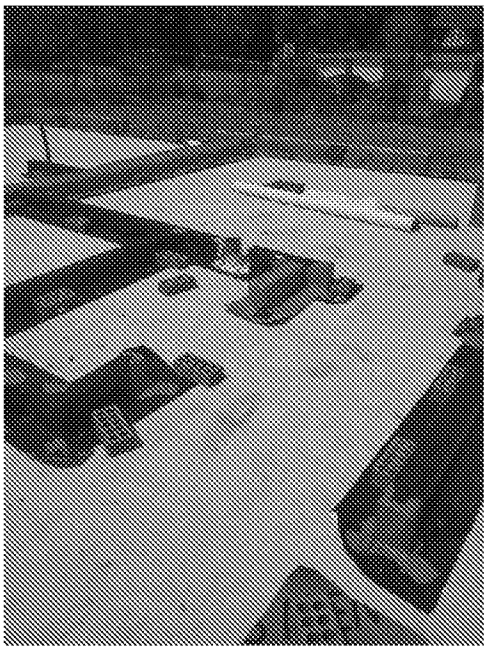
Plot 10 overview
	Plot 10 wall

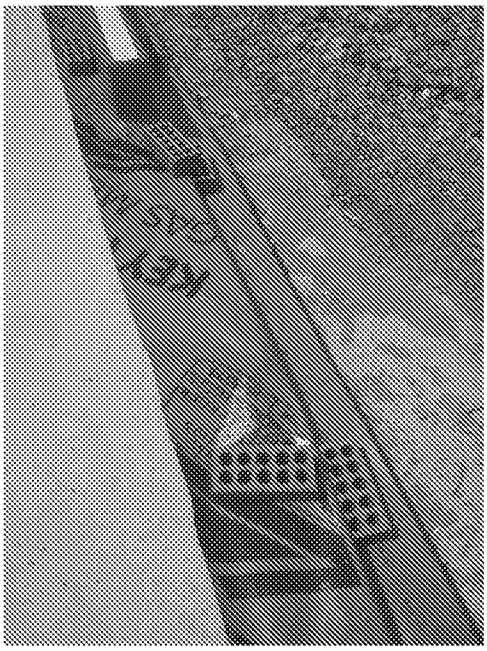
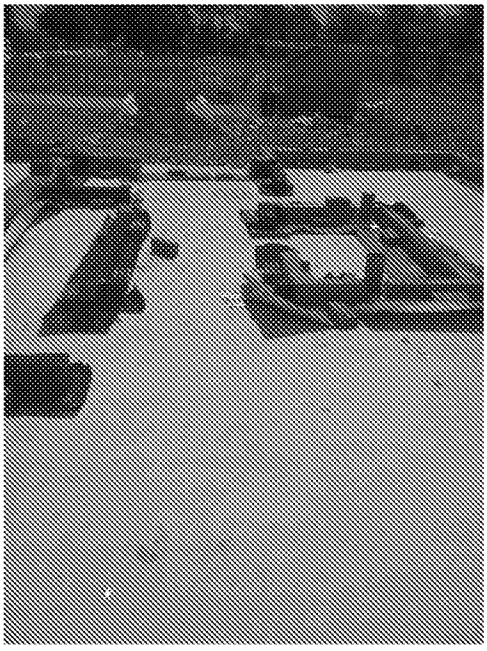
Plot 10 services
	Plot 11 overview

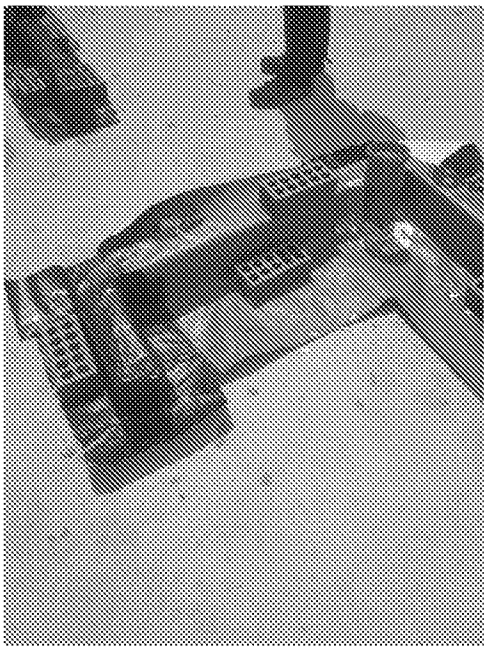
Plot 11 services
	Plot 12 overview

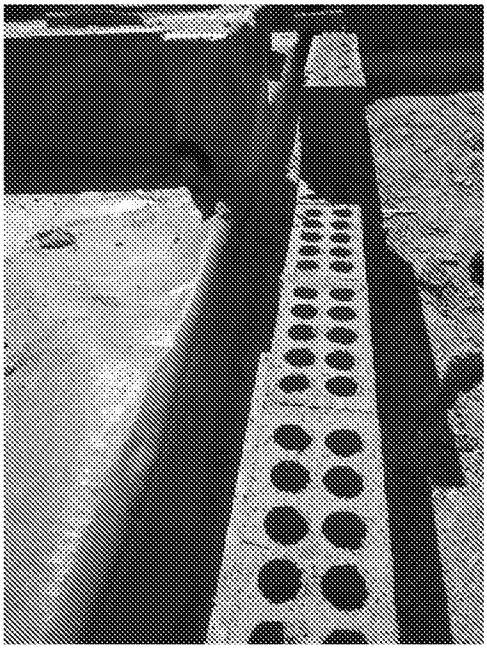
Plot 1 services
	Plot 1steel

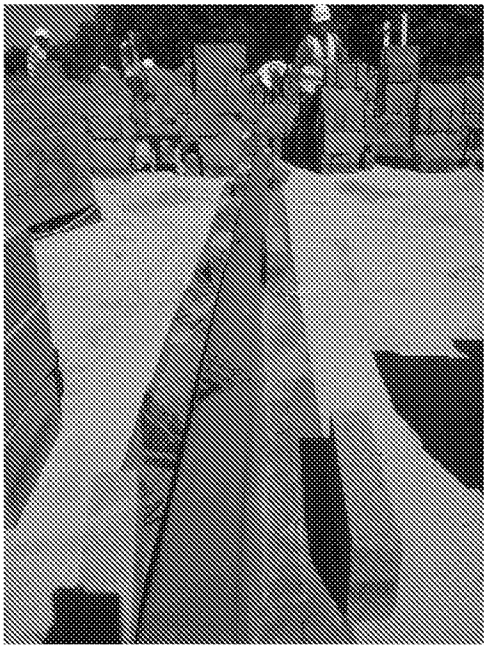
Plot 1 seals
	Plot door threshold
	Plot 1 stairwell

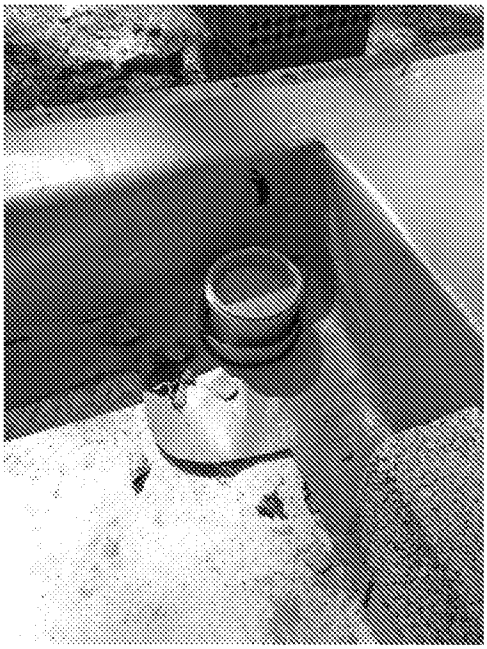
Plot 4 - service seal
	Plot 4 - join between wall and floor

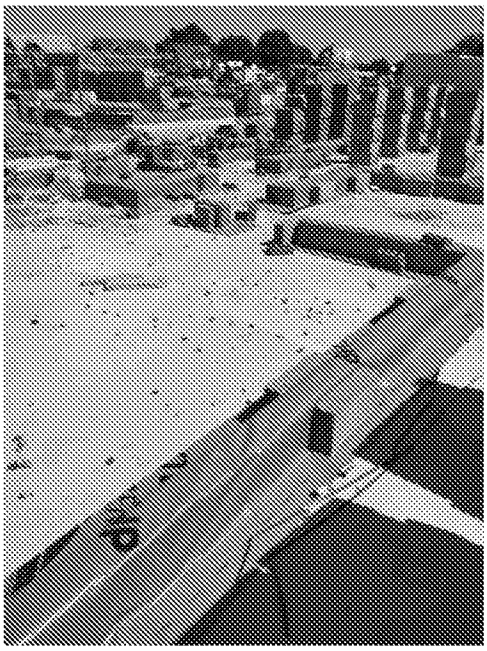
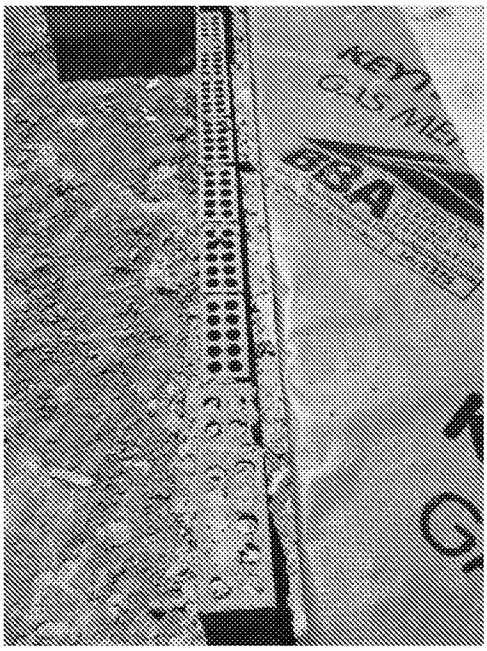
Plot 4 - Threshold
	Plot 4 - Black putty tape sealant under frame
	Plot 4 - Patching of any holes has already been completed

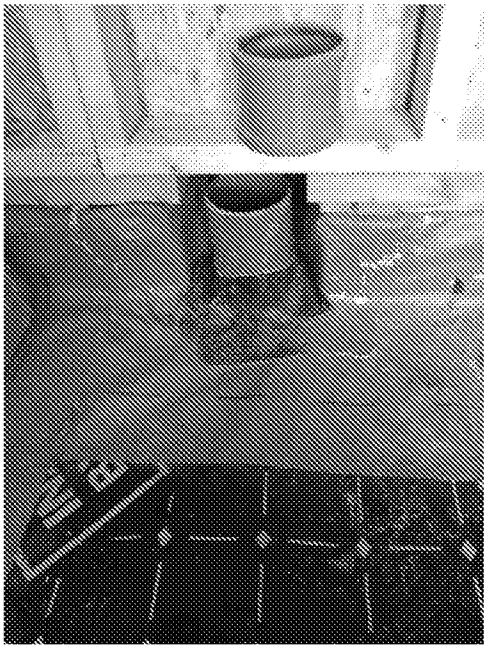
Plot 8 overview
	Plot 8 under stairs

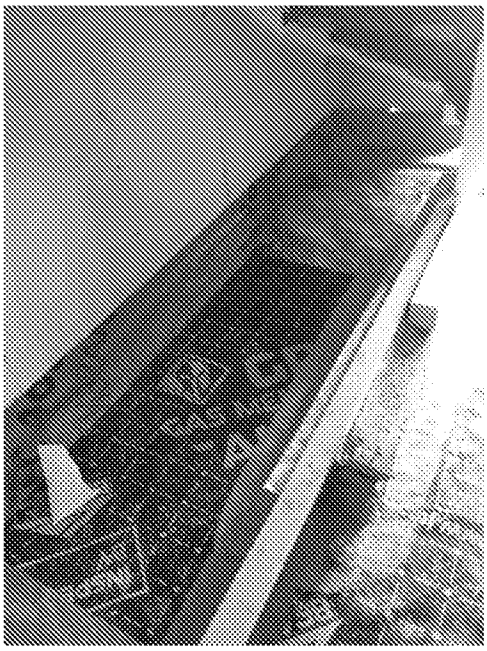
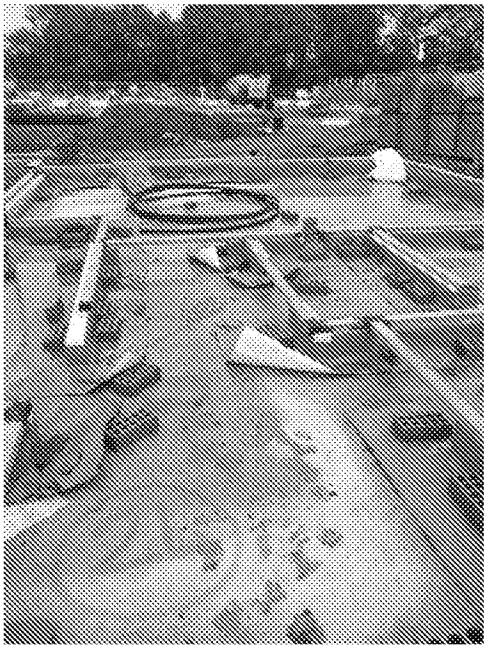
Plot 8 patch repair
	Membrane type

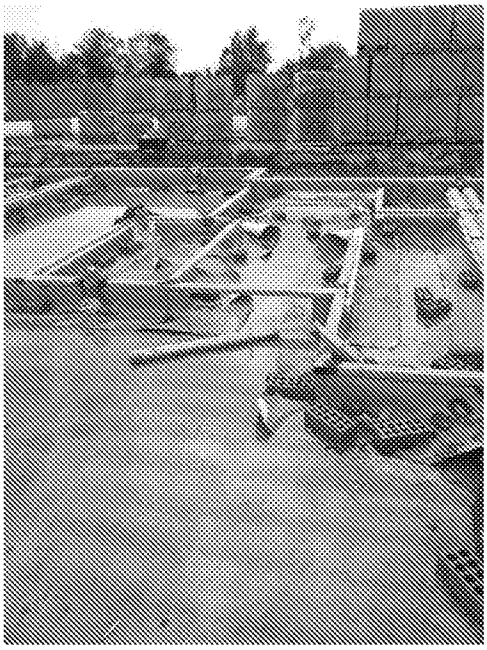
Plot 8 join
	Plot 9 overview

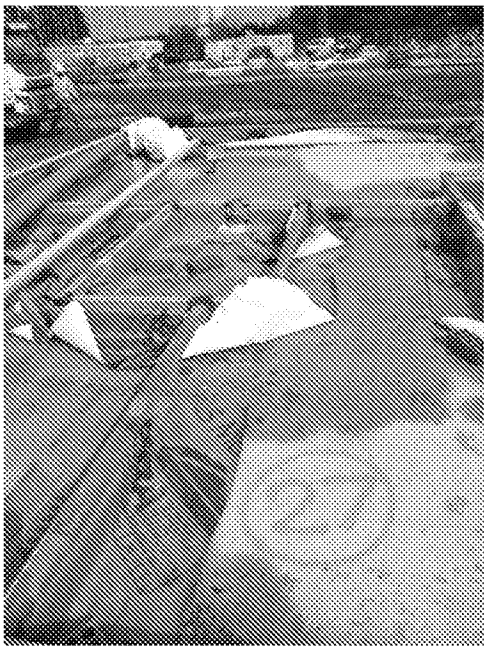
Plot 9 service seal
	Plot 9 patch repair

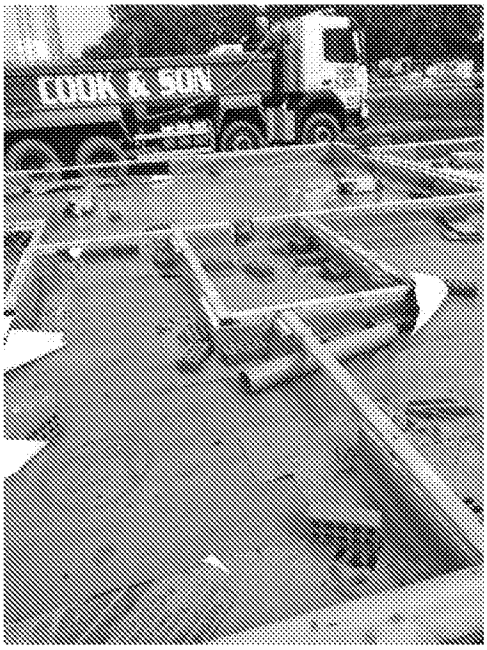
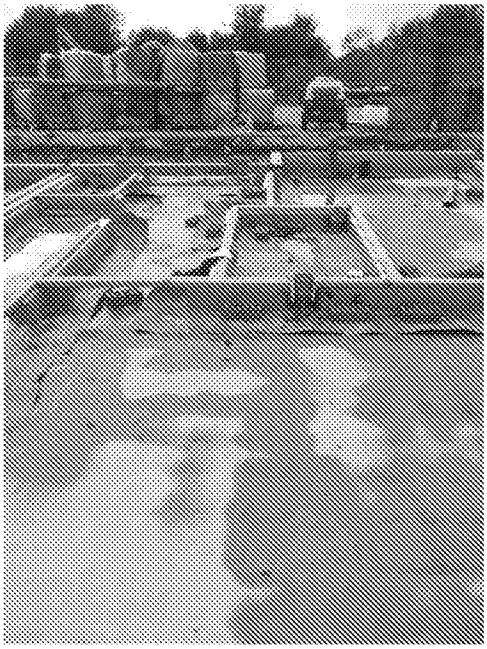
Plot 9 floor
	Plot 10 overview

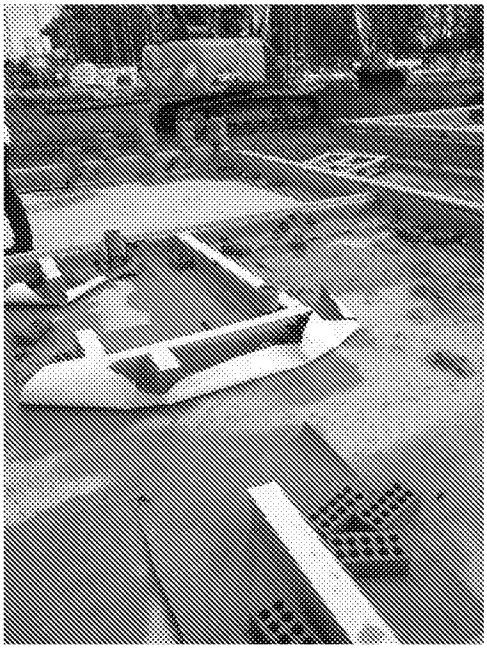
Pot 10 membrane joins
	Plot 10 services

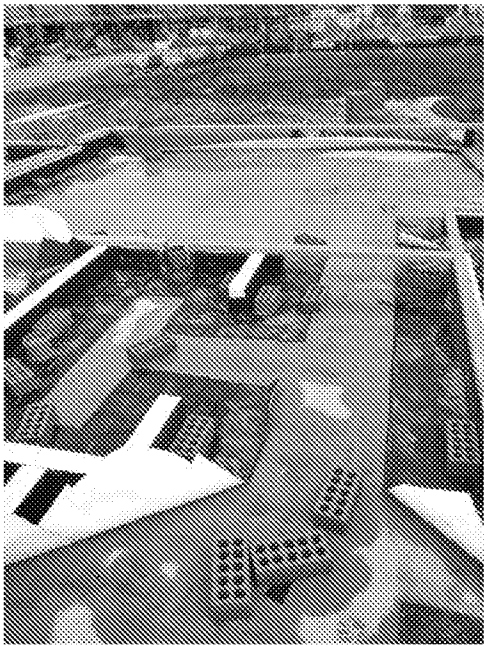
Plot 10 under stairs
	Plot 24 reinspection

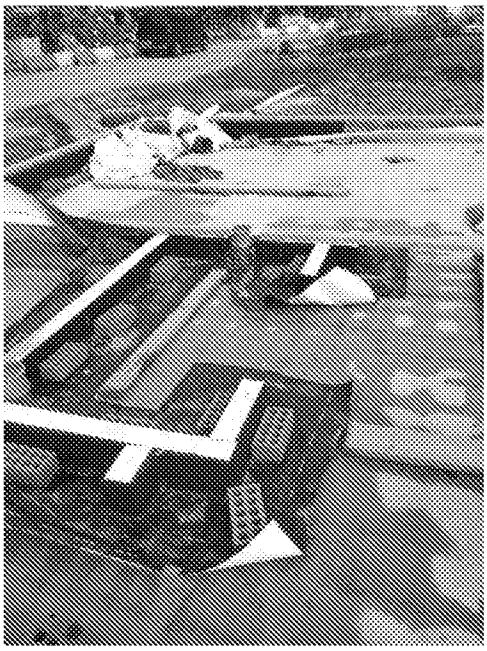
Plot 25 reinspection
	Plot 26 service

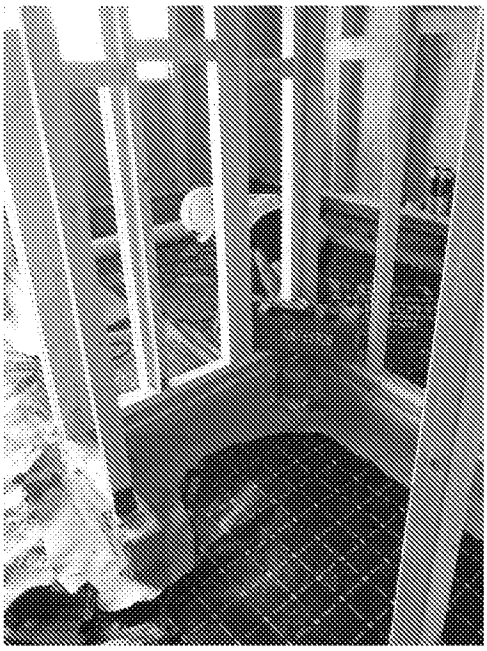
Plot 27
	Plot 28

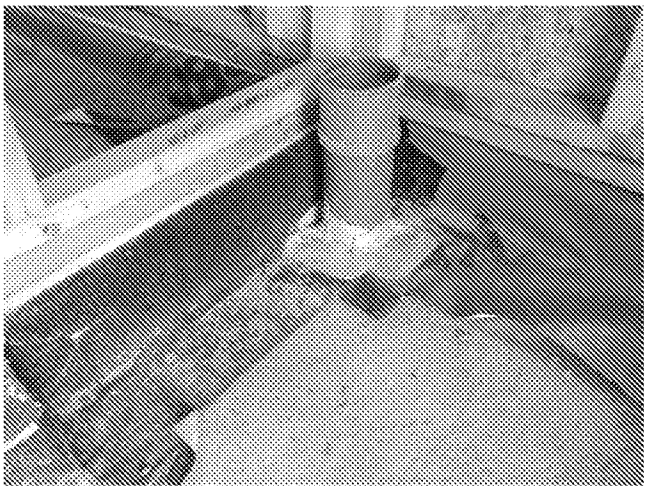
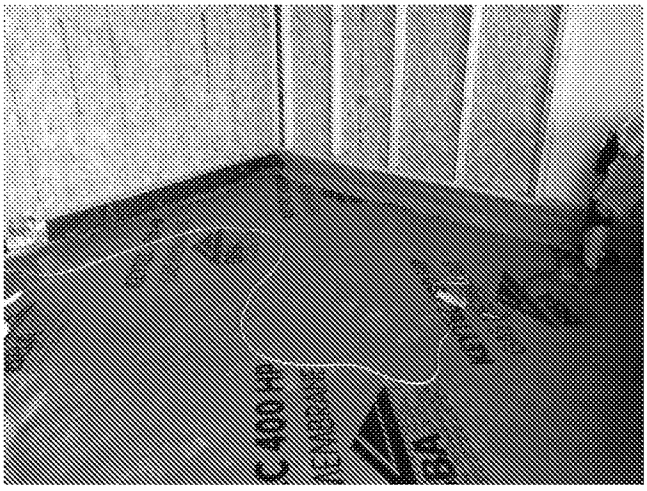
Plot 12 - View across floor
	Plot 12 - service seal
	Plot 12 - Holes have been patched

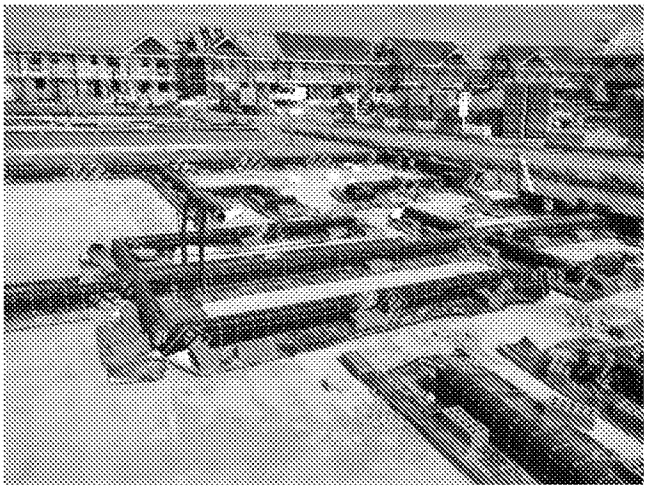
Plot 12 - Threshold
	Plot 13 - Threshold
	Plot 13 - Corner detail

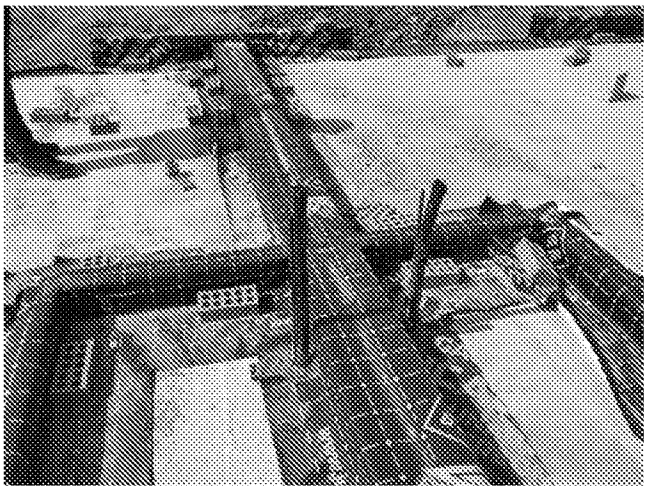
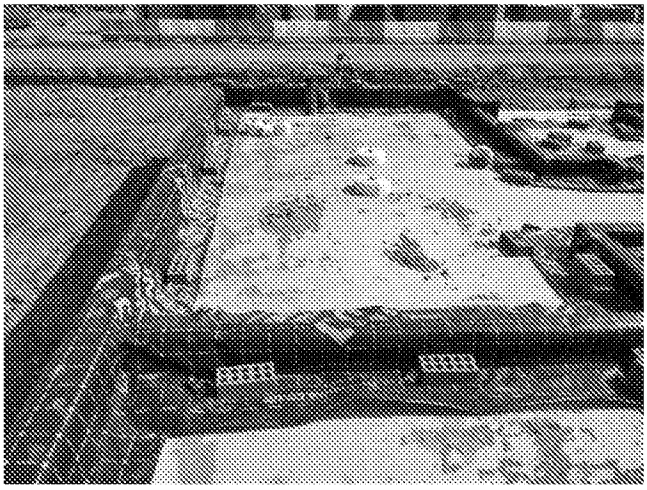
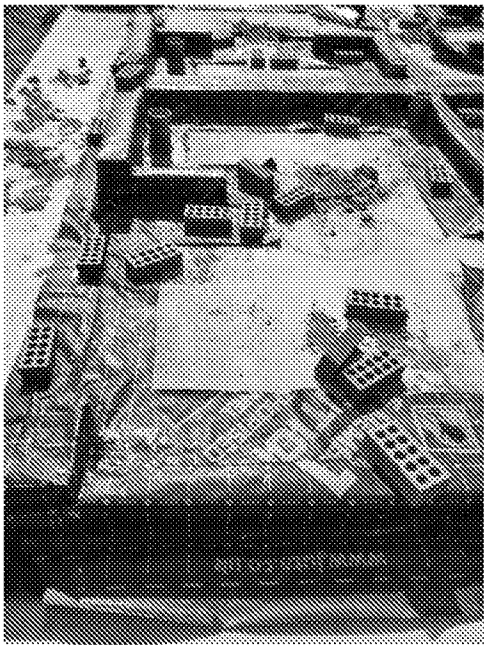
Plot 13 - Floor
	Plot 13 - Floor and service seal
	Plot 13 - Threshold

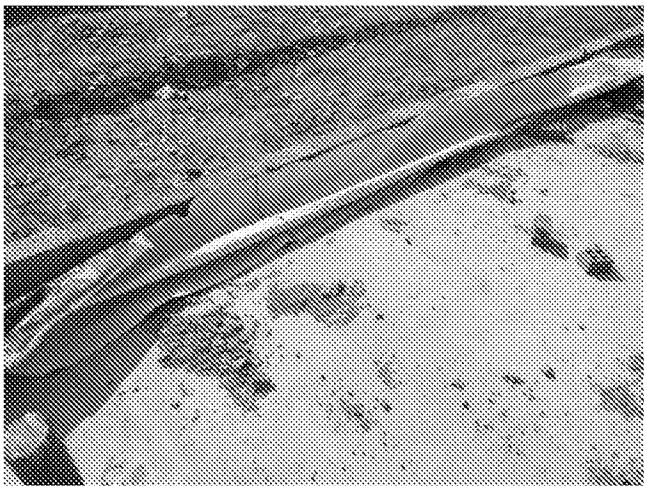
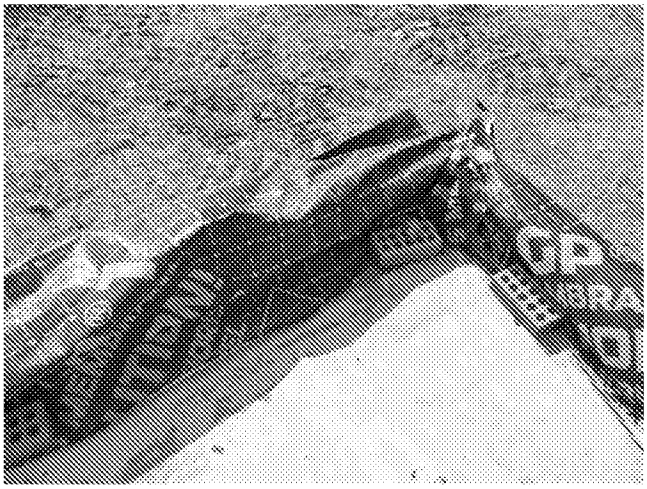
Plot 13 - Patching
	Plot 13 - Under stairs
	Plot 15 - In progress

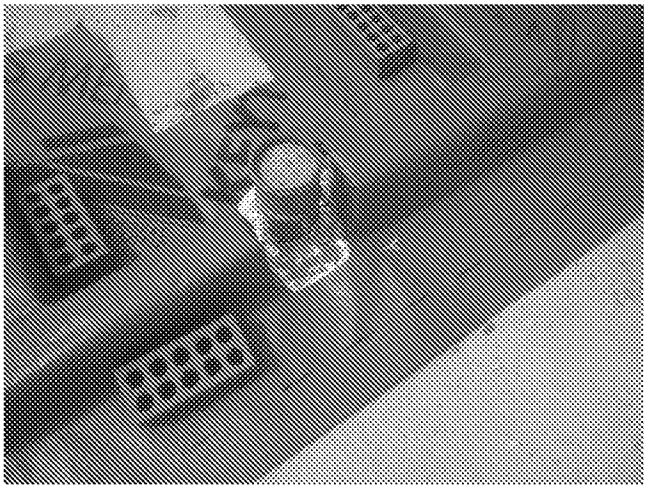
Plots 36-37. View across plots.
	Plots 36-37. Example of underside of membrane.
	Plots 38-39. Example of weld.

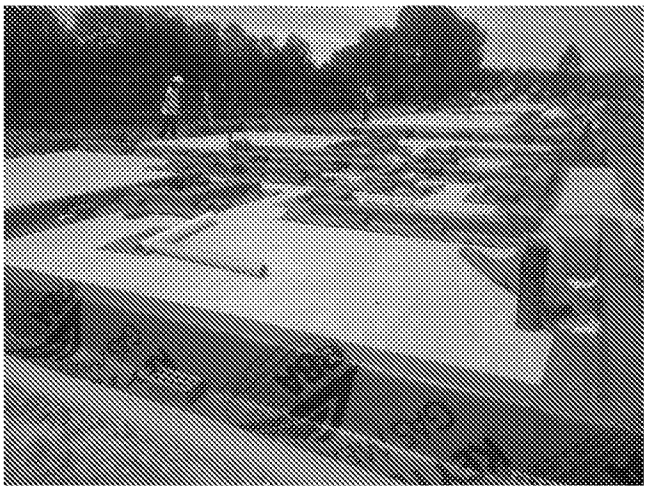
Plots 38-39. Underside of wooden frame with butyl tape for sealing screws.
	Plots 38-39. Example of butyl tape under wooden frame.

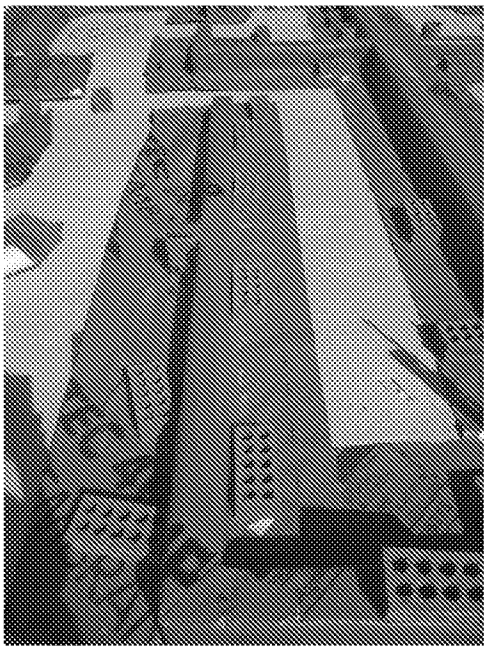
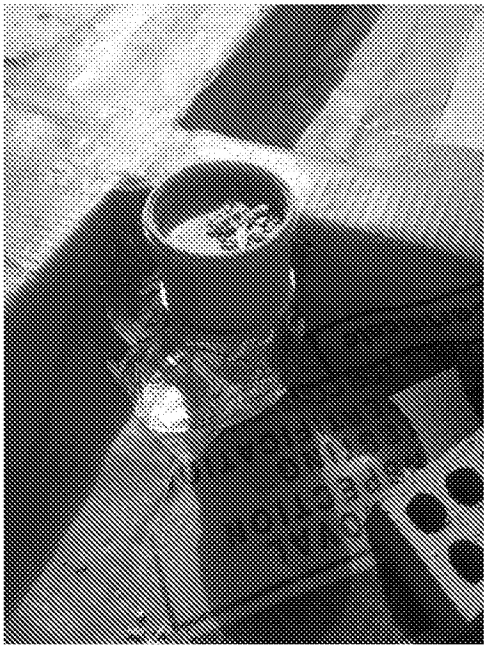
Block B Overview
	Block B Block work

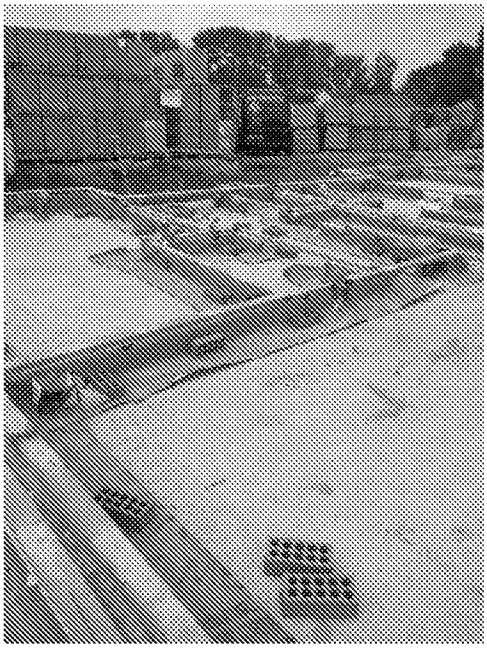
Plot 24
	Plot 24 services

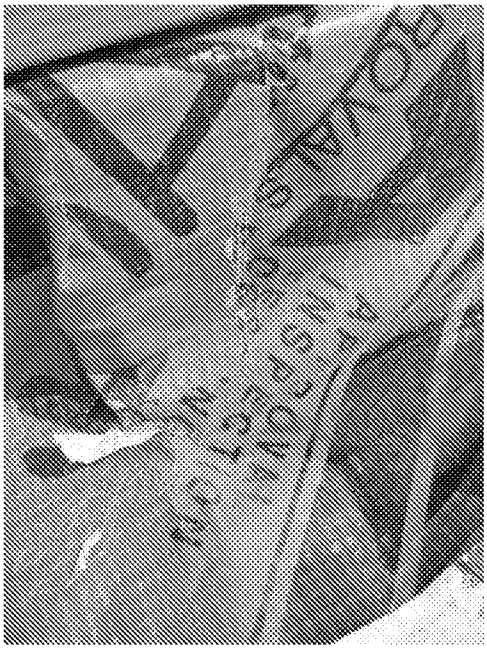
Plot 24 tape for timber frame
	Plot 24 cavity

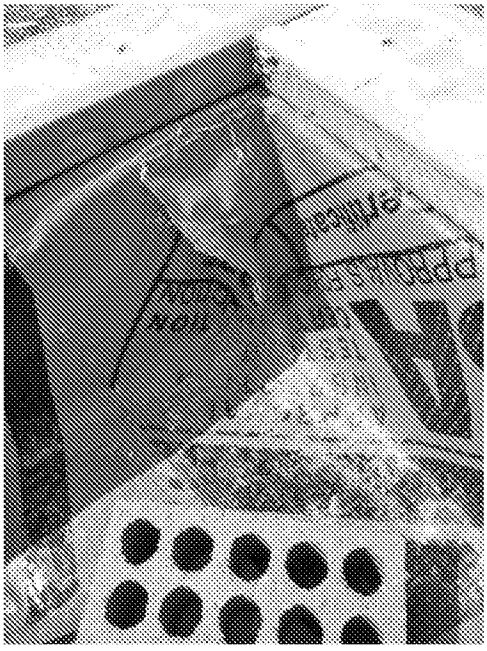
Plot 25
	Plot 25 threshold

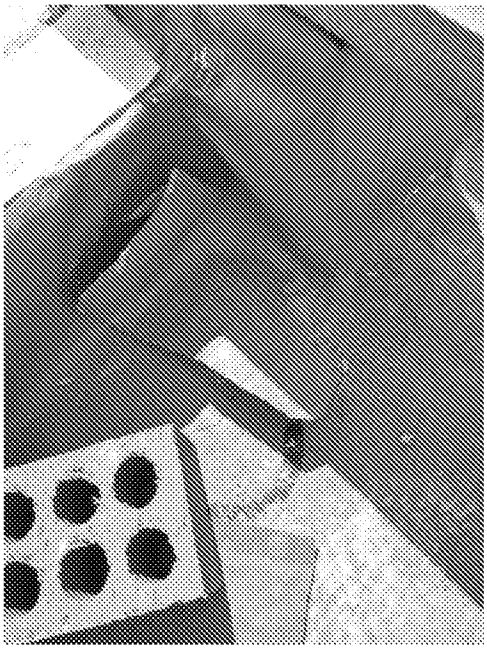
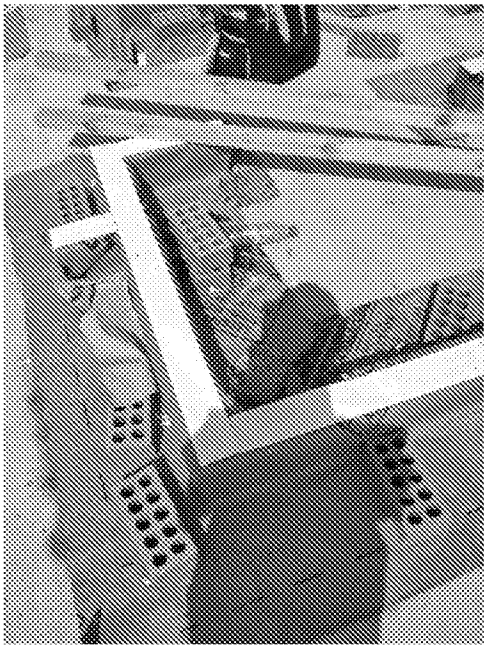
Plot 25 service
	Plot 26

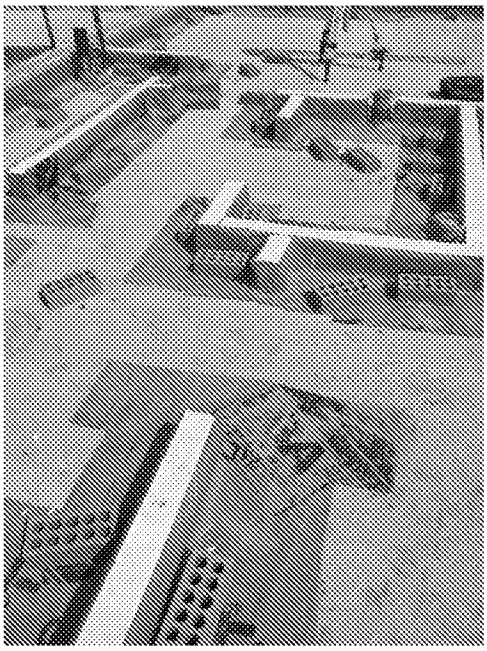
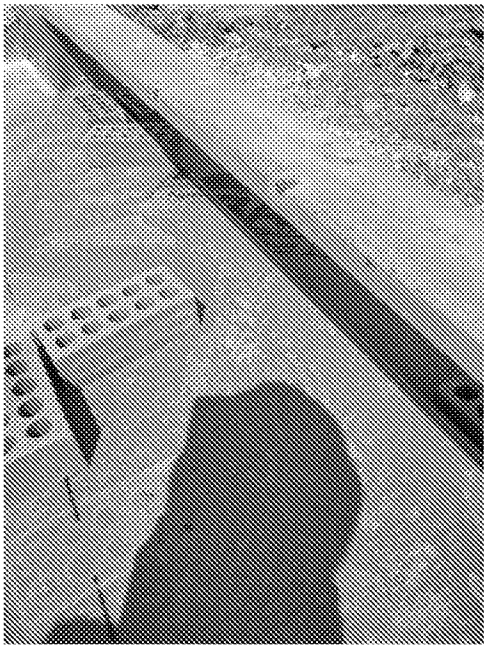
Plot 26 corner
	Plot 26 lapping

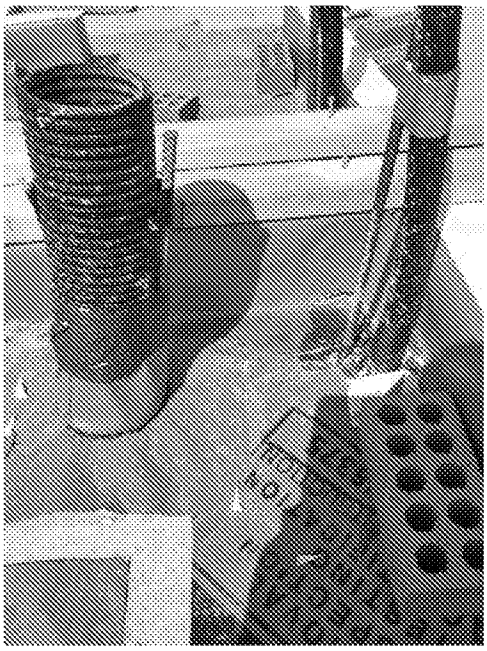
Plot 27
	Plot 27 service

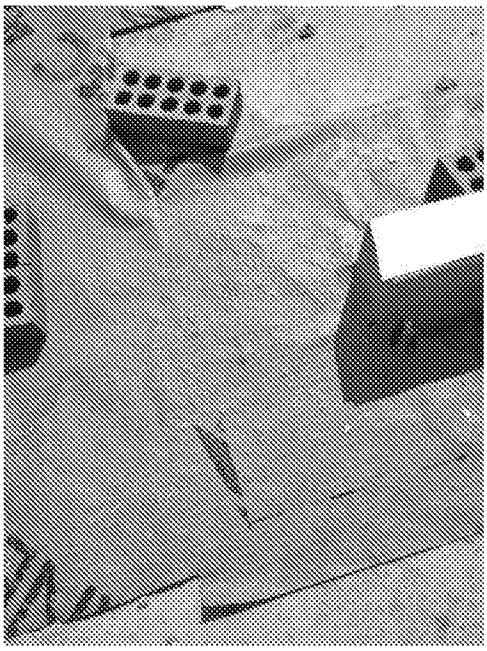
Plot 27 damage
	Plot 27 corner damage

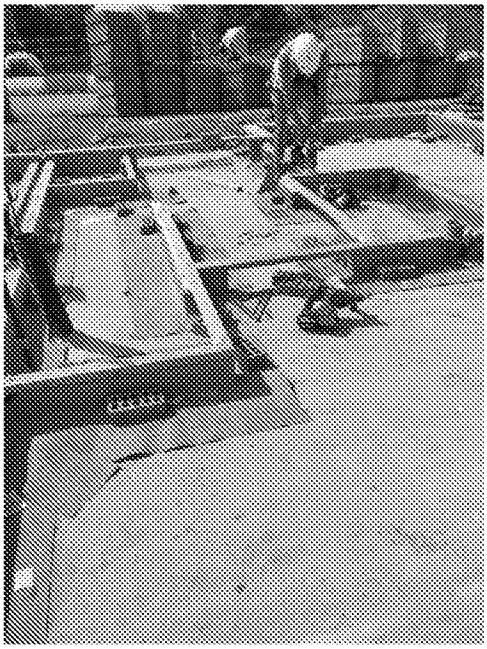
Plot 28
	Plot 28 corner needs sealing

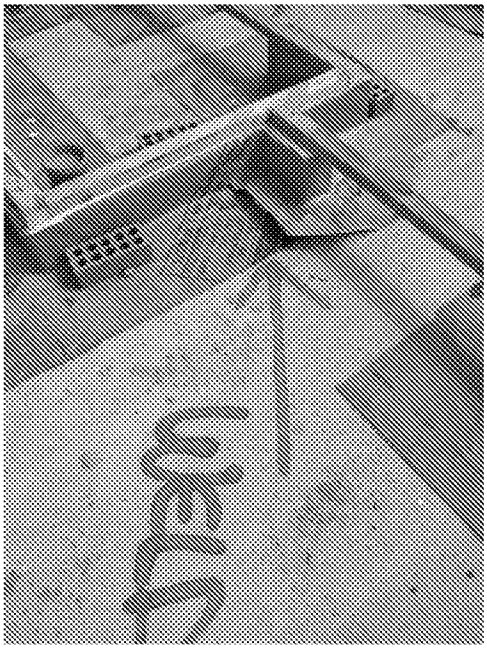
Plot 28 lapping needs sealing
	Plot 28 tape for frame

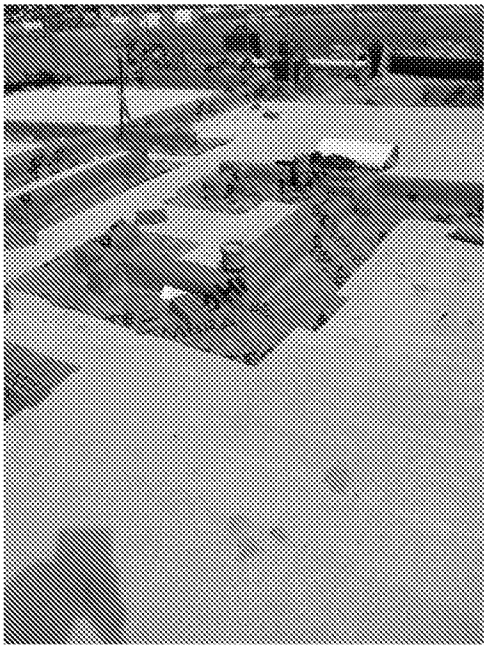
Plot 29
	Plot 29 threshold

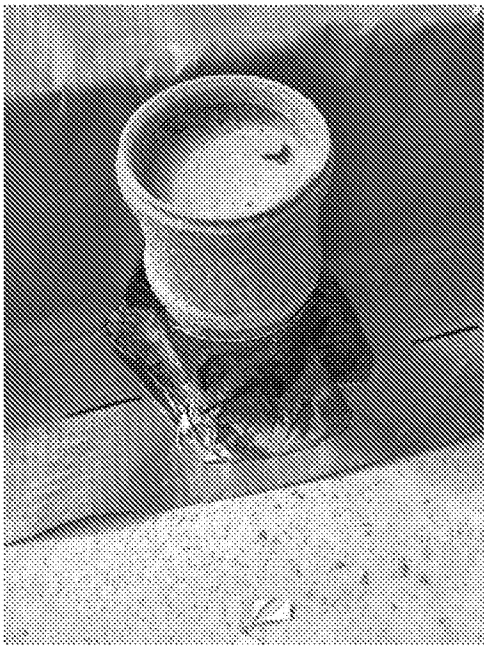
Plot 29 services
	Plot 30

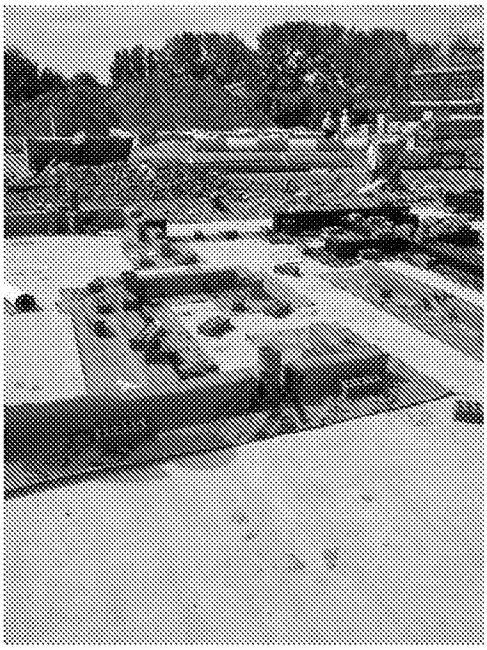
Plot 30 joins
	Plot 30 services

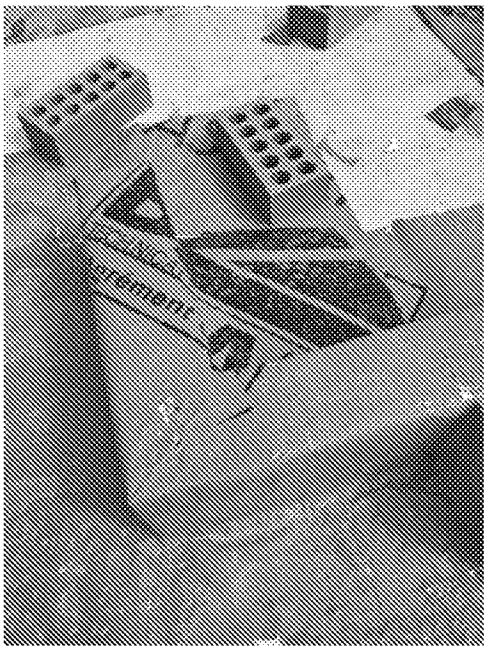
Plot 30 corner
	Plot 31

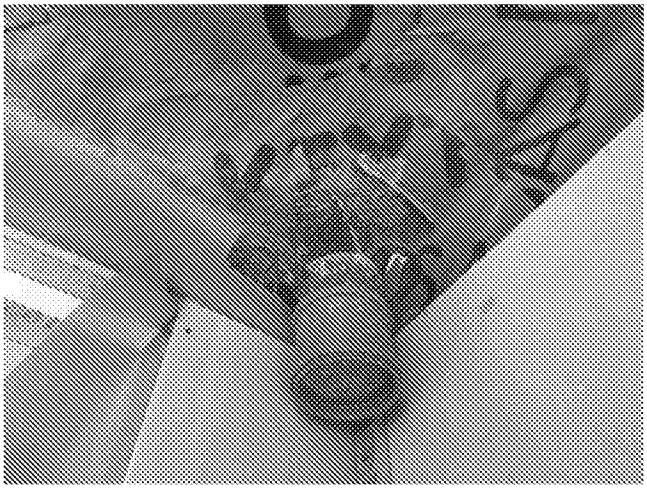
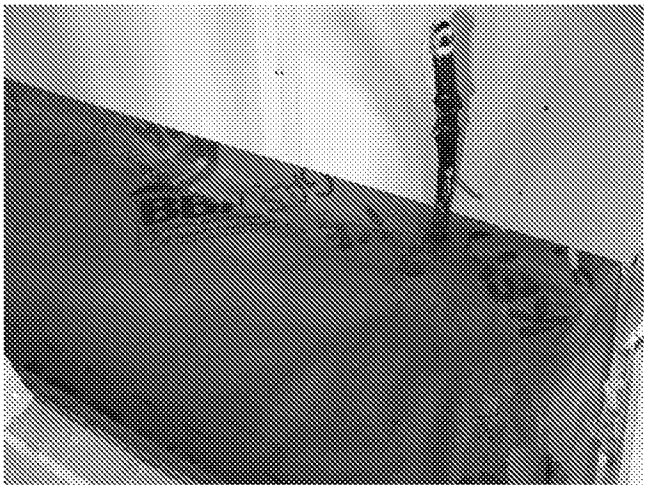
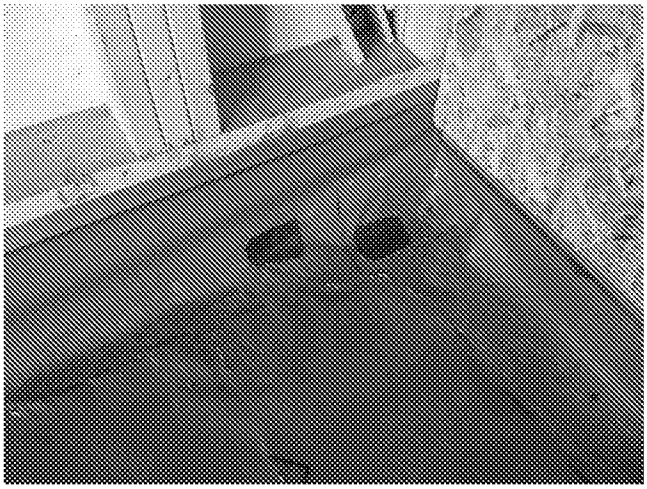
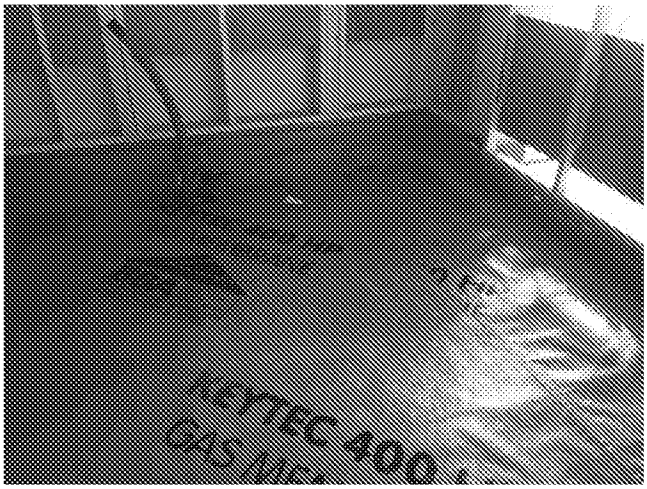
Plot 36 Joins
	Plot 36 Patch repairs
	Plot 36 sides

Plot 36 Front room
	Plot 37
	Plot 37 Joins and a patch repair
