Project Name:	DAISY FIELDS.LITTLEHAMPTON.BN17 6LT
Project Description:	TO CARRY OUT CCTV SURVEY AT THE ABOVE ADDRESS
Project Number:	02
Project Status:	Complete
Project Date:	30/06/2025
Inspection Standard:	MSCC5 Sewers & Drainage GB (SRM5 Scoring)

PROLINE DRAINAGE LTD
CHARLWOOD ROAD, CRAWLEY
[redacted]

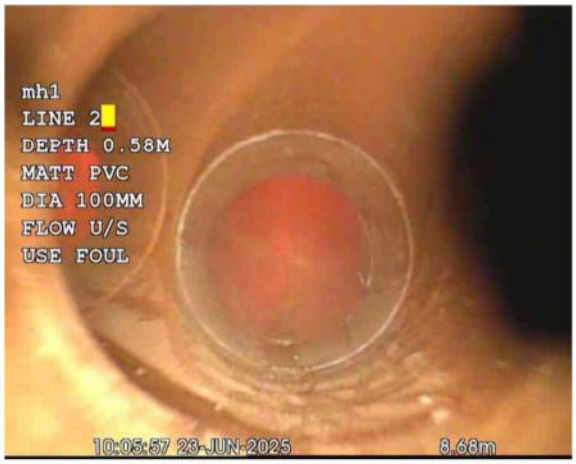
L2X_2511c4da-2cc1-462c-a3ae-c4b7dc92e414_20250701_165650_134.jpg, 00:00:00, 0.00 m
Start node, manhole, reference: FIC1

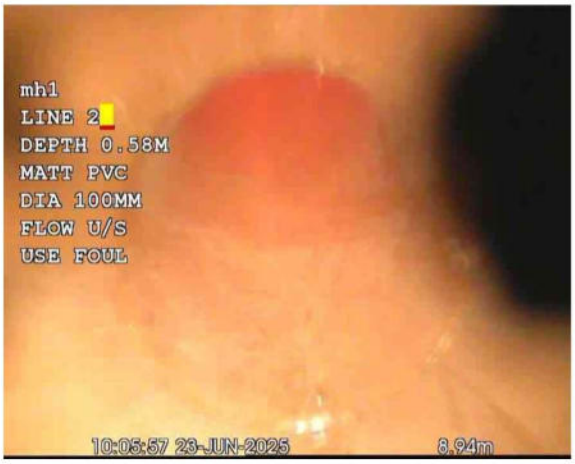
L2X_fc0790c1-3560-447c-a154-331fc145833d_20250701_165651_981.jpg, 00:00:22, 8.68 m
Junction at 9 o'clock, 100mm dia

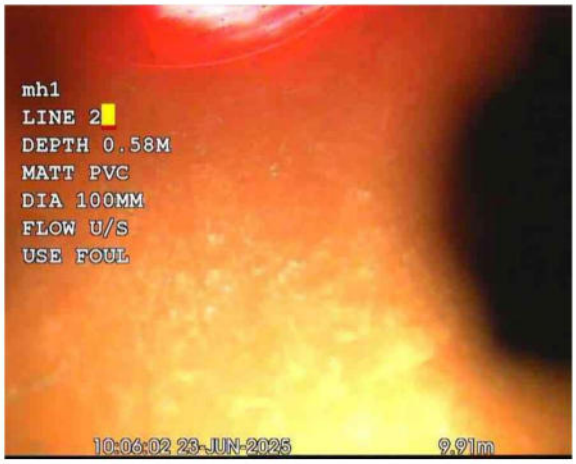
L2X_58c295d6-6d6b-47d4-baf9-7f201caeab20_20250701_165653_361.jpg, 00:00:23, 8.94 m
Line deviates up

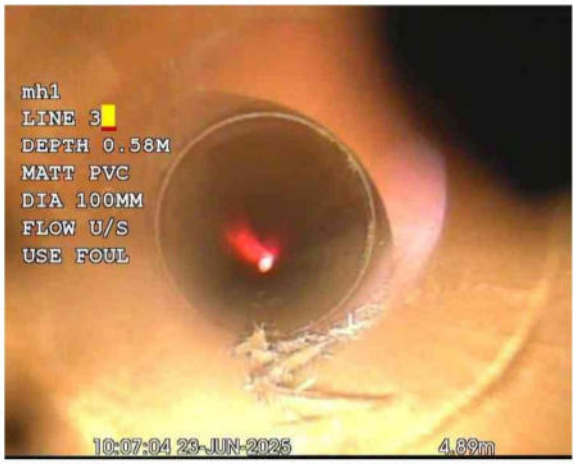
L3X_e10ebae3-6c2e-48ef-8aab-ca1c8fe4c35e_20250701_165659_651.jpg, 00:00:00, 0.00 m
Start node, manhole, reference: FIC1

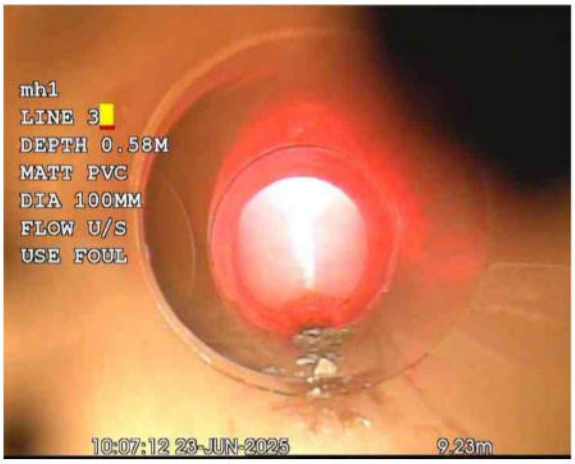
L3X_0b9d4282-8b8e-4210-9ecb-88f7975ffd78_20250701_165701_356.jpg, 00:00:13, 4.89 m
Junction at 2 o'clock, 100mm dia

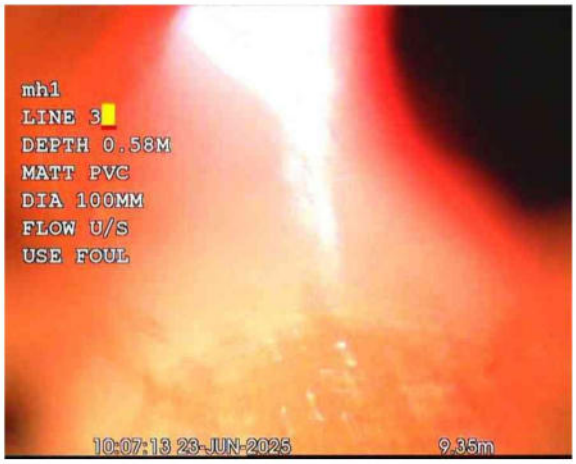
L3X_59a283f4-b9ee-48e1-a44a-7199d18bc453_20250701_165702_914.jpg, 00:00:21, 9.23 m
Junction at 9 o'clock, 100mm dia

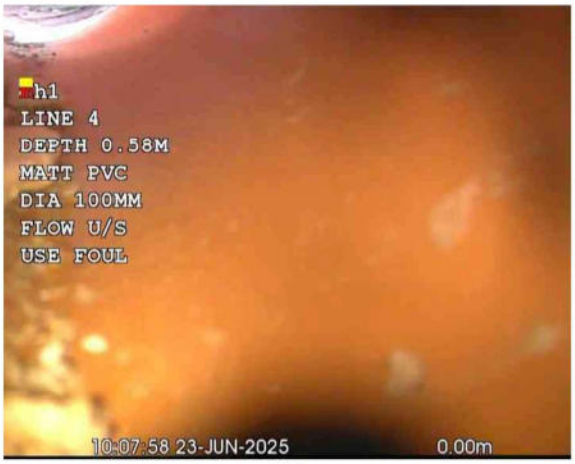
MH
1X_7628e776-9933-4dfa-9d46-dc22df8876ef_20250701_165714_434.jpg, 00:00:00, 0.00 m
Start node, manhole, reference: FIC1

MH
1X_514b3128-7805-4a17-9427-a0a140d41911_20250701_165715_665.jpg, 00:00:07, 0.30 m
Finish node, manhole, reference: FIC2

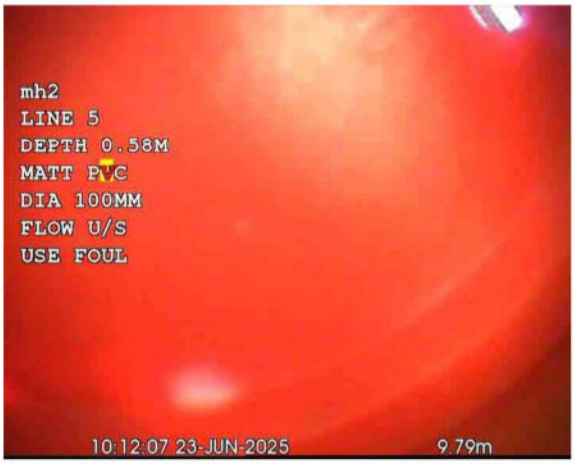
L5X_1a0213cc-e291-4f6f-a7c6-8620313a7280_20250701_165726_898.jpg, 00:00:29, 9.79 m
Finish node, other special chamber, reference: L5

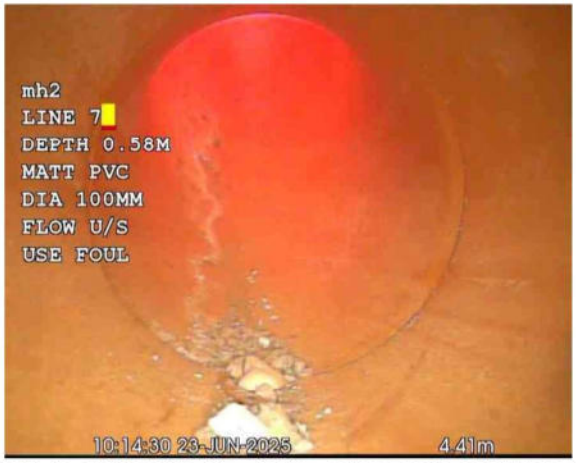
L7X_7c378d31-52e2-4373-ba48-3c02269acc9c_20250701_165808_083.jpg, 00:00:00, 0.00 m
Start node, manhole, reference: FIC2

L7X_d8a5b776-61d9-4dee-b049-ee94d4a66250_20250701_165808_887.jpg, 00:00:22, 4.41 m
Line deviates up

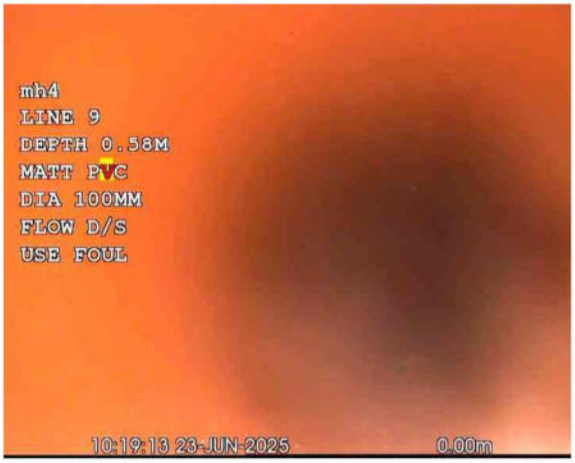
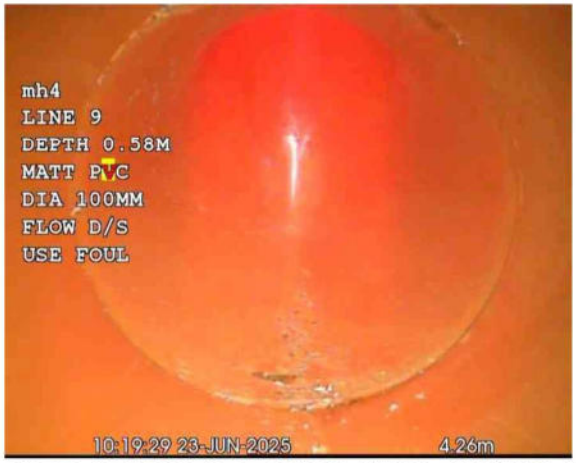
L9X_695abca1-7d3a-43c9-b614-72c7028508a9_20250630_185645_455.jpg, 00:00:00, 0.00 m
Start node, manhole, reference: FIC3

L9X_6a8c22e5-1168-48a0-a32d-5cf0c5b7625a_20250701_165858_809.jpg, 00:00:17, 4.26 m
Line deviates up

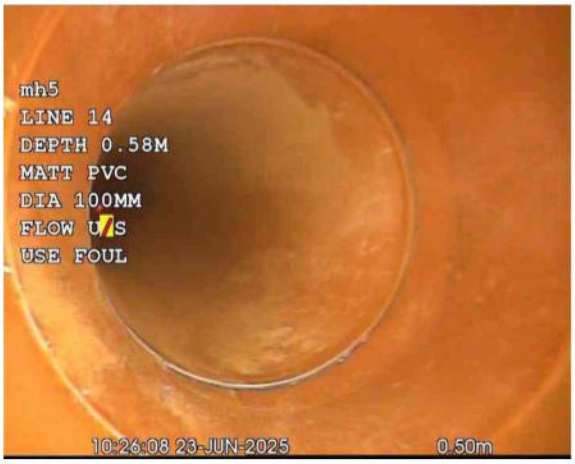
L14X_350b519f-60d0-4551-aa9e-b8f7cb8791cb_20250701_165941_811.jpg, 00:00:02, 0.04 m
Line deviates right

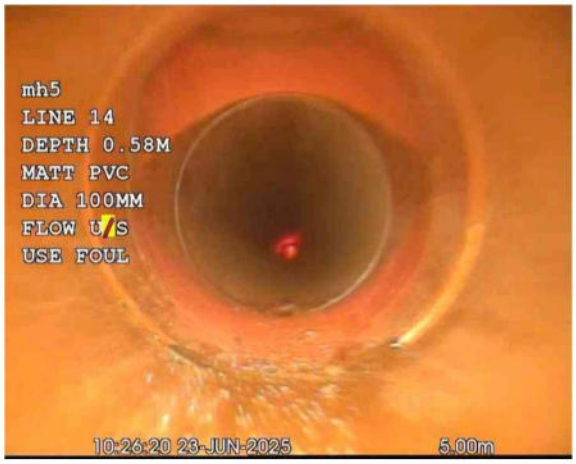
L14X_1b6d1808-0998-4c7c-8f52-ef9d7cade173_20250701_165943_387.jpg, 00:00:06, 0.59 m
Line deviates left

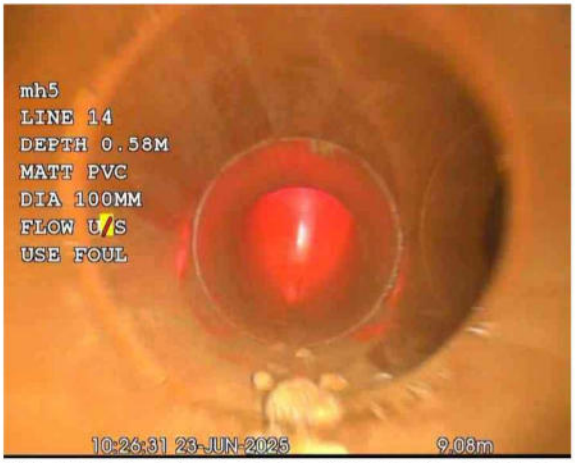
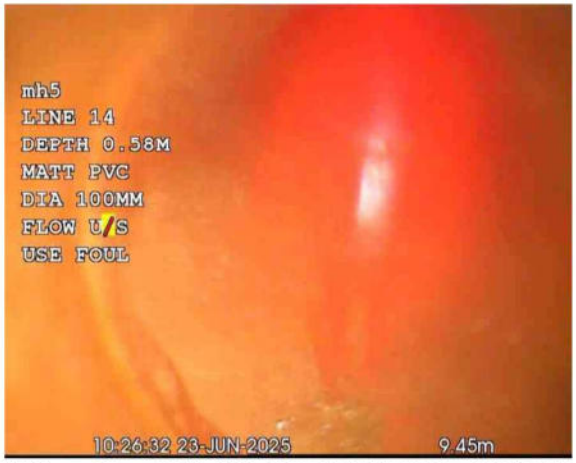
L14X_48e92ebe-8d23-4adb-b3a8-6b40c62f347c_20250701_165946_565.jpg, 00:00:28, 8.90 m
Junction at 3 o'clock, 100mm dia

L14X_eec33aec-2041-472c-8420-53125881882e_20250701_165948_859.jpg, 00:00:29, 9.45 m
Line deviates up

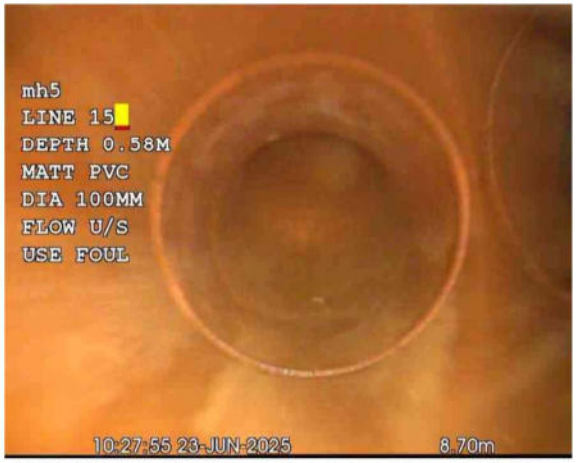
L15X_ee47413a-f90d-4052-9078-b98d4a60baaa_20250701_170004_497.jpg, 00:00:00, 0.00 m
Start node, manhole, reference: FIC4

L15X_9dd469a6-cff0-446a-8d6c-26f385a1409c_20250701_170006_358.jpg, 00:00:31, 8.70 m
Junction at 3 o'clock, 100mm dia

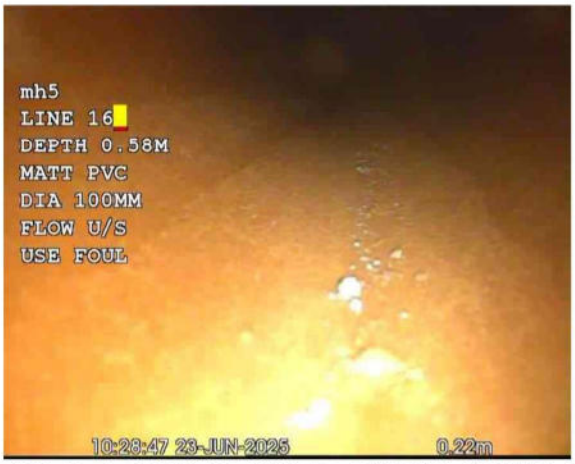
L16X_e0ec2ed7-08f6-4814-95f9-d2ea35796184_20250701_170016_857.jpg, 00:00:00, 0.00 m
Start node, manhole, reference: FIC4

L16X_2b70c7af-9f89-49f3-9f3e-118ce13f01d9_20250701_170017_910.jpg, 00:00:19, 4.84 m
Line deviates up

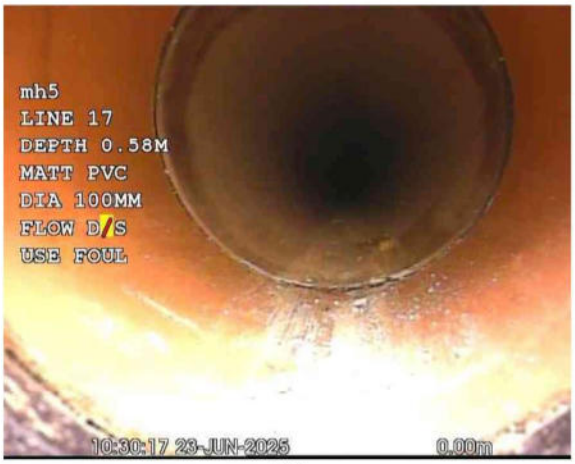
MH
5X_9c7c546a-2809-48f7-af21-f5dc52fd9237_20250701_170032_703.jpg, 00:00:00, 0.00 m
Start node, manhole, reference: FIC4

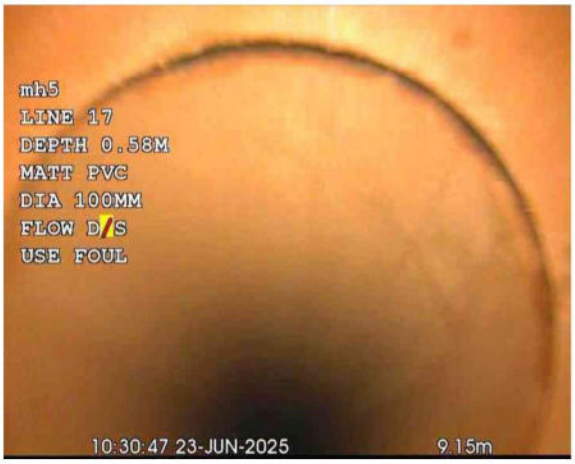
MH
5X_79554204-539b-43bf-9e42-5e1eb01cfb4e_20250701_170034_661.jpg, 00:00:05, 0.24 m
Pipe material changes to vitrified clay at this point

Comments:
Recommendations: HPWJ LINE

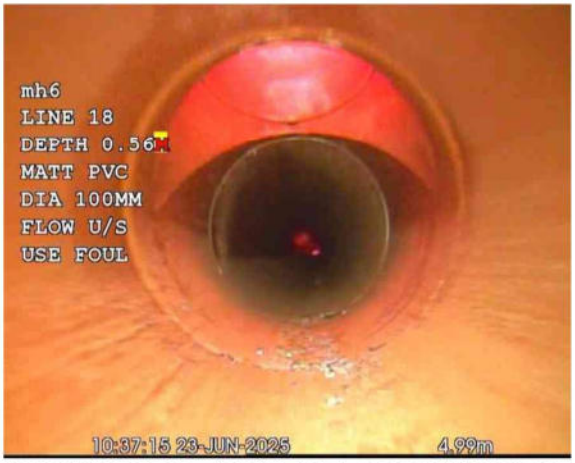
L18X_71753cfd-526d-4b79-986c-b3174321c1a7_20250701_170111_730.jpg, 00:00:00, 0.00 m
Start node, manhole, reference: FIC5

L18X_b559e82b-323a-4201-8ed5-b0c320c86847_20250701_170049_660.jpg, 00:00:20, 4.99 m
Junction at 12 o'clock, 100mm dia

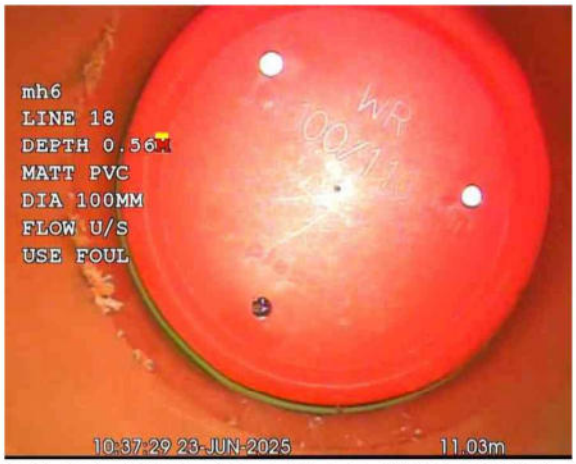
L18X_e2a569b3-baf8-4abe-aab2-cdb83d3a3d36_20250701_170102_115.jpg, 00:00:32, 9.90 m
Junction at 12 o'clock, 100mm dia

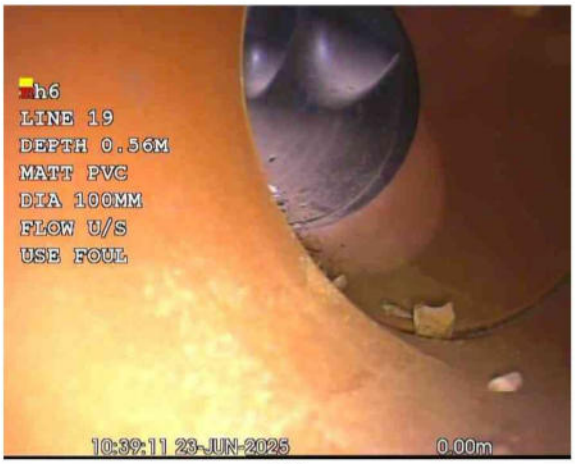
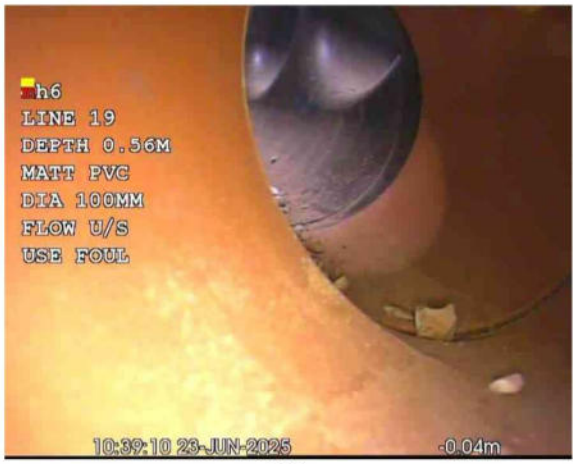
MH
7X_a0dc5e27-d718-41c2-a8d8-48a490e3f360_20250701_170129_242.jpg, 00:00:00, 0.00 m
Start node, manhole, reference: FIC5

MH
7X_a79175aa-e2fa-4ecb-8d22-c68fd7e514fb_20250701_170130_436.jpg, 00:00:00, 0.04 m
Line deviates left

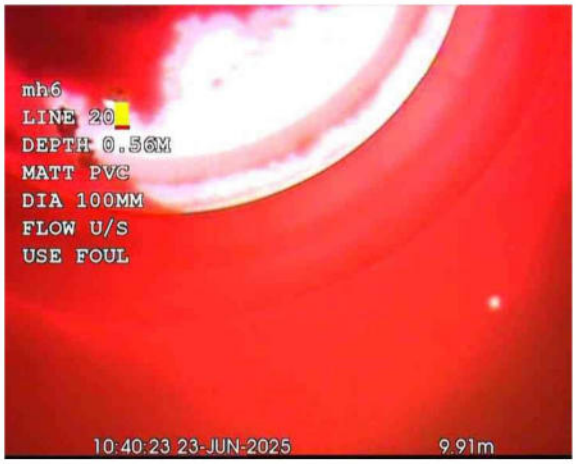
L20X_af50a0fc-6632-498a-8f06-06ae9ff0437e_20250701_170137_175.jpg, 00:00:00, 0.00 m
Start node, manhole, reference: FIC5

L20X_e231ad4f-6329-4834-bbd9-60ce2bfd9fef_20250701_170138_447.jpg, 00:00:06, 0.37 m
Line deviates left

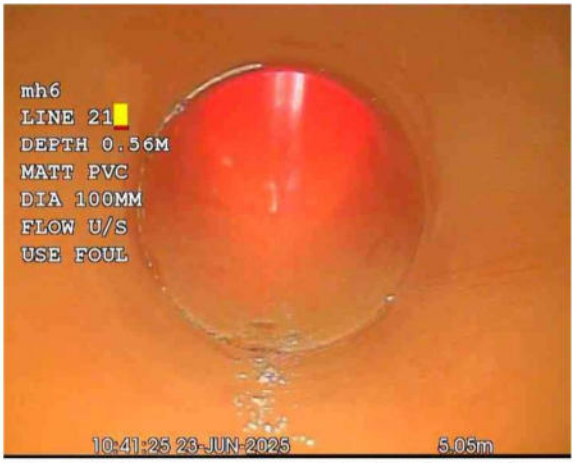
L21X_3362d6ac-9d56-4fcb-a30b-61576191f540_20250701_170148_977.jpg, 00:00:00, 0.00 m
Start node, manhole, reference: FIC5

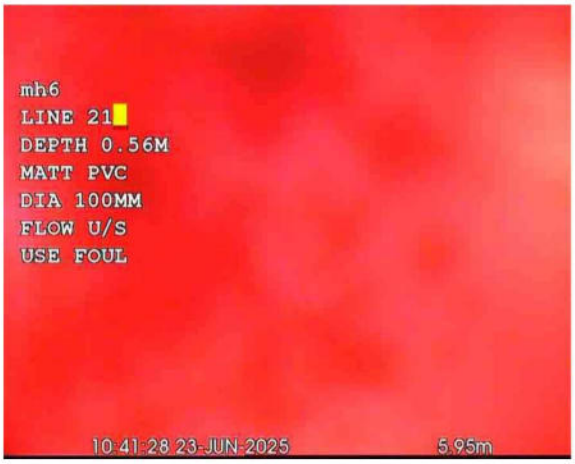
L21X_d82494c6-9ef7-44d0-861c-520d7362bb84_20250701_170150_265.jpg, 00:00:16, 5.05 m
Line deviates up

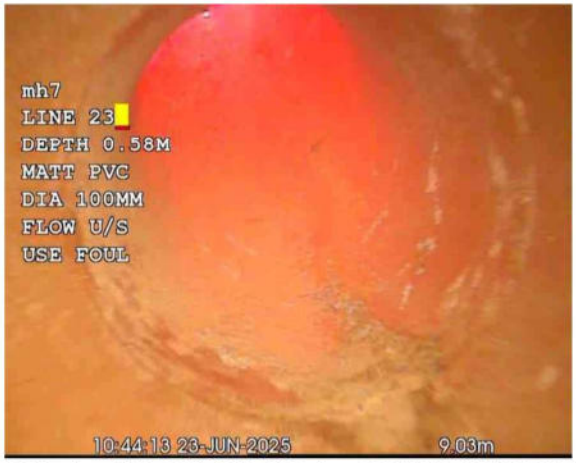
L23X_05483963-bd6a-42a9-9a2b-20fb4b71cc9b_20250701_170221_825.jpg, 00:00:00, 0.00 m
Start node, manhole, reference: FIC6

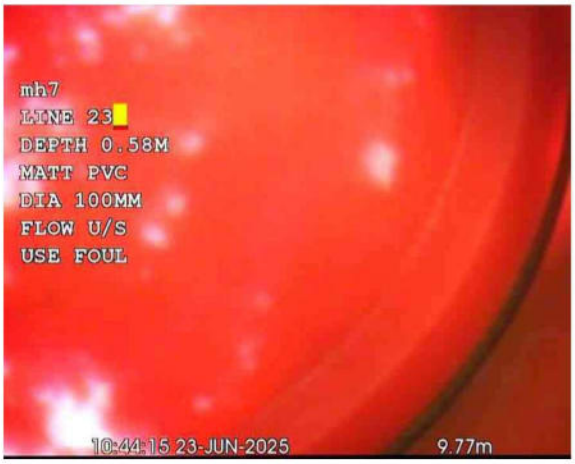
L23X_c1caa1c2-c20d-4253-8b0c-4cec330014f6_20250701_170223_349.jpg, 00:00:29, 9.03 m
Line deviates up

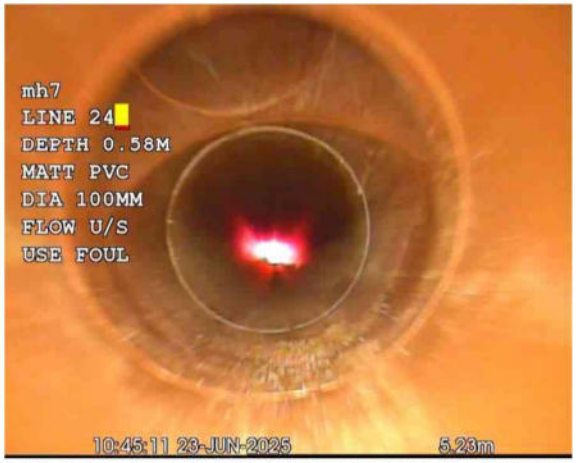
L24X_b3aecc8a-89fc-441c-9322-54aeb5668802_20250701_170239_547.jpg, 00:00:00, 0.00 m
Start node, manhole, reference: FIC6

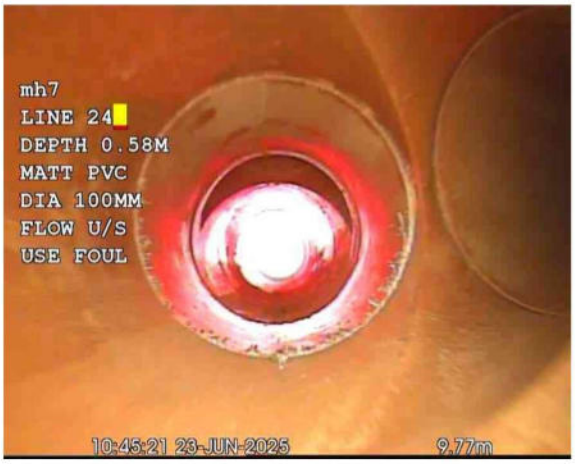
L24X_632ce246-3902-421b-b351-0284182b7ed8_20250701_170240_640.jpg, 00:00:17, 5.23 m
Junction at 12 o'clock, 100mm dia

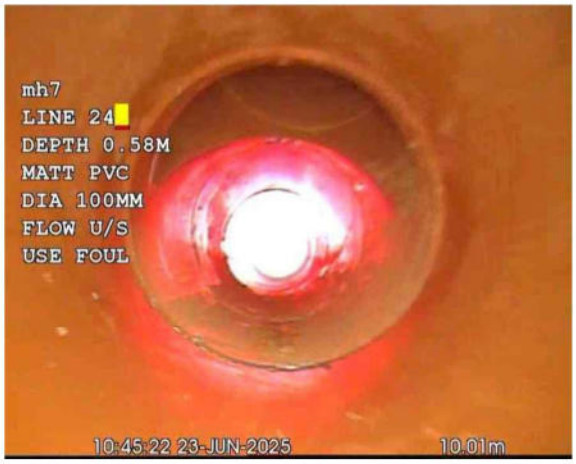
L24X_edb9189f-978a-4e52-a46c-f695935820cc_20250701_170241_508.jpg, 00:00:27, 9.77 m
Junction at 3 o'clock, 100mm dia

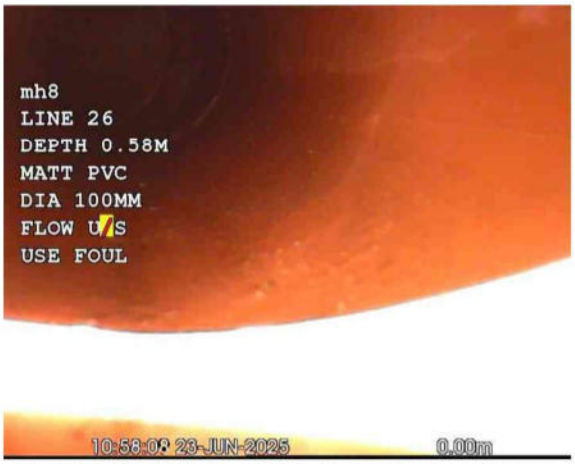
L26X_9da0f554-513e-4e1a-88b3-15def15fd299_20250701_150823_731.jpg, 00:00:00, 0.00 m
Start node, manhole, reference: FIC7

L26X_fbcd8b09-5c2b-45e3-9260-c38fb52b49f9_20250701_170325_927.jpg, 00:00:04, 0.22 m
Line deviates left

Comments:
Recommendations: HPWJ LINE

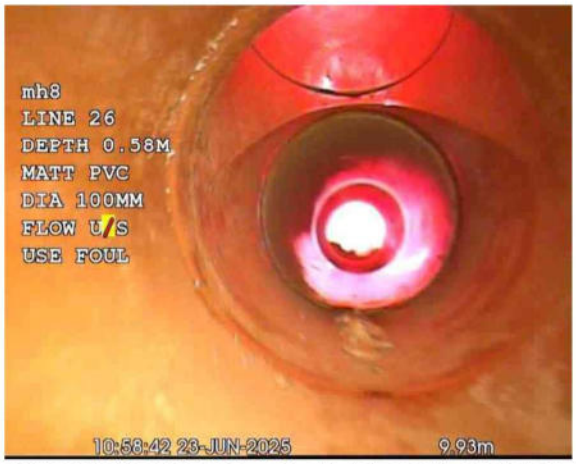
L26X_2d7e3045-ccc4-4a4c-9202-c453bad45397_20250701_170332_782.jpg, 00:00:33, 9.33 m
Junction at 9 o'clock, 100mm dia

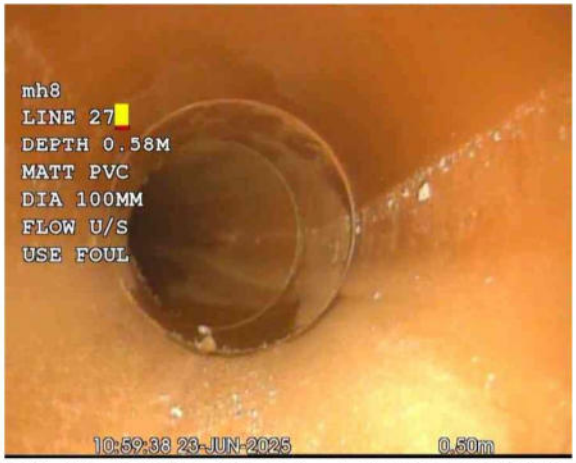
L27X_6e79de81-231d-41d5-8f39-2fcb37537f0b_20250701_170656_245.jpg, 00:00:00, 0.00 m
Start node, manhole, reference: FIC7

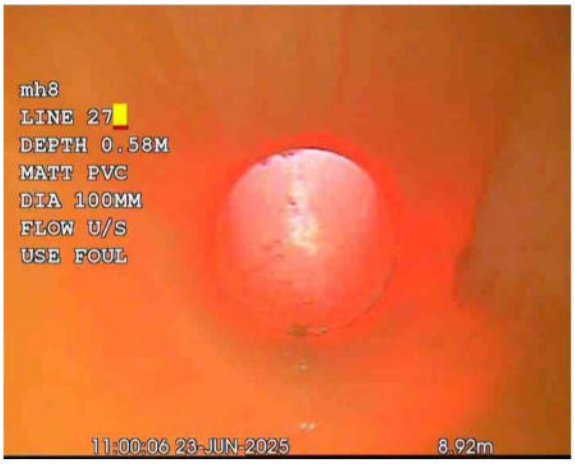
L27X_ddb0d084-8b81-450a-921b-cdab44ff2023_20250701_170657_353.jpg, 00:00:05, 0.50 m
Line deviates left

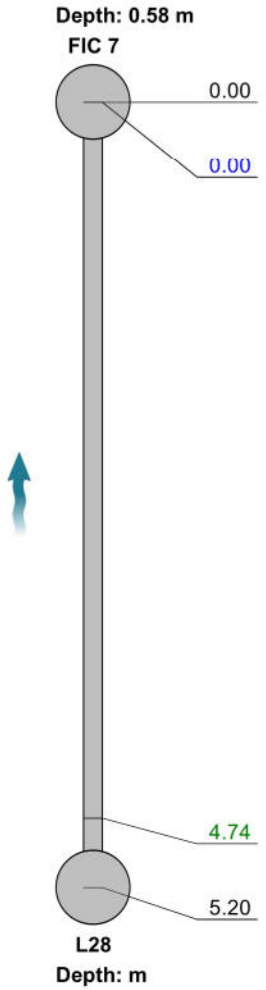
Position [m]	Code	Observation	MPEG	Photo	Grade
0.00	MH	Start node, manhole, reference: FIC7	00:00:00	L28X_680eec6d-8221-4989-be	
0.00	WL	Water level, 5% of the vertical dimension	00:00:01		
4.74	LU	Line deviates up	00:00:15	L28X_6ece63e4-544b-49c5-bb	
5.20	OCF	Finish node, other special chamber, reference: L28: REST BEND	00:00:17	L28X_1db90be5-4416-4f6f-b51

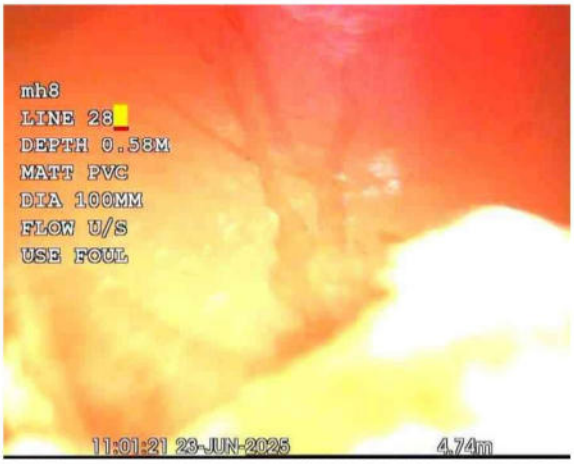
L28X_680eec6d-8221-4989-be09-cd10bb23a6d0_20250701_151458_645.jpg, 00:00:00, 0.00 m
Start node, manhole, reference: FIC7

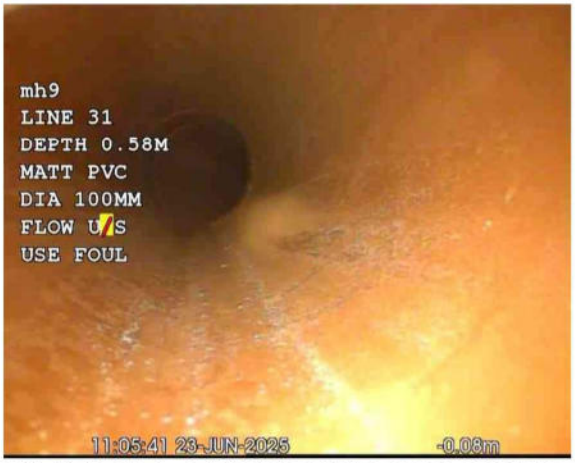
L31X_7b19a8f0-dca6-4bb9-b6b3-050d38c26002_20250701_170752_079.jpg, 00:00:00, 0.00 m
Start node, manhole, reference: FIC8

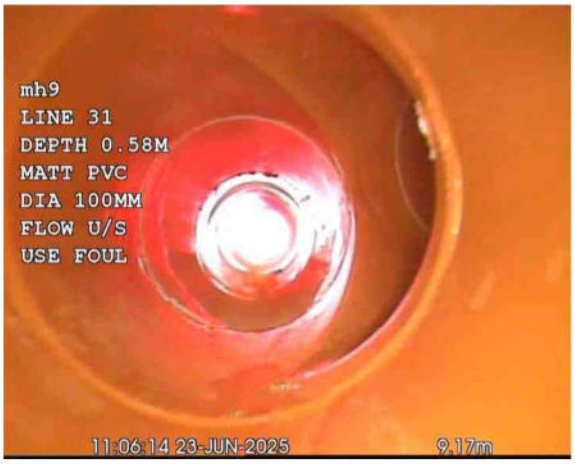
L31X_3b2e0d3d-8fa8-4fc7-a71a-8be422023423_20250701_170752_924.jpg, 00:00:06, 0.32 m
Line deviates right

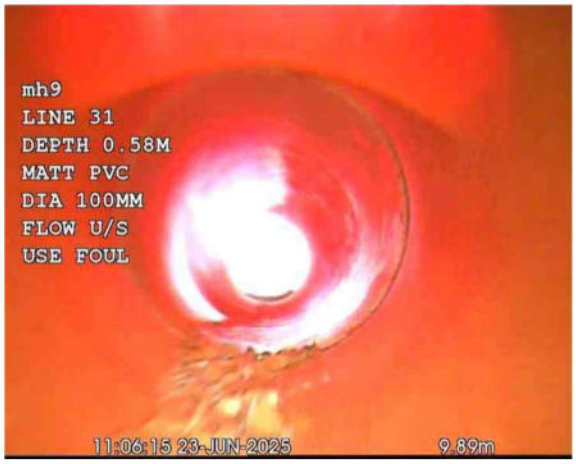
L31X_17a81b75-1a42-4daa-9a7e-307be2c49266_20250701_170753_850.jpg, 00:00:32, 9.17 m
Junction at 3 o'clock, 100mm dia

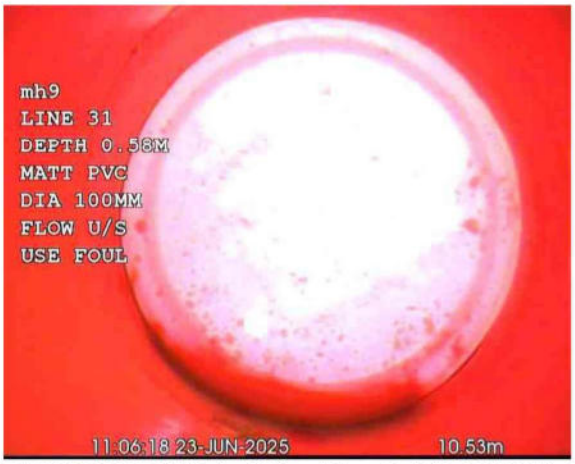
L31X_18350002-44d5-4eaf-80ba-452eaa3bf113_20250701_170756_338.jpg, 00:00:36, 10.53 m
Finish node, other special chamber, reference: L31

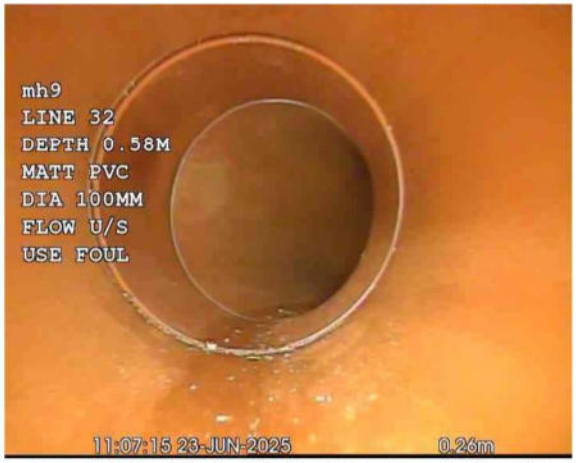
L32X_ef774b42-8bb7-4e83-96a9-bd27bfc016f7_20250701_170802_674.jpg, 00:00:00, 0.00 m
Start node, manhole, reference: FIC8

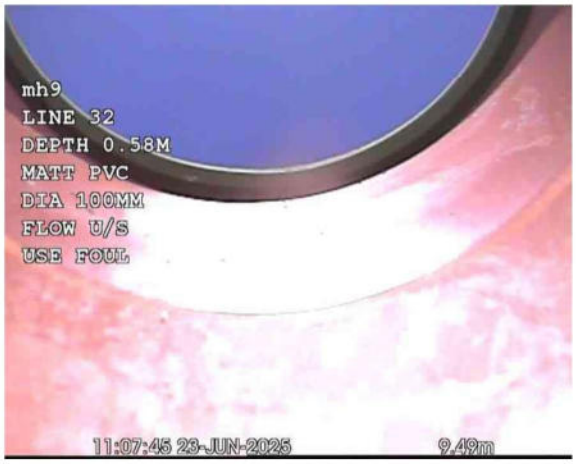
L32X_15bb80fe-d993-43e1-b97b-02fa2b90178f_20250701_170804_974.jpg, 00:00:36, 9.17 m
Line deviates up

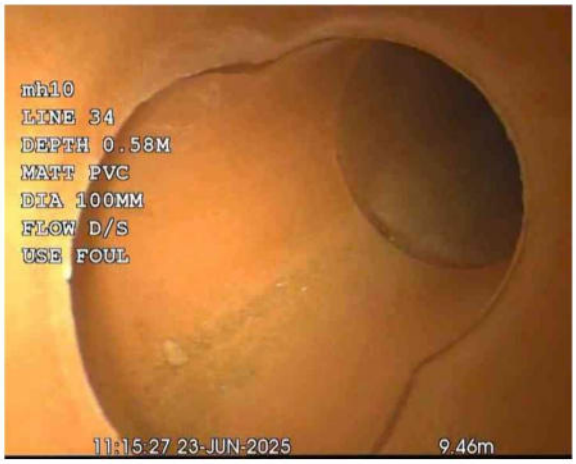
MH
10X_2cbfc18d-a6a1-41fa-a0d2-7c275e7a450a_20250701_170821_815.jpg, 00:00:00, 0.00 m
Start node, manhole, reference: FIC9

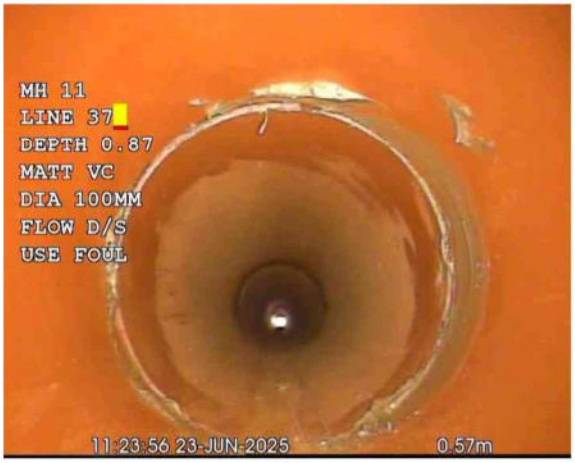
MH
11X_1965b6ba-210c-480b-9f64-abe928a145e6_20250701_170905_822.jpg, 00:00:00, 0.00 m
Start node, manhole, reference: FIC10

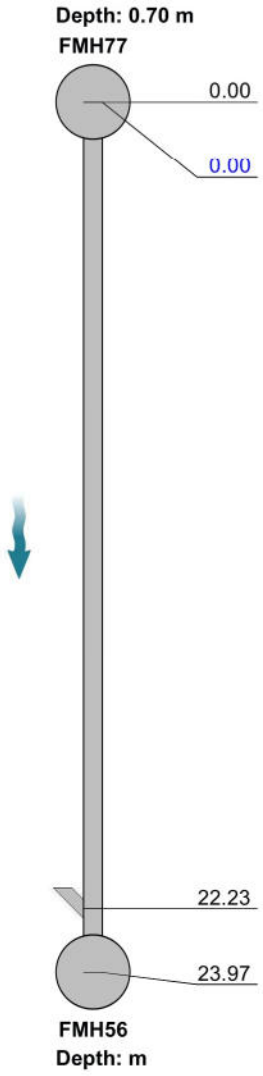
Position [m]	Code	Observation	MPEG	Photo	Grade
0.00	MH	Start node, manhole, reference: FMH77: L39	00:00:00	MH 12X_0df86777-8bc3-	
0.00	WL	Water level, 5% of the vertical dimension	00:00:01		
22.23	JN	Junction at 2 o'clock, 150mm dia	00:00:53	MH 12X_ae8ecd57-5ba5	
23.97	MHF	Finish node, manhole, reference: FMH56: CAPPED	00:00:59	MH 12X_9cc4ca99-7b63-

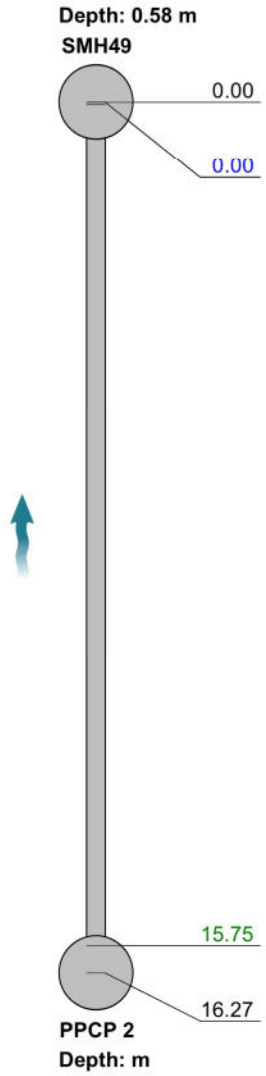
Position [m]	Code	Observation	MPEG	Photo	Grade
0.00	MH	Start node, manhole, reference: SMH49	00:00:00	RW 4X_a93b3 982-9e1b-	
0.00	WL	Water level, 5% of the vertical dimension: L41	00:00:01		
15.75	LR	Line deviates right	00:00:46	RW 4X_4a3d0 c84-57e7-	
16.27	MHF	Finish node, manhole, reference: PPCP2	00:00:52	RW 4X_4293e 051-128e-

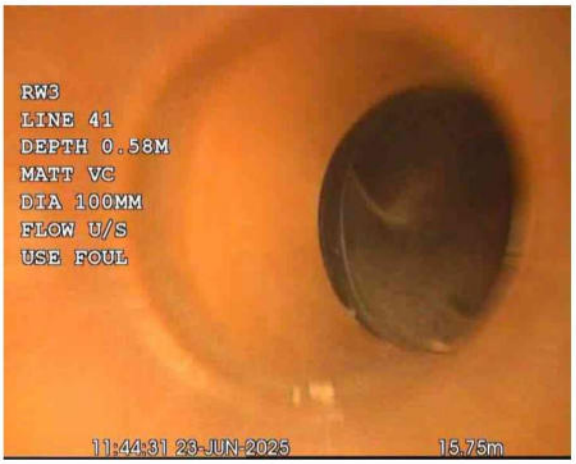
RW
4X_a93b3982-9e1b-4ea8-9f32-d73468393559_20250701_171036_564.jpg, 00:00:00, 0.00 m
Start node, manhole, reference: SMH49

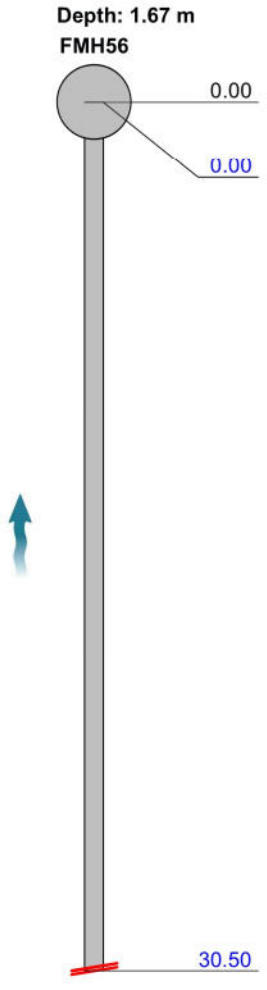
Position [m]	Code	Observation	MPEG	Photo	Grade
0.00	MH	Start node, manhole, reference: FMH56	00:00:00	L45X_54fa6a9d-8fa3-4c87-8269	
0.00	WL	Water level, 5% of the vertical dimension	00:00:00		
30.50	SA	Survey abandoned: LINE NOT INSTALLED	00:01:14	FMH51X_c519aef4-3824-4b76

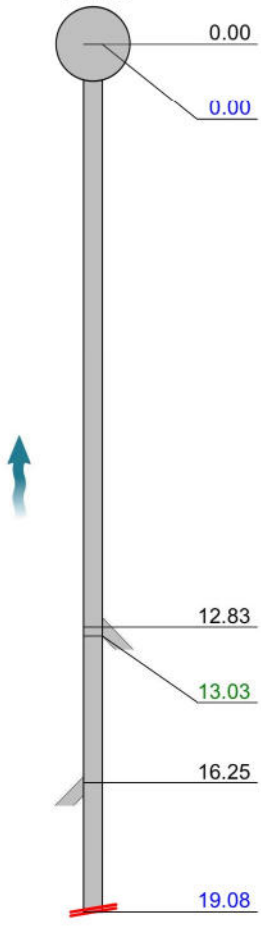
Scale: 1:166	Position [m]	Code	Observation	MPEG	Photo	Grade
	0.00	MH	Start node, manhole, reference: SMH19	00:00:00	RW 6X_ee1bd 8ae-80e0-	
	0.00	WL	Water level, 5% of the vertical dimension	00:00:00		
	12.83	CN	Connection other than junction at 9 o'clock, 150mm dia	00:00:35	RW 6X_a3597 531-0668-	
	13.03	DER	Settled deposits, coarse, 10% cross-sectional area loss	00:00:35	RW 6X_41c28 64b-3924-	4
	16.25	CN	Connection other than junction at 2 o'clock, 150mm dia	00:01:17	RW 6X_3b52f4 c5-18b4-4	
	19.08	SA	Survey abandoned: UNABLE TO PUSH	00:02:08	RW 6X_1a452 a71-d337-

Comments:
Recommendations: HPWJ LINE

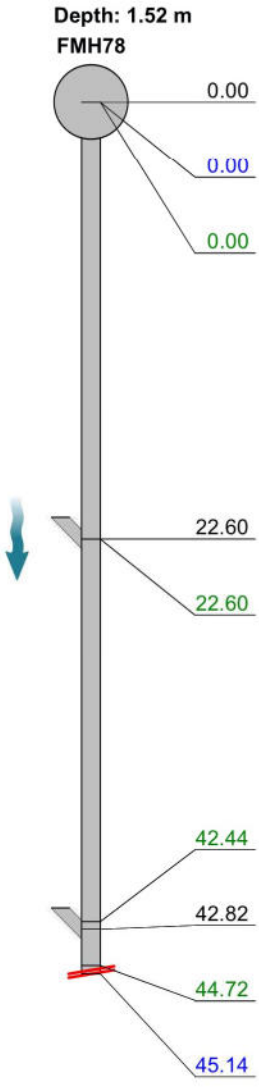
Position [m]	Code	Observation	MPEG	Photo	Grade
0.00	MH	Start node, manhole, reference: MH 16	00:00:00	MH 16X_ffa5c aad-b699-	
0.00	WL	Water level, 5% of the vertical dimension	00:00:03		
0.00	DER	Settled deposits, coarse, 10% cross-sectional area loss	00:00:03	MH 16X_831b e70e-b5d3	4
22.60	JN	Junction at 2 o'clock, 150mm dia	00:00:44	MH 16X_4920 7387-fce9-	
22.60	DER	Settled deposits, coarse, 10% cross-sectional area loss	00:00:44	MH 16X_ae66 37d3-2ee9	4
42.44	DER	Settled deposits, coarse, 10% cross-sectional area loss	00:01:18	MH 16X_f0451 5b5-4de7-	4
42.82	JN	Junction at 2 o'clock, 100mm dia	00:01:22	MH 16X_06d9 a35f-f385-	
44.72	DER	Settled deposits, coarse, 10% cross-sectional area loss	00:01:34	MH 16X_21b8 2981-a94f-	3
45.14	SA	Survey abandoned: UNABLE TO PUSH	00:01:43	MH 16X_1eca beb2-2ba5

Comments:
Recommendations: HPWJ LINE

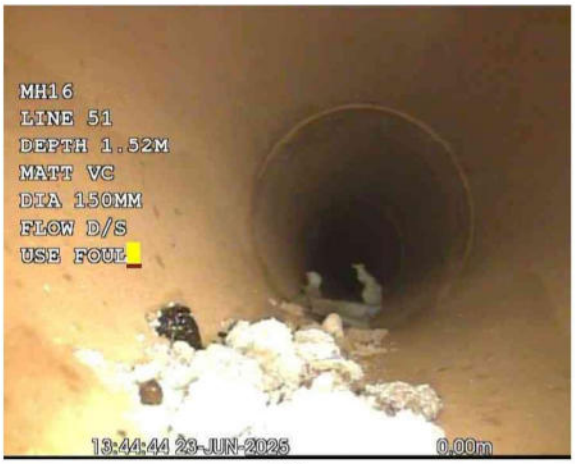
MH
16X_ffa5caad-b699-48b2-b22e-d61fc1640811_20250701_163439_190.jpg, 00:00:00, 0.00 m
Start node, manhole, reference: MH 16

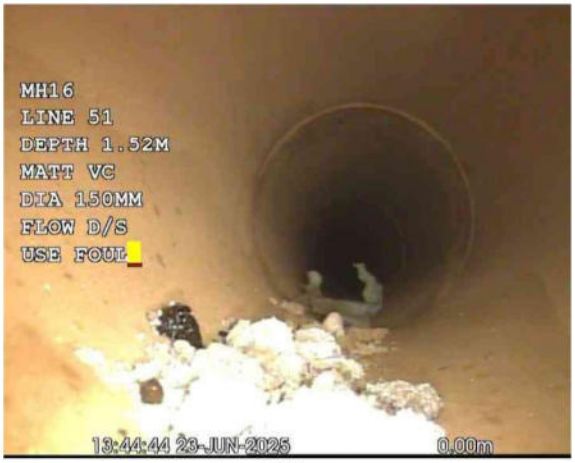
MH
16X_831be70e-b5d3-4fd3-a591-6508bf28d573_20250701_171316_109.jpg, 00:00:03, 0.00 m
Settled deposits, coarse, 10% cross-sectional area loss

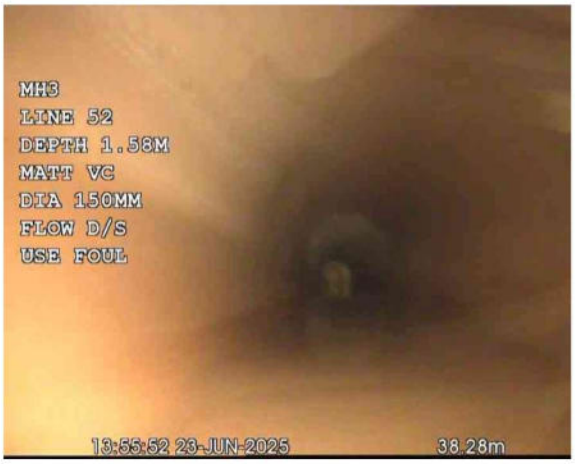
MH
3X_f1f45171-fd3f-45b6-89f7-ecc838128f44_20250701_171355_430.jpg, 00:00:48, 26.15 m
Junction at 3 o'clock, 100mm dia
