VERIFICATION REPORT

for PLOTS 44-49 (SOIL COVER SYSTEMS) &

ALL PLOTS (GROUND GAS) AT

CORNFIELD CLOSE, LITTLEHAMPTON,

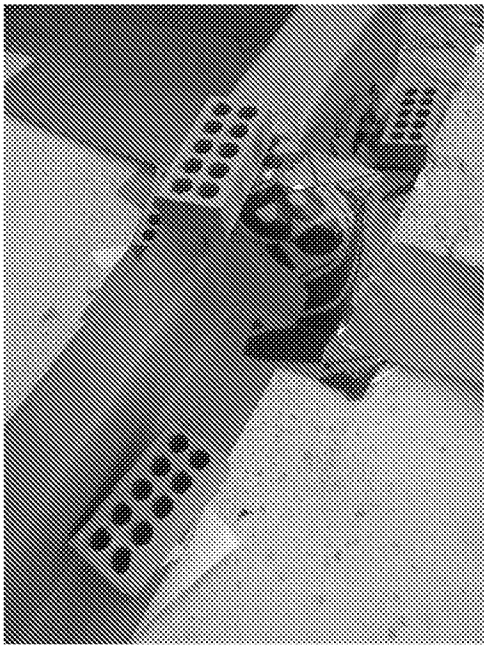
1.1 Condition of sub-grade and underside of membrane	Clean, recently swept flat concrete.
1.2 Gas membrane type	Keytec 400 HP - Self branded bought from Juta.
1.3 Gas membrane condition	Very good. No sign of previous repair or weakness.
Jointing tape product	Membrane cutouts used as principal joint tape. 301483 Foil Band 150mm width/ 1.5mm thickness/10m length - Aluminum heat weld membrane tape - used around service ducts.
1.5 Lapping design	Lapped >=50mm in all areas where achievable
1.6 Laps, welds and joints seals	Heat welded membrane used to seal joints.
1.7 Service seals	Seal with foil band weld membrane joining tape.

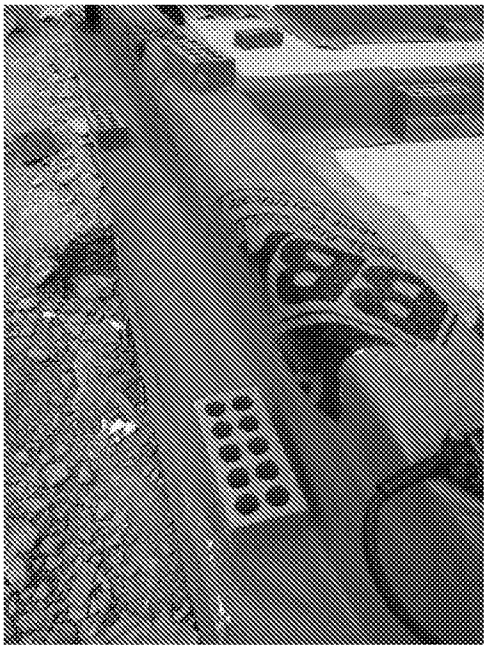
1.1 Condition of sub-grade and underside of membrane	Very clean, recently swept.
1.2 Gas membrane type	Keytec 400 HP - bought from Juta branded by Keytec. Red. Stored in van.

1.3 Gas membrane condition	No punctures, evidence of footprints, repairs or weakness. Joining tape will be used to protect membrane against wooden beam installation at later date
Jointing tape product	Membrane used as principal joint tape as opposed to membrane tape due to longer life span (25 years). Joining tape used on service ducts only. Brand:301483 Foil Band 150mm width/ 1.5mm thickness/10m length - Aluminum heat membrane tape - used around service ducts

1.7 Service seals	Services sealed with heat sealed tape

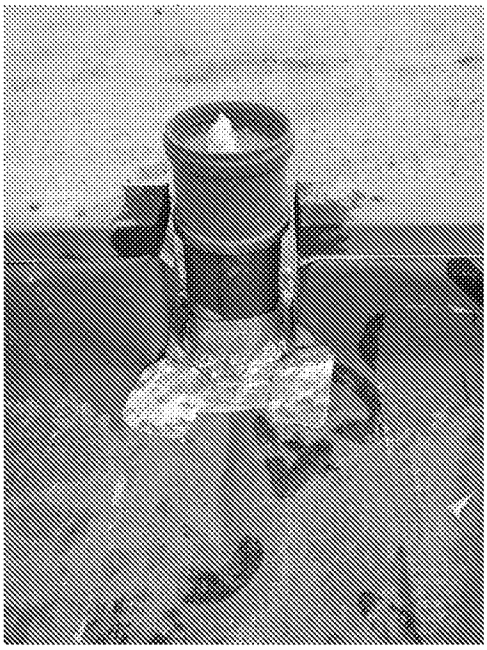
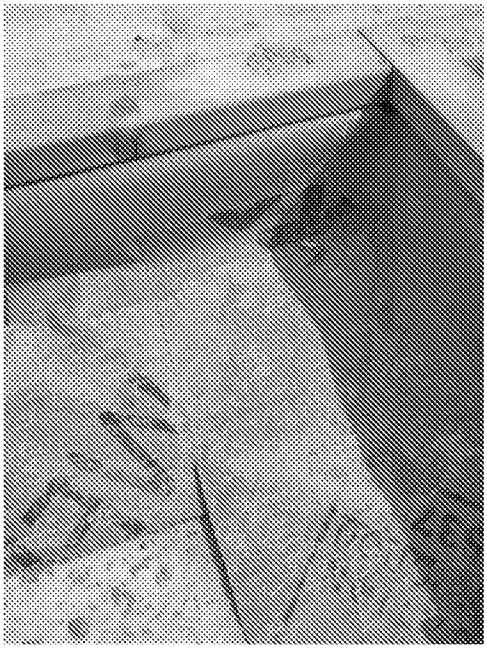
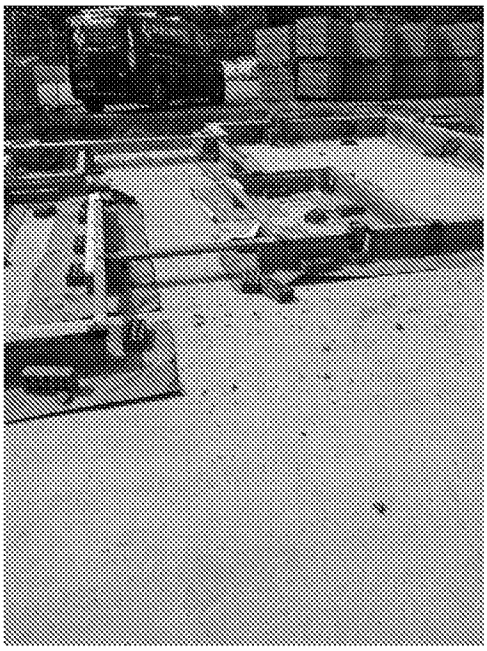
Plot 24
	Plot 24 services

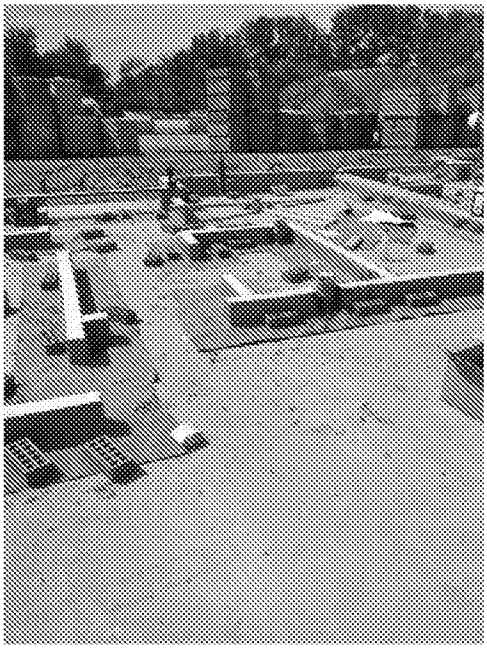
Plot 27
	Plot 27 service

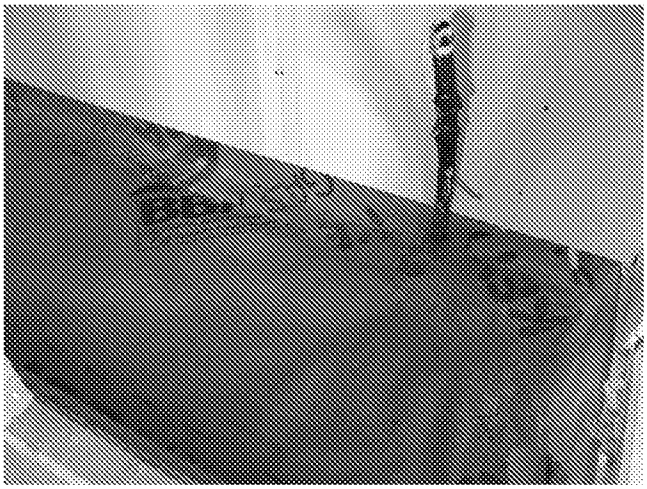
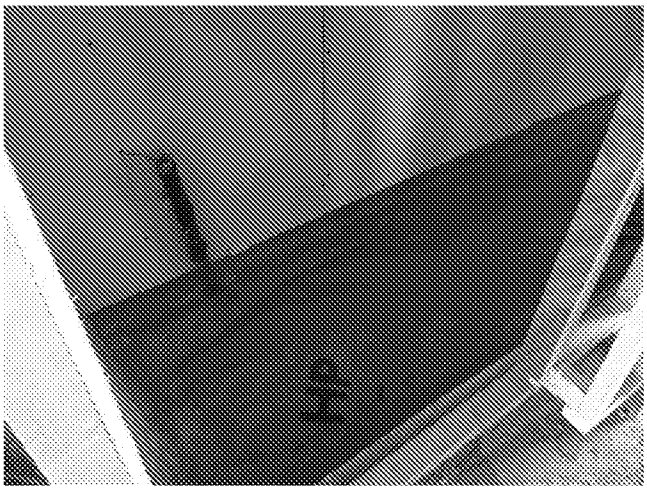
1.1 Condition of sub-grade and underside of membrane	Good condition. Membrane sealed in Plots 36-37
1.2 Gas membrane type	Keytec 400 HP
1.3 Gas membrane condition	Good condition. Any damage patched with tape
Jointing tape product	Heat welded joints
1.5 Lapping design	Min 150mm overlap
1.6 Laps, welds and joints seals	Welded joints sealed. In good condition
1.7 Service seals	Sealed using membrane and tape. All well sealed, no damage

Plot 36 Joins
	Plot 36 Patch repairs
	Plot 36 sides

Plot 36 Front room
	Plot 37
	Plot 37 Joins and a patch repair
