APPENDIX C

Photographs of Gas Membrane Installation works (Provided by Client)

Gas Protection Measures – Photographs provided by the Client.

ARUN DISTRICT COUNCIL LU/226/21/DOC

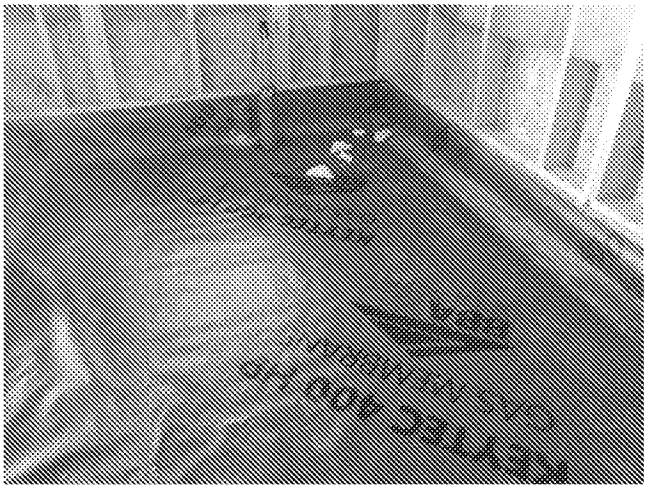
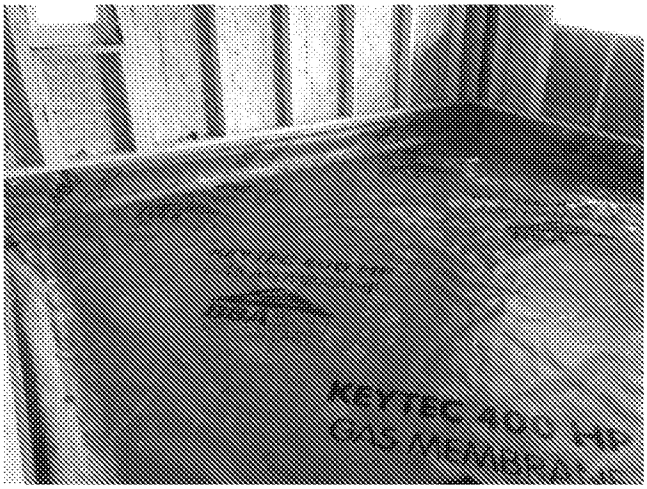
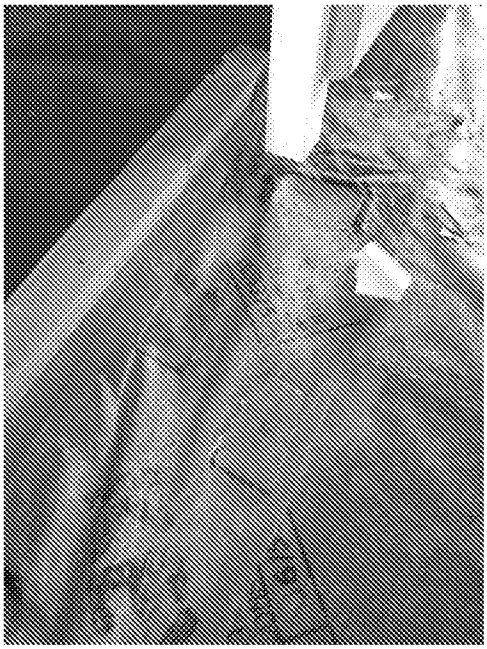
Plot 41 - Threshold
	Plot 41 - Floor and services sealed
	Plot 41 - under stairs sealed

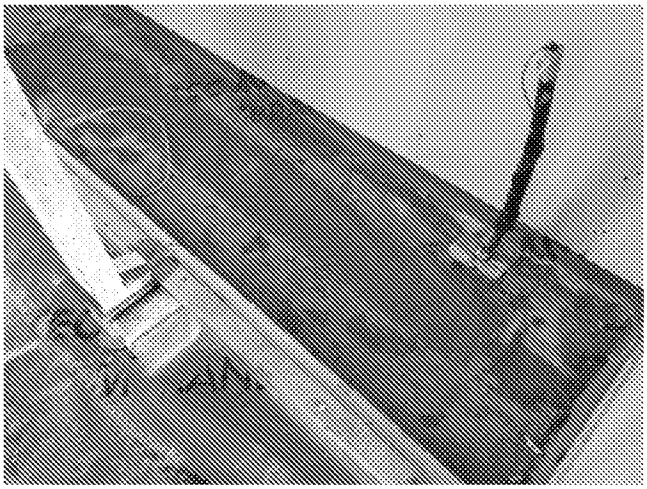
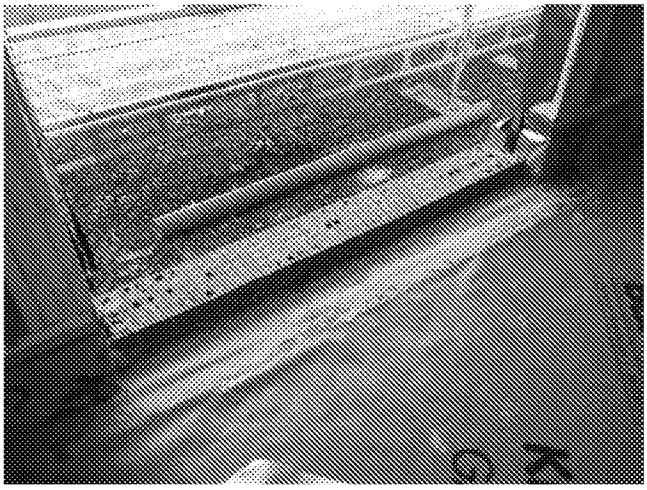
Plot 41 - floors sealed
	Plot 41 - Threshold
	Plot 41 - Holes patched during inspection

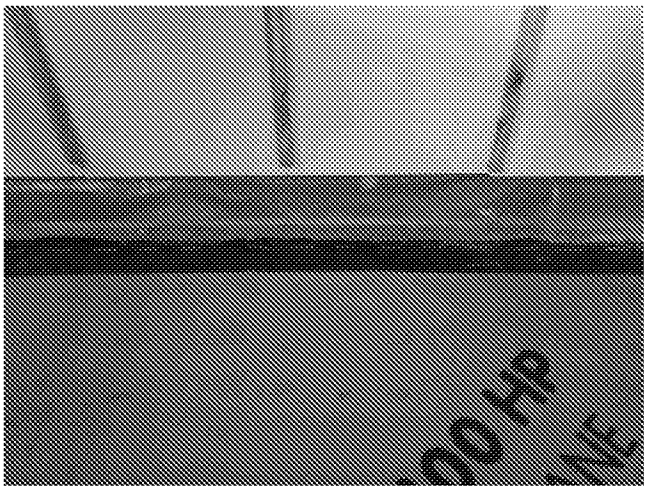
Plot 32 overview
	Plot 32 services
	Plot 32 detail

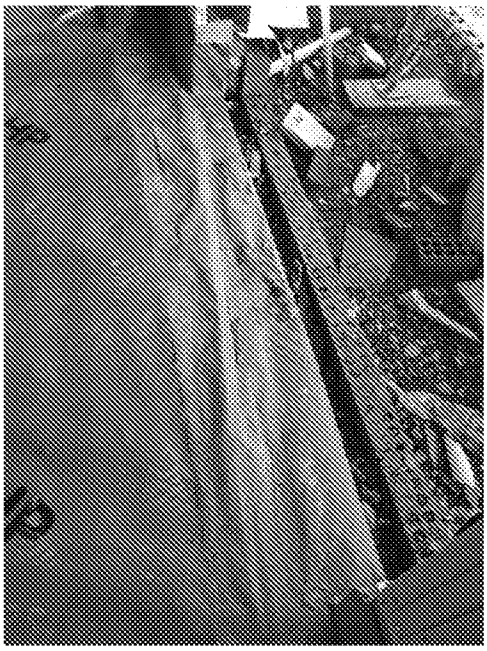
Plot 30 - Threshold
	Plot 30 - Service seals
	Plot 30 - Under stairs

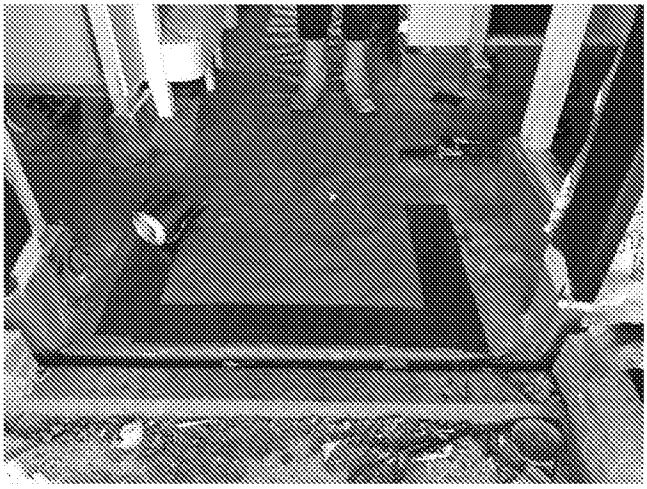
1.1 Condition of sub-grade and underside of membrane	Underside of membrane unable to be inspected as fully sealed. Gravel removed from some areas of subgrade and membrane subsequently patched up in Plots 28 and 30.
1.2 Gas membrane type	Keytec gas membrane.
1.3 Gas membrane condition	Good condition. Dusty with some debris in areas due to construction work within the plots. Any holes identified were patched during the inspection visit.
Jointing tape product	Heat sealed joints with some tape patching.
1.5 Lapping design	Min 150mm overlap
1.6 Laps, welds and joints seals	Heat sealed joints with some tape patching.
1.7 Service seals	Services sealed with tape.

Plot 30 - Floor
	Plot 30 - Patching after removal of debris under membrane
	Plot 30 - Threshold

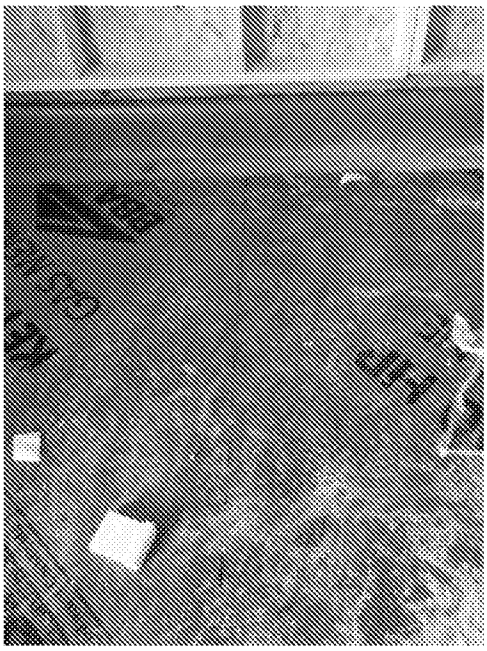
Plot 27 services
	Plot 27 detail
	Plot 27 overview

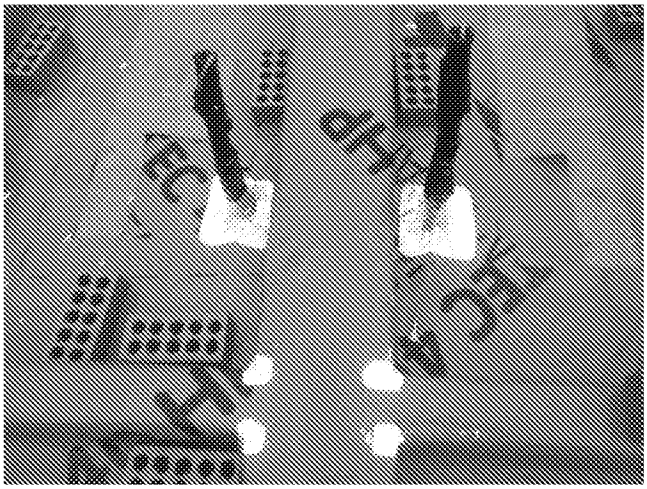
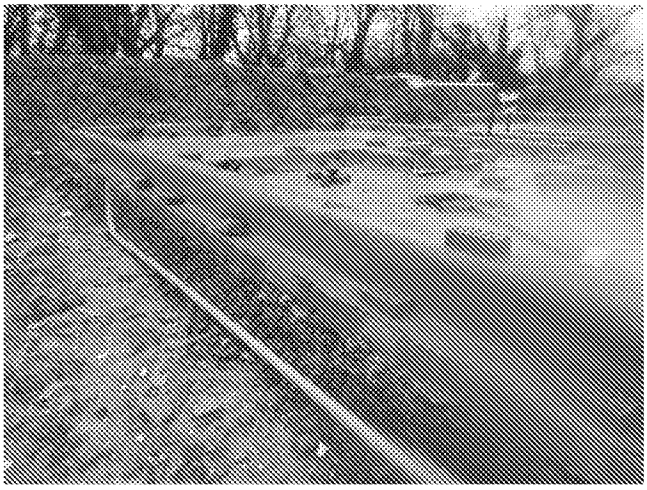
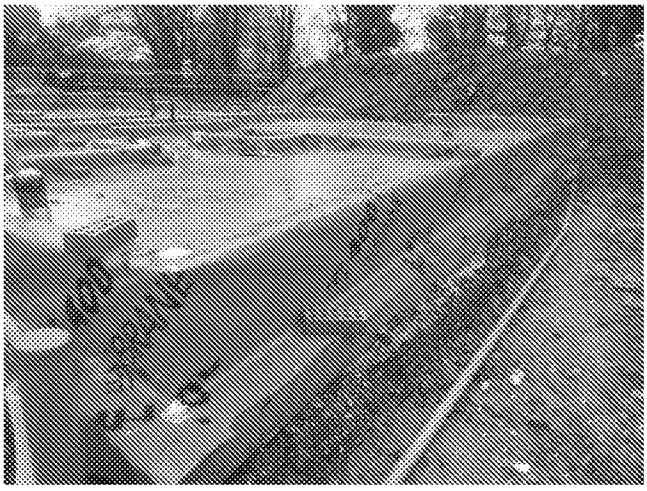
Plot 18 - floor
	Plot 18 - under stairs
	Plot 18 - floor

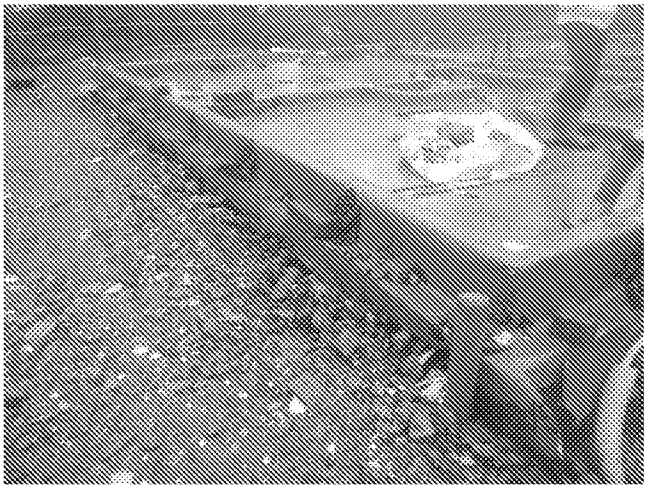
Plot 19 - Floor
	Plot 19 - service seal
	Plot 19 - floor

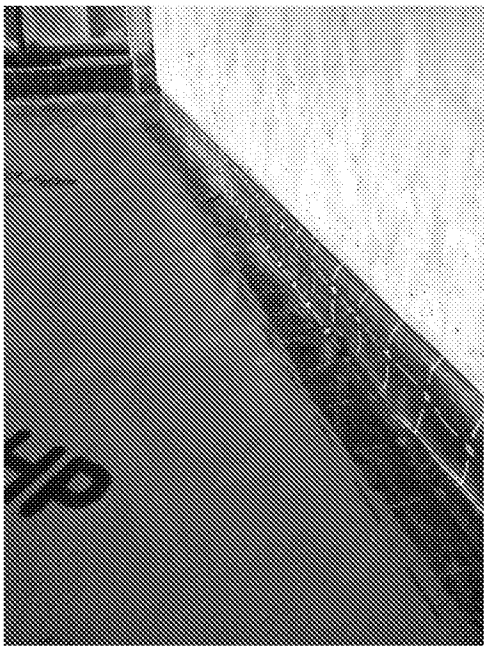
Plot 20 - entrance
	Plot 20 - sealed foul outlet WC

Plot 20 - sealed water in & foul outlet Kitchen
	Plot 20 - front of property all good.
	Plot 20 - rear of property all good.

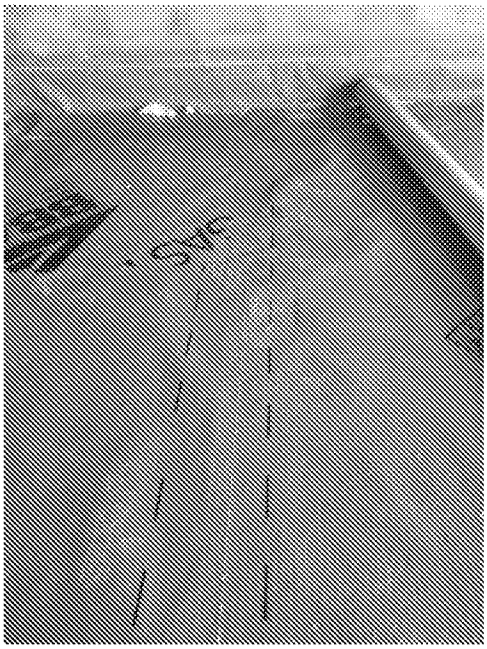
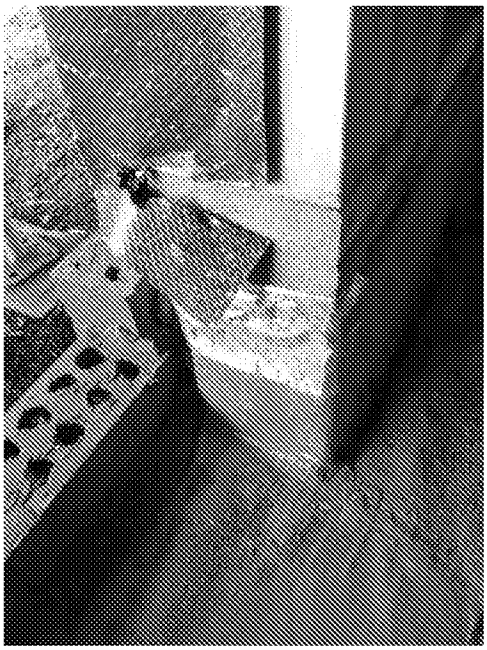
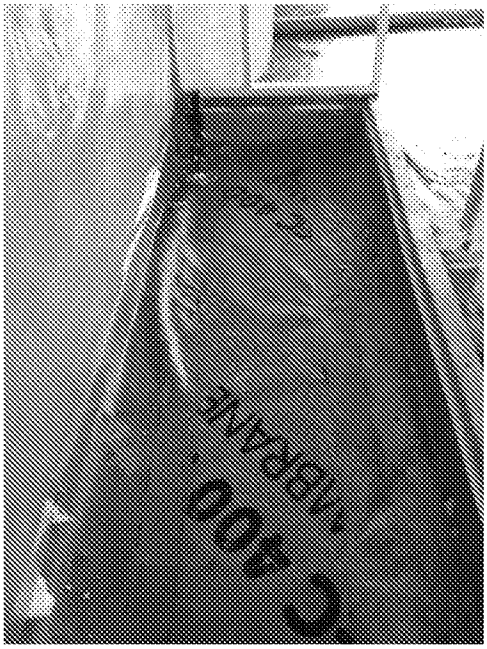
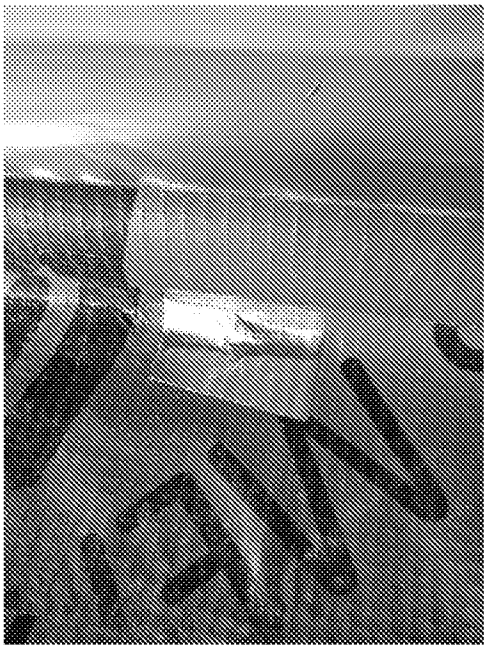
1.1 Condition of sub-grade and underside of membrane	Unable to inspect as sealed
1.2 Gas membrane type	Keytec 400 hp gas resistant membrane
1.3 Gas membrane condition	Generally in good condition
Jointing tape product	Heat sealed joins with some taping
1.5 Lapping design	At least 150mm
1.6 Laps, welds and joints seals	All heat sealed and well sealed
1.7 Service seals	Services sealed with site made seals, all well sealed

Plot 22 overview
	Plot 22 membrane joins
	Plot 22 patch repair

Plot 23 patch repair
	Plot 23 corner detail

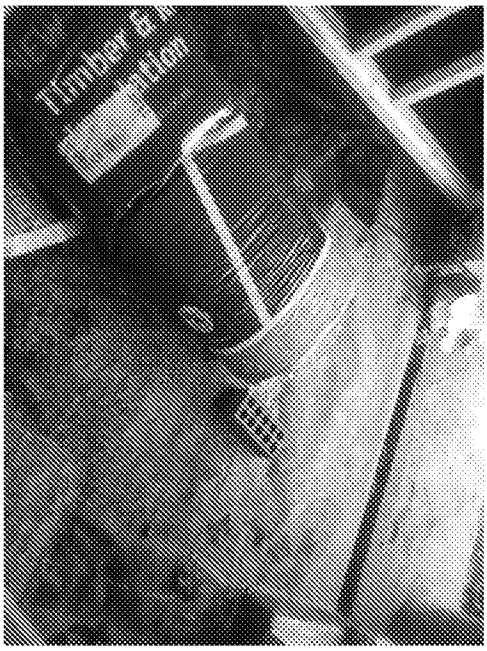
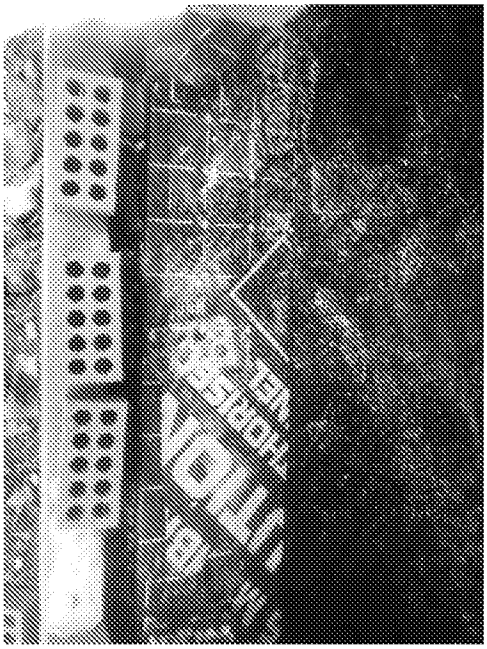
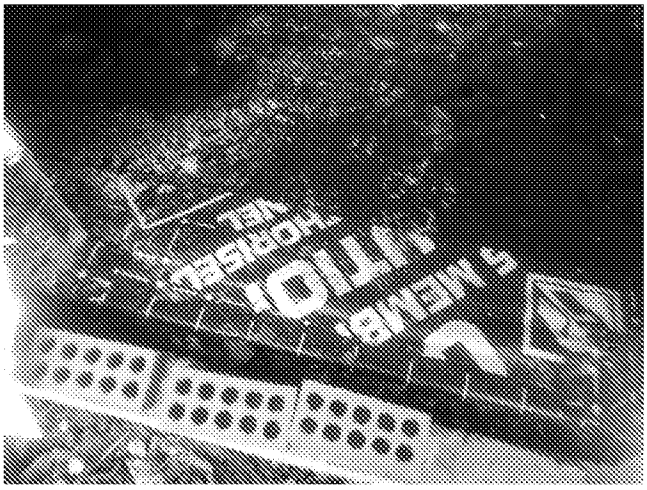
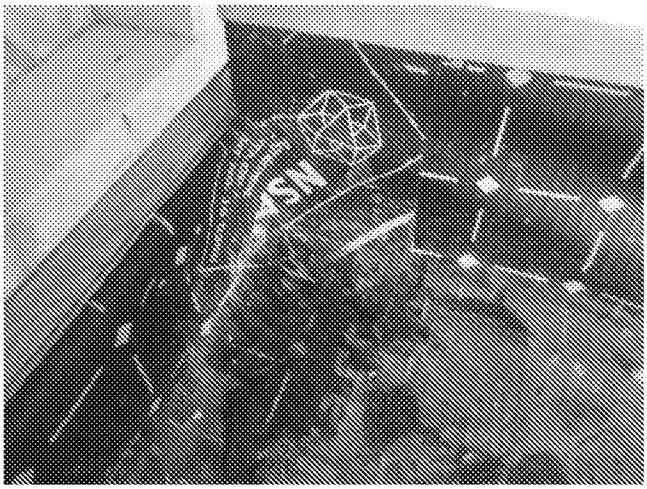
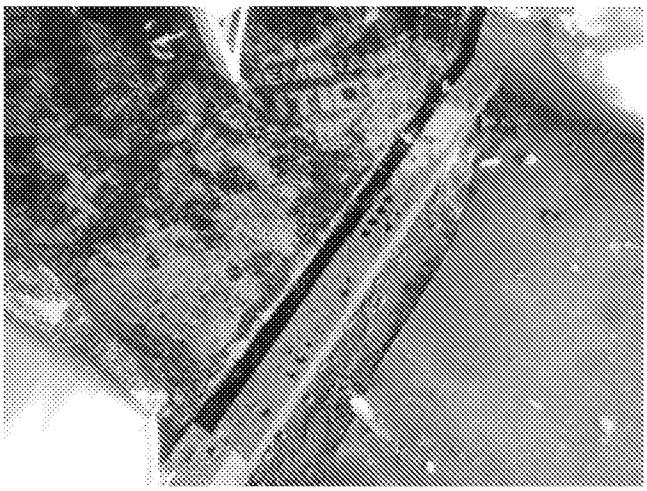
1.1 Condition of sub-grade and underside of membrane	Membrane fully sealed, unable to see underside.
1.2 Gas membrane type	Black gas membrane
1.3 Gas membrane condition	Surface muddy due to foot traffic in bad weather. Some leaves and debris on surface as plots not fully roofed and without windows. Otherwise in good condition. Any holes patched during site visit.
Jointing tape product	Heat welded joints.
1.5 Lapping design	Min 150mm
1.6 Laps, welds and joints seals	All in good condition.
1.7 Service seals	Service seals in good condition.

Plot 49 entrance. Undergoing insulation.
	Plot 49 floor.
	Plot 49 floor and service seal.

Plot 49 floor.
	Plot 49 Threshold.
	Plot 49 patching.

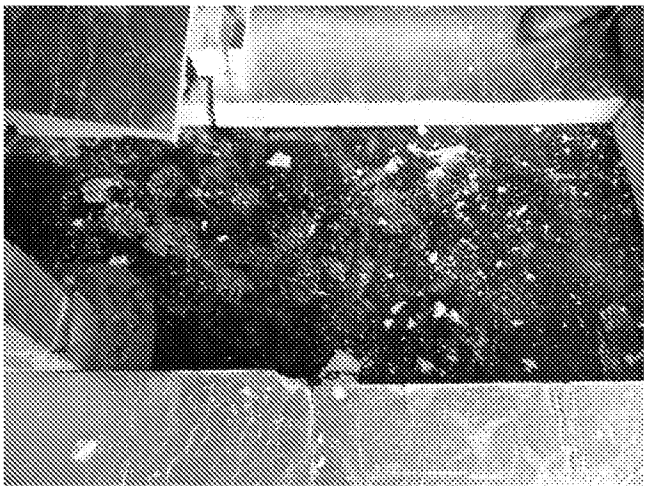
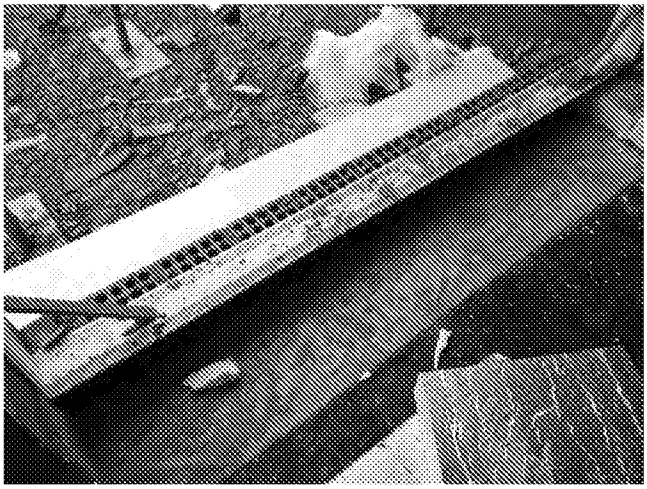
60 bathroom
	60 lounge
	60 lounge

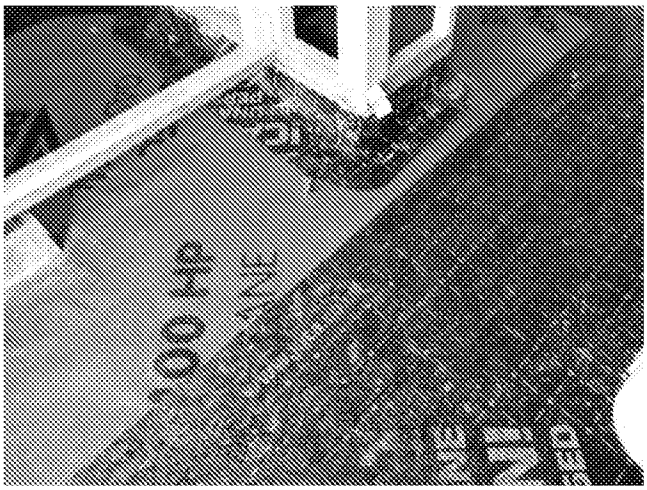
Nail under walkway. Plot 46 fail.

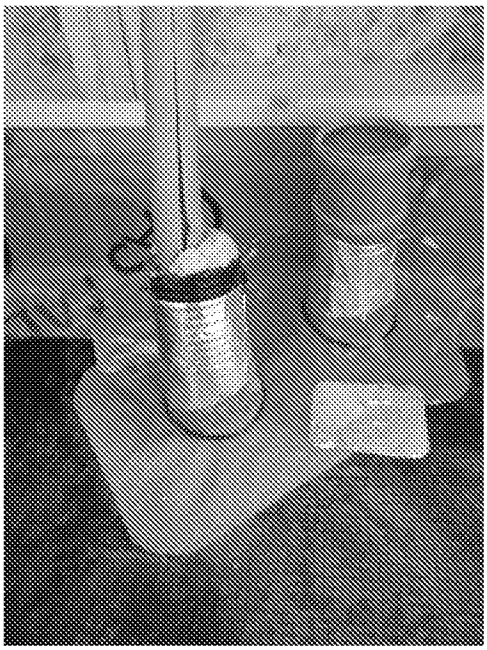
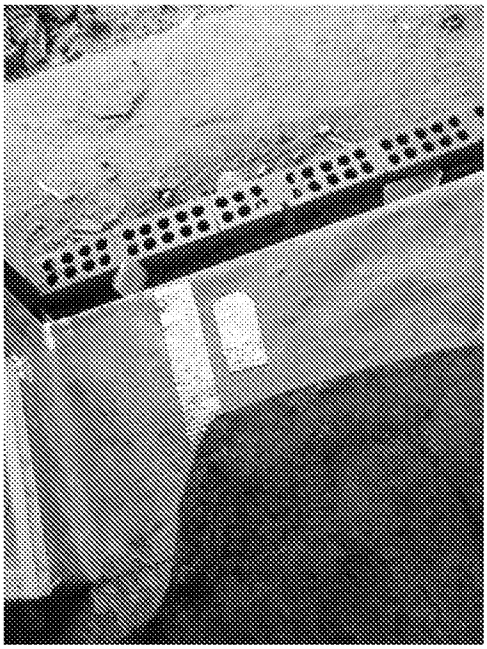
1.1 Condition of sub-grade and underside of membrane	Unable to inspect as sealed
1.2 Gas membrane type	Black unbranded juta GP1 gas resistant membrane
1.3 Gas membrane condition	Membrane in very good condition well swept
Jointing tape product	Heat sealed double sided tape
1.5 Lapping design	At least 150mm overlap
1.6 Laps, welds and joints seals	Heat sealed, all well sealed
1.7 Service seals	Site made seals, well sealed

Plot 51 services
	Plot 51 overview
	Plot 51 repairs

Plot 52 patch repair
	Plot 53

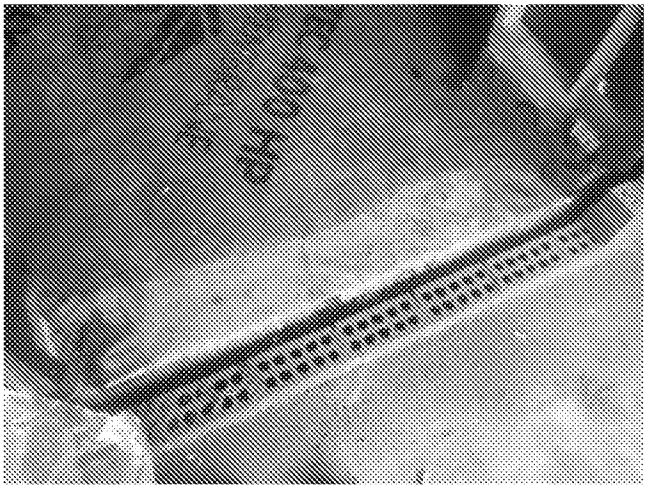
Plot 54 threshold
	Plot 54 corner detail
	Plot 55 entrance

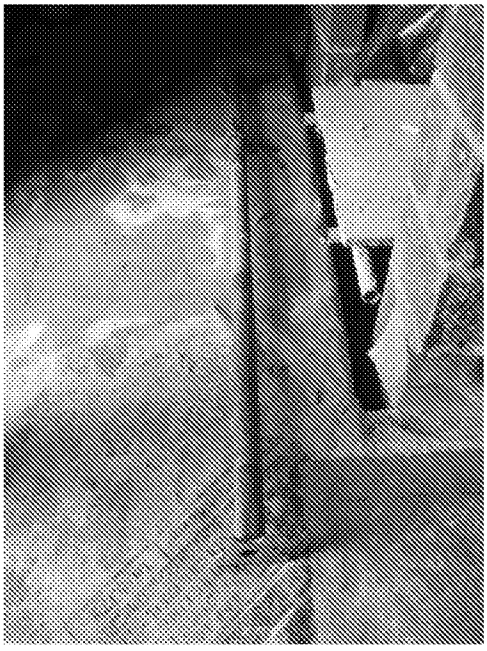
Block B damage
	Block B damage
	Block B materials stored

Block A not sealed
	Block A
	Bock A materials

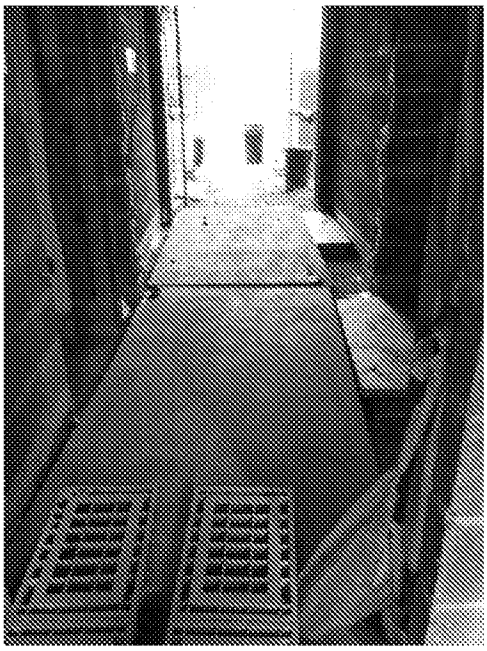
Block B overview
	Block B repairs
	Block B repairs

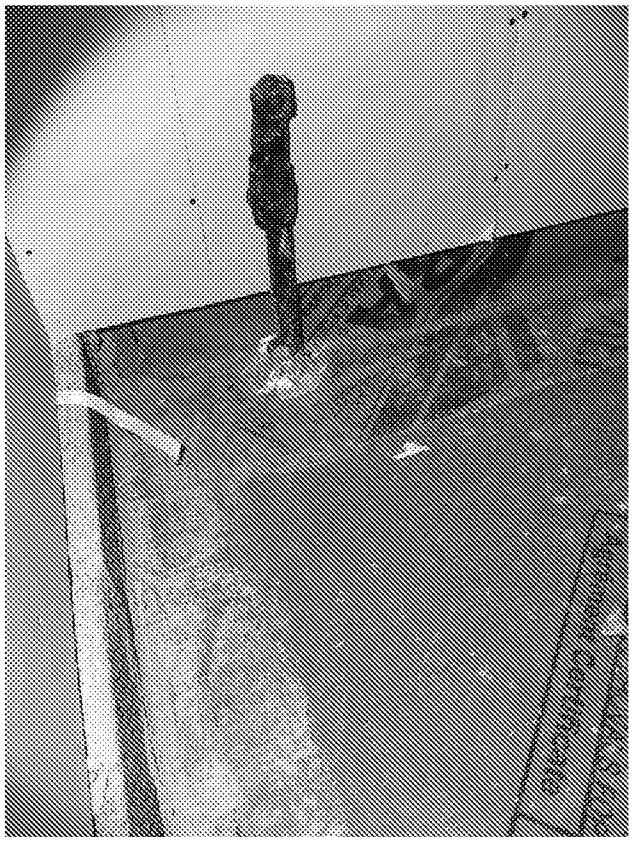
Plate 3 – Infills Plot 11

Plate 4 – Infills Plot 11

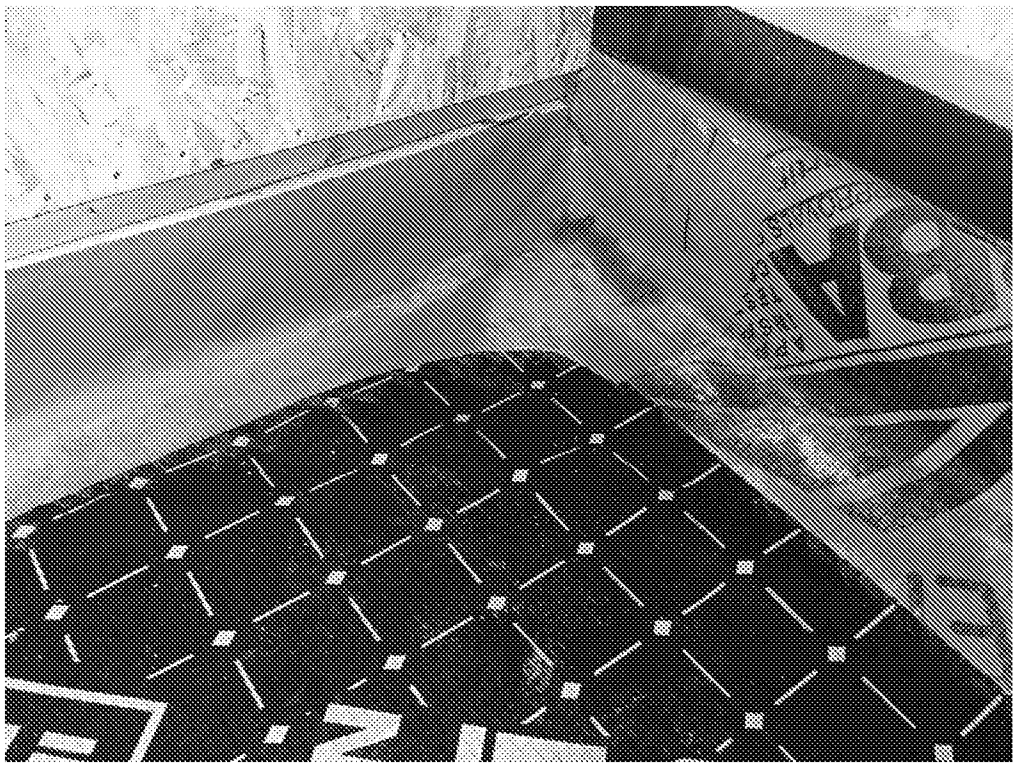
Plate 5 – Infills Plot 11

Plate 6 – Infills Plot 11
