Project Name	Cornfield Close
Project No.	GE18103
Client	Thakeham Homes
Geo-Environmental Project Manager's Email	[redacted]
Date	01/10/2020, 11:52
Site Engineer	
William Hughes	[redacted]
Weather at time of inspection	Sunny
Gas Characteristic Situation	Characteristic Situation 2
Type of development and building/block checked	Residential - terraced houses
Plot No.	Plots 36-37 complete, Plots 38-39 in progress
Foundation Type	Suspended
Gas Protection Type	Passive
What is being inspected	[ ] Venting [X] Membrane [ ] Venting and Membrane

1. MEMBRANE

4. PHOTOGRAPHS

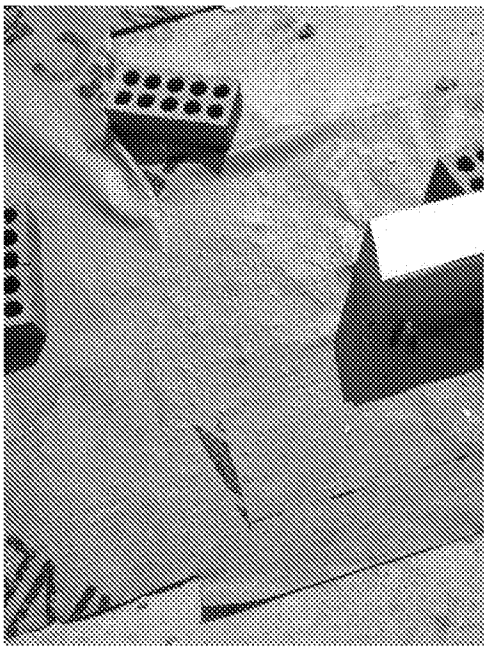
Plot 27 damage
	Plot 27 corner damage

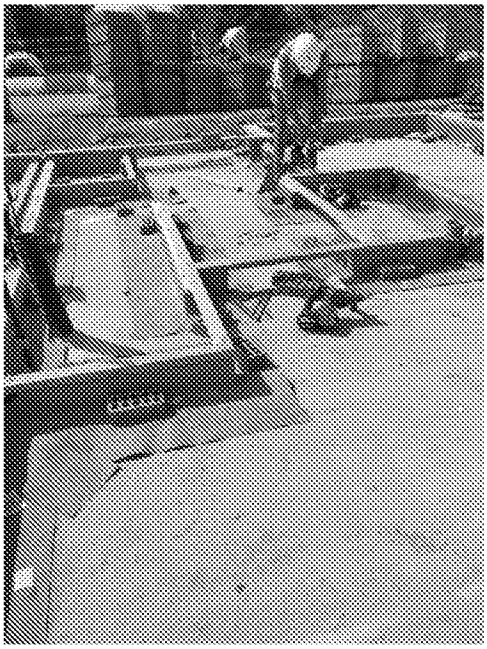
Plot 28
	Plot 28 corner needs sealing

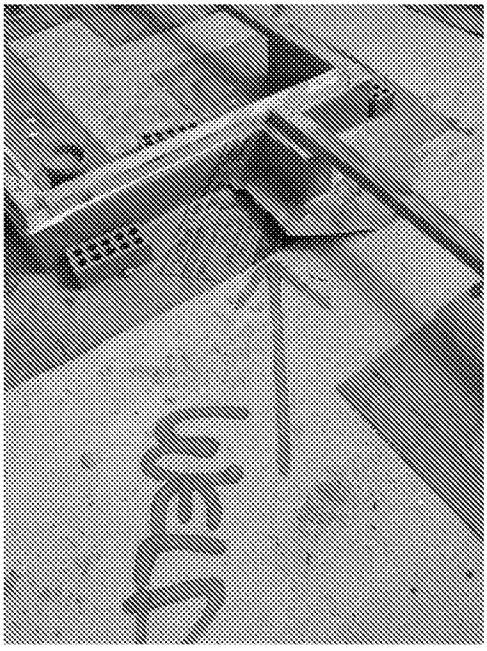
Plot 28 lapping needs sealing
	Plot 28 tape for frame

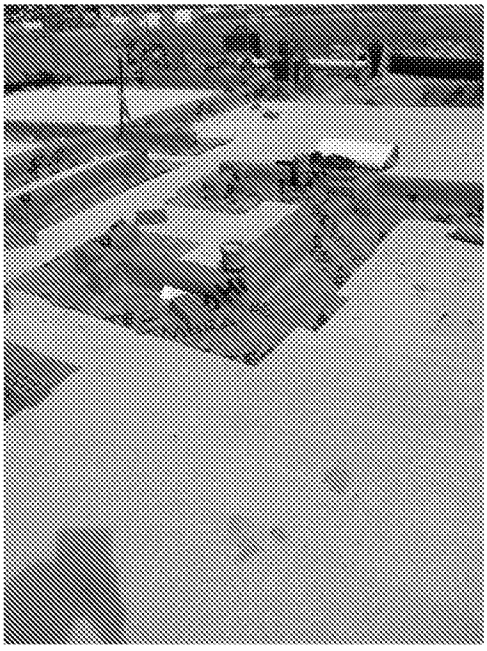
Plot 29
	Plot 29 threshold

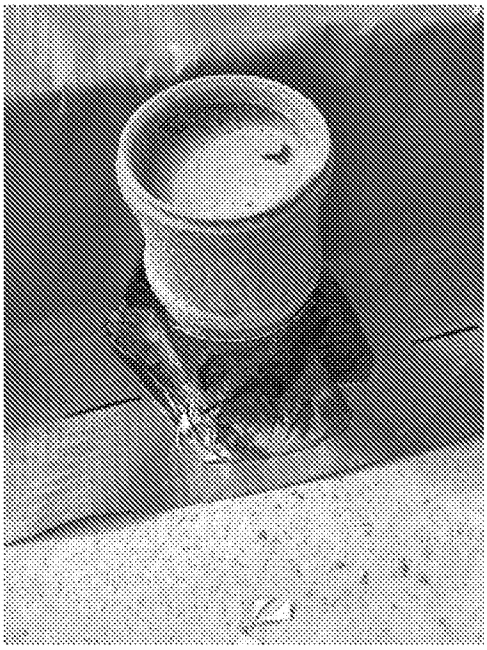
Plot 29 services
	Plot 30

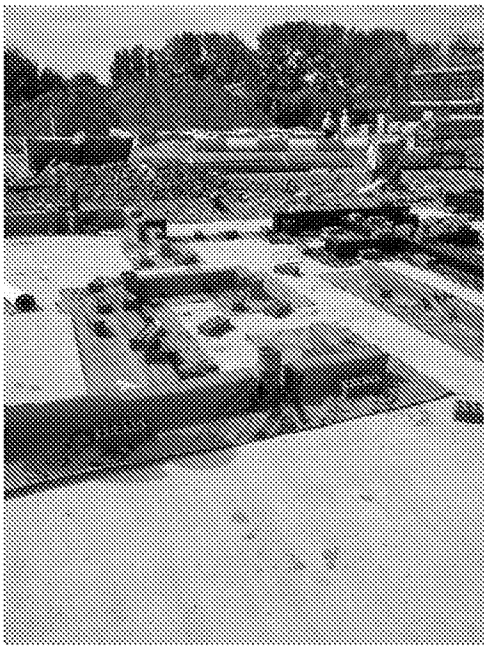
Plot 30 joins
	Plot 30 services

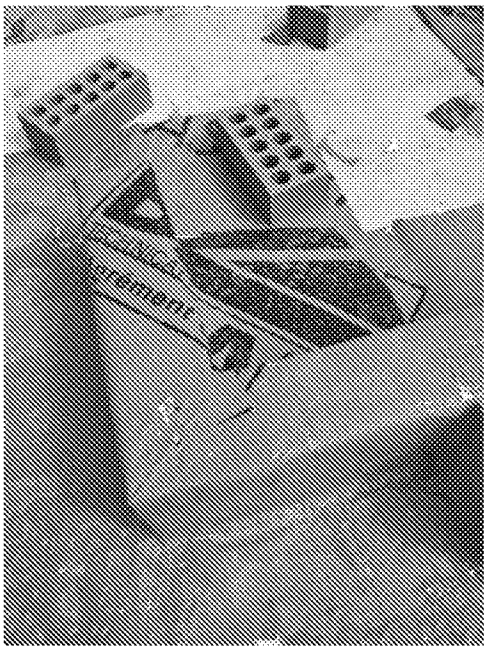
Plot 30 corner
	Plot 31

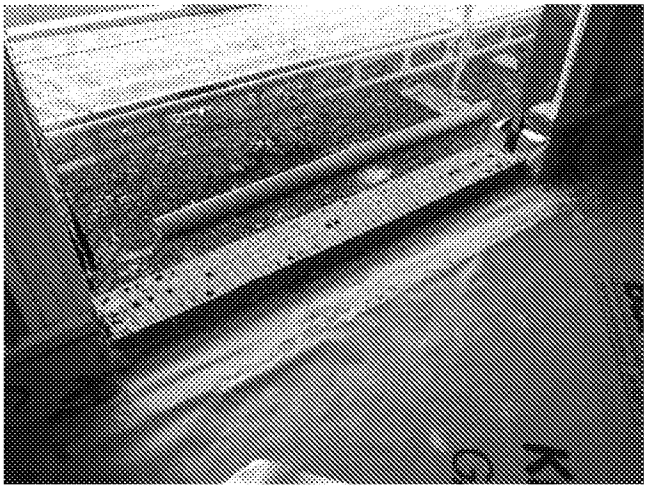
Plot 40 - floors sealed
	Plot 40 - example of service seal
	Plot 40 - Corner detail

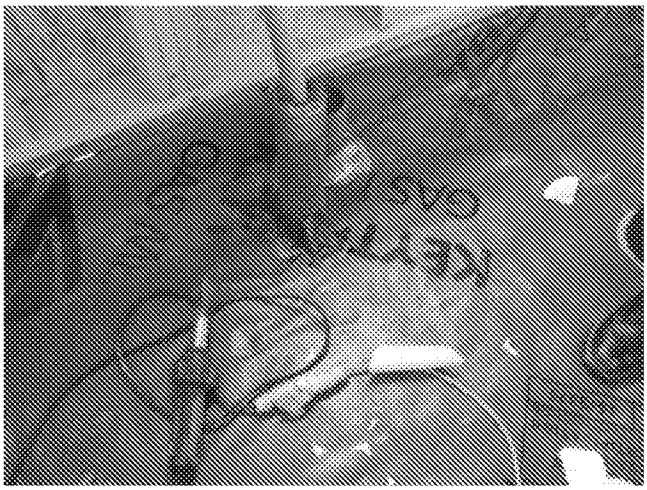
Plot 40 - under stairs
	Plot 40 - floors sealed
	Plot 40 - Threshold

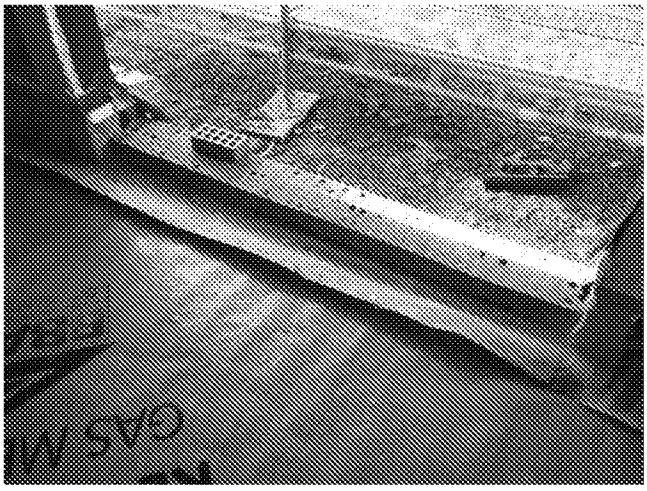
Plot 41 - Threshold
	Plot 41 - Floor and services sealed
	Plot 41 - under stairs sealed

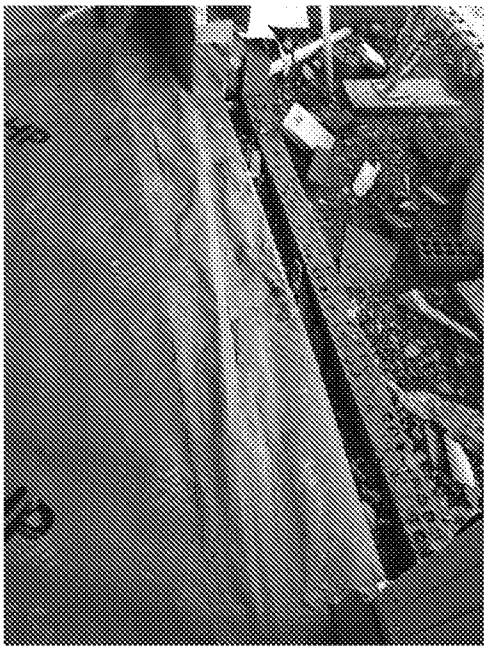
Plot 30 - Threshold
	Plot 30 - Service seals
	Plot 30 - Under stairs

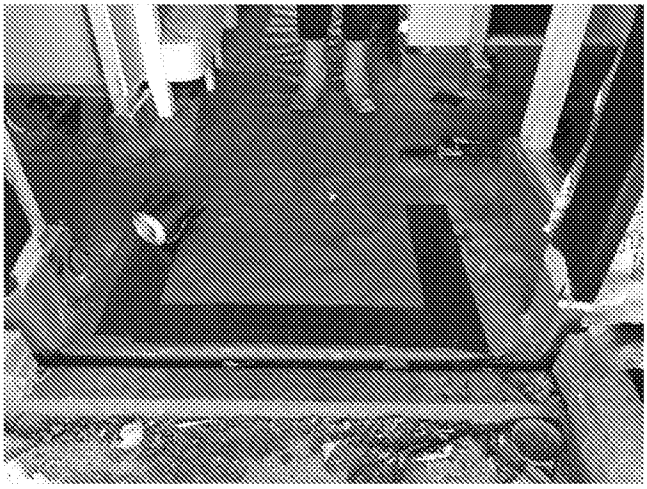
Plot 30 - Floor
	Plot 30 - Patching after removal of debris under membrane
	Plot 30 - Threshold

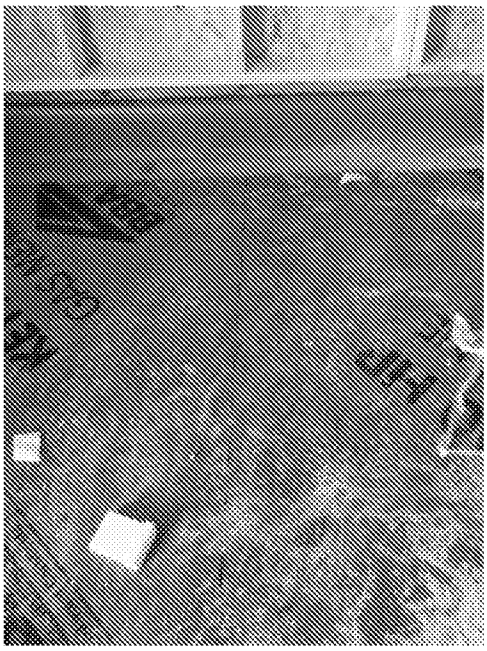
Plot 27 services
	Plot 27 detail
	Plot 27 overview

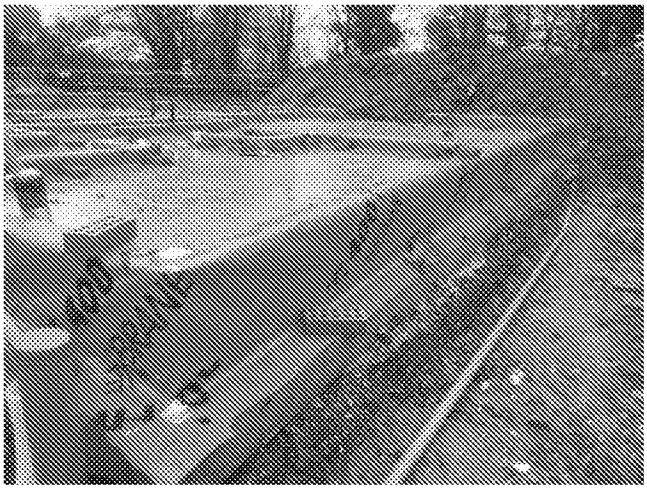
Plot 18 - floor
	Plot 18 - under stairs
	Plot 18 - floor

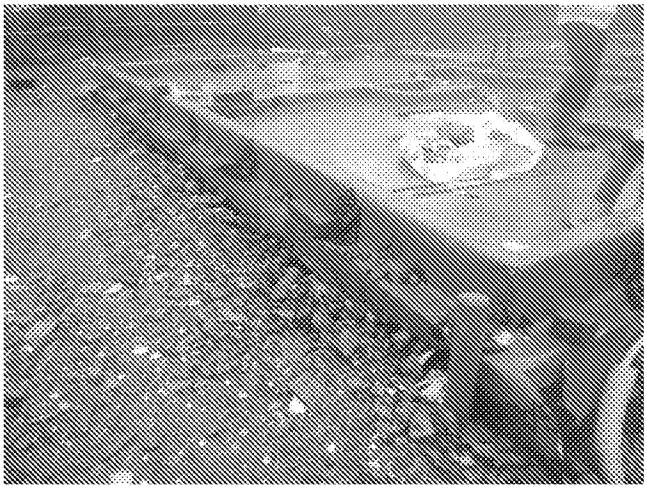
Plot 19 - under stairs
	Plot 19 - Threshold
	Plot 19 - Floor

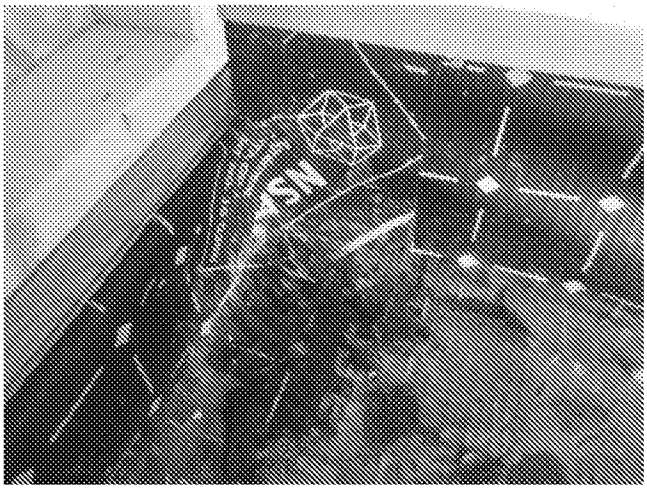
Plot 49 entrance. Undergoing insulation.
	Plot 49 floor.
	Plot 49 floor and service seal.

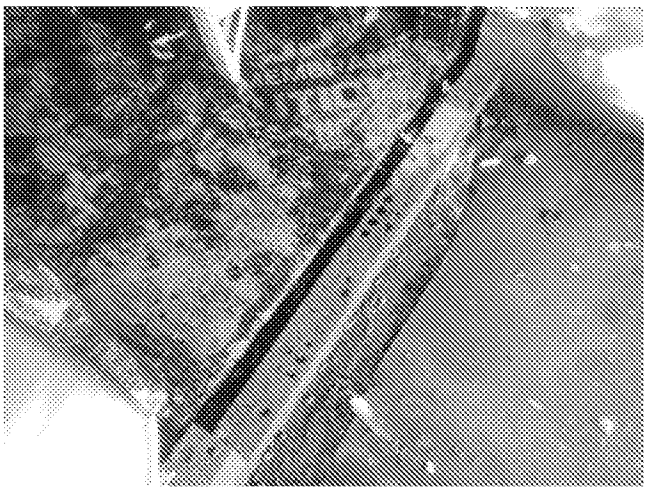
Plot 49 floor.
	Plot 49 Threshold.
	Plot 49 patching.

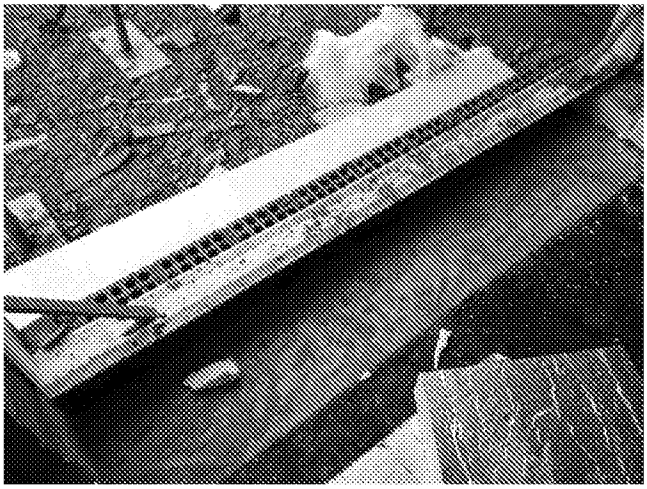
60 bathroom
	60 lounge
	60 lounge

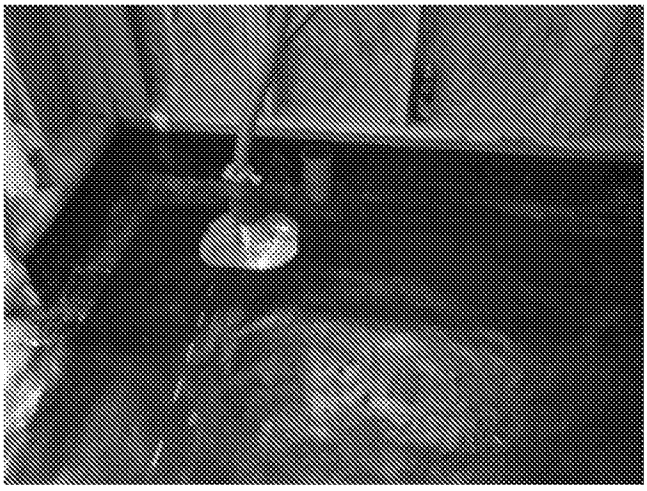
60 lounge
	60 kitchen

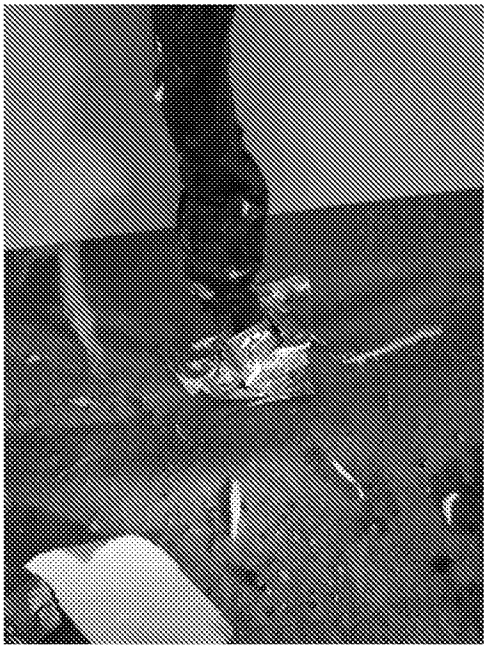
Plot 50 overview
	Plot 50 joins
	Plot 50 services

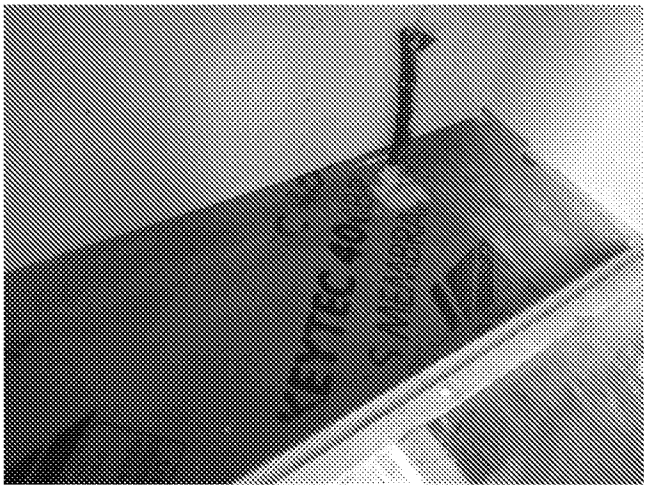
Plot 54 entrance
	Plot 54 under stairs
	Plot 54 floor

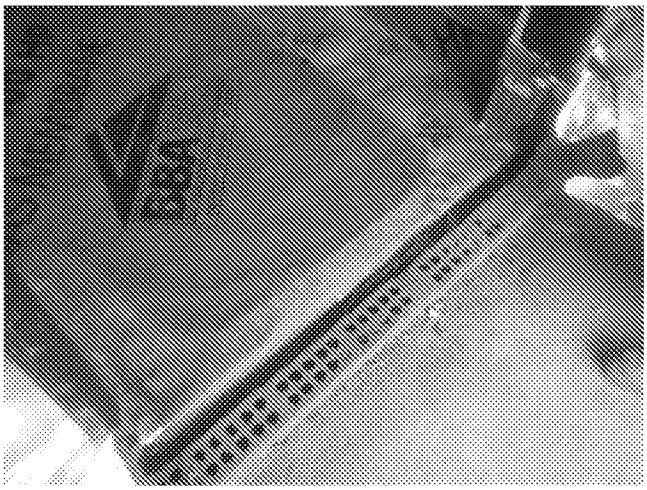
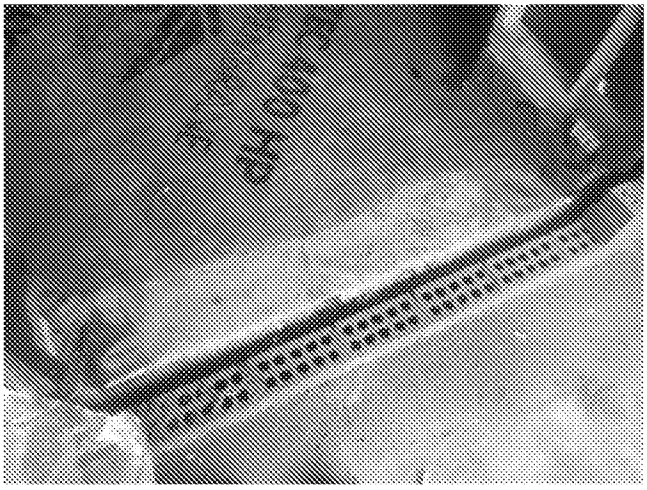
Plot 54 threshold
	Plot 54 corner detail
	Plot 55 entrance
