Geo-Environmental

Project Name	Cornfield Close
Project No.	GE18103
Client	Thakeham Homes
Geo-Environmental Project Manager's Email	[redacted]
Date	01/10/2020, 11:52
Site Engineer	
William Hughes	[redacted]
Weather at time of inspection	Sunny
Gas Characteristic Situation	Characteristic Situation 2
Type of development and building/block checked	Residential - terraced houses
Plot No.	Plots 36-37 complete, Plots 38-39 in progress
Foundation Type	Suspended
Gas Protection Type	Passive
What is being inspected	[ ] Venting [X] Membrane [ ] Venting and Membrane

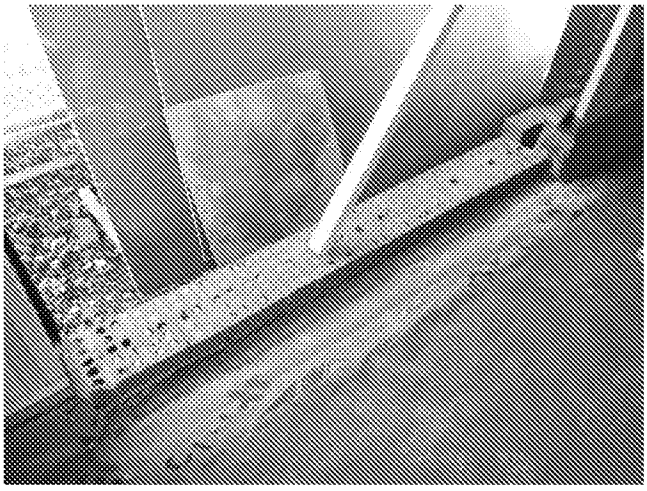
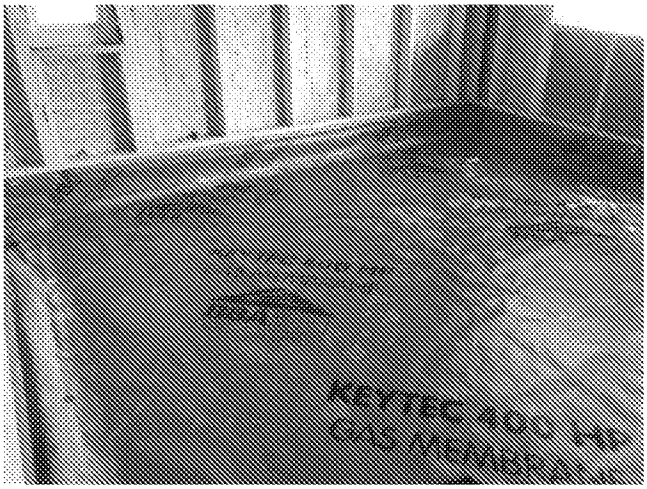
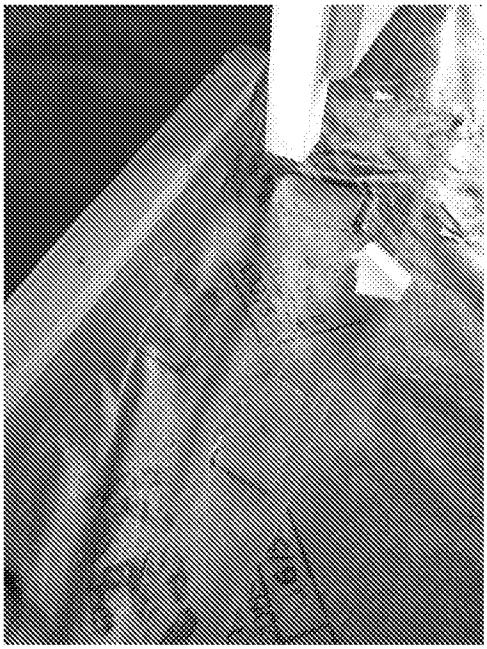
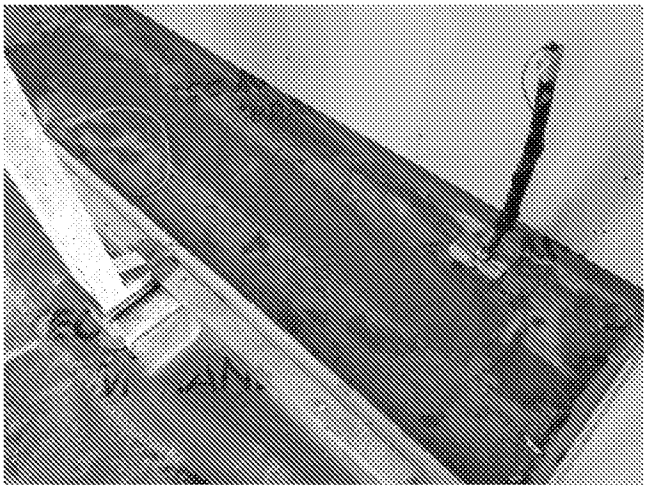
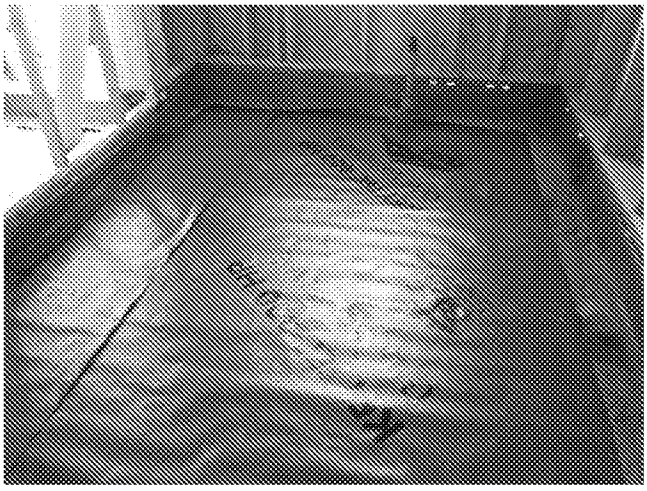
Plot 40 - floors sealed
	Plot 40 - example of service seal
	Plot 40 - Corner detail

Plot 40 - under stairs
	Plot 40 - floors sealed
	Plot 40 - Threshold

Plot 41 - Threshold
	Plot 41 - Floor and services sealed
	Plot 41 - under stairs sealed

Plot 41 - floors sealed
	Plot 41 - Threshold
	Plot 41 - Holes patched during inspection

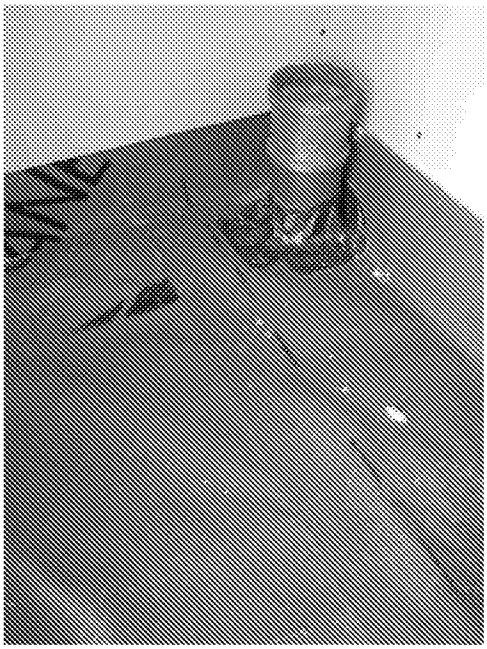
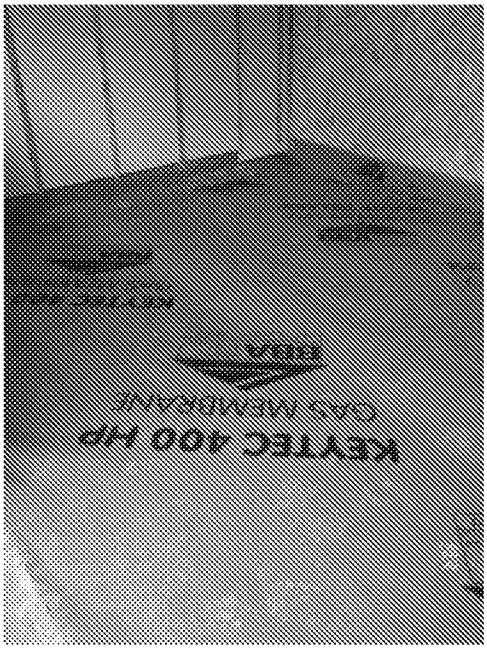
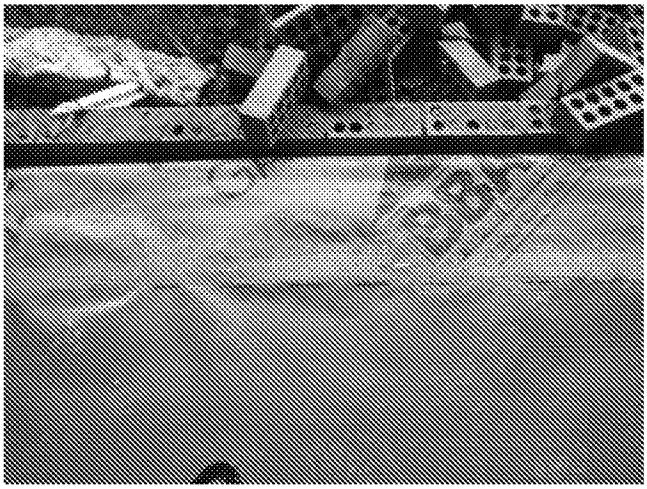
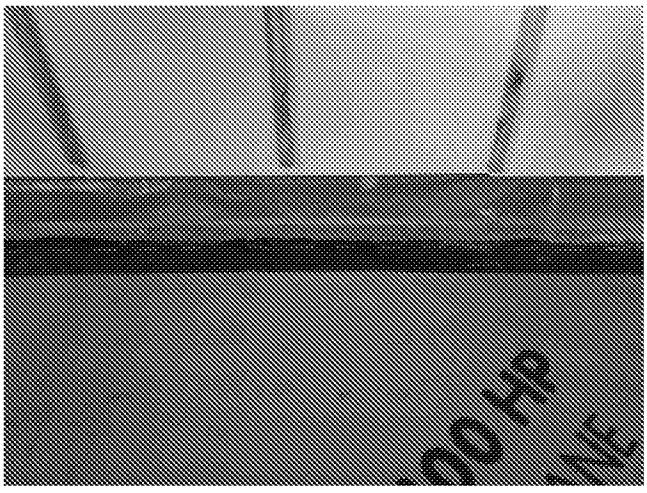
Plot 33 overview
	Plot 33 threshold
	Plot 33 patch repair

Plot 33 repair
	Plot 33 timber frame
	Plot 34 overview

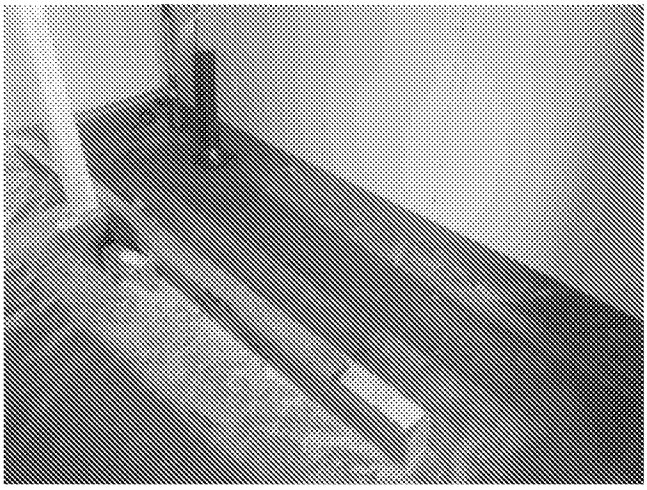
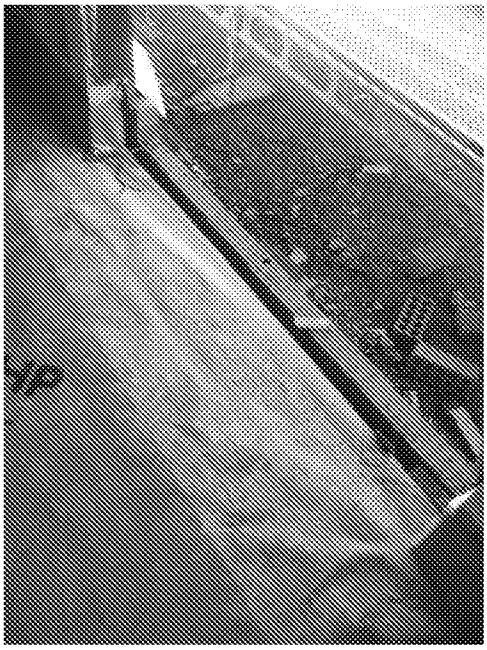
Plot 31 - Threshold
	Plot 31 - Under stairs
	Plot 31 - Floor and service seals

Plot 31 - Service seals. Bricks to hold membrane in shape
	Plot 31 - Floor
	Plot 31 - Threshold

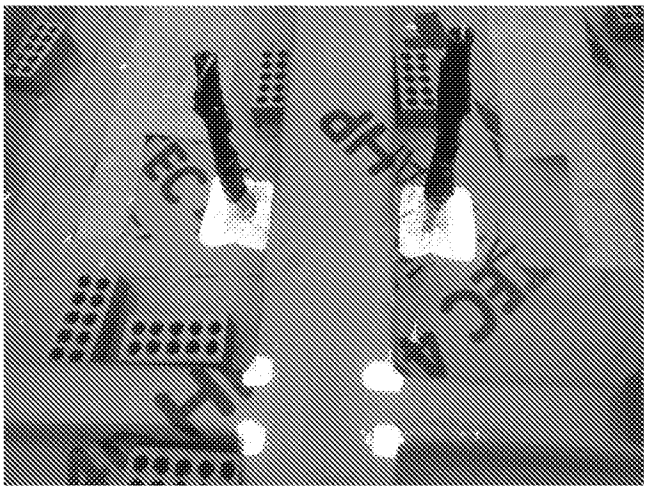
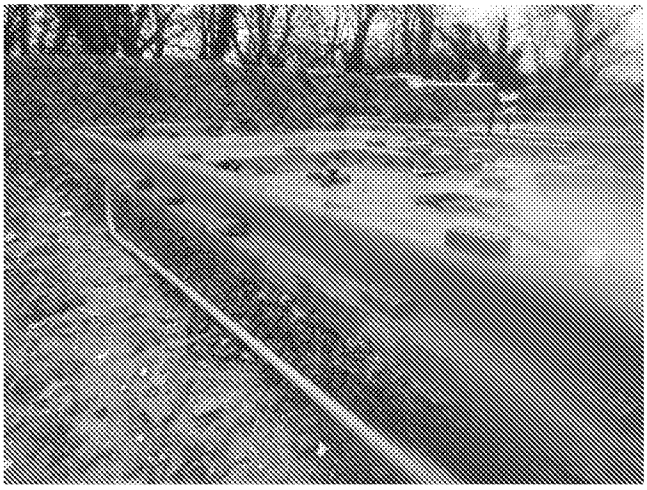
Plot 18 - floor
	Plot 18 - under stairs
	Plot 18 - floor

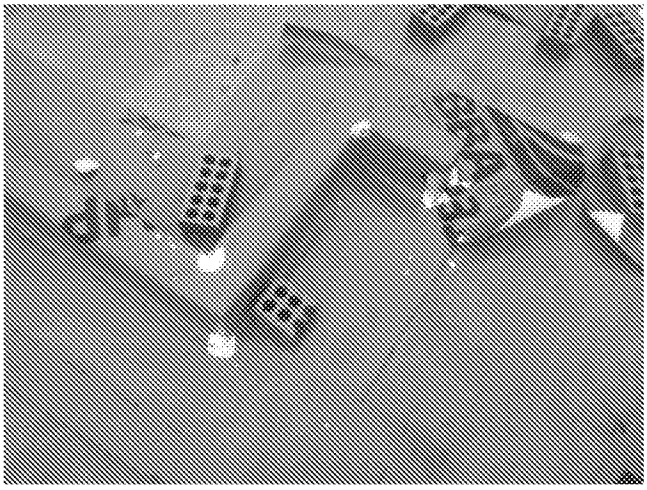
Plot 19 - Floor
	Plot 19 - service seal
	Plot 19 - floor

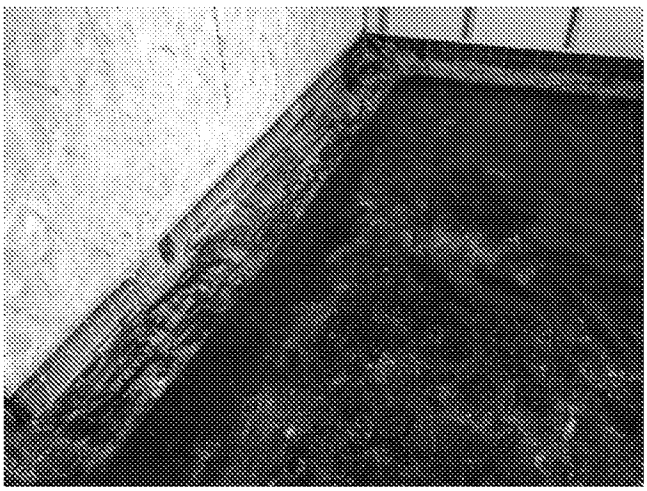
Service sealed and laped.
	Laped patio.
	60 kitchen diner.

60 Kitchen diner.
	61
	61

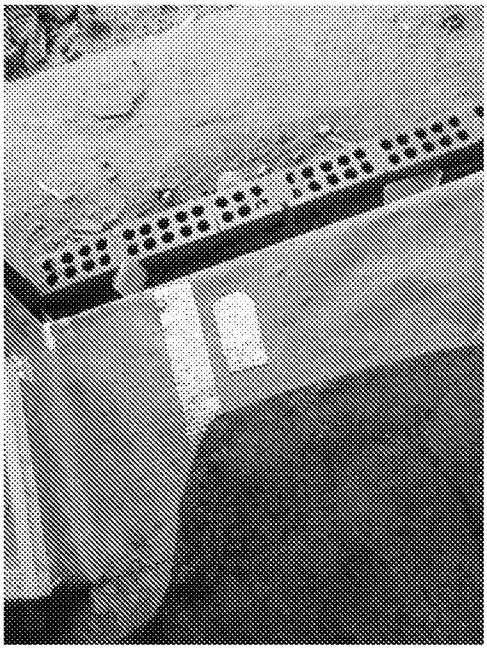
Plot 50 overview
	Plot 50 joins
	Plot 50 services

Plot 50
	Plot 51

Plot 51 services
	Plot 51 overview
	Plot 51 repairs

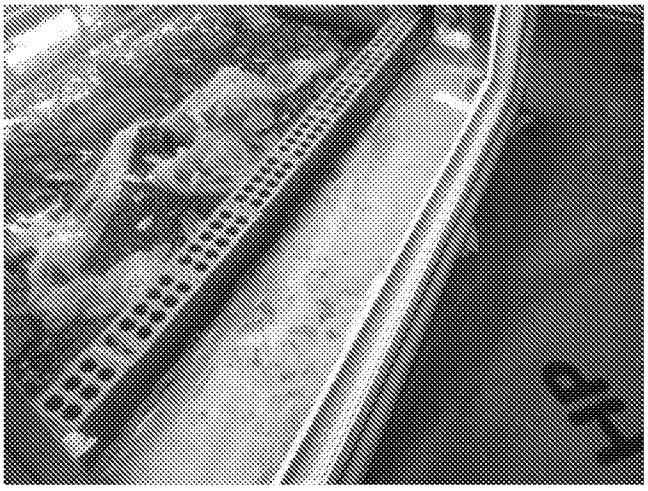
Plot 58
	Plot 58 floor and service seal

Plot 58 under stairs
	Plot 58 floor
	Plot 58 Threshold

Plot 58 patch repair
	Plot 59

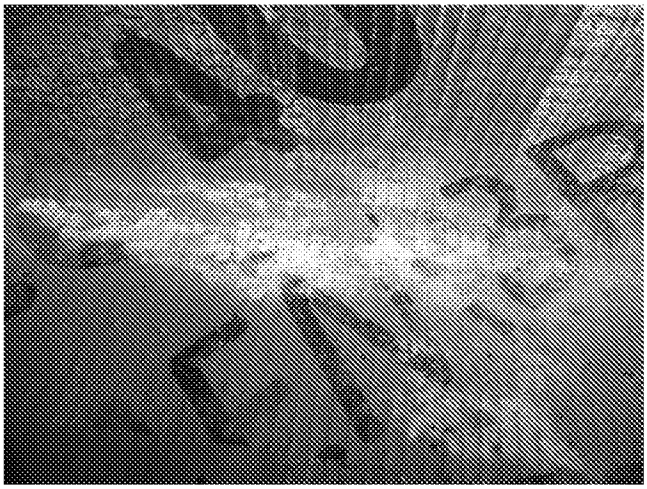
1.1 Condition of sub-grade and underside of membrane	Unable to inspect as sealed
1.2 Gas membrane type	Keytec 400 gas resistant membrane
1.3 Gas membrane condition	Block B - Main floor area generally clear however membrane did require sweeping. Materials were being stored on top of membrane in stairwell and a lot of rubble and debris on membrane in the smaller rooms Block A membrane needs clearing and materials being stored on it
Jointing tape product	Heat sealed joins mainly welded some heat sealed taped joins
1.5 Lapping design	At least 150mm overlap
1.6 Laps, welds and joints seals	All heat sealed joins. Block B - A large number of patch repairs are required Block A - seal around stairs is not sufficient
1.7 Service seals	Services sealed with site made seals, all well sealed

Block B damage
	Block B damage
	Block B materials stored

Remedial Measures Required
