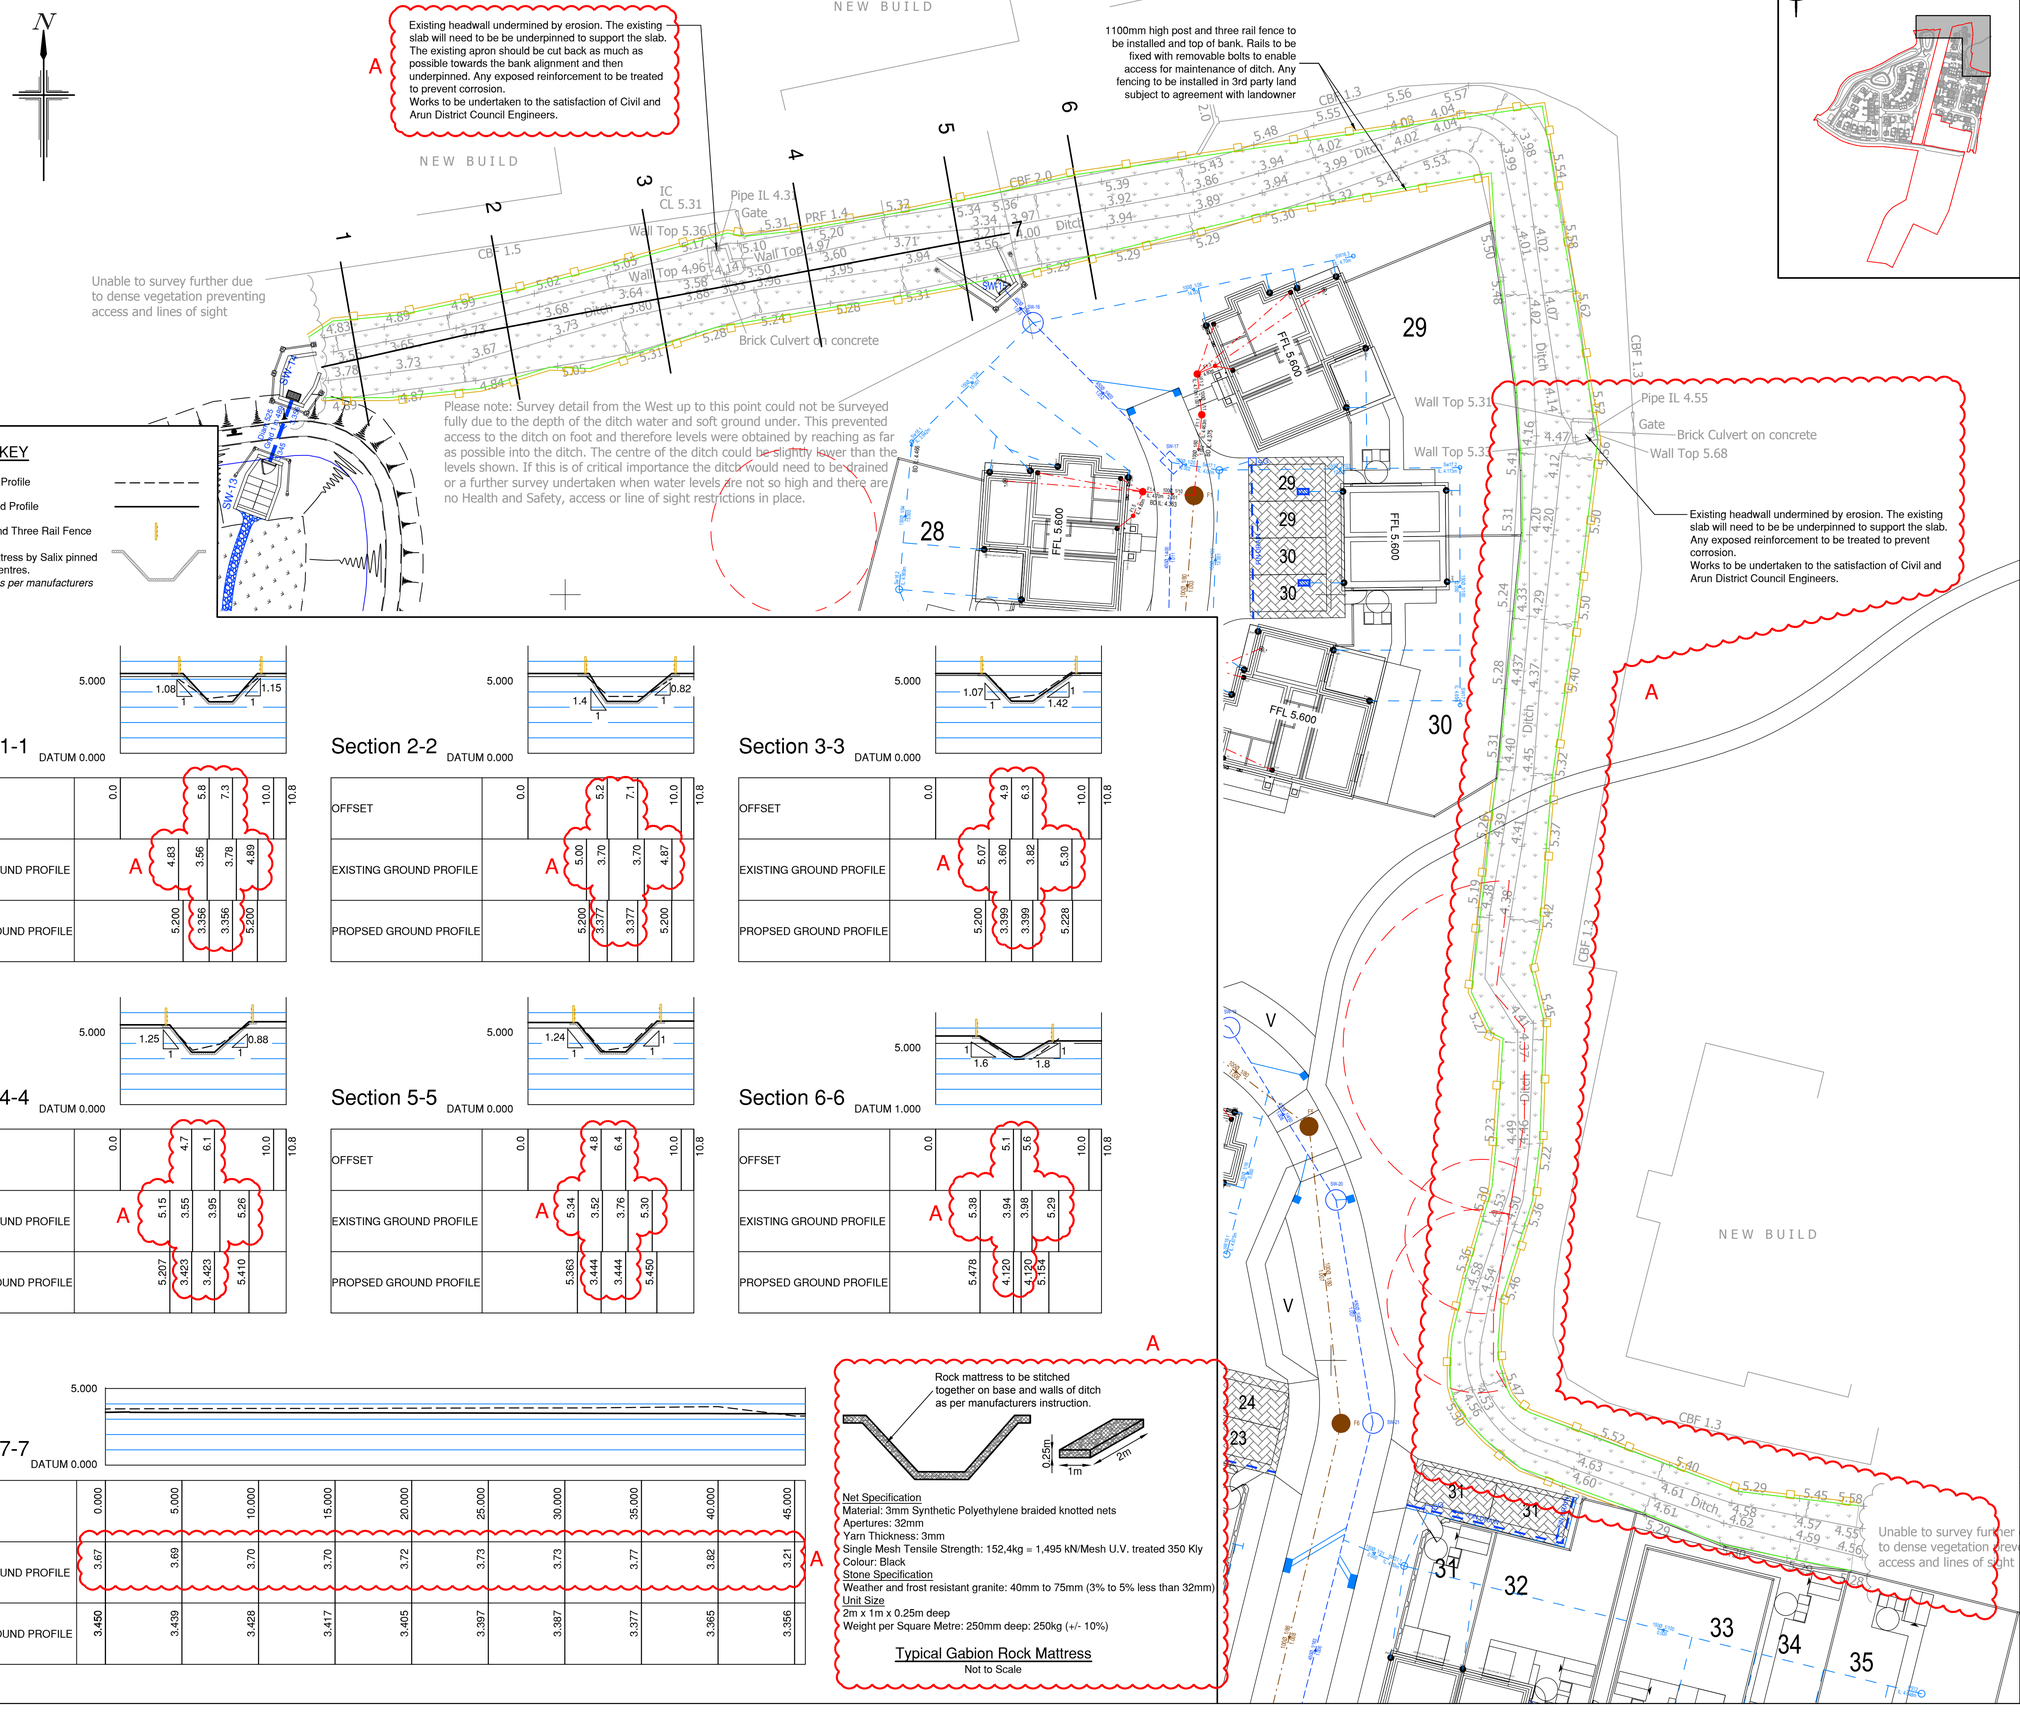
N
Existing headwall undermined by erosion. The existing slab will need to be be underpinned to support the slab. The existing apron should be cut back as much as possible towards the bank alignment and then underpinned. Any exposed reinforcement to be treated to prevent corrosion.
Works to be undertaken to the satisfaction of Civil and Arun District Council Engineers.
A
NEW BUILD
1100mm high post and three rail fence to be installed and top of bank. Rails to be fixed with removable bolts to enable access for maintenance of ditch. Any fencing to be installed in 3rd party land subject to agreement with landowner
Unable to survey further due to dense vegetation preventing access and lines of sight
Brick Culvert on concrete
Pipe IL 4.31
Gate
Wall Top 5.36
Wall Top 4.96
Ditch
CBF 2.0
CBF 1.5
PRF 1.4
IC CL 5.31
Please note: Survey detail from the West up to this point could not be surveyed fully due to the depth of the ditch water and soft ground under. This prevented access to the ditch on foot and therefore levels were obtained by reaching as far as possible into the ditch. The centre of the ditch could be slightly lower than the levels shown. If this is of critical importance the ditch would need to be drained or a further survey undertaken when water levels are not so high and there are no Health and Safety, access or line of sight restrictions in place.
