Julian Munn Drainage Services Ltd

CCTV Survey

Address: Sainsburys Store, Rustington
Job No.S0477/09/13
Client: Barr Ltd

Drain Trace Layout

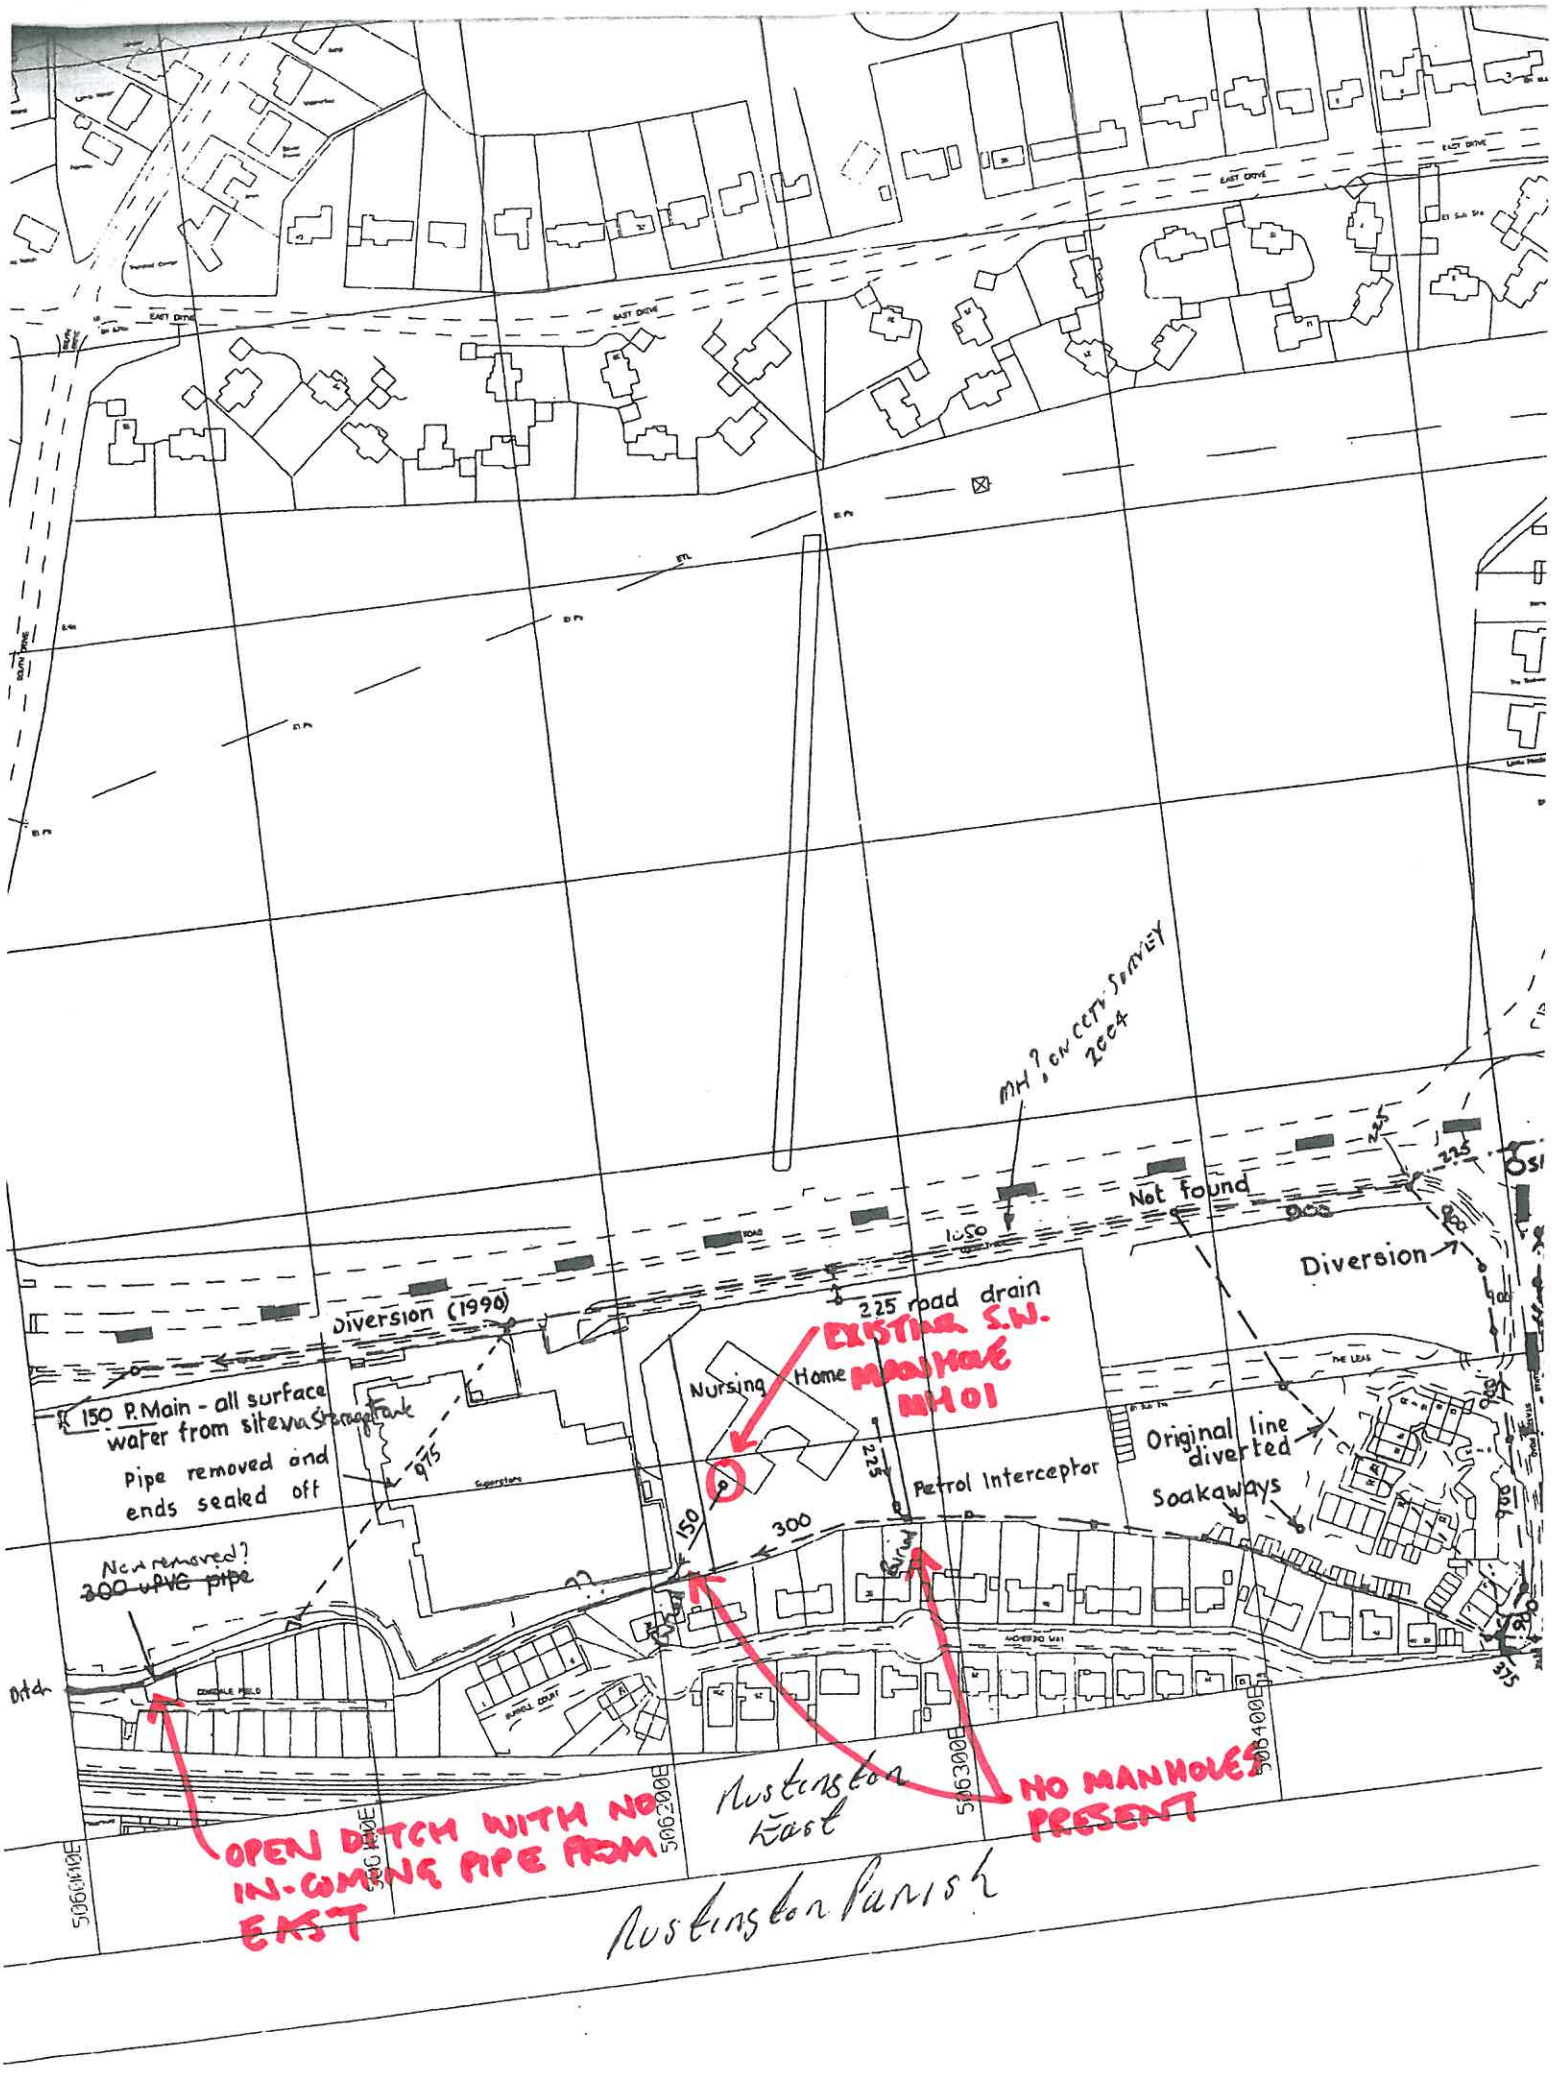
EAST DRIVE
MH ? CONCRETE SURVEY 2004
Not found
Diversion
Diversion (1990)
225 road drain
EXISTING S.W. MANHOLE MH01
150 P.Main - all surface water from site via Storage Tank
Pipe removed and ends sealed off
Nursing Home
Petrol Interceptor
Original line diverted
Soakaways
New removed? 300 uPVC pipe
Ditch
OPEN DITCH WITH NO IN-COMING PIPE FROM EAST
NO MANHOLES PRESENT
Rustington East
Rustington Parish
506200E
506300E
506400E
