PROJECT: Extension and Enhancements to Days, Fontwell

DRAWING TITLE: Proposed Elevations

DRAWING NO: P015/P017(a)

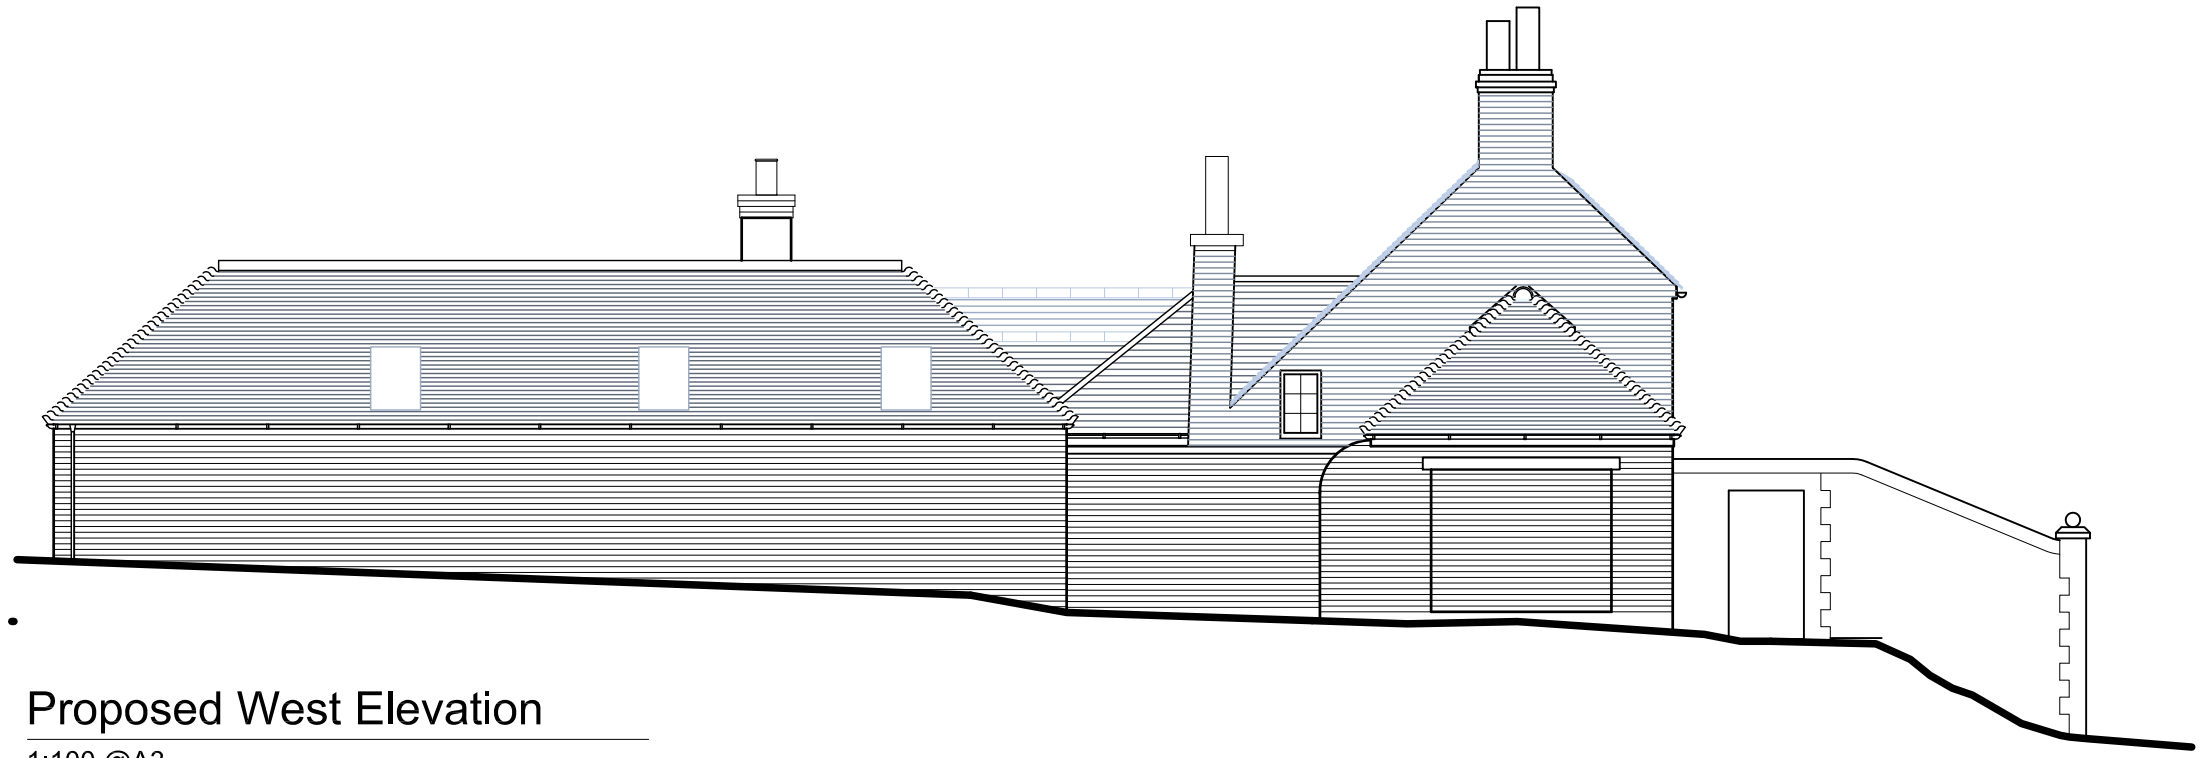
Proposed West Elevation

(a) The tops of all walls appear to be suffering from movement beneath / behind the fascias & guttering & it is expected that the tops of all walls will need stabilising with some fairly extensive repairs & re-pointing once the old roof coverings are removed & these areas exposed.

(b) Existing sw windows are in very poor state of repair and have large areas of wet rot. Replace with new white painted sw casement double glazed sw windows.

(f) Much of the pointing to both the brickwork & flint-work is poor condition, allow for the complete re-pointing of all exposed wall areas during the renovation of the property.

(h) Render is poor state of repair around windows and will need to be replaced.

(m) Chimney stacks are unstable and will be rebuilt to match existing

(n) Existing rooflight is in very poor state of repair and has large areas of wet rot. Replace with new oak unit.

(d) Remove and set a side all existing clay roof tiles. Replace roof timbers as required. New roofing membrane and insulation installed.

(e) All existing guttering and sw fascias removed and disposed of.
New cast iron gutters and down pipes
All the guttering and down pipes, discharging into new soakaways.

(l) Slate roof. Retain and salvage as much of the existing slate as possible. New slate to match existing as close as possible.
