ALL HOURS PLUMBING

Inspection Report

Site; **Tye Lane** Place: **Walberton**	Divsion: District: **S.W** Tape No: **1**	Start MH: **SMH 21** End MH: **SMH 21.1** Total Length:

Purpose:	**Structural Defects**	**Size/Shape:**	**Circular dia 150mm**
Use:	**STORM**	**Material:**	**PLASTIC**
Catchment:	**P1 Schedule**	**Lining:**	
		Category:

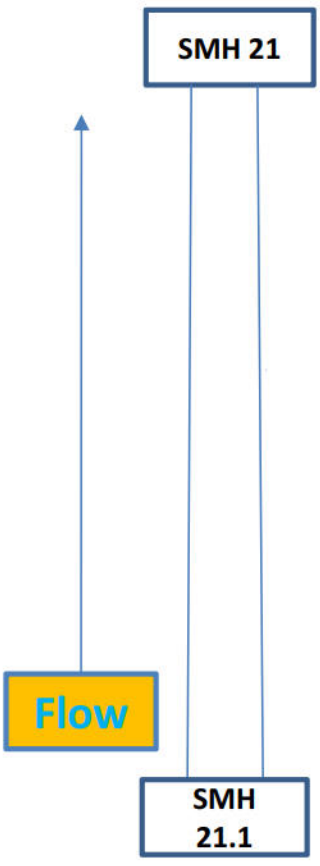
Position	Code	Observation
0.0M	ST	Start Of Survey
0.0M	WL	Water Level 0 %

11.2M	MH	Camera Enters Manhole S 21.1

REM ; THERE ARE NO DEFECTS WITH THIS SECTION OF PIPE

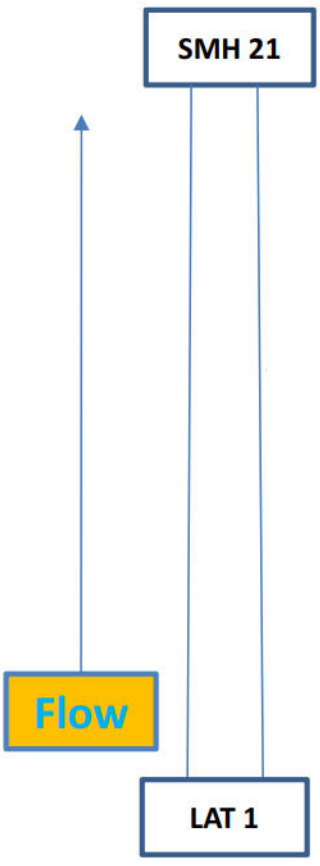
8.3M	G	Camera Stops At Gully 1

REM ; THERE ARE NO DEFECTS WITH THIS SECTION OF PIPE

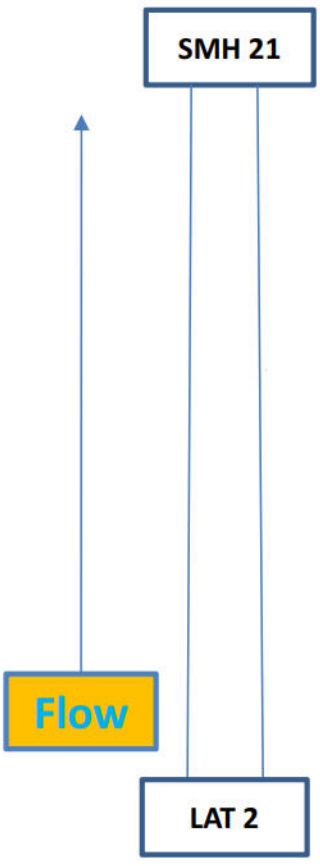
Position	Code	Observation
3.0M	G	Camera Stops At Gully 2

REM ; THERE ARE NO DEFECTS WITH THIS SECTION OF PIPE

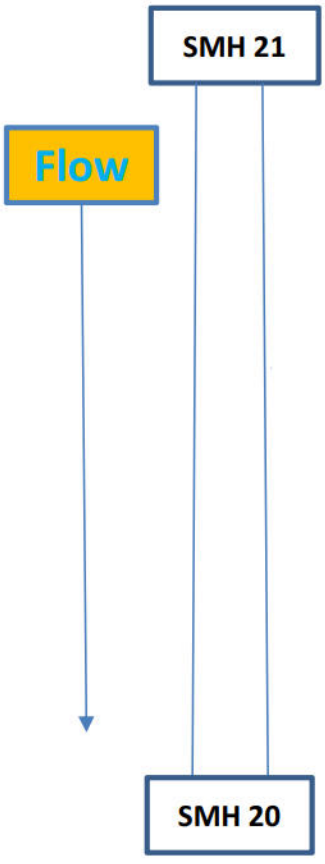
26.3M JN Line Drops In From The Left From Manhole S 20.3

REM ; THERE ARE NO DEFECTS WITH THIS SECTION OF PIPE

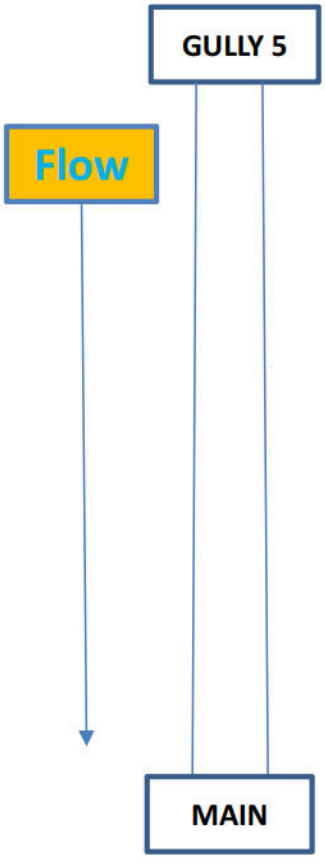
Position	Code	Observation
0.0M	ST	Start Of Survey
0.0M	WL	Water Level 0 %
1.2M	PS	Pipe Smashed At Top
2.8M	LD	Line Drops Into Main

REM ; THERE IS A HOLE IN THE TOP OF THE PIPE AT 1.2 METRES

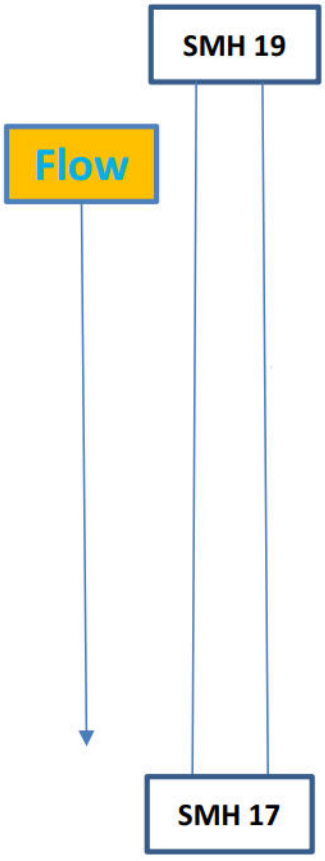
Position	Code	Observation
0.0M	ST	Start Of Survey
0.0M	WL	Water Level 0 %
7.6M	JN	Line Drops In From The Right From S 18.1
10.5M	JN	Line Drops In From The Right From G 5
11.2M	JN	Line Drops In From The Left From G 6
22.1M	MH	Camera Enters Manhole S 17

REM ; THERE ARE NO DEFECTS IN THIS SECTION OF PIPE
MANHOLE S 17.1 HAS NOT BEEN INSTALLED YET

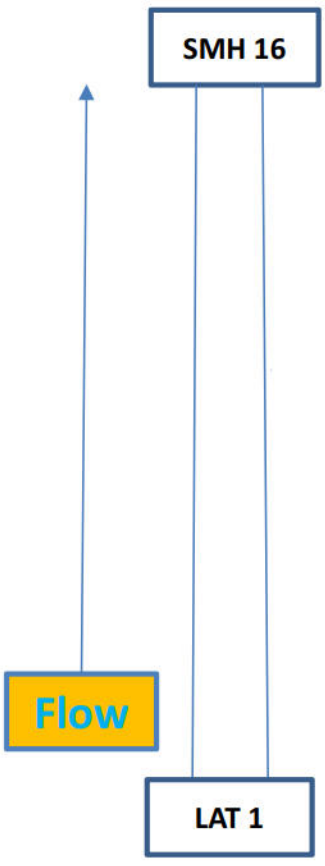
Position	Code	Observation
0.0M	ST	Start Of Survey
0.0M	WL	Water Level 0 %
0.1M	WL	Water Level 20 %
9.5M	WL	Water Level 0 %
12.8M	G	Camera Stops At Gully 13

REM ; THERE IS AN UNDEROLL IN THIS SECTION OF PIPE

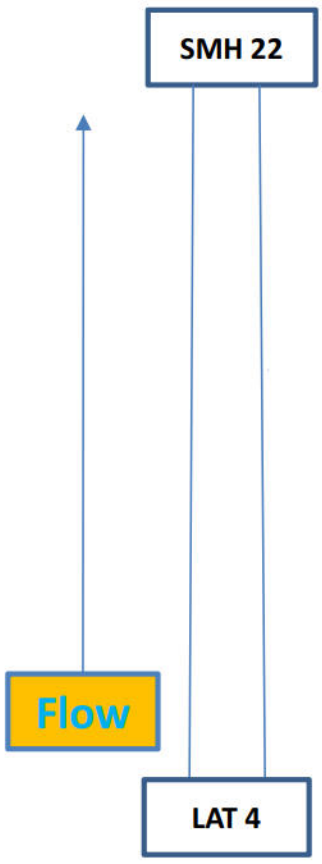
4.2M	CP	Line Capped Off

REM ; THERE ARE NO DEFECTS WITH THIS SECTION OF PIPE, BUT MANHOLE S22.1 HAS NOT BEEN INSTALLED YET

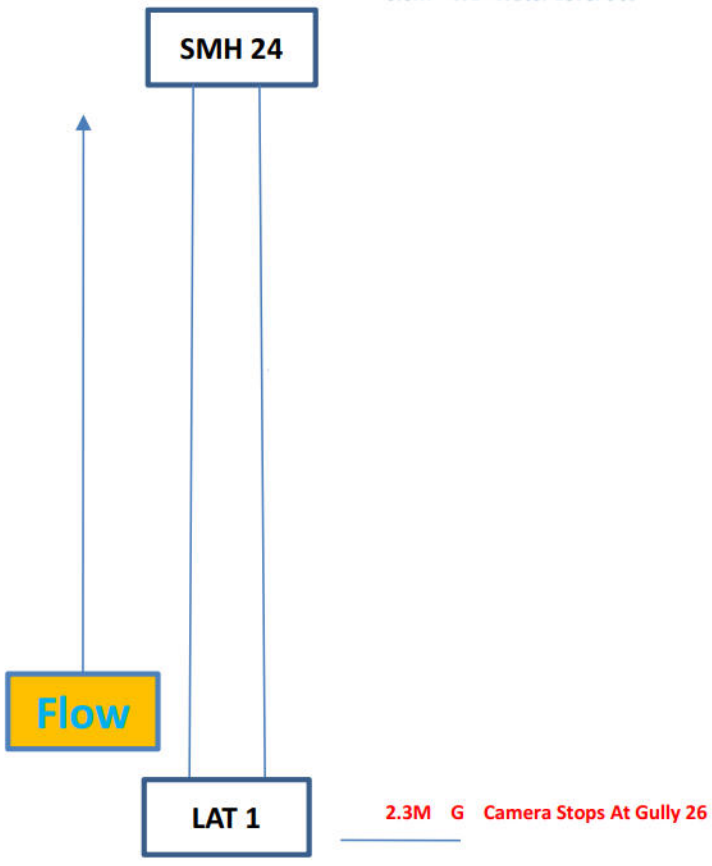
2.3M	G	Camera Stops At Gully 26

REM ; THERE ARE NO DEFECTS WITH THIS SECTION OF PIPE

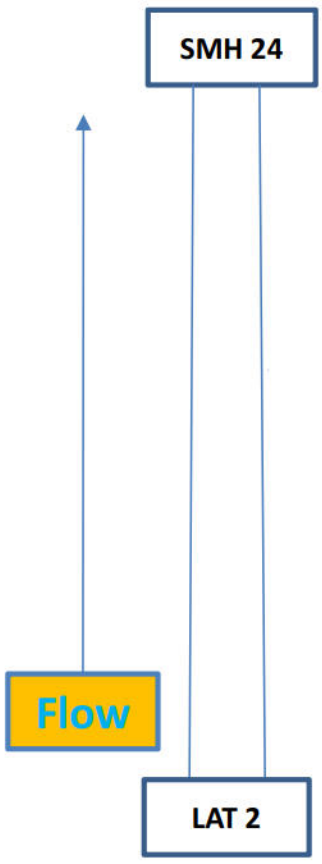
6.2M	CP	Line Capped Off

REM ; THERE ARE NO DEFECTS WITH THIS SECTION OF PIPE, BUT MANHOLE S24.1 HAS NOT BEEN INSTALLED YET

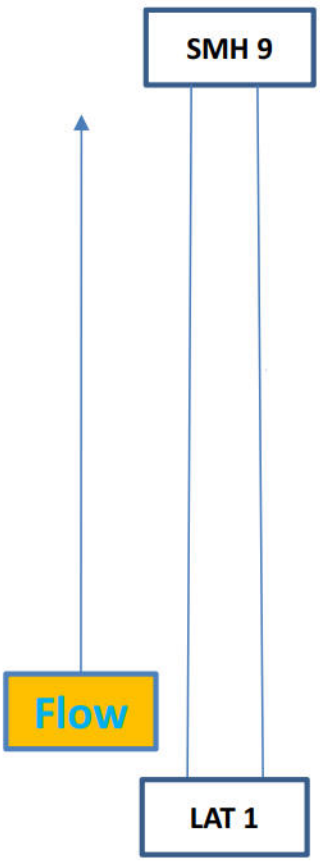
1.9M CP Line Capped Off

REM ; THERE ARE NO DEFECTS WITH THIS SECTION OF PIPE, BUT MANHOLE S9.1 , S9.2, S9.3 & S10.1 HAVE NOT BEEN INSTALLED YET

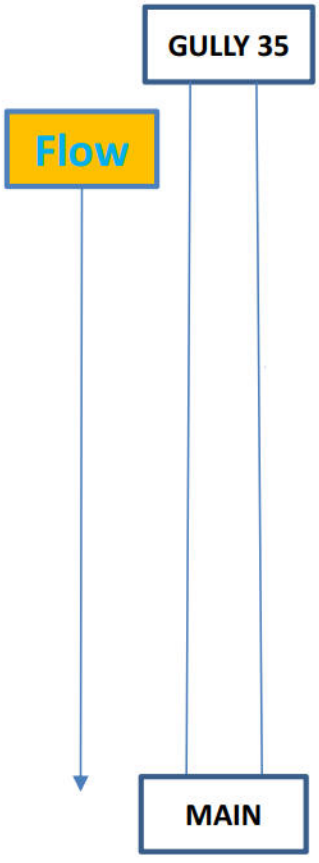
3.2M	D	Concrete In Line, Unable To Pass

REM ; THERE IS CONCRETE IN THIS LINE WHICH WE CAN NOT REMOVE. UNABLE TO ACCESS MANHOLE S35.1 AS HAS SCAFFOLD ERECTED ON IT

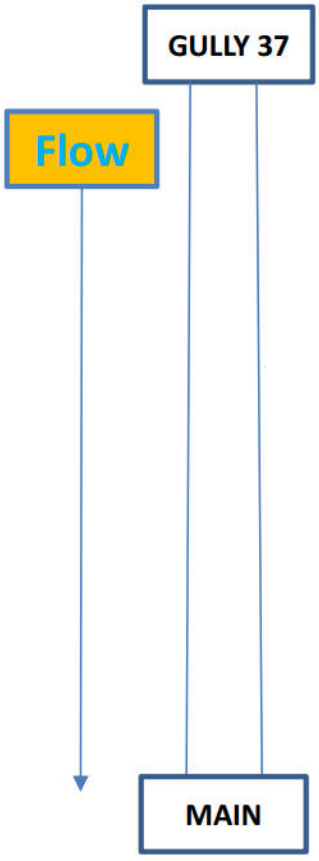
3.9M	LD	Line Drops Into Main

REM ; THERE ARE NO DEFECTS WITH THIS SECTION OF PIPE
MANHOLE S 33.1 HAS NOT BEEN INSTALLED YET

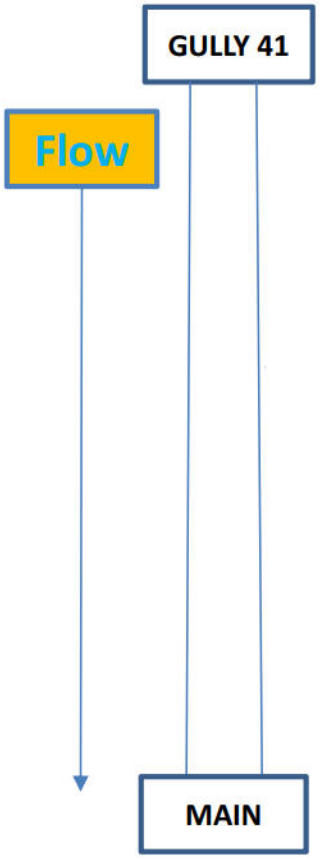
Position	Code	Observation
0.0M	ST	Start Of Survey
0.0M	WL	Water Level 0 %
0.1M	JN	Line Drops In From The Left From G 40

2.6M LD Line Drops Into Main

REM ; THERE ARE NO DEFECTS WITH THIS SECTION OF PIPE
MANHOLE S33.3 AND GULLIES 42 & 43 HAVE NOT BEEN INSTALLED YET

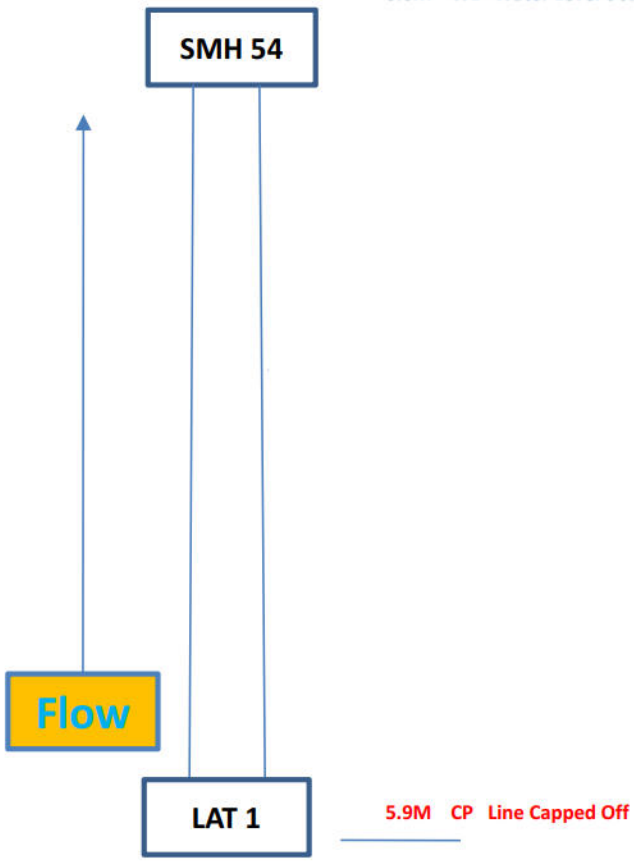
REM ; THERE ARE NO DEFECTS WITH THIS SECTION OF PIPE
MANHOLE S54.2 NOT INSTALLED YET

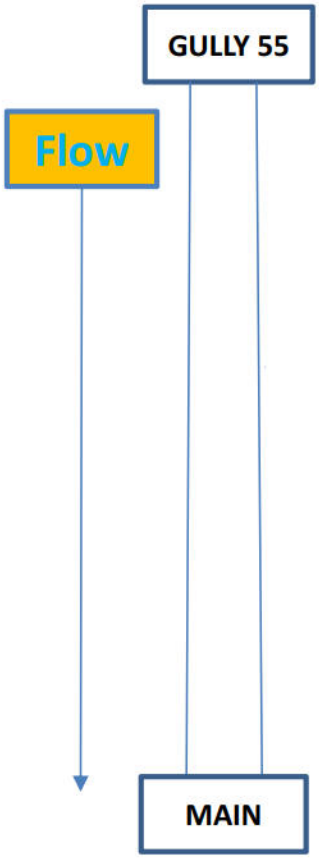
REM ; THERE ARE NO DEFECTS WITH THIS SECTION OF PIPE
GULLIES G 56 & G 57 BOTH HAVE THE TOP BUNGS CONCRETED IN SO CAN NOT CAMERA

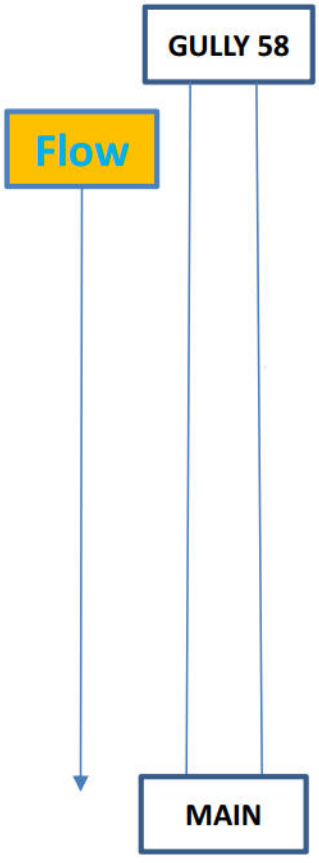
3.2M	D	Concrete In Entrance To Drain
3.2M	LD	Line Drops Into Main

REM ; THERE IS CONCRETE IN THIS SECTION OF PIPE

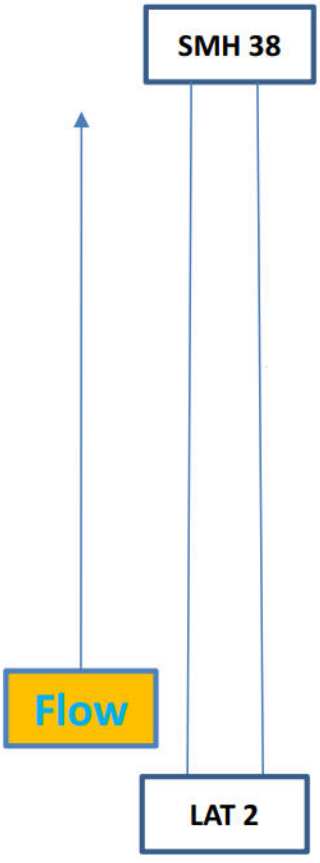
Position	Code	Observation
0.0M	ST	Start Of Survey
0.0M	WL	Water Level 0 %
5.2M	CR	Cracks In Top Of Pipe
10.5M	PR	Pipe Reduces To 100mm
12.2M	MH	Camera Enters Manhole S 38.1

REM ; THERE ARE CRACKS IN THE TOP OF THIS PIPE WHERE WATER IS DRIPPING IN

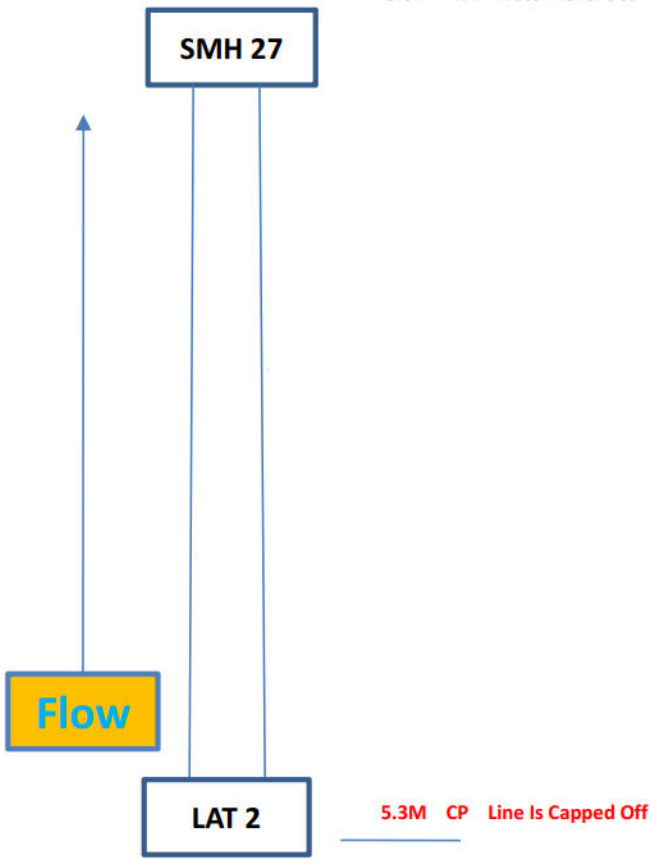
5.3M	CP	Line Is Capped Off

REM ; THERE ARE NO DEFECTS IN THIS SECTION OF PIPE
MANHOLE S 27.1 NOT INSTALLED YET

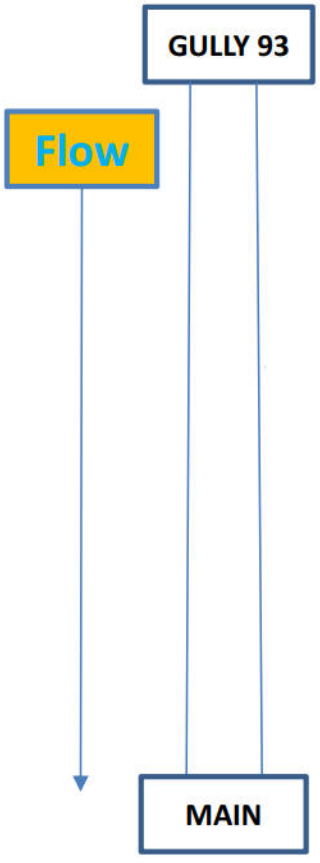
1.2M LD Line Drops Into Main

REM ; THERE ARE NO DEFECTS IN THIS SECTION OF PIPE

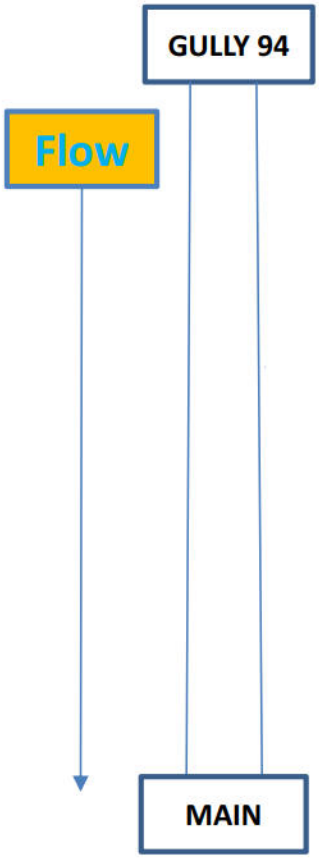
2.6M	LD	Line Drops Into Main

REM ; THERE ARE NO DEFECTS IN THIS SECTION OF PIPE

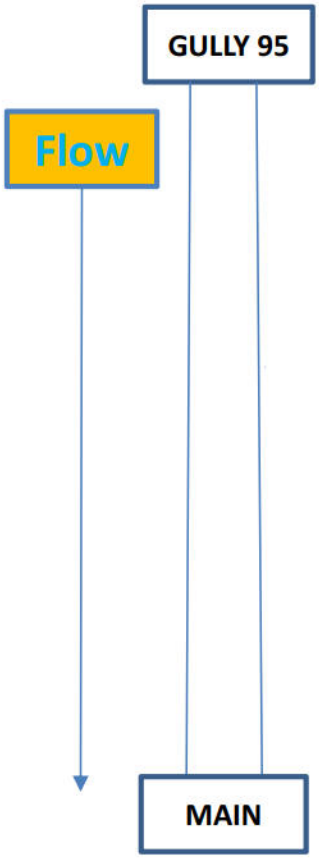
5.2M LD Line Drops Into Main

REM ; THERE ARE NO DEFECTS IN THIS SECTION OF PIPE

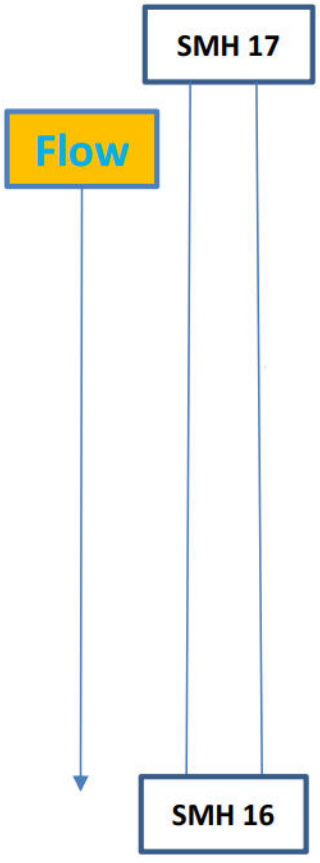
Position	Code	Observation
0.0M	ST	Start Of Survey
0.0M	WL	Water Level 0 %
3.6M	JN	Line Drops In From The Right
16.4M	JN	Line Drops In From The Left
17.9M	JN	Line Drops In From The Right
21.3M	JN	Line Drops In From The Right
35.5M	JN	Line Drops In From The Right
41.1M	JN	Line Drops In From The Left
41.8M	JN	Line Drops In From The Right
46.3M	JN	Line Drops In From The Left
47.3M	JN	Line Drops In From The Left
48.3M	MH	Camera Enters Manhole S 16

REM ; THERE ARE NO DEFECTS IN THIS SECTION OF PIPE

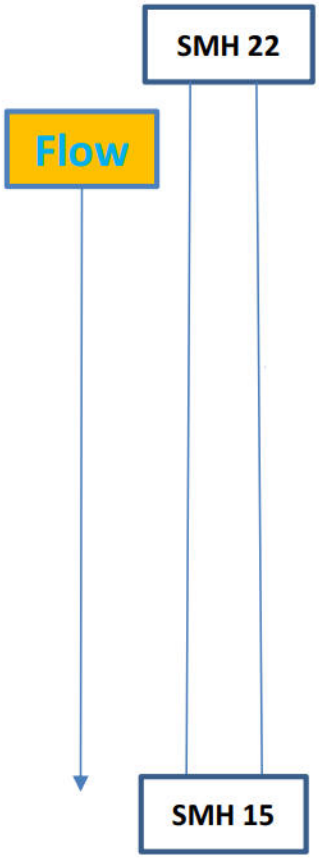
Position	Code	Observation
0.0M	ST	Start Of Survey
0.0M	WL	Water Level 0 %
25.0M	JN	Line Drops In From The Left
30.0M	JN	Line Drops In From The Left
30.2M	JN	Line Drops In From The Left
42.2M	JN	Line Drops In From The Left
44.7M	MH	Camera Enters Manhole S 15

REM ; THERE ARE NO DEFECTS IN THIS SECTION OF PIPE

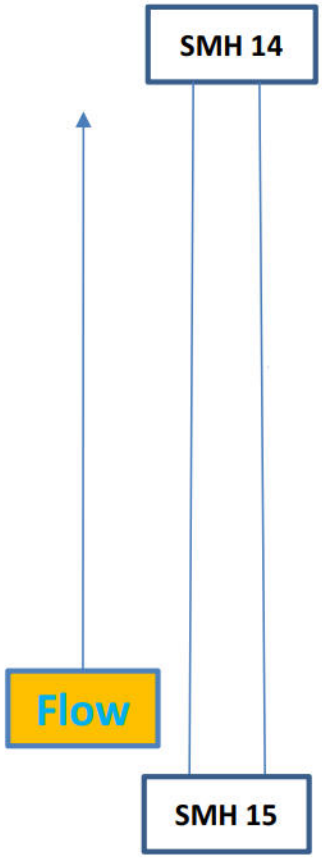
Position	Code	Observation
0.0M	ST	Start Of Survey
0.0M	WL	Water Level 0 %
8.4M	JN	Line Drops In From The Left From S 14.1
22.6M	JN	Line Drops In From The Left From S 14.23
29.4M	MH	Camera Enters Manhole S 15

REM ; THERE ARE NO DEFECTS IN THIS SECTION OF PIPE

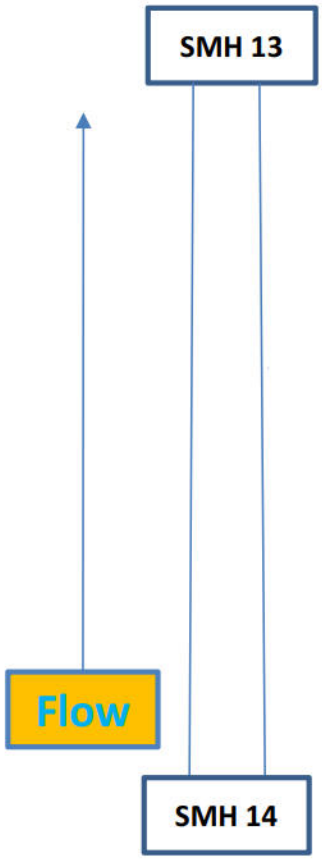
Position	Code	Observation
0.0M	ST	Start Of Survey
0.0M	WL	Water Level 0 %
4.6M	JN	Line Drops In From The Left From S 13.1
5.8M	JN	Line Drops In From The Right
11.9M	MH	Camera Enters Manhole S 14

REM ; THERE ARE NO DEFECTS IN THIS SECTION OF PIPE

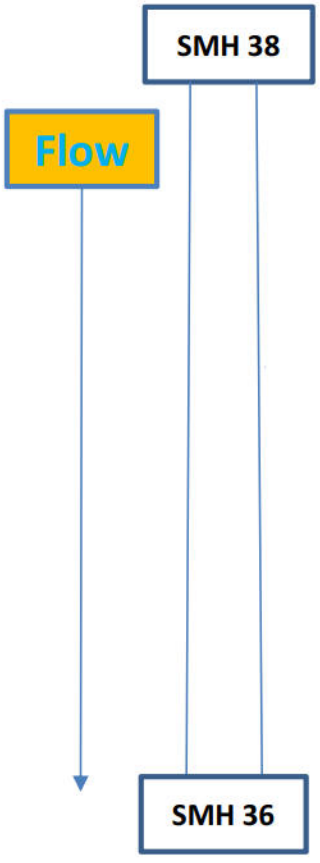
Position	Code	Observation
0.0M	ST	Start Of Survey
0.0M	WL	Water Level 0 %
21.1M	JN	Line Drops In From The Left
24.0M	JN	Line Drops In From The Right
24.8M	JN	Line Drops In From The Left
39.3M	MH	Camera Enters Manhole S 36

REM ; THERE ARE NO DEFECTS IN THIS SECTION OF PIPE

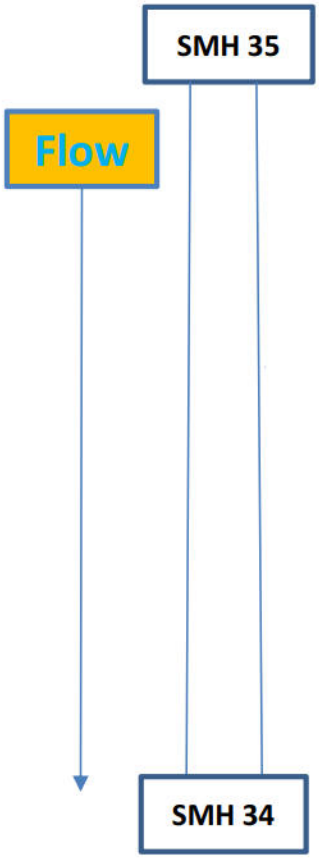
14.5M	JN	Line Drops In From The Right From S 34.1
23.6M	MH	Camera Enters Manhole S 34

REM ; THERE ARE NO DEFECTS IN THIS SECTION OF PIPE

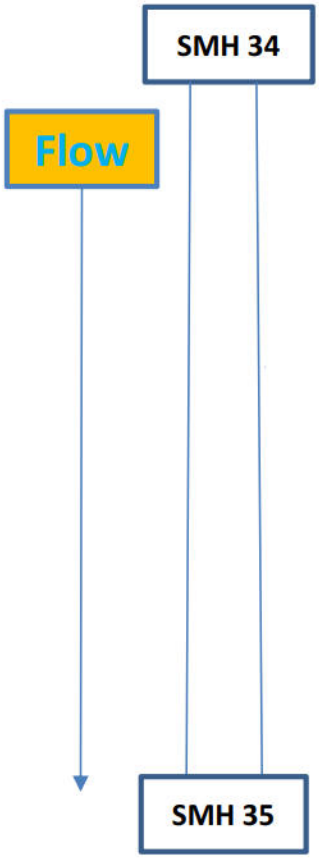
Position	Code	Observation
0.0M	ST	Start Of Survey
0.0M	WL	Water Level 0 %
3.2M	JN	Line Drops In From The Right
5.9M	JN	Line Drops In From The Left
9.9M	JN	Line Drops In From The Right From S 33.1
12.2M	JN	Line Drops In From The Right
14.7M	MH	Camera Enters Manhole S 35

REM ; THERE ARE NO DEFECTS IN THIS SECTION OF PIPE
MANHOLE S 33.1 HAS NOT BEEN INSTALLED YET

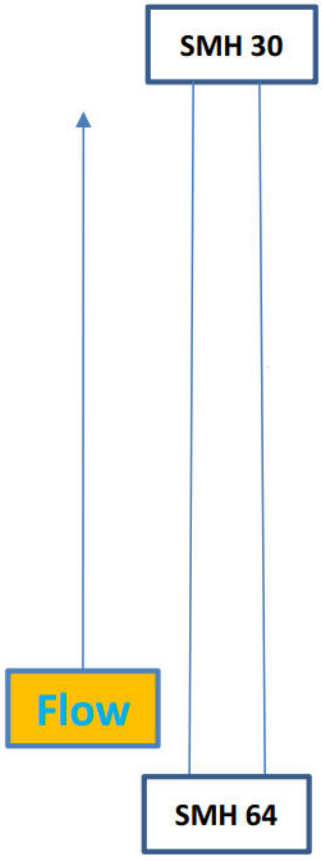
Position	Code	Observation
0.0M	ST	Start Of Survey
0.0M	WL	Water Level 0 %
4.5M	JN	Line Drops In From The Left From S 30.3
5.5M	JN	Line Drops In From The Right
6.4M	JN	Line Drops In From The Right
31.1M	MH	Camera Enters Manhole S 64

REM ; THERE ARE NO DEFECTS IN THIS SECTION OF PIPE
MANHOLE S 30.3 HAS NOT BEEN NSTALLED YET

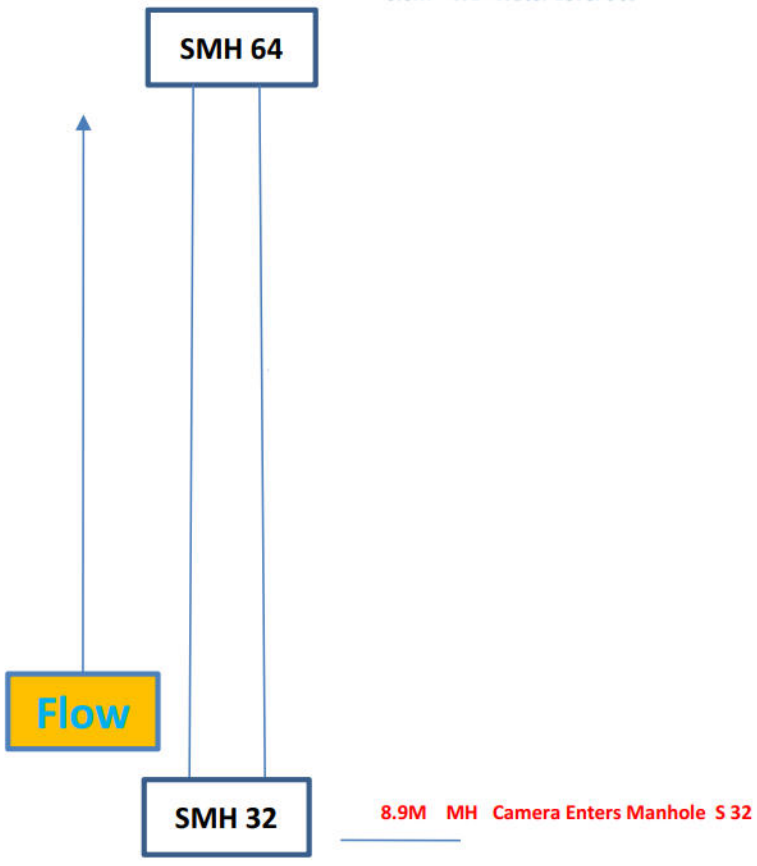
8.9M	MH	Camera Enters Manhole S 32

REM ; THERE ARE NO DEFECTS IN THIS SECTION OF PIPE

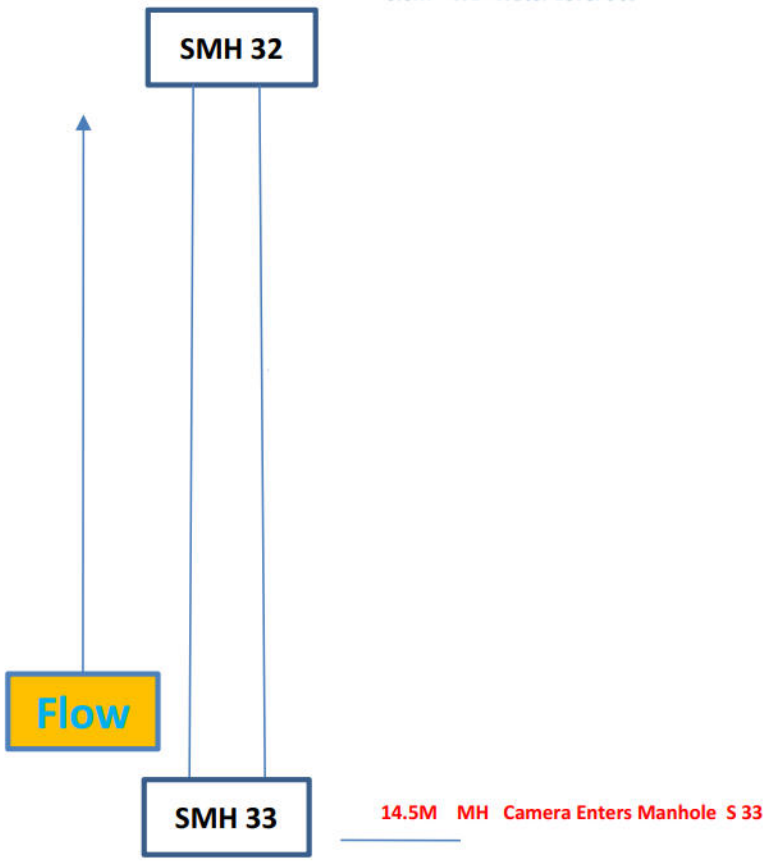
REM ; THERE ARE NO DEFECTS IN THIS SECTION OF PIPE

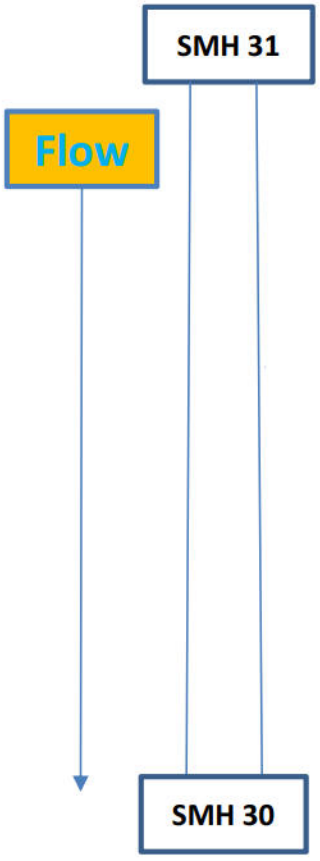
Position	Code	Observation
0.0M	ST	Start Of Survey
0.0M	WL	Water Level 0 %
5.9M	JN	Line Drops In From The Left
7.1M	JN	Line Drops In From The Right
12.2M	JN	Line Drops In From The Right From S 30.6
13.0M	JN	Line Drops In From The Left From S 30.7
27.8M	JN	Line Drops In From The Right From S 30.5
28.6M	JN	Line Drops In From The Left From S 30.4
31.4M	JN	Line Drops In From The Right
32.2M	JN	Line Drops In From The Left
50.8M	MH	Camera Enters Manhole S 30

REM ; THERE ARE NO DEFECTS IN THIS SECTION OF PIPE
MANHOLES S 30.4 -S 30.5 - S 30.7 - S 30.6 HAVE NOT BEEN INSTALLED YET

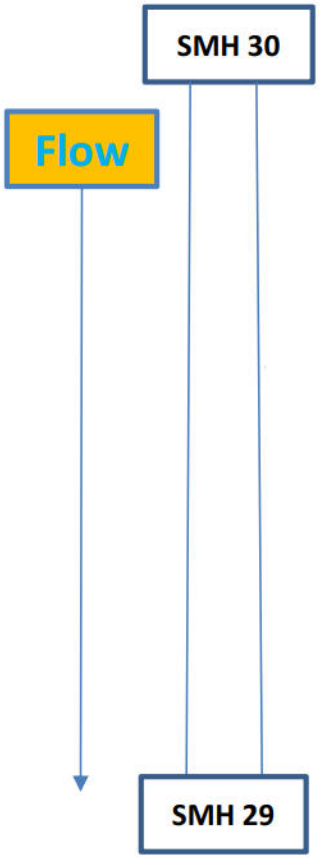
11.5M	MH	Camera Enters Manhole S 29

REM ; THERE ARE NO DEFECTS IN THIS SECTION OF PIPE

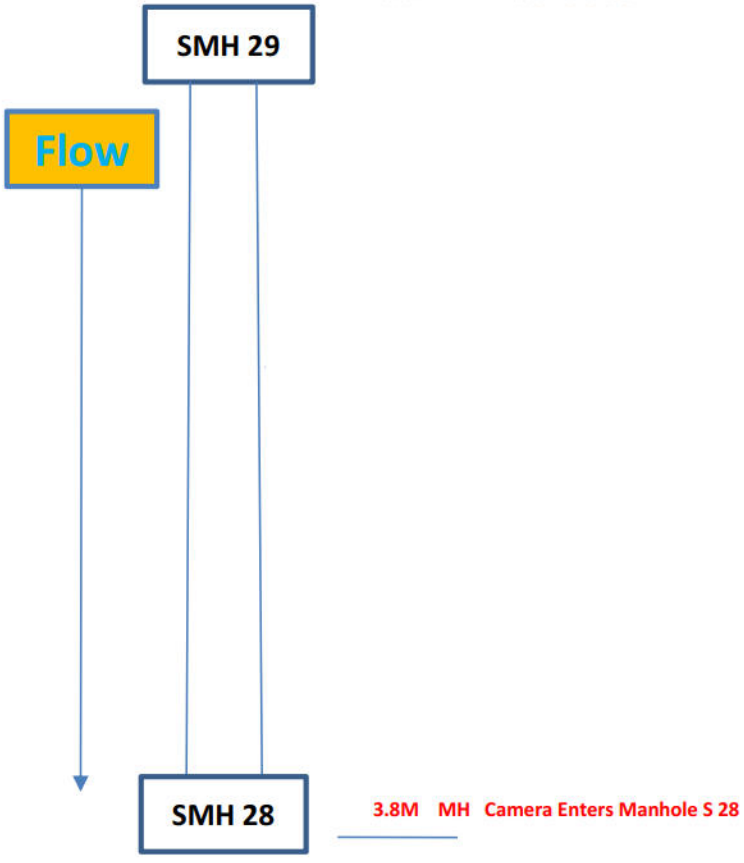
3.8M	MH	Camera Enters Manhole S 28

REM ; THERE ARE NO DEFECTS IN THIS SECTION OF PIPE

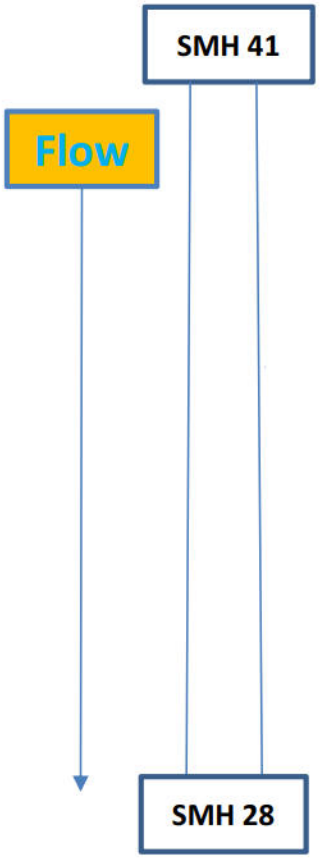
Position	Code	Observation
0.0M	ST	Start Of Survey
0.0M	WL	Water Level 0 %
18.7M	JN	Line Drops In From The Left
19.3M	JN	Line Drops In From The Right From S 28.4
31.4M	JN	Line Drops In From The Left
36.2M	MH	Camera Enters Manhole S 28

REM ; THERE ARE NO DEFECTS IN THIS SECTION OF PIPE
MANHOLE S 28.4 HAS NOT BEEN INSTALLED

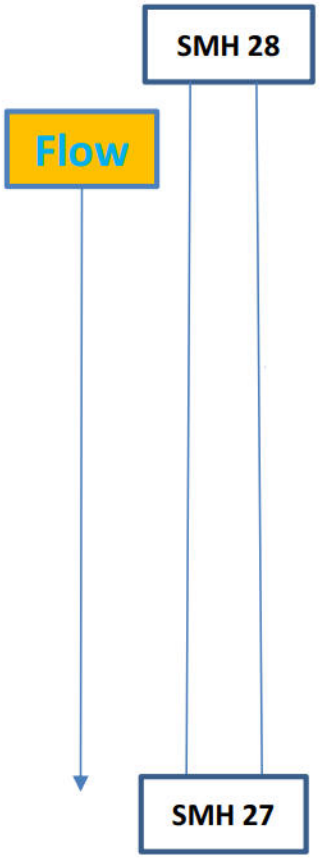
Position	Code	Observation
0.0M	ST	Start Of Survey
0.0M	WL	Water Level 0 %
12.5M	JN	Line Drops In From The Right
13.4M	JN	Line Drops In From The Left
28.0M	MH	Camera Enters Manhole S 27

REM ; THERE ARE NO DEFECTS IN THIS SECTION OF PIPE

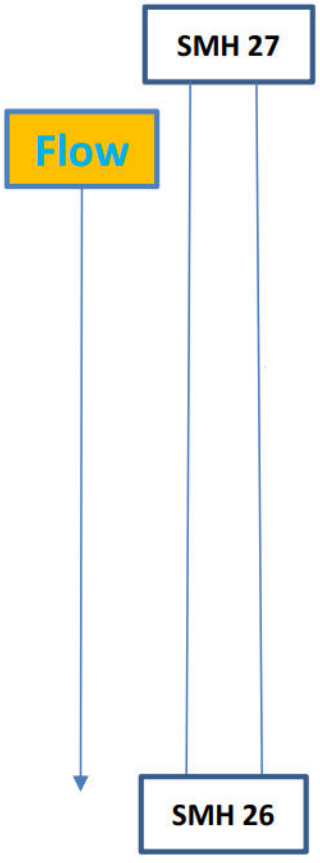
Position	Code	Observation
10.4M	JN	Line Drops In From The Right
13.5M	MH	Camera Enters Manhole S 26

REM ; THERE ARE NO DEFECTS IN THIS SECTION OF PIPE

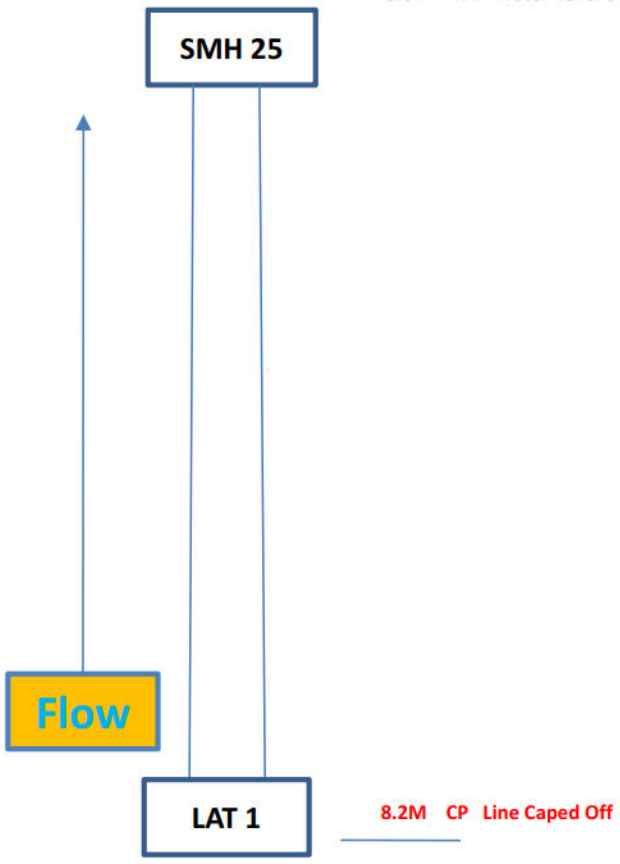
8.2M	CP	Line Caped Off

REM ; THERE ARE NO DEFECTS IN THIS SECTION OF PIPE, BUT MANHOLE S26.1 HAS NOT BEEN INSTALLED YET

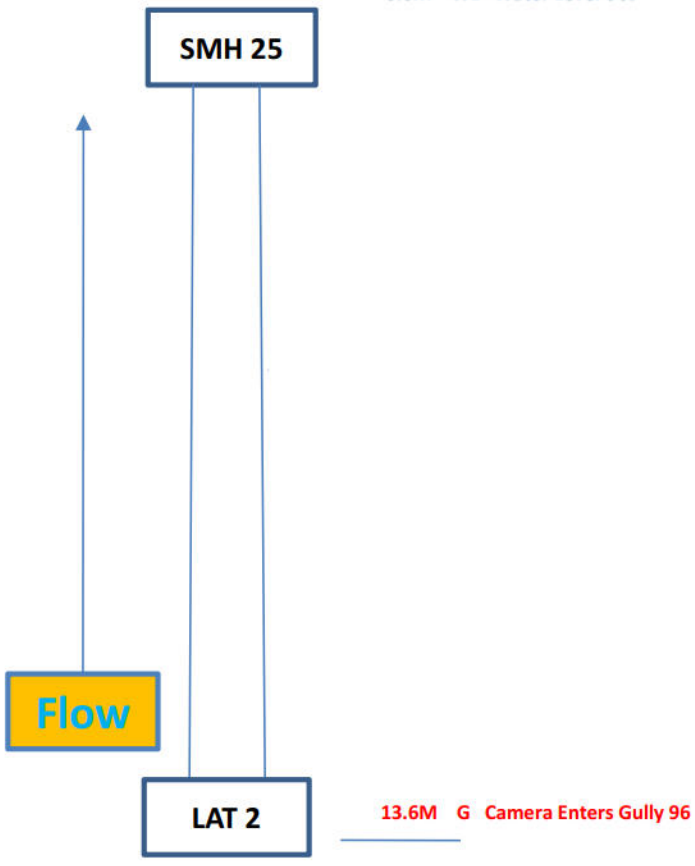
13.6M	G	Camera Enters Gully 96

REM ; THERE ARE NO DEFECTS IN THIS SECTION OF PIPE

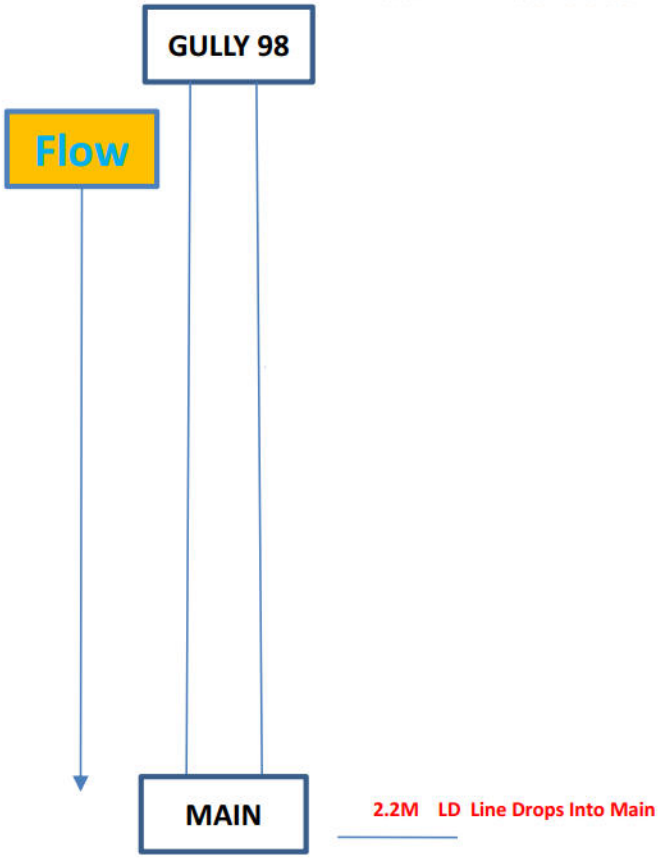
REM ; THERE ARE NO DEFECTS IN THIS SECTION OF PIPE

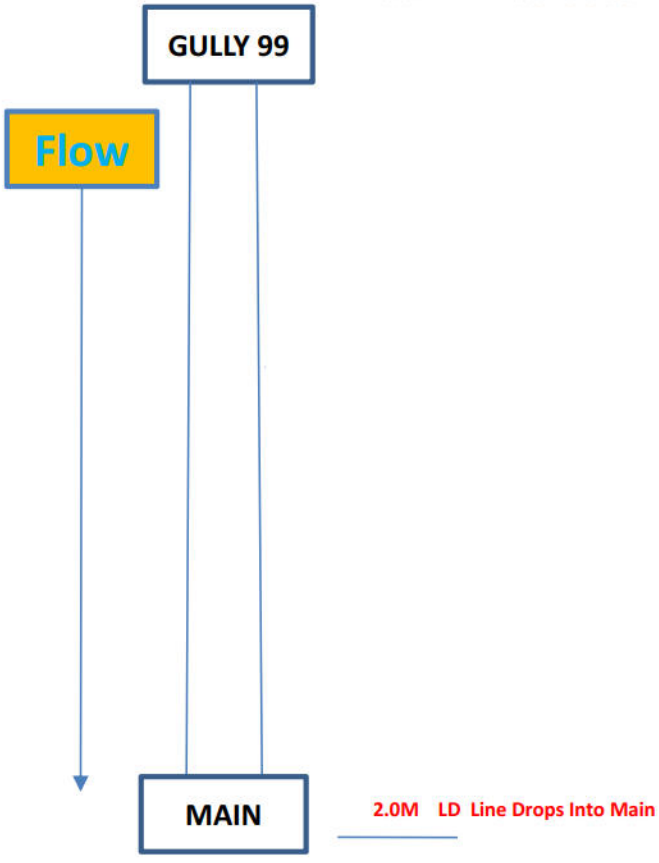
REM ; THERE ARE NO DEFECTS IN THIS SECTION OF PIPE

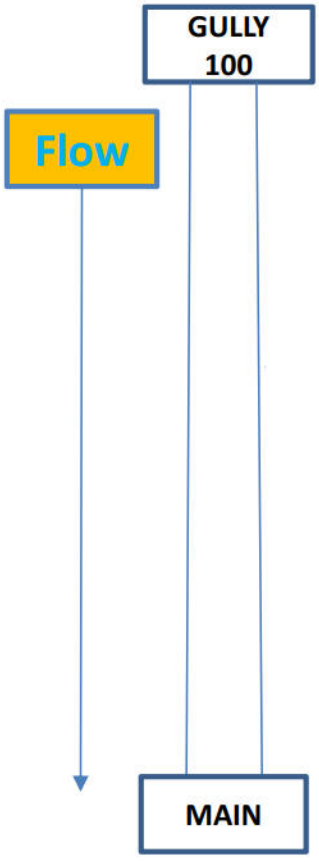
3.8M	LD	Line Drops Into Main

REM ; THERE ARE NO DEFECTS IN THIS SECTION OF PIPE

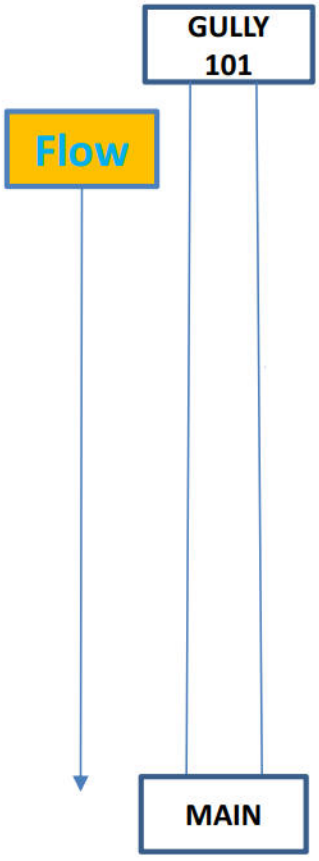
2.0M LD Line Drops Into Main

REM ; THERE ARE NO DEFECTS IN THIS SECTION OF PIPE

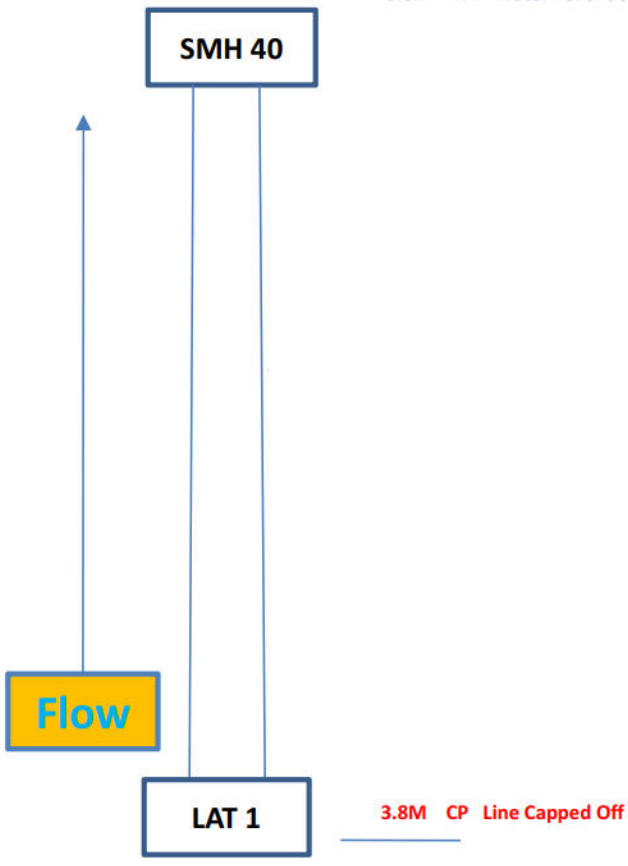
3.8M CP Line Capped Off

REM ; THERE ARE NO DEFECTS IN THIS SECTION OF PIPE, MANHOLE S40.1 HAS NOT BEEN INSTALLED YET

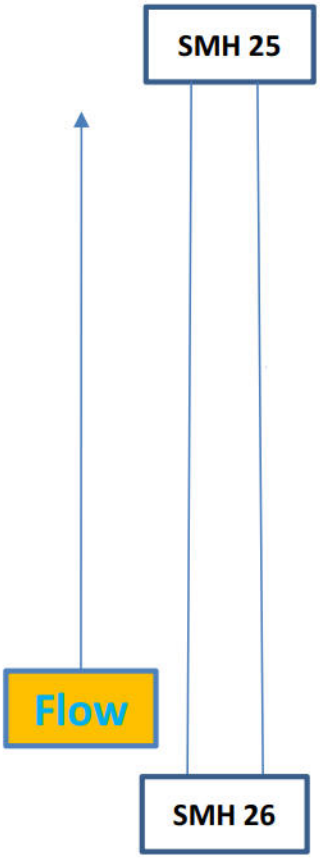
Position	Code	Observation
0.0M	ST	Start Of Survey
0.0M	WL	Water Level 0 %
4.4M	JN	Line Drops In From The Right From G 95
7.0M	JN	Line Drops In From The Left From G 94
11.2M	MH	Camera Enters Manhole S 26

REM ; THERE ARE NO DEFECTS IN THIS SECTION OF PIPE

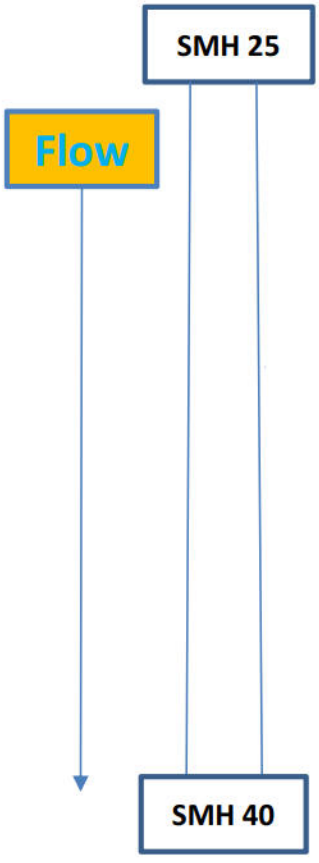
Position	Code	Observation
0.0M	ST	Start Of Survey
0.0M	WL	Water Level 0 %
3.1M	JN	Line Drops In From The Right From G 98
4.1M	JN	Line Drops In From The Right From Gully 99
10.9M	JN	Line Drops In From Above From G100
12.0M	JN	Line Drops In From The Right From G 101
14.9M	MH	Camera Enters Manhole S 40

REM ; THERE ARE NO DEFECTS IN THIS SECTION OF PIPE

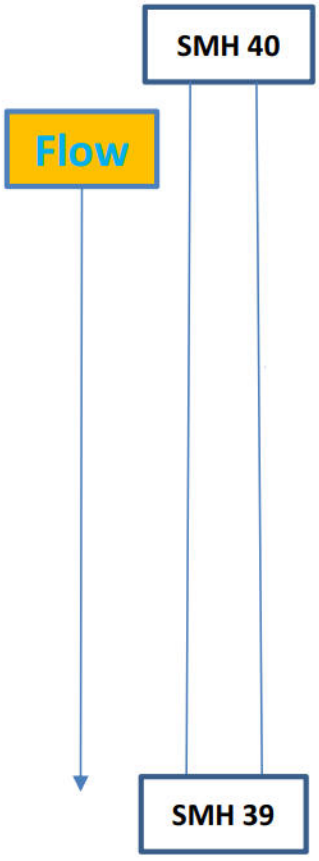
16.3M	JN	Line Drops In From The Right From G 102- G 103
17.4M	JN	Line Drops In From The Right
25.6M	MH	Camera Enters Manhole S 39

REM ; THERE ARE NO DEFECTS IN THIS SECTION OF PIPE, MANHOLE S39.1 HAS NOT BEEN INSTALLED YET
UNABLE TO CLEAN FROM MANHOLE S 39 TO S 5 AS UNABLE TO ACCESS MANHOLE S 39 AS COVERED OVER WITH SCAFFOLDING

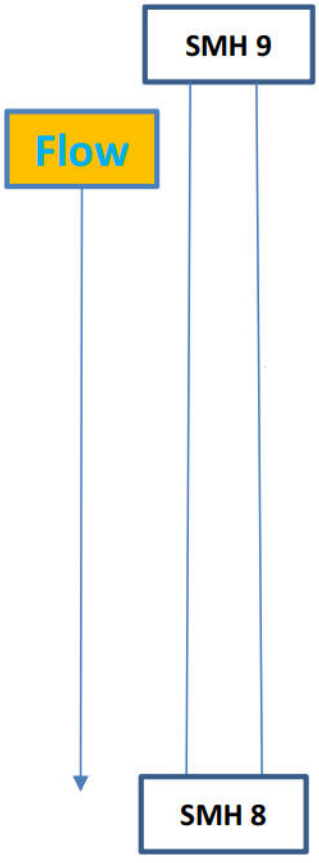
15.9M	D	Debris In Line, Unable To Pass

REM ; UNABLE TO GET LORRY NEAR MANHOLE S 8 TO CLEAN LINE

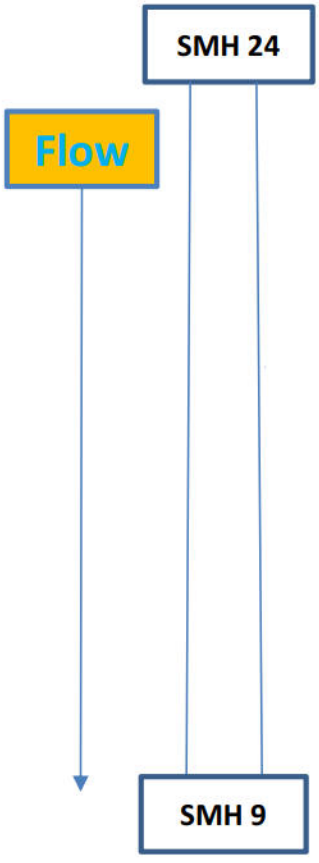
18.9M	JN	Line Drops In From Above
21.1M	MH	Camera Enters Manhole S 9

REM ; THERE ARE NO DEFECTS WITH THIS SECTION OF PIPE

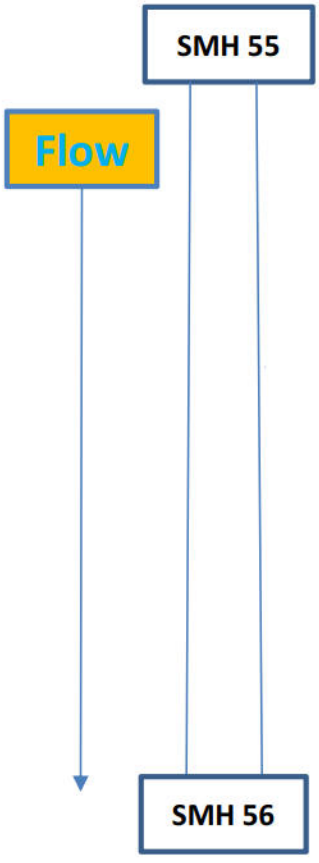
33.6M	JN	Line Drops In From The Right
35.6M	JN	Line Drops In From The Left
42.8M	MH	Camera Enters Manhole S 56

REM ; THERE ARE NO DEFECTS WITH THIS SECTION OF PIPE

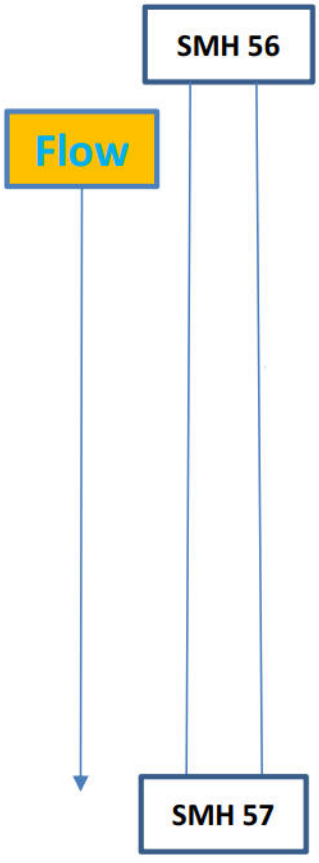
12.6M	MH	Camera Enters Manhole S 57

REM ; THERE ARE NO DEFECTS WITH THIS SECTION OF PIPE

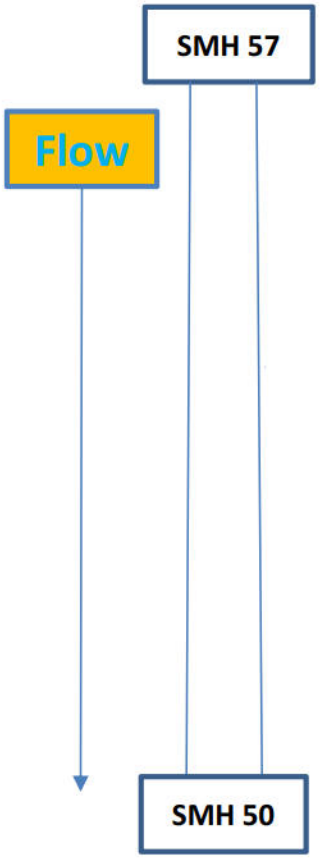
Position	Code	Observation
0.0M	ST	Start Of Survey
0.0M	WL	Water Level 0 %
7.0M	JN	Line Drops In From The Right
7.9M	JN	Line Drops In From The Left
11.4M	JN	Line Drops In From The Right
12.1M	JN	Line Drops In From The Right
15.1M	JN	Line Drops In From The Left
16.6M	MH	Camera Enters Manhole S 50

REM ; THERE ARE NO DEFECTS WITH THIS SECTION OF PIPE

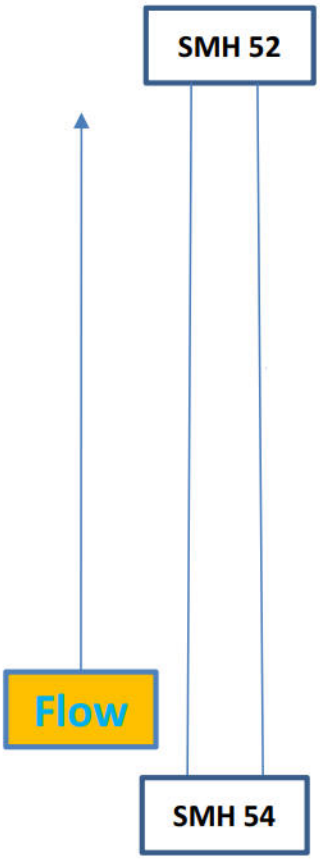
Position	Code	Observation
0.0M	ST	Start Of Survey
0.0M	WL	Water Level 0 %
3.0M	JN	Line Drops In From The Right
7.3M	MH	Camera Enters Manhole S 54

REM ; THERE ARE NO DEFECTS IN THIS SECTION OF PIPE

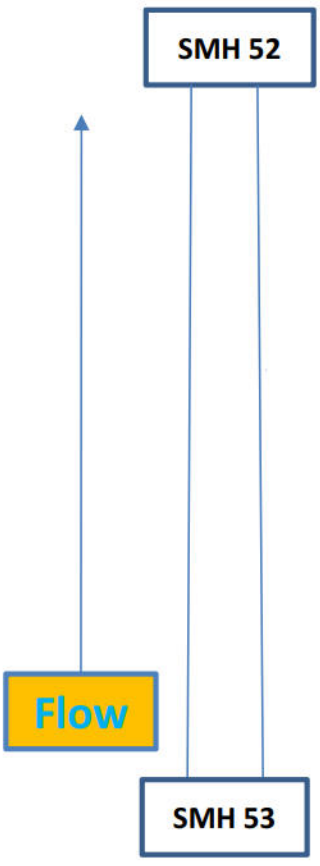
Position	Code	Observation
0.0M	ST	Start Of Survey
0.0M	WL	Water Level 0 %
5.6M	JN	Line Drops In From The Right
14.6M	MH	Camera Enters Manhole S 53

REM ; THERE ARE NO DEFECTS IN THIS SECTION OF PIPE

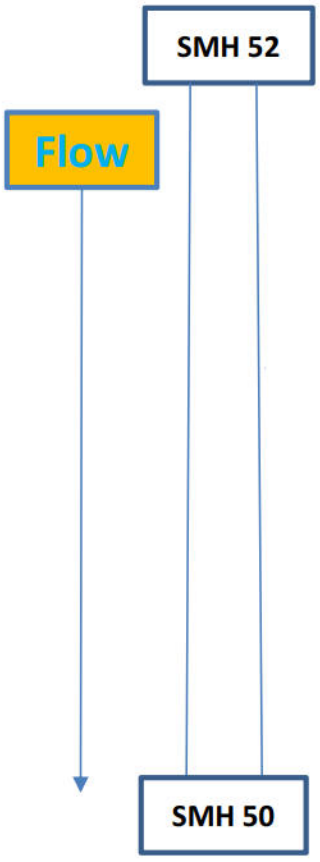
Position	Code	Observation
0.0M	ST	Start Of Survey
0.0M	WL	Water Level 0 %
16.2M	JN	Line Drops In From The Left
16.7M	JN	Line Drops In From The Right
20.3M	JN	Line Drops InFrom The Right
21.1M	JN	Line Drops In From The Right
29.9M	JN	Line Drops In From The Right
44.9M	JN	Line Drops In From The Left
45.5M	JN	Line Drops In From The Right
51.2M	JN	Line Drops In From The Left
60.1M	JN	Line Drops In From The Left
64.7M	MH	Camera Enters Manhole S 50

REM ; THERE ARE NO DEFECTS WITH THIS SECTION OF PIPE. MAHOLES S49 & S 48 ARE CONCRETED OVER AND FULL OF DEBRIS SO UNABLE TO CLEAN OR CAMERA THESE LINES AROUND THESE MANHOLES INCLUDING THE GULLIES UNTILL THE MANHOLES HAVE BEEN EXPOSED
