Land at Stakers Farm, Yapton

Ground Investigation – Interpretative Report
A112666

Dandara Ltd
28 May 2019
Prepared on behalf of WYG Group Limited.

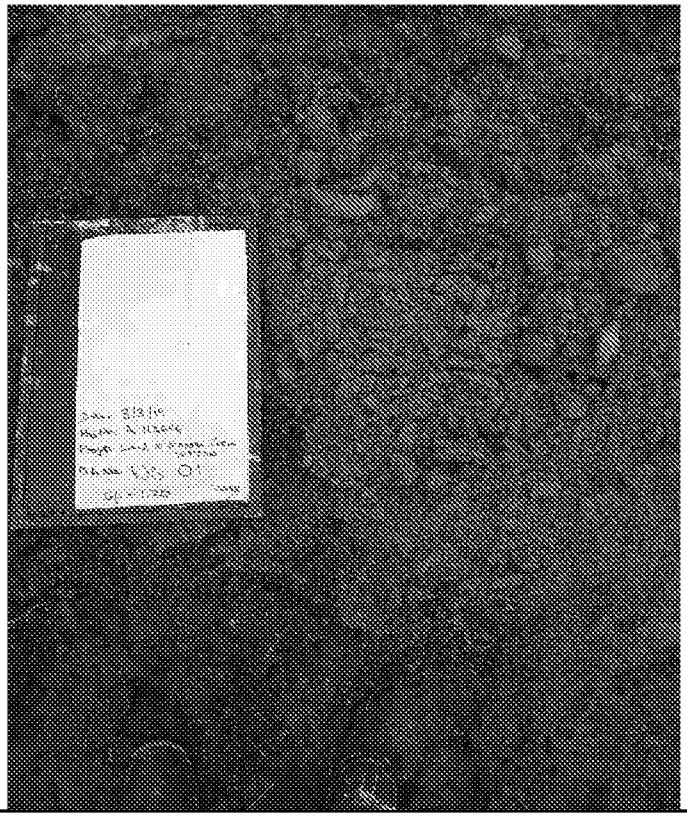
Plate 1 WS01 hand pit arisings

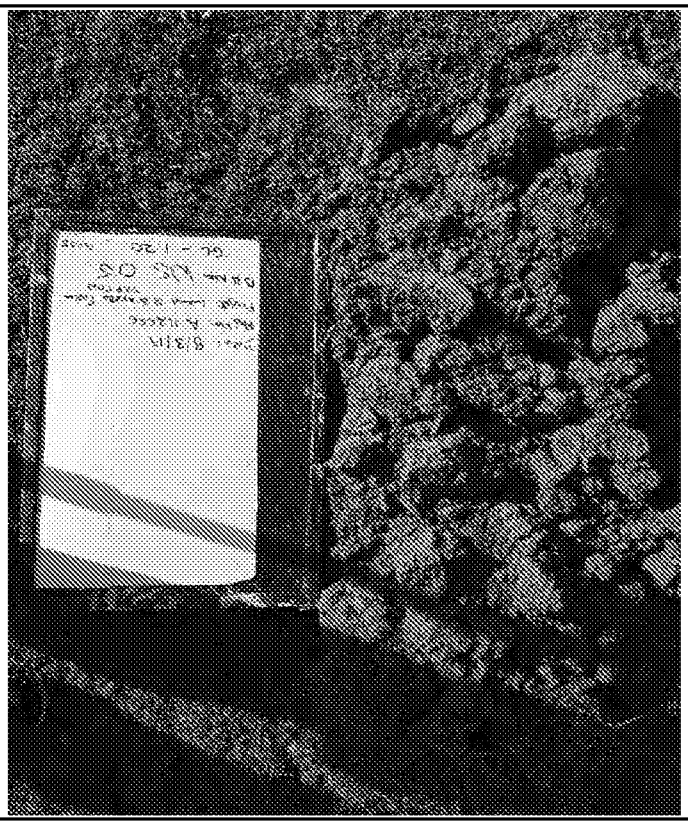
Plate 6 WS05 hand pit arisings

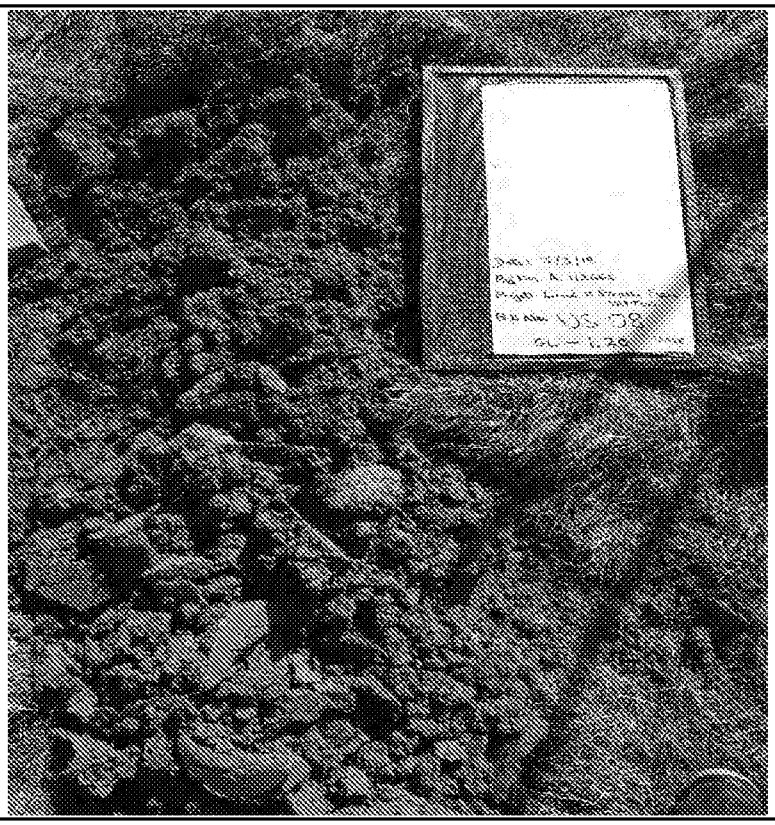
Plate 15 WS08 hand pit arisings

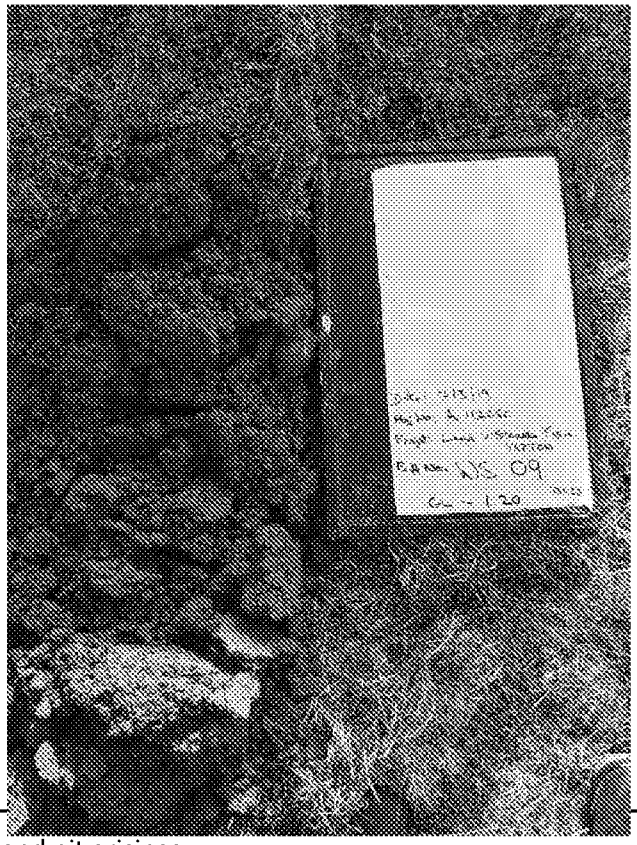
Plate 18 WS09 hand pit arisings

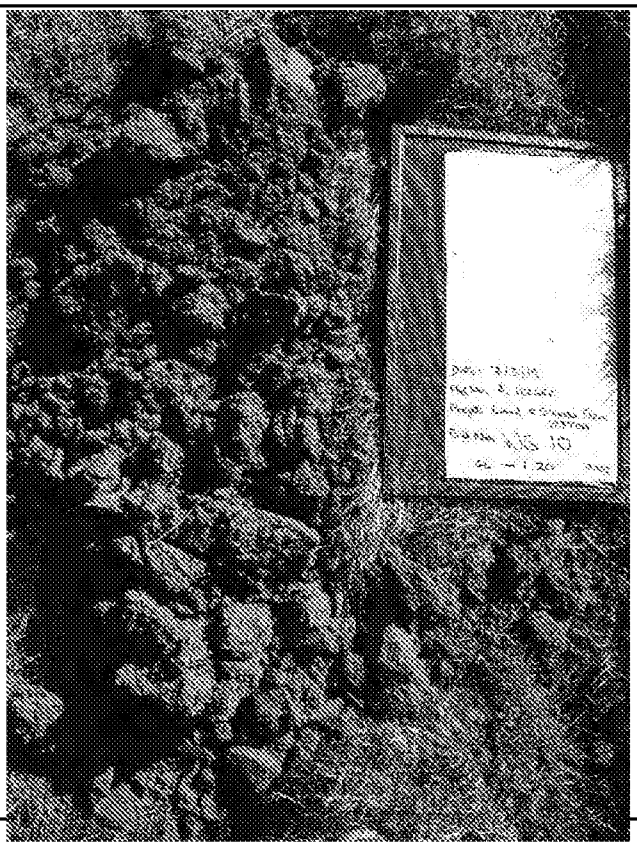
Plate 21 WS10 hand pit arisings

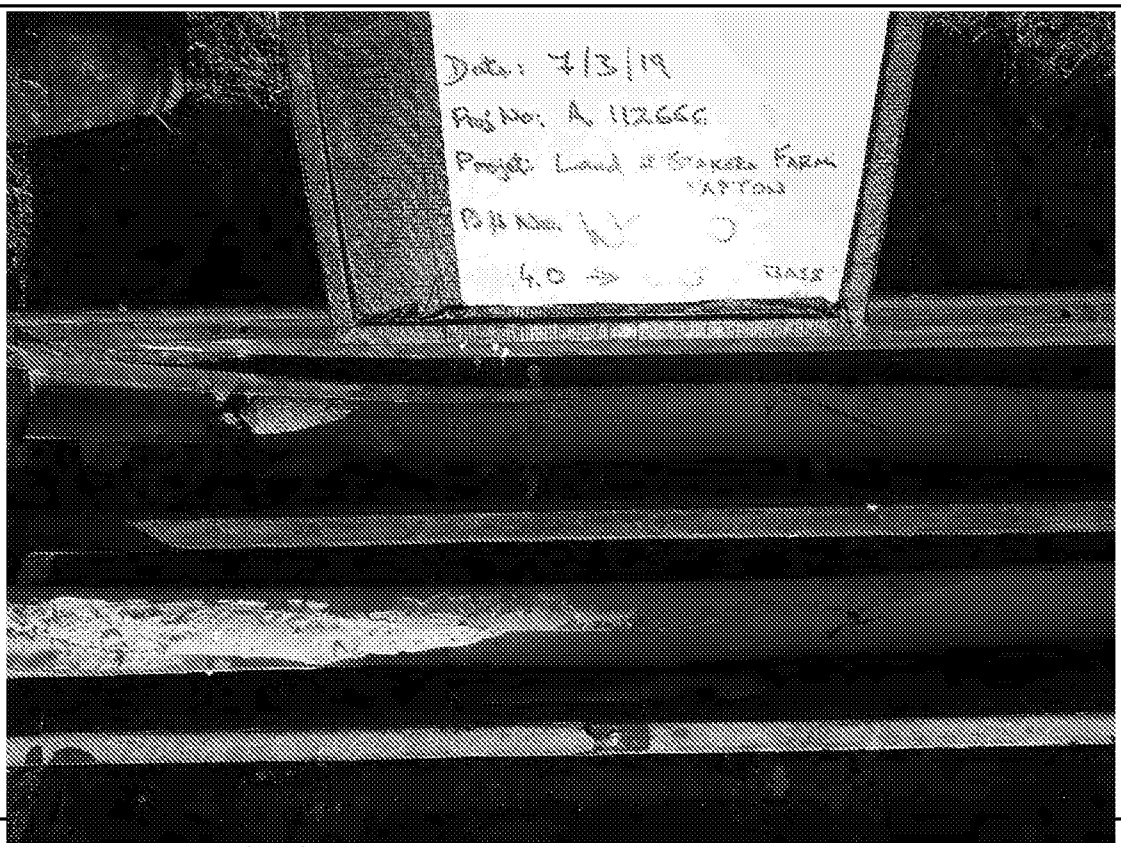
Plate 23 WS10 hand pit arisings

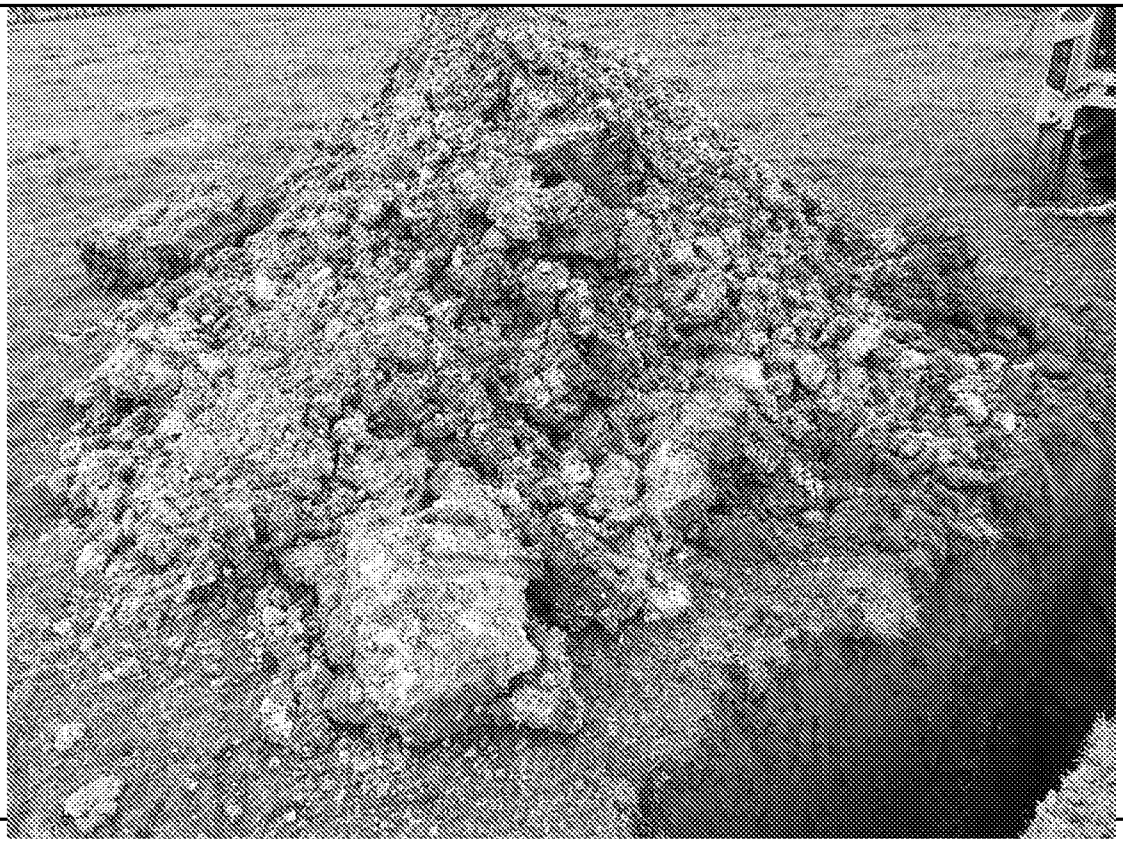
Plate 29 TP04 arisings
