# Description of Works

**44 Tarrant Street**

**Arundel**

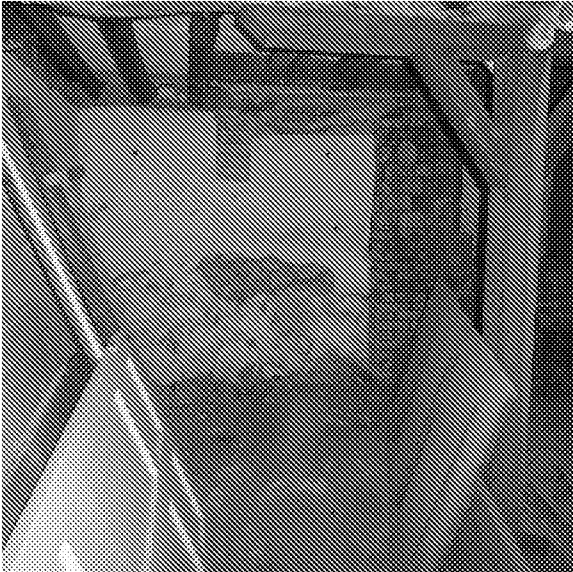
| Kitchen | | |

Exposed oak ceiling joists. Mostly good condition 3 no. beyond useable condition.

Replacement of 3 no. 5x4" oak ceiling joists, to existing joint detail. Plasterboard on battens between oak joists, to be left exposed.

Repair to spine beam in accordance with SE info.

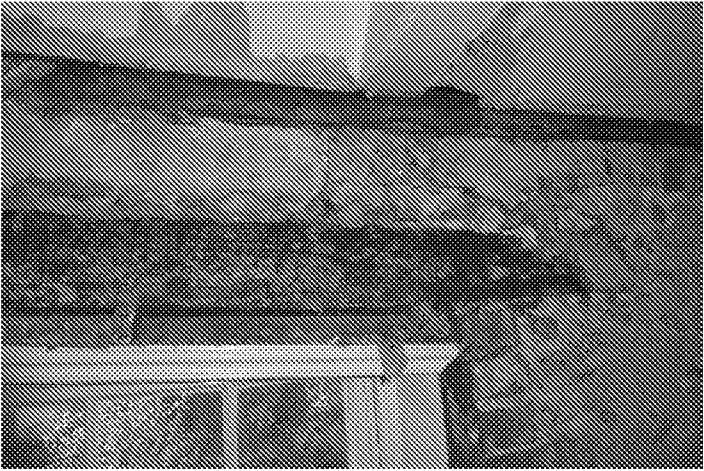
## Bedroom 4

| <p>Ceiling</p> | <p>Mostly over boarded with plasterboard.</p> <p>Skeiling lath and plaster</p> | <p>Remove areas of skeiling to enable like-with-like 5"x5" oak wall plate.</p> |
