Arundel Cathedral House  
*Arundel, West Sussex*

Garden wall repairs and alteration

Design & access  
statement

## Arundel Cathedral House, West Sussex: Proposed repairs and alteration to garden wall

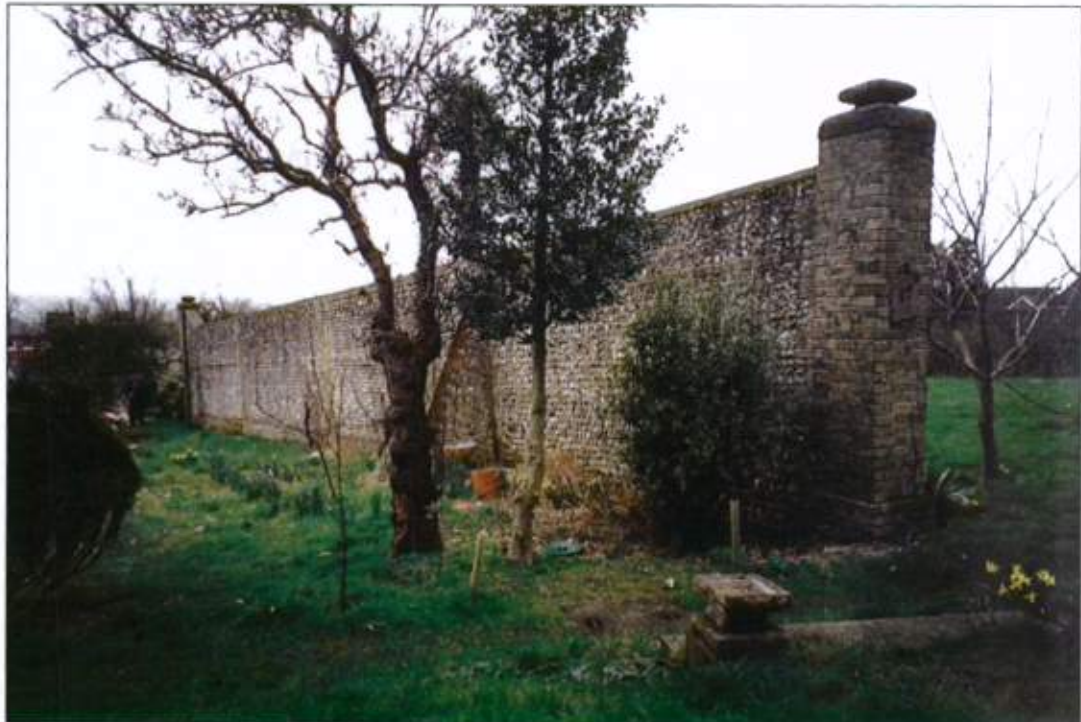
- 1.01 The garden wall which divides the Cathedral House garden into two appears to predate the construction of the Cathedral Complex and is considered to be a 'curtilage' structure within the boundary of the grade II listed Cathedral Clergy House. Its location is shown on drawing 766/20/01.
