| <b>Project Name:</b> | Land at Bayards, Eastergate (Miller Homes) |
| <b>Document Reference:</b> | 091.5016/SVR/2.2 |
| <b>Document Name:</b> | SuDS Verification Report – Area 2 |

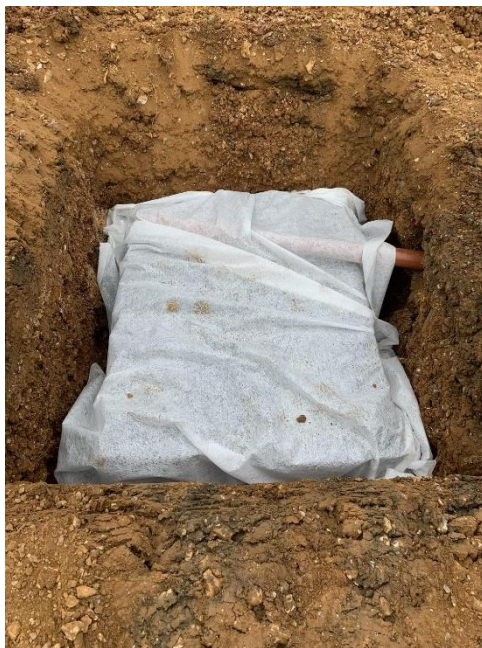
Plot 50

- 4.8 The images also suggest that vents have not been installed in line with the construction detail on sheet 091.5061.551 C01 and in accordance with manufactures specifications which can be found in **Appendix D**.
- 4.9 No images have been provided for any of the permeable paving within this area, therefore, we are unable to verify this element on the absence of this evidence.
