| <b>Project Name:</b> | Land at Bayards, Eastergate (Miller Homes) |
| <b>Document Reference:</b> | 091.5016/SVR/5 |
| <b>Document Name:</b> | SuDS Verification Report – Area 5 |

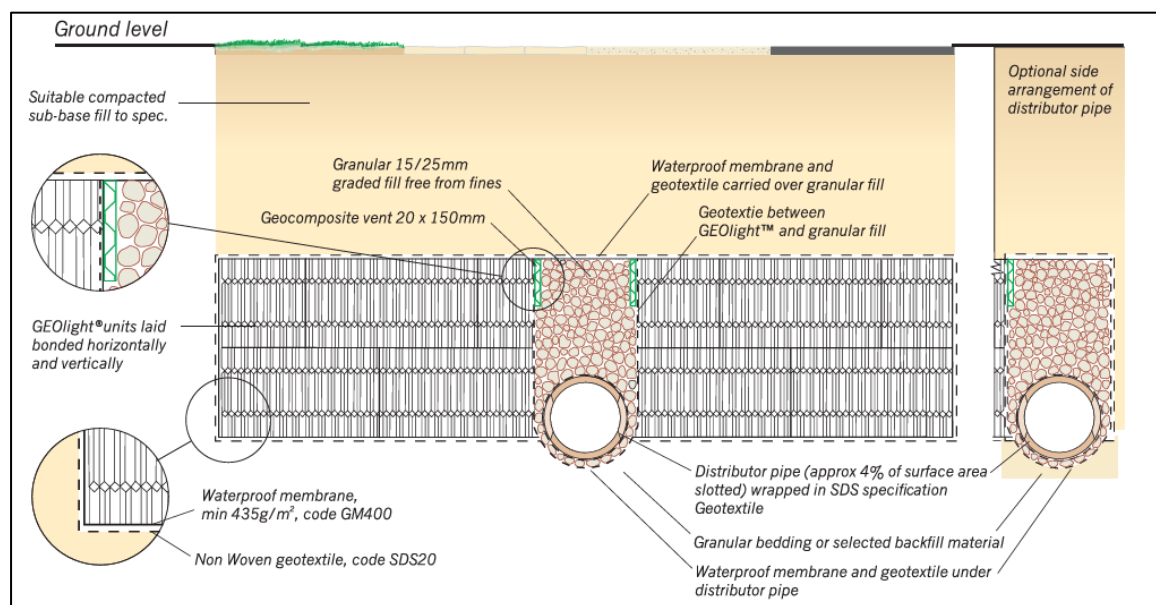
**Figure 3: SDS GEOLight Cross Section**

4.9 The SDS GEOLight system appears to have been substituted and installed in this area. This product typically requires a specific arrangement, including a perforated pipe running centrally through the attenuation crates, as illustrated in **Figure 3** below.

Furthermore, the structural integrity of the pipe has likely been compromised due to the hand-cut slits, which is also evident from the CCTV footage. There also appears to be no restraint preventing the pipe from shifting or rotating. As a result, there is no assurance that the slits will remain correctly oriented (i.e. facing downward towards the crates).

This may lead to ineffective interaction between the pipe and the attenuation system, potentially causing the drainage to perform in an unintended and unpredictable manner.
