Our Ref: 211379 - Let 1 - Aldingbourne

16 June 2021

**Re: Tree issues at land at Springfield Hook Lane, Aldingbourne, PO20 3TE**

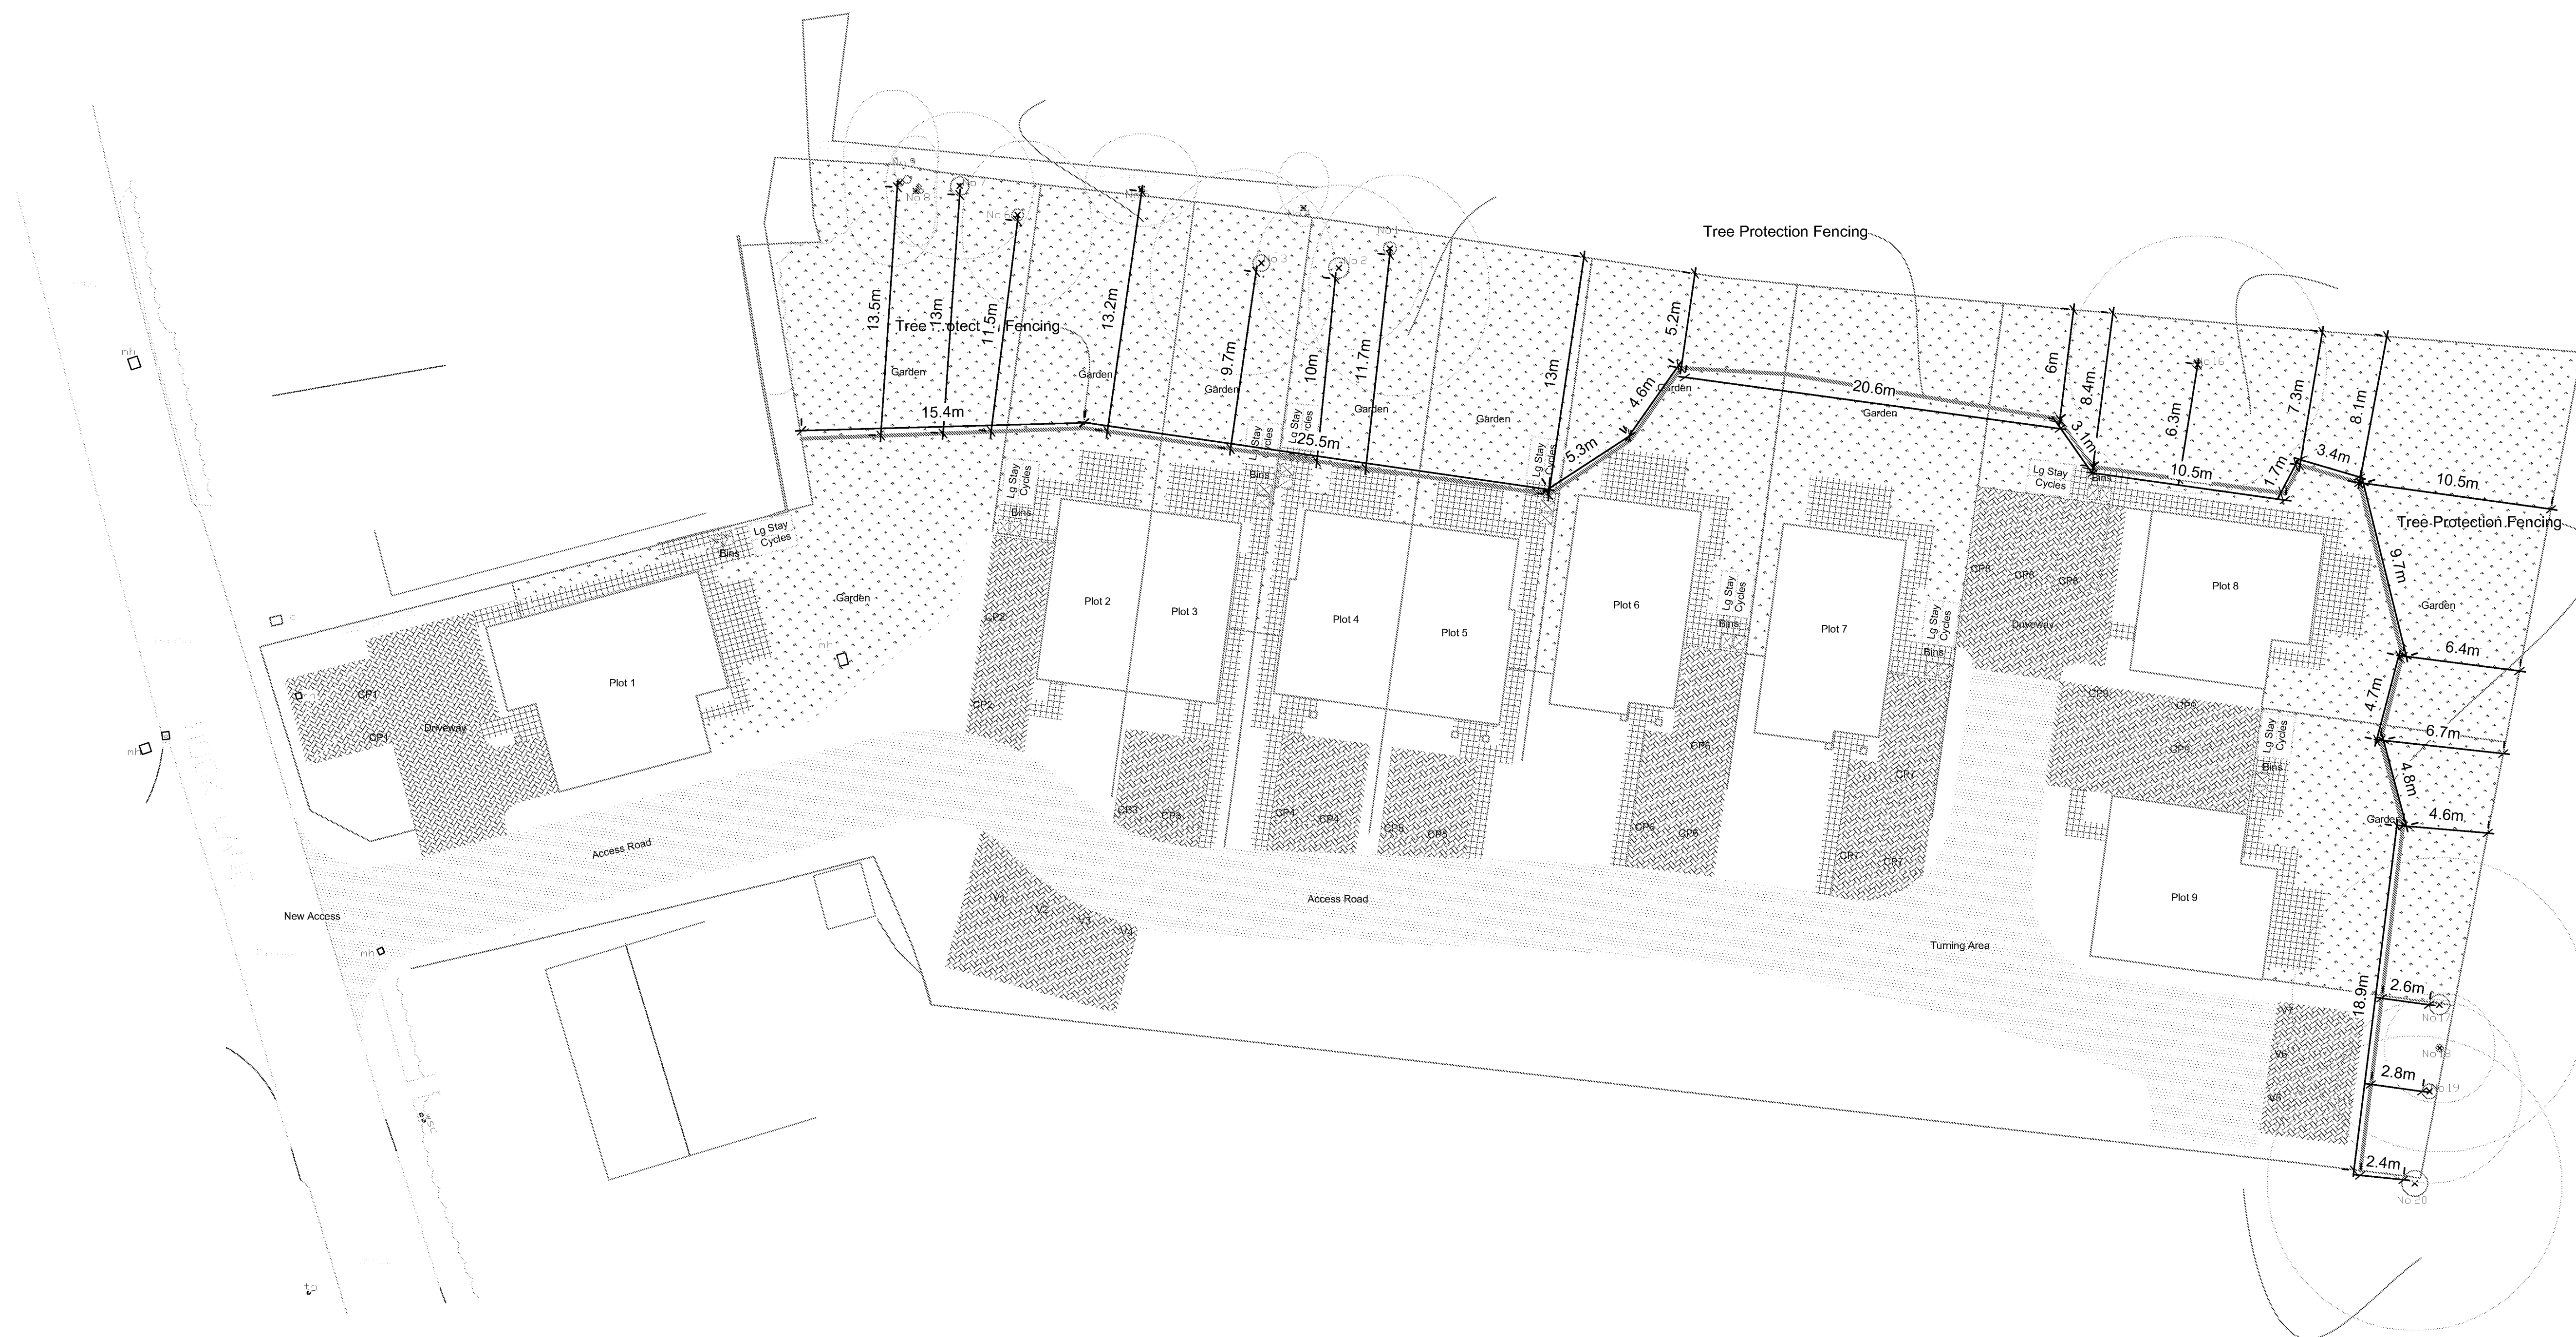
Where there were less significant trees (or areas of scrub), then a lesser specification was being utilised, which incorporated mesh panels on rubber block trays, with rear facing stabiliser struts pinned in position (photograph 3). Tree protection notices were being attached to the panels during my visit (photograph 4). The tree protection barriers on the eastern site boundary (and where trees have been removed previously) appeared to be in roughly the correct positions, but the protection consisted of weld mesh panels placed on their rubber block trays.

**Photograph 4** – Tree protection signage
