# Tree Survey & Arboricultural Impact Assessment

Land at SRC Recycling,  
Eastergate

October 2021 | Project Ref 06369

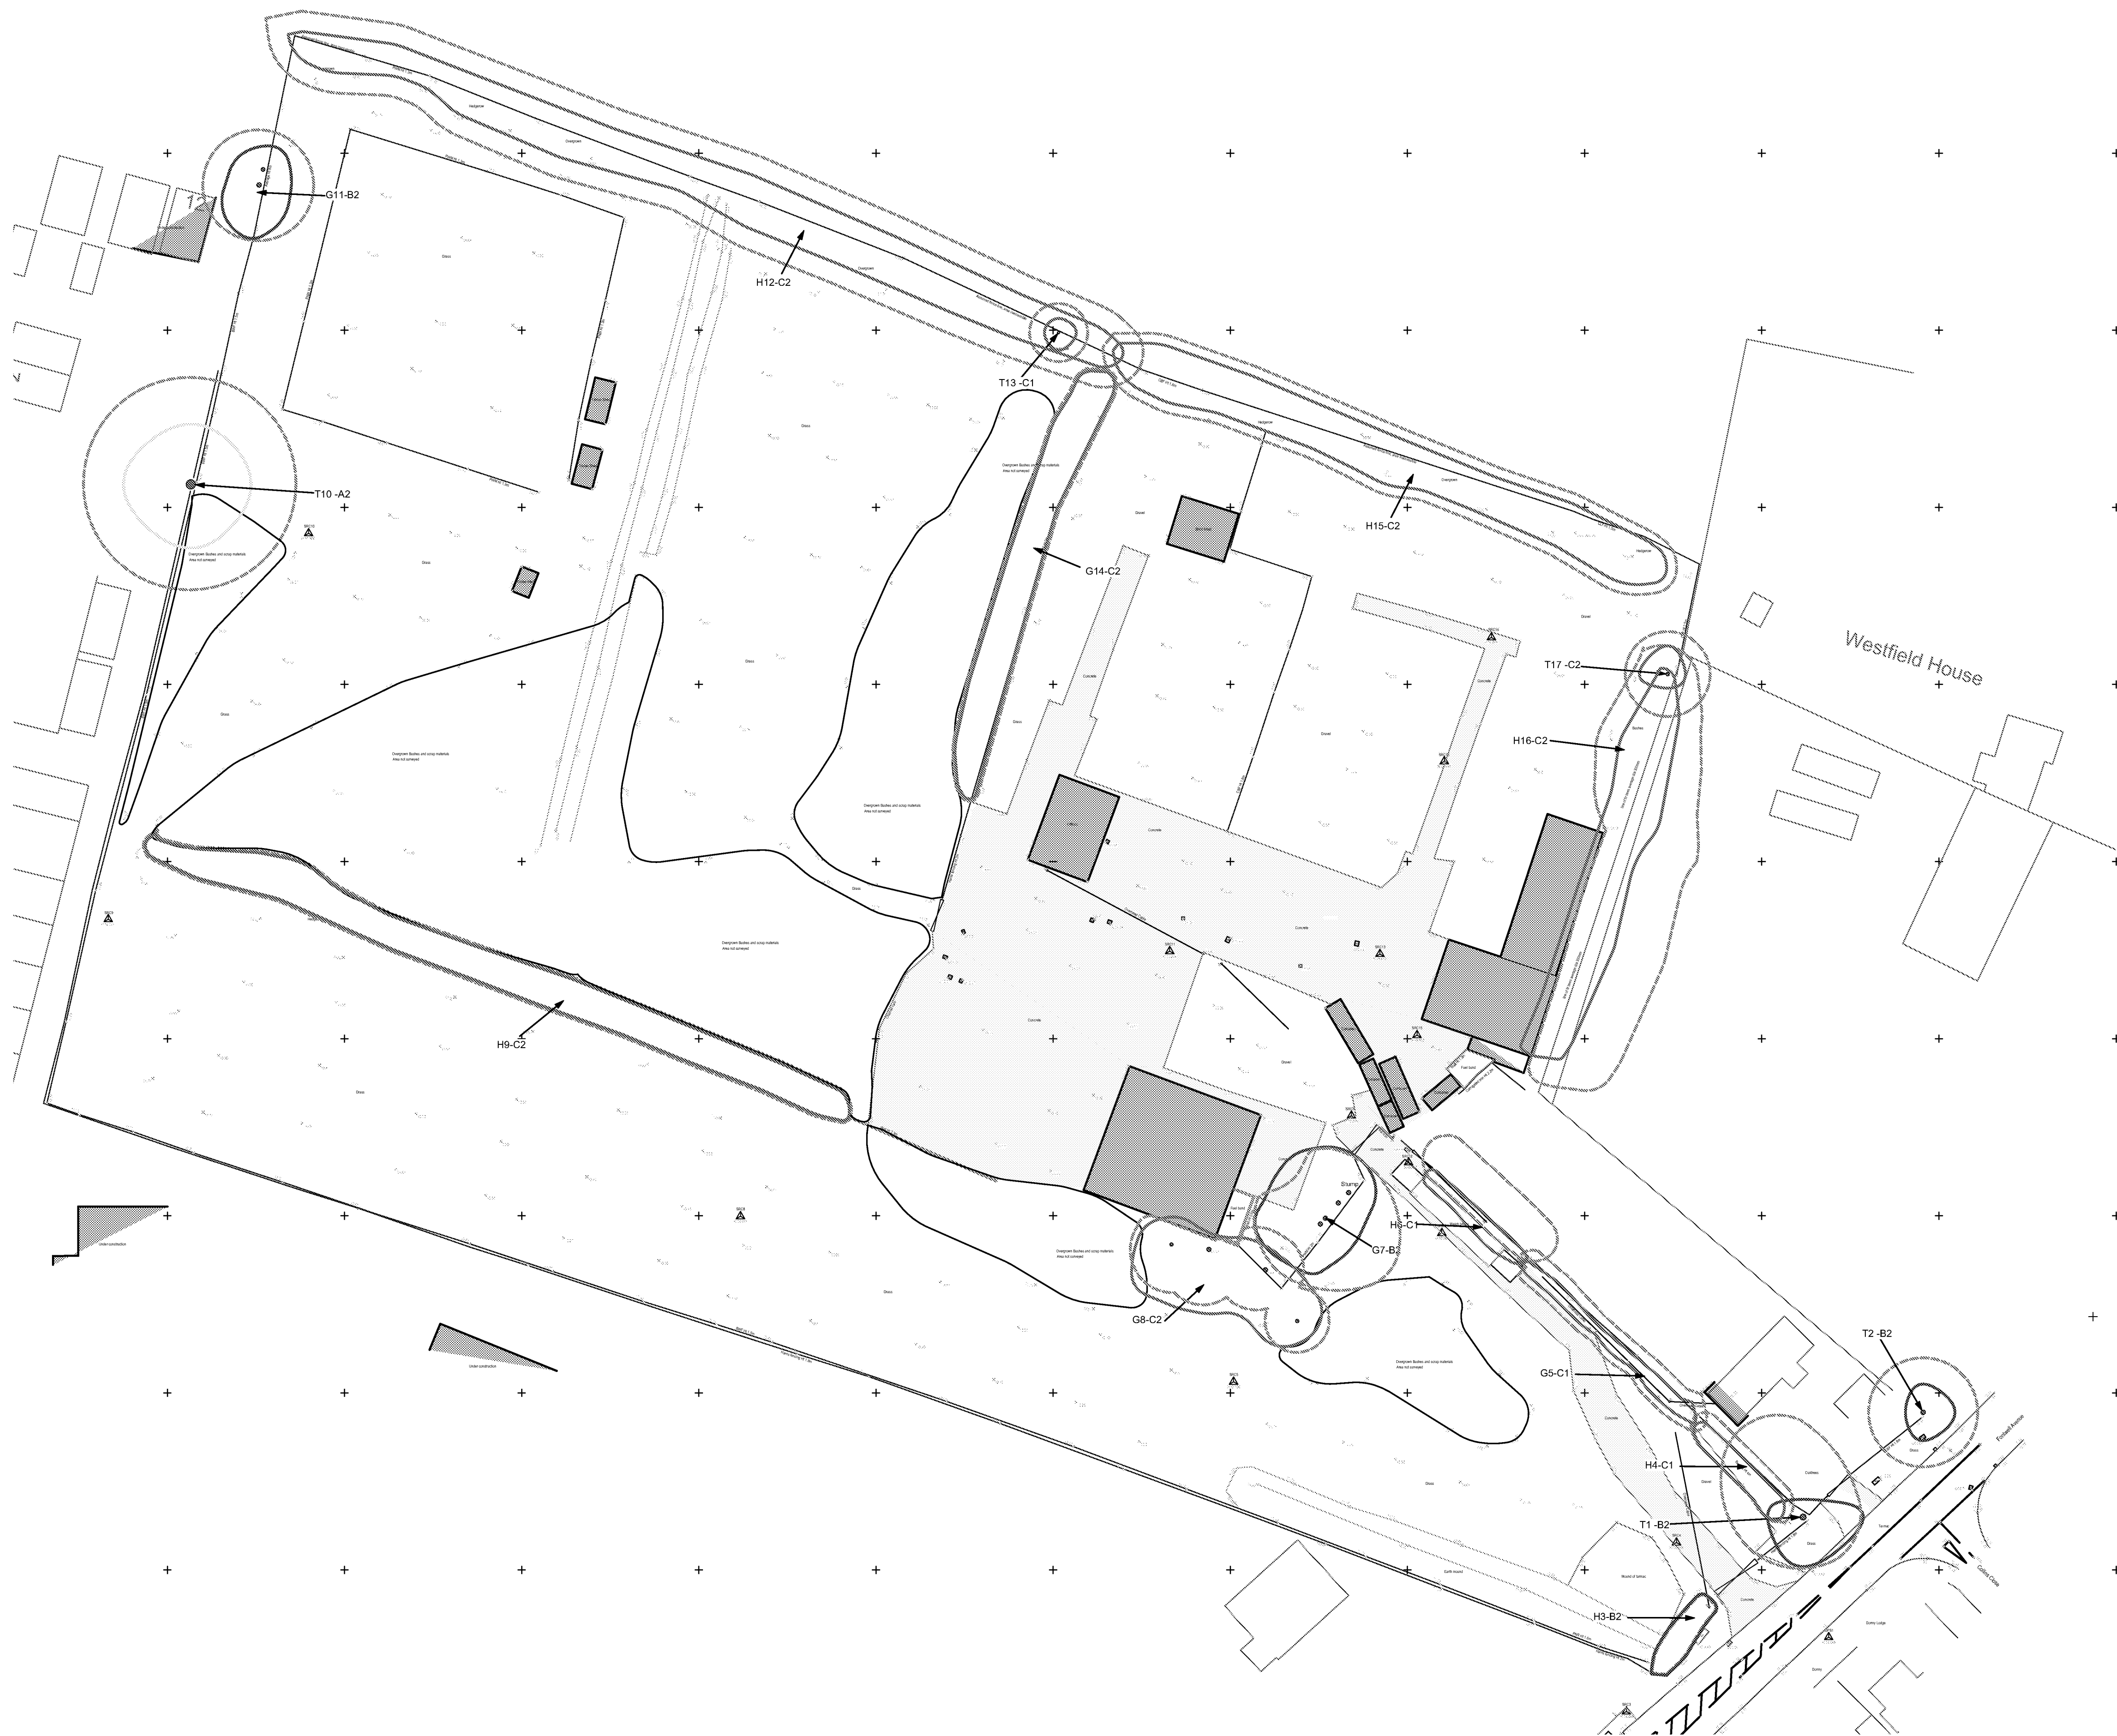
| Job Number:<br><b>06368</b> | Drawing Number:<br><b>01</b> | Revision:<br><b>A</b> | |

| Ref.no. | Species | Ht. (m) | Stem | | RPA radius | RPA area | Category Grading | Crown Spread (m) | | | | | | | | Life stage | ULE | Physiological Condition | Structural Condition and Notes |
|---|---|---|---|---|---|---|---|---|---|---|---|---|---|---|---|---|---|---|---|
| G7 | Cypress | 16.5 | 1 | 850 | 10.2 | 327 | B2 | 3.5 | 3.5 | 3.5 | 3.0 | 0.0 | - | - | 3.0 | M | 20+ | Fair | Small group of cypress. Dbh range from 650 - 950. One monolith stump on northern end. Adjacent to fencing and clutter. Some pruned lower laterals. Good landscape feature. Some damage to stem of large item probably limb breakage. |
| G8 | Cherry, sycamore | 9.5 | 1 | 450 | 5.4 | 92 | C2 | 0.0 | 0.0 | 0.0 | 0.0 | 0.0 | - | - | 0.0 | M | 20+ | Fair | Loose group within scrub and piles of clutter. Close to a large barn. Possibly self sown, with some natural regeneration. Adjacent to fence. Ht from 5m rot 9.5m |
| H9 | Hawthorn, bramble, oak | 4.0 | 1 | 200 | 2.4 | 18 | C2 | 0.0 | 0.0 | 0.0 | 0.0 | 0.0 | - | - | 0.0 | M | 20+ | Poor | Under managed, gappy, deteriorating native hedge. Scrub in places. A lot of dead wood. But still a fairly intact native hedge. Has scrap and soil piled against the northern side in places. Needs management. |
| T10 | Oak | 21.0 | 1 | 1300 | 15.6 | 765 | A2 | 8.5 | 8.5 | 9.0 | 9.5 | 1.5 | # | South | 2.5 | M | 40+ | Good | Lovely spreading crown shape. Adjacent to boundary fence. Forked at 2m. Broken lower lateral on east side. Dbh is estimated because of access problem. |
| T13 | Cypress | 8.5 | 1 | 340 | 4.1 | 52 | C1 | 2.0 | 2.5 | 2.5 | 2.0 | 1.0 | - | South | 1.5 | M | 20+ | Poor | Lean to east. Damage to lower branching on south side. Little amenity value |
