# Gale Tree Consultancy

Tree Condition Report

35 Colts Bay, Aldwick

Ref: TCR/322/22

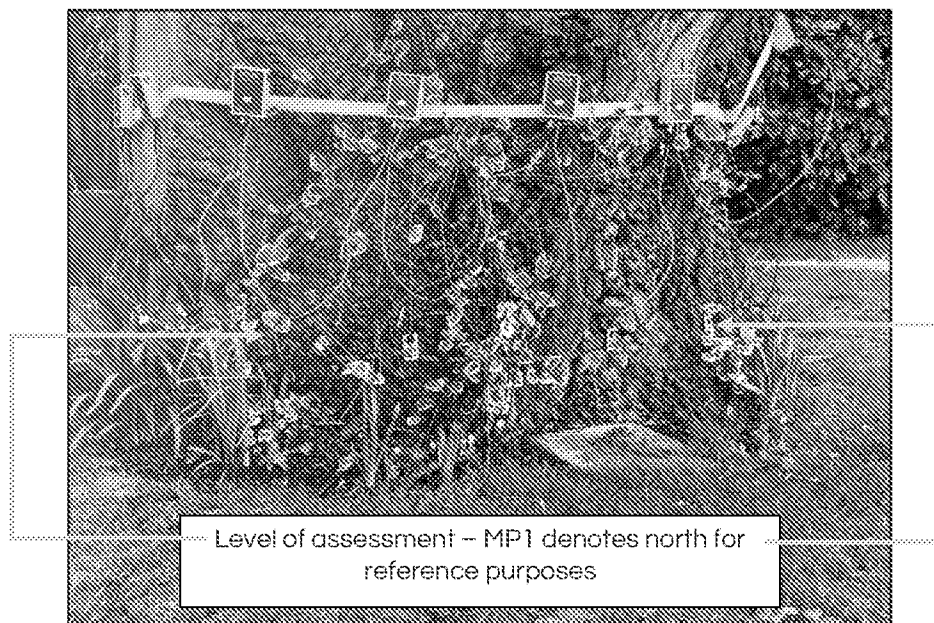
- The Picus 2 sonic tomography unit was used c.20cm above ground level with 15 measuring points (MP). MP 1 was placed at north for reference purposes – please see below:
