## Tree report

- Land adjacent to 7 Countisbury Road Aldwick Bognor Regis West Sussex -

Planning Application: AW/141/16/PL

David Meagher – Landscape Architect

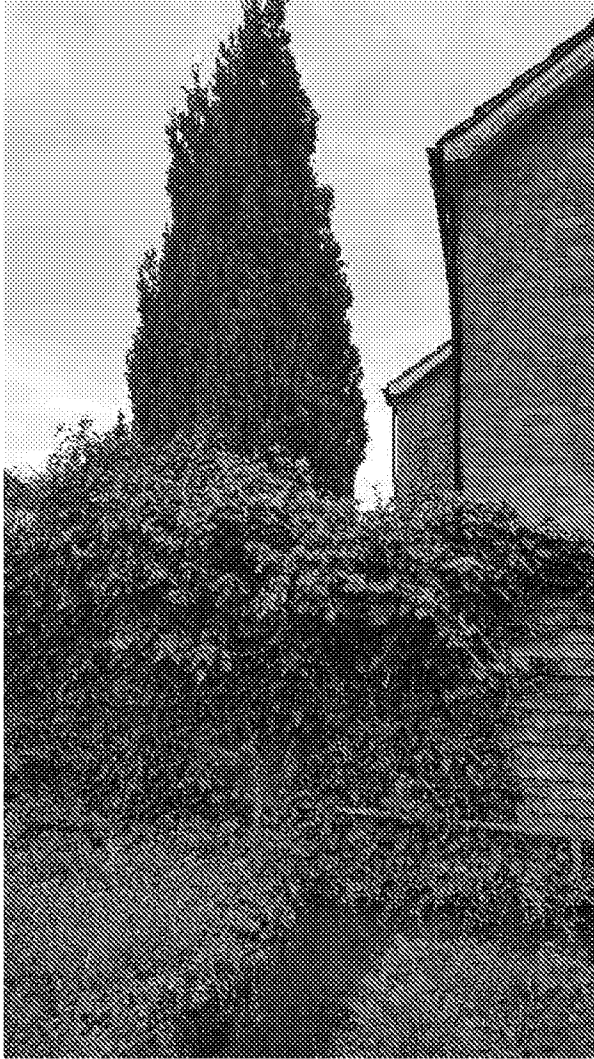
#### **Appendix 1:**

The individual T1 appears to be of good vigour, unaffected by foundations which have been dug prior to the lapse of outline planning permission. On closer inspection the foundation trench is devoid of roots structure, apart from a shallow root which appears to be severed, which may have been historically associated with a tree which had been removed prior to the planting of the Lawson's cypress.

The foundation trench photographed recently (left and bottom)

The foundation trench when it was first excavated (below)

5.2 Trees T1-T4: It is not envisaged that there will be a need for further excavations which will impact on T1. Services such as telecommunication fibre optics, water gas or electric services should be installed away from the RPA of T1 which should be afforded temporary protection with Arris fencing (See appendix 4). If there is a need for further excavation, it is recommended that excavation is by hand only (see appendix 3 Tree constraints plan).
