## **Tree Care Consultant**

### **ARBORICULTURAL REPORT**

**Reference:** MC/197/22

**Location:** Malmayne Court, Aldwick Fields, Bognor Regis, West Sussex, PO21 3SW

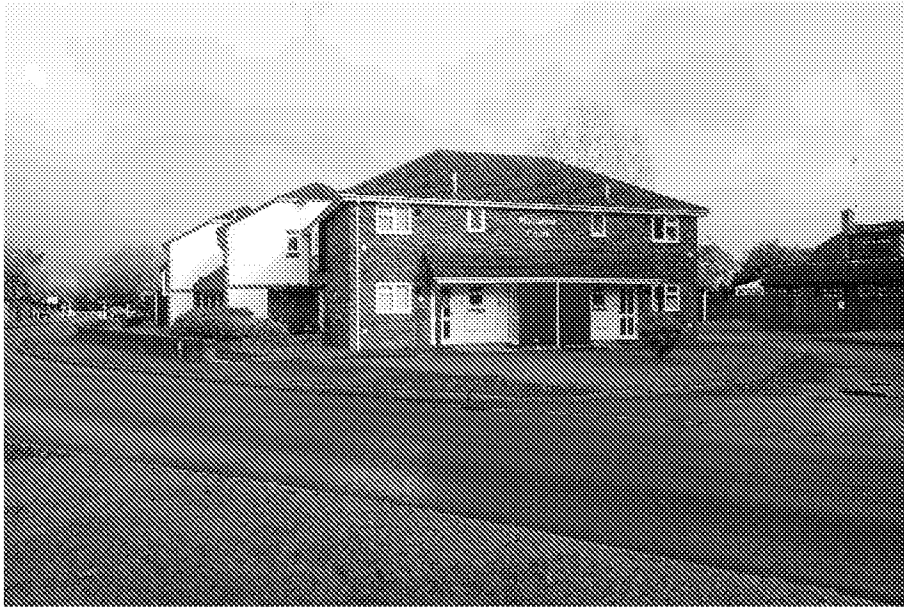
**Fig 1 Site entrance off Aldwick Fields**

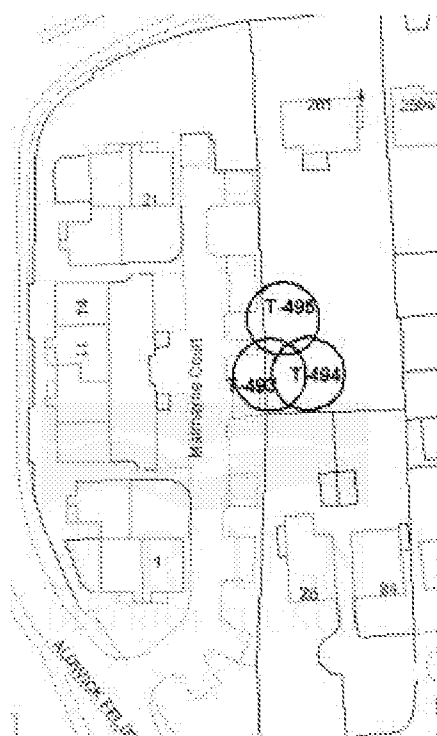
- 4.3 A second TPO applies to the adjoining property 201 Aldwick Road including a Poplar that is close to Beech T 30005 TPO/AN/152/10.

**TPO/AW/152/10 showing neighbours protected trees**
