**Bellamy Wallace Partnership**  
Consulting Structural Engineers

**REPORT ON VISUAL INSPECTION OF  
CONDITION OF EXISTING BUILDINGS AT  
SITE OF PROPOSED REDEVELOPMENT**

**Arundel Road  
Angmering,  
Littlehampton,  
BN16 4ET**

Job No: K2327

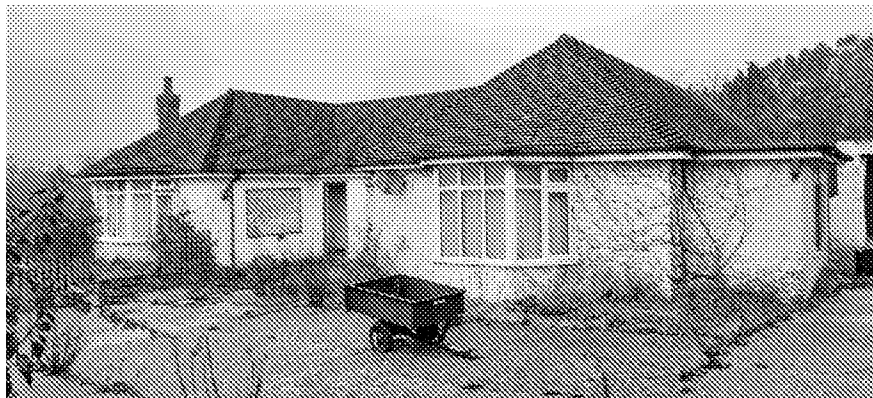
Photo 1 - Block A – Front elevation of bungalow

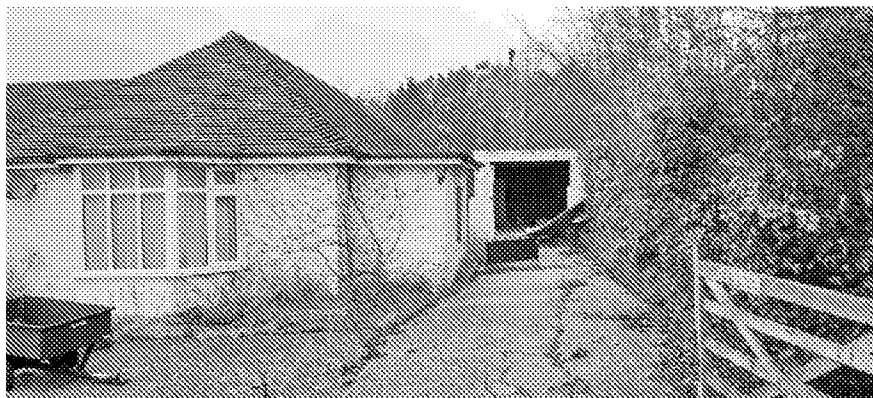
Photo 2 - Block A – Front elevation of bungalow showing garage

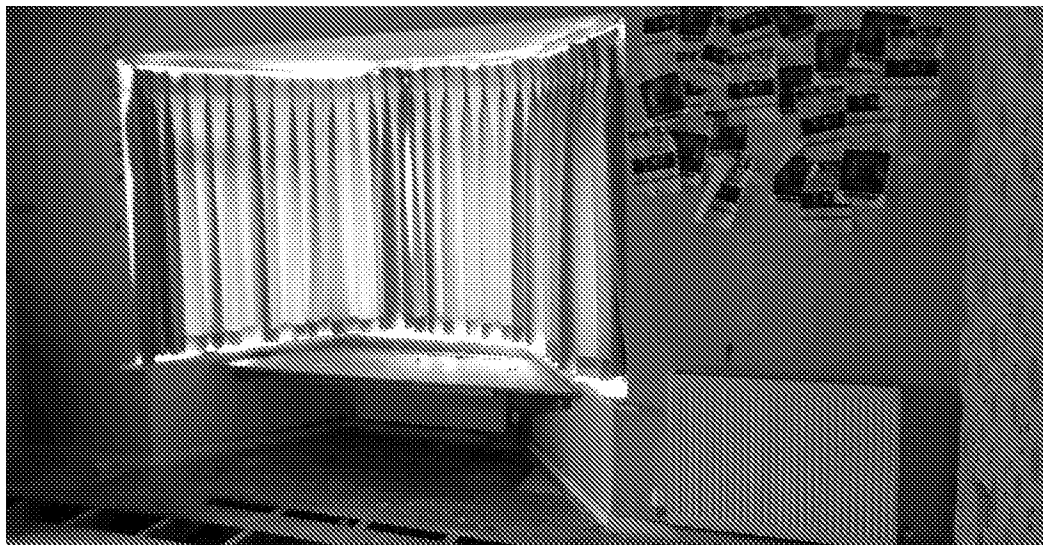
Photo 8 - Block A - front bay window

Given the uneven settlement of the ground bearing slab and the cracking that this appears to have caused to the walls of the house and garage it is recommended that the house and garage be demolished.

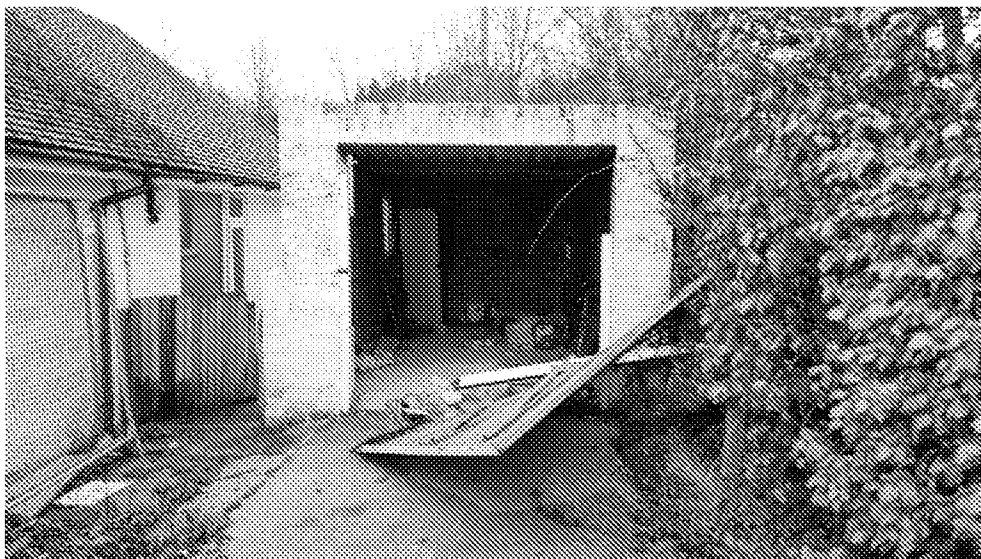
Photo 11 - Block A – view of garage

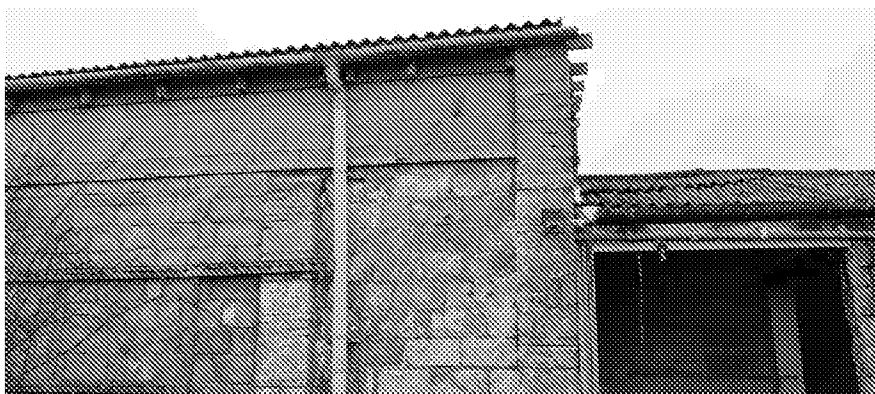
- 4.0.1 Block B comprises a large shed with load bearing masonry walls. The roof is of corrugated iron construction.
- 4.0.2 The walls comprise stone block with a concrete block vertical extension on top, as shown in photo 17.
- 4.0.3 The roof ceiling would appear to be sagging as can be seen in photo 22.
- 4.0.4 Photo 20 shows the beam that supports the roof trusses to be sagging.
- 4.0.5 Photo 21 shows a prop to support the roof beam that in turn supports the trusses.
- 4.0.6 An extension has been built to the end of the building which appears to be of rendered block. Photo 26 shows cracking to the gable end of the extension wall.

- 4.1.1 The wall detail in photo 17 with a concrete block vertical extension on top is not of robust construction and the quality of construction cannot be verified.
- 4.1.2 Photo 21 shows a prop to support the roof beam and trusses. This would appear not to meet the requirements of robustness and has the potential for collapse as the removal of this prop could cause the roof to become unsafe.
- 4.1.3 The extension at the end in rendered block is cracking in the gable wall.

Photo 17 – Block B - Side elevation – vertical extension in concrete block above the stone block

The vertical wall extension is potentially unsafe, the gable end of the extension is cracking and the roof would appear to be unsafe. Given these factors it is recommended that the building be demolished.

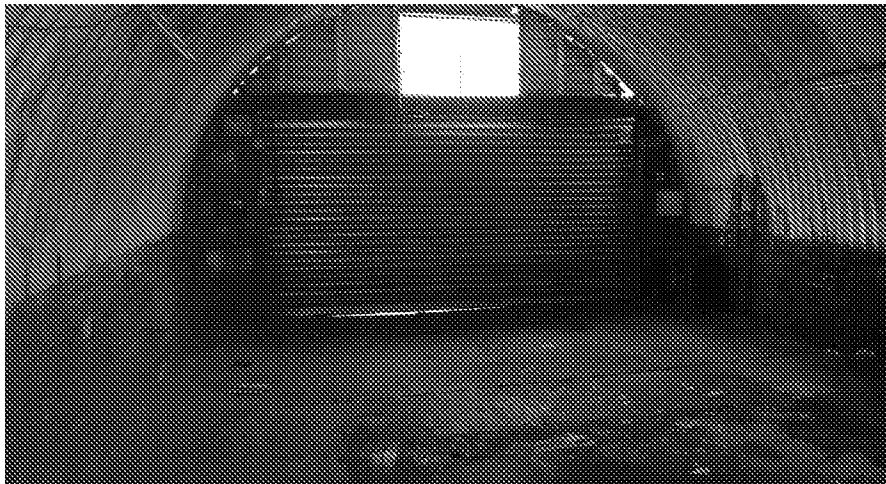
Photo 37 – Block C – Roller shutter door at the rear gable

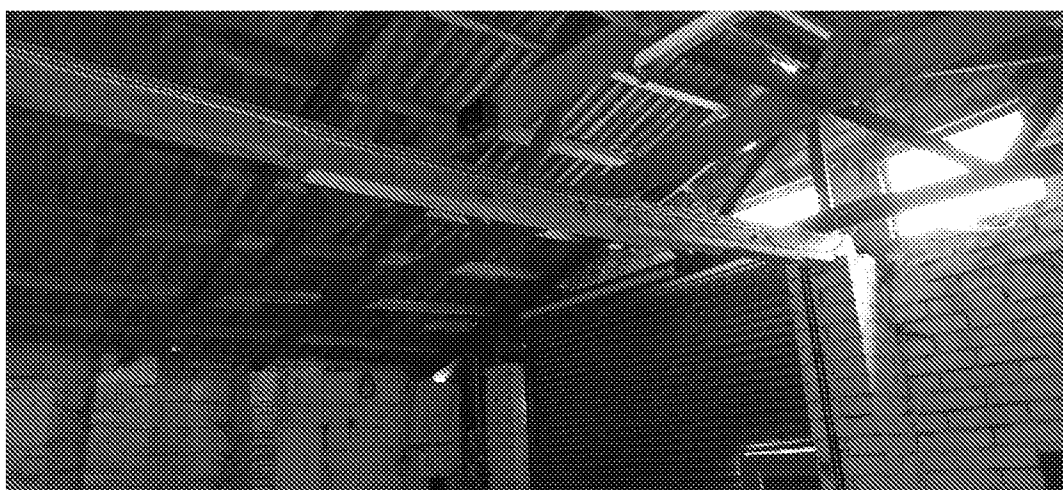
- 6.1.1 The roof is sagging and the props supporting the roof appear to be temporary props rather than permanent construction.
- 6.1.2 There is cracking indicative of settlement in the ground bearing slab.
- 6.1.3 The rear wall is leaning outwards in which could be spread from the roof load above.

Photo 47 – Block D – Roof beam propping roof trusses

The ground bearing slab is cracking and the rear wall and roof are non-robust and potentially unsafe. The ground bearing slab is cracking, which implies some ground movement and subject to further soils investigation should be removed. The existing roof structure would appear to be of a sub-standard form of construction and is propped temporarily throughout. Spread of the roof at the eaves would appear to have affected the perimeter walls, which now appear out of tolerance. Given these factors it is recommended that the buildings be demolished.

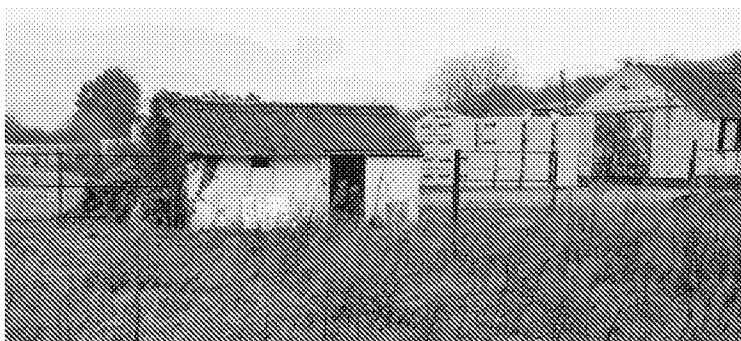
Photo 57 – Block F – Side elevation

8.2 Photo 56 shows the roof to be sagging unevenly along its ridge and also cable ducts outside the building.

Given the factors listed in 8.1 is recommended that the building be demolished.

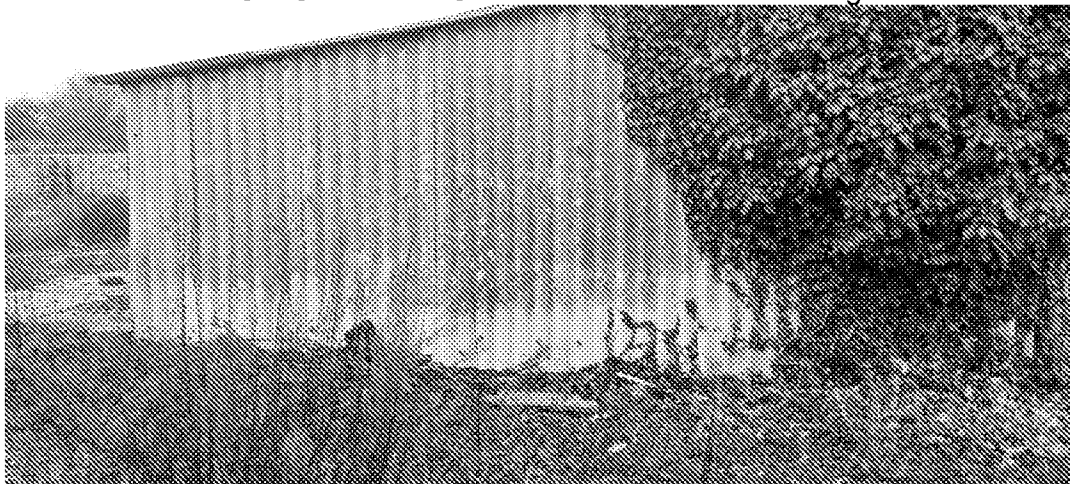
Photo 59 – Block G – Side view

- 9.0.1 Block G comprises a single small building with corrugated cement panel walls with a corrugated iron roof.
- 9.0.2 Photo 58 shows the building to be dilapidated and sections of wall and roof are missing.

Given the factors listed in 9.1 it is recommended that the building be demolished.

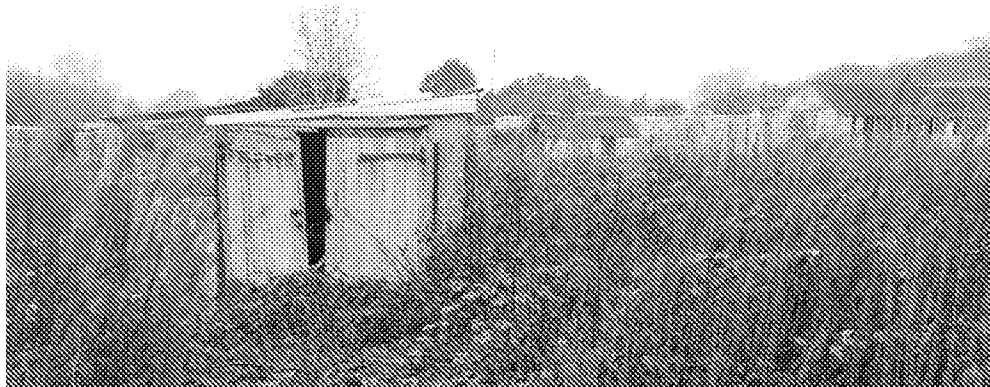
Photo 61 – Block H – Gable end

10.0.3 Above the doorway at the gable end the blocks over the lintel were loose.

Given the factors listed in 10.1 it is recommended that the building be demolished.

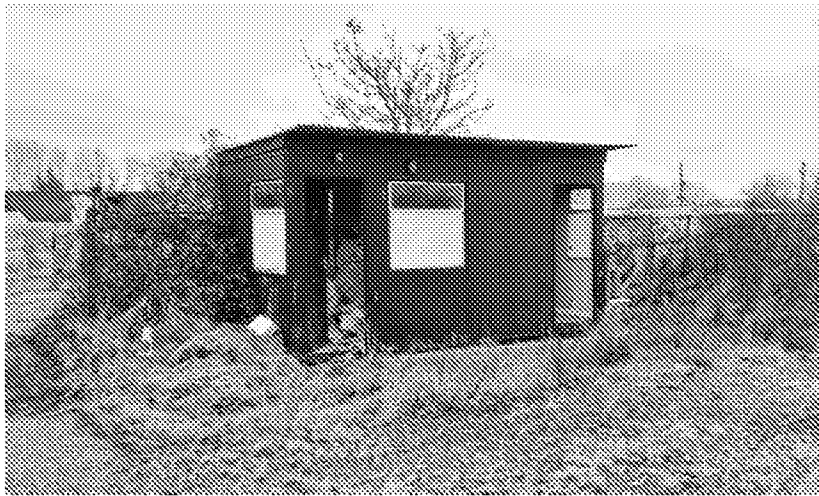
11.1.1 The hut is more of a temporary structure akin to a portacabin or caravan than a permanent structure.

Photo 62 – Block J – View of the hut

Given the factor listed in 11.1 it is recommended that the hut be demolished and removed.
