## Tree risk management report

St Margaret's Church

Arundel Road Angmering

Our Ref: 1021-9084-JGS

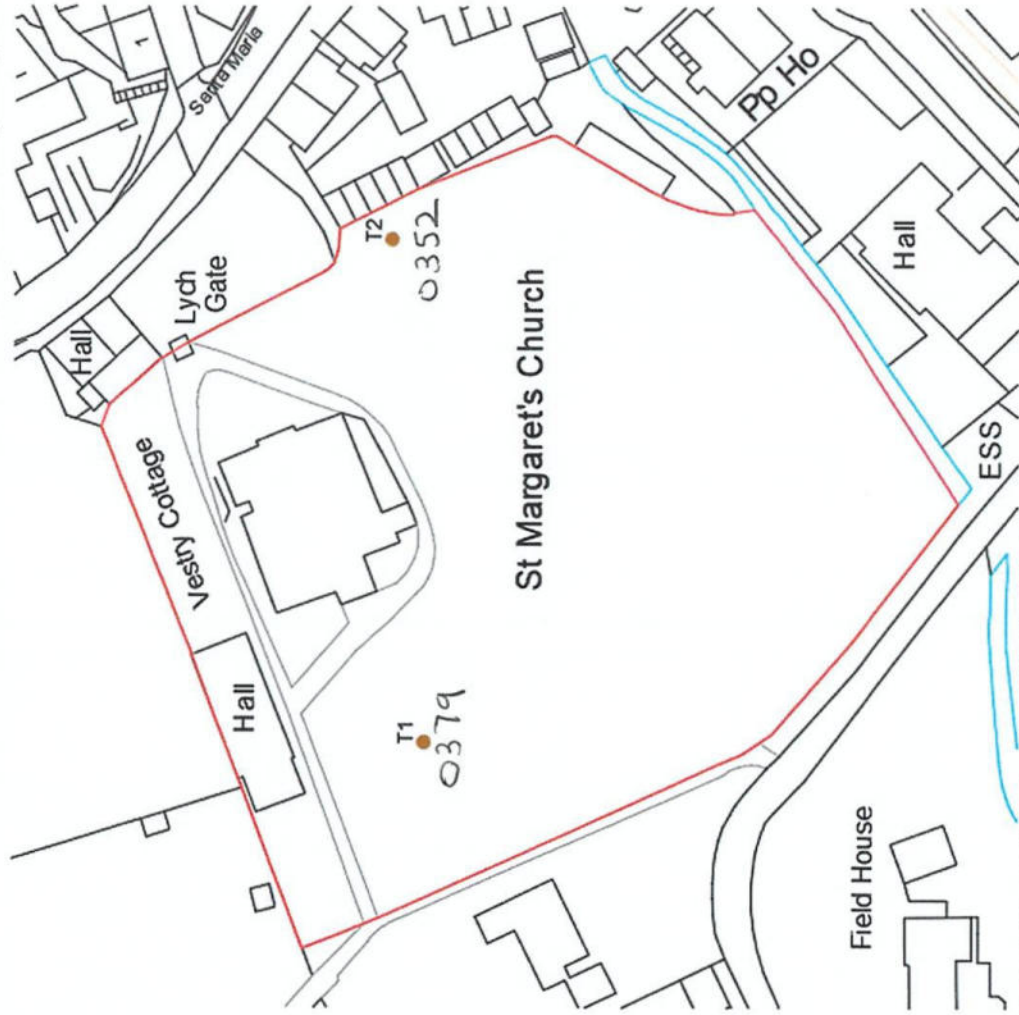
| | Tree location plan for<br>St Margaret's Church, Arundel Road,<br>Angmering, West Sussex.<br>BN16 4JS |

| Tree No. | Tree Species | Hgt (m) | Maturity | Notes | Recommendations | Work Priority |
|---|---|---|---|---|---|---|
| T2 | Bay laurel | 10 | Early mature | Large <i>Ganoderma</i> sp. fungal fruiting body at base, adjacent stem recently failed, historically reduced | Reduce by 3–4 m to previous pruning points | Within 6 months |
