## Section Inspection - 25/05/2021 - SP5X

| Town or Village: | Angmering | Inspection Direction: | Upstream | Upstream Node: | SP5 |
| Road: | Dappers Lane | Inspected Length: | 4.40 m | Upstream Pipe Depth: | |

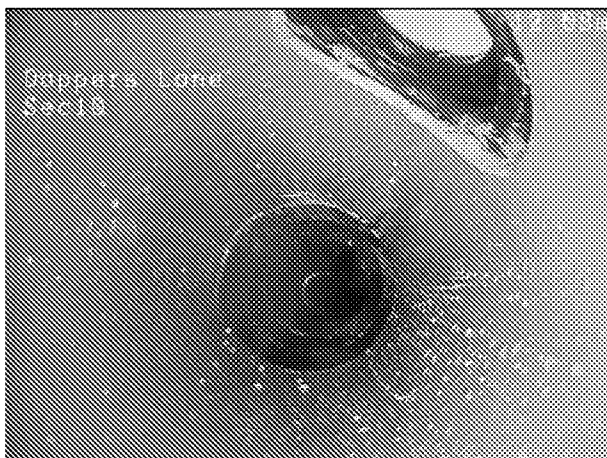
5, 00:01:08, 12.10 m  
Finish node, manhole, reference: SP8

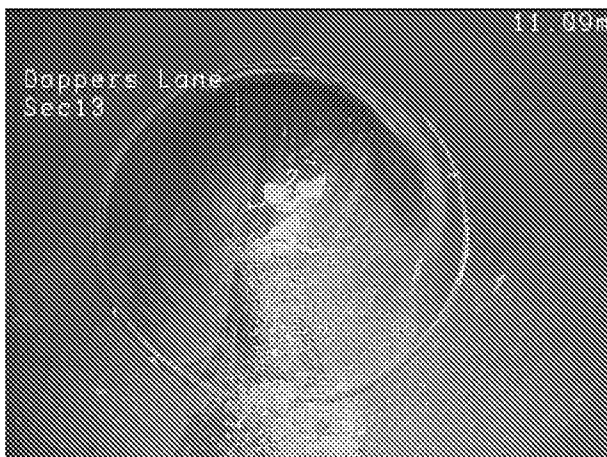
3, 00:00:45, 11.20 m  
Line deviates up

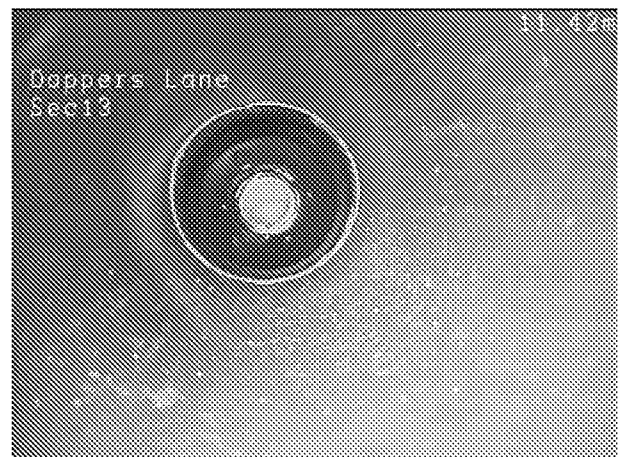
4, 00:00:50, 11.40 m  
Finish node, manhole, reference: SP10

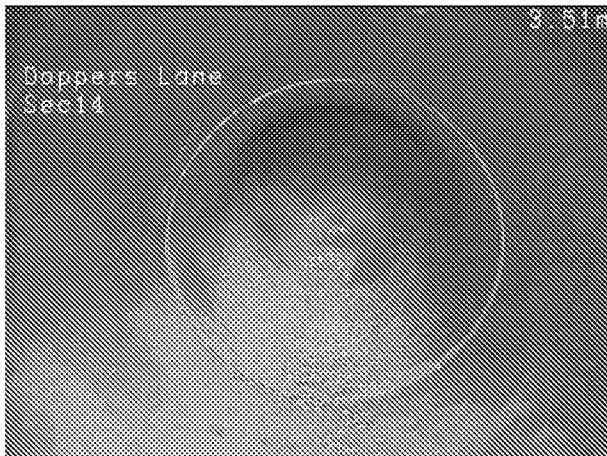
3, 00:00:22, 3.60 m  
Line deviates up

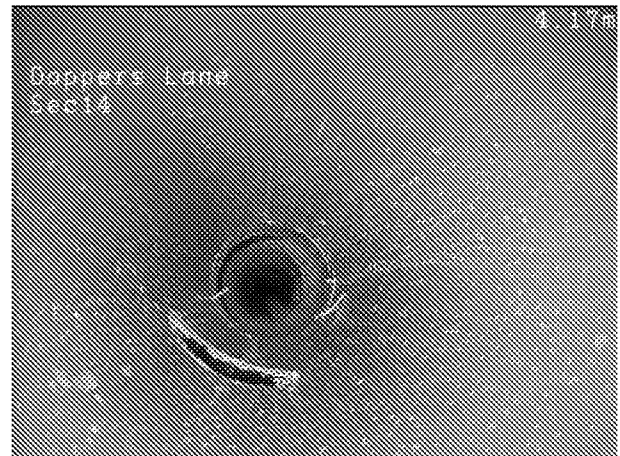
4, 00:00:27, 4.20 m  
Finish node, manhole, reference: SP11

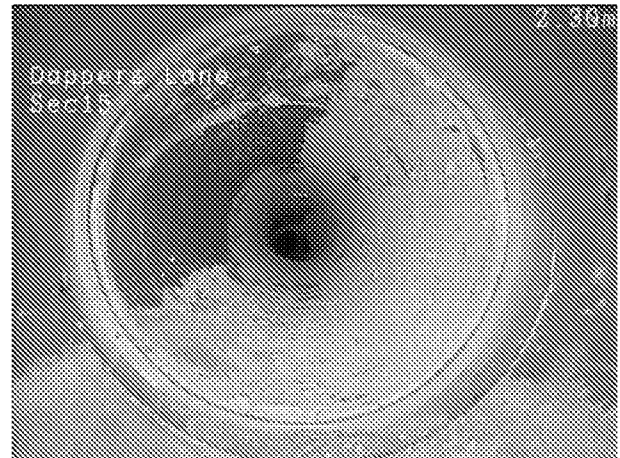
2, 00:00:19, 2.30 m  
Line deviates up

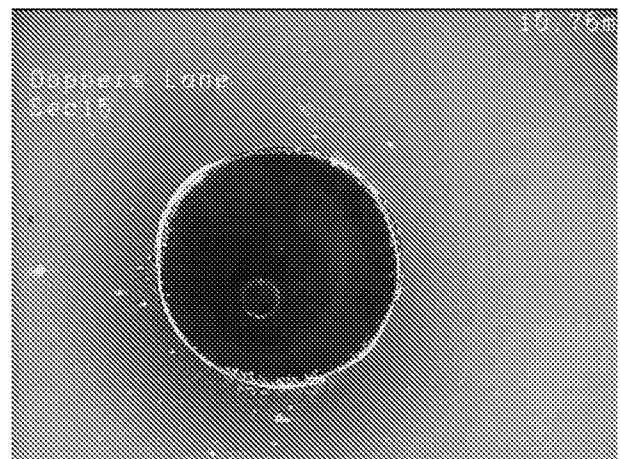
4, 00:00:49, 10.80 m  
Finish node, manhole, reference: SP12

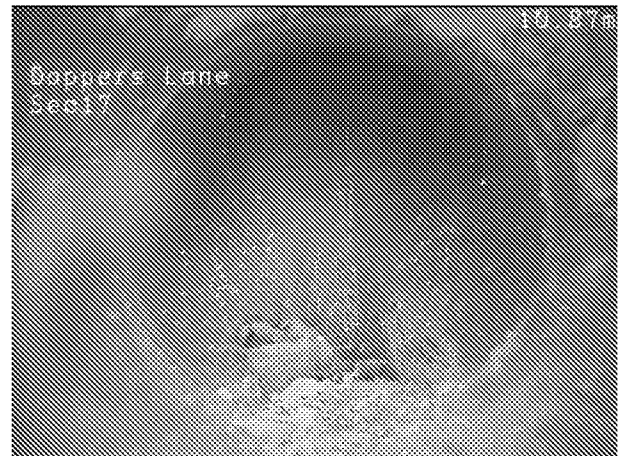
4, 00:01:18, 11.00 m  
Line deviates up

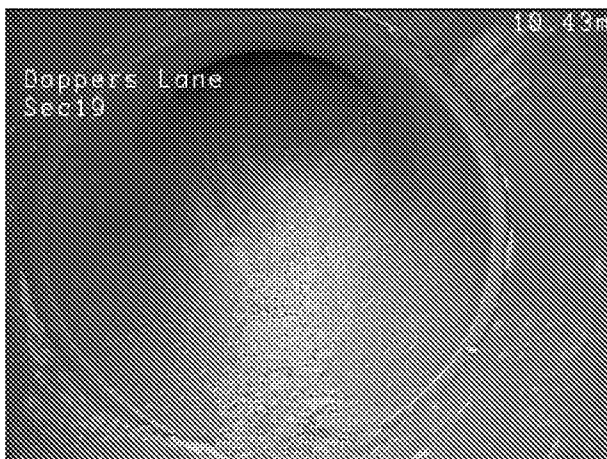
3, 00:00:57, 10.50 m  
Line deviates up

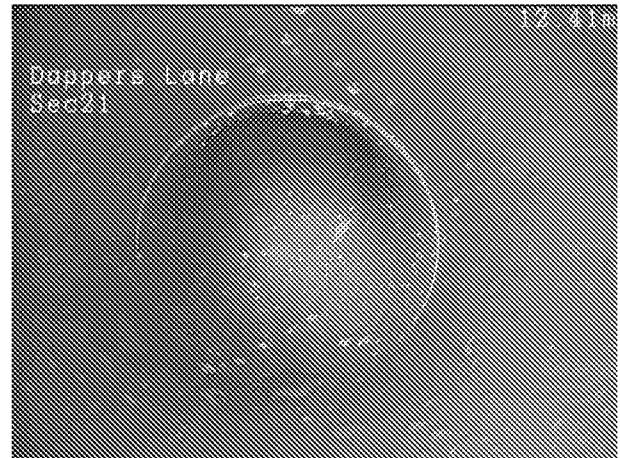
2, 00:00:41, 12.50 m  
Line deviates up

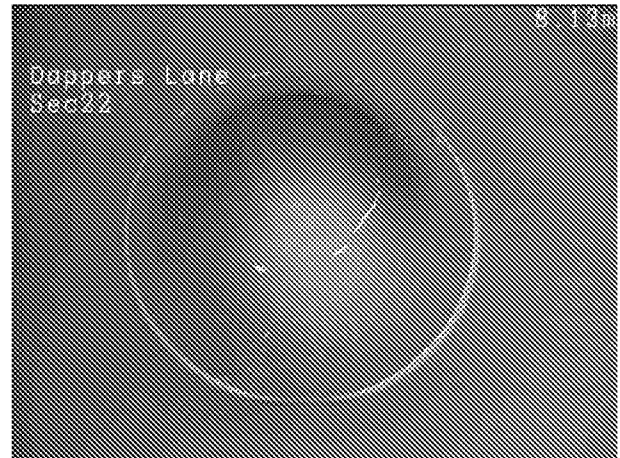
2, 00:00:30, 8.20 m  
Line deviates up

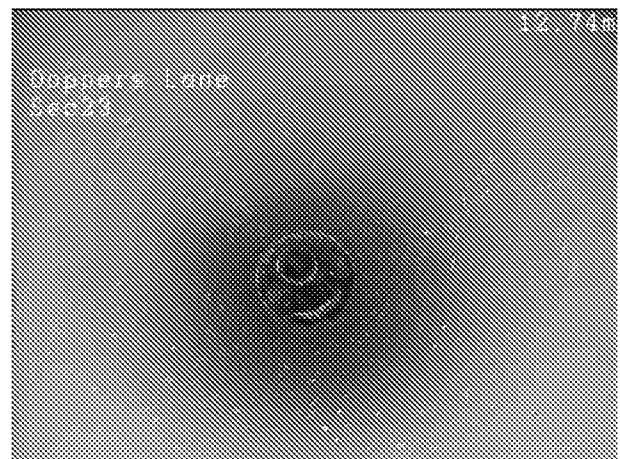
4, 00:00:52, 12.70 m  
Finish node, manhole, reference: SP18

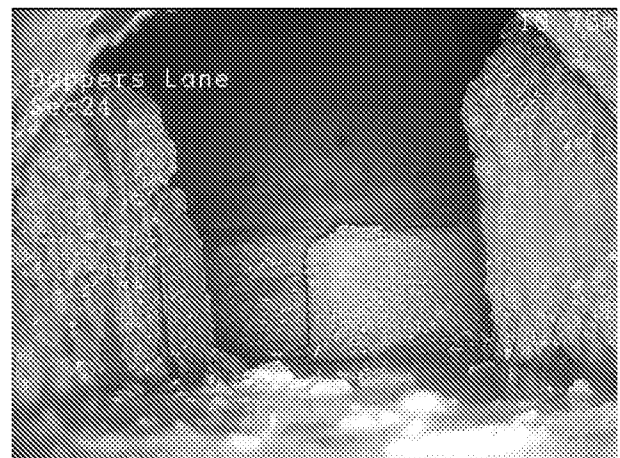
6, 00:00:53, 10.80 m  
Finish node, manhole, reference: F1, Debris in channel

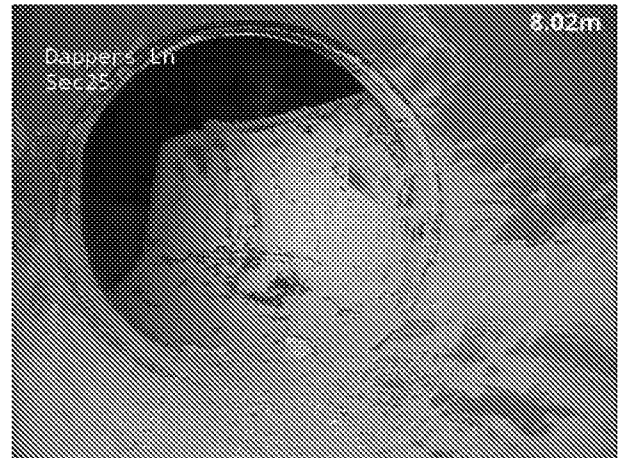
2, 00:00:04, 8.30 m  
Finish node, manhole, reference: F33

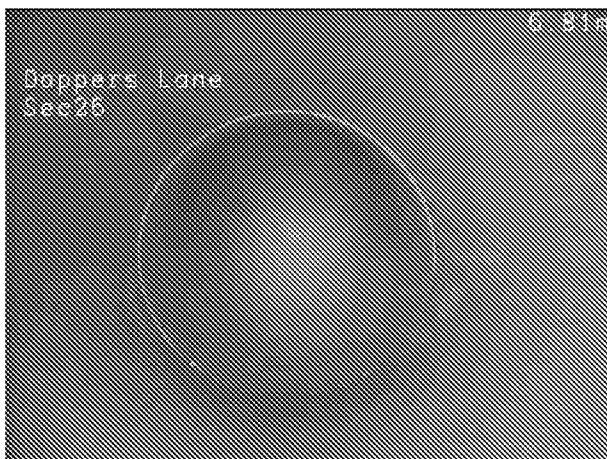
3, 00:00:26, 6.90 m  
Line deviates up

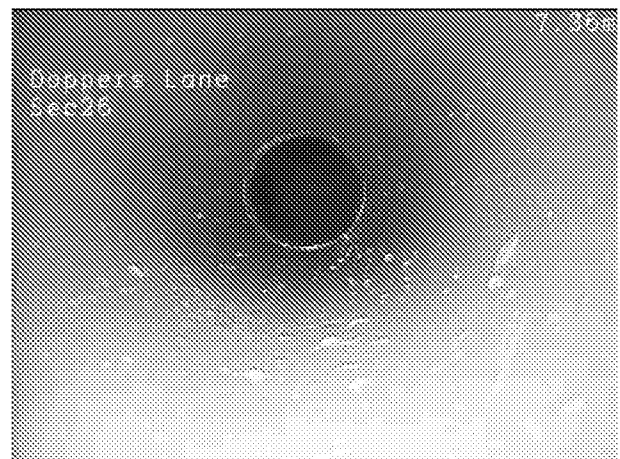
4, 00:00:30, 7.40 m  
Finish node, manhole, reference: SP19

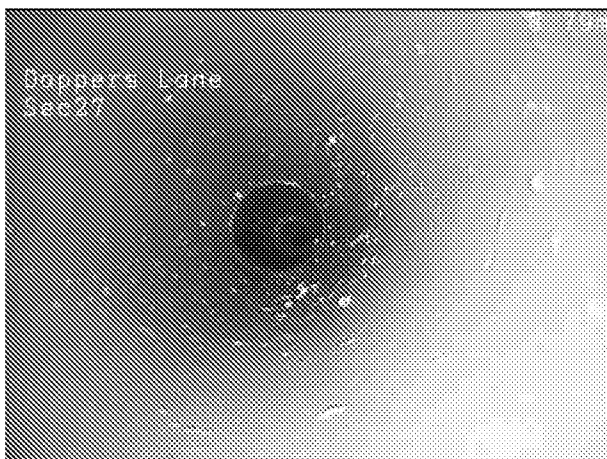
3, 00:00:38, 8.80 m  
Finish node, manhole, reference: SP20

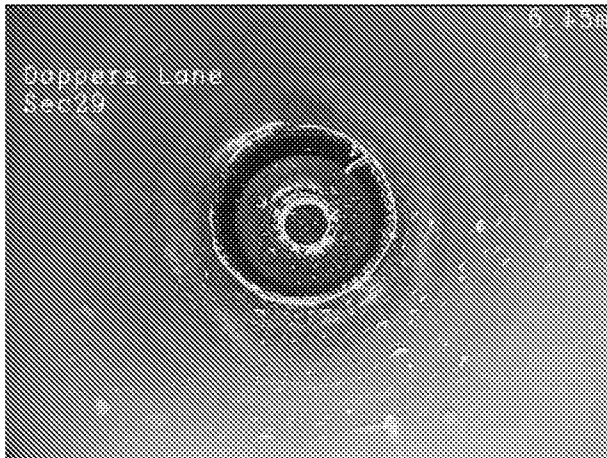
7, 00:01:11, 6.20 m  
Finish node, manhole, reference: SP21
