## Section Inspection - 26/05/2021 - SP22X

| Town or Village: | Angmering | Inspection Direction: | Upstream | Upstream Node: | SP22 |
| Road: | Dappers Lane | Inspected Length: | 13.10 m | Upstream Pipe Depth: | |

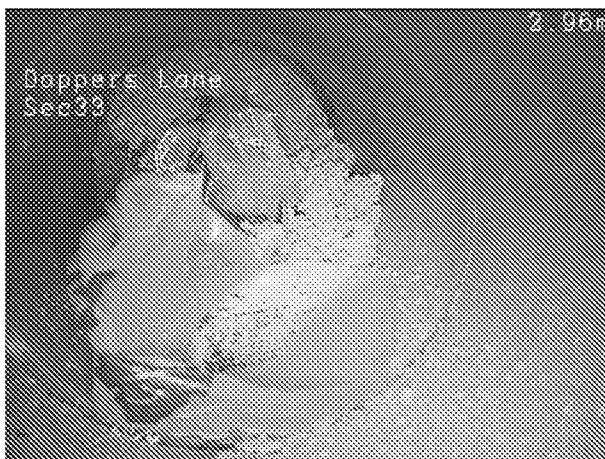
3, 00:00:25, 3.10 m  
Settled deposits, hard or compacted, 100% cross-sectional area loss, Concrete

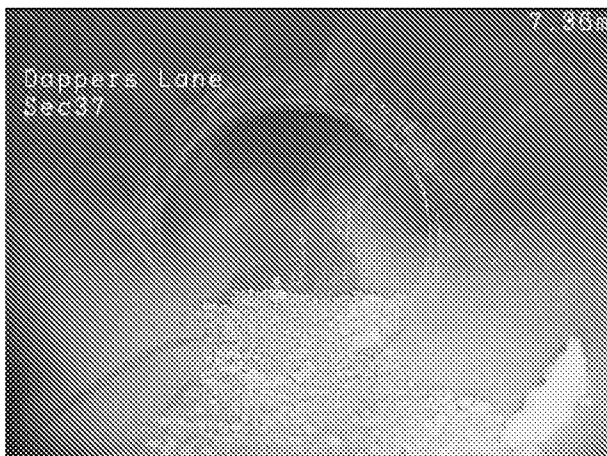
5, 00:01:22, 7.50 m  
Line deviates up

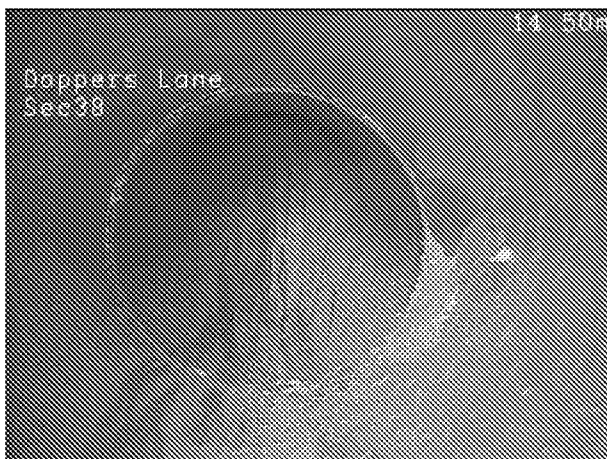
3, 00:00:44, 14.60 m  
Line deviates up

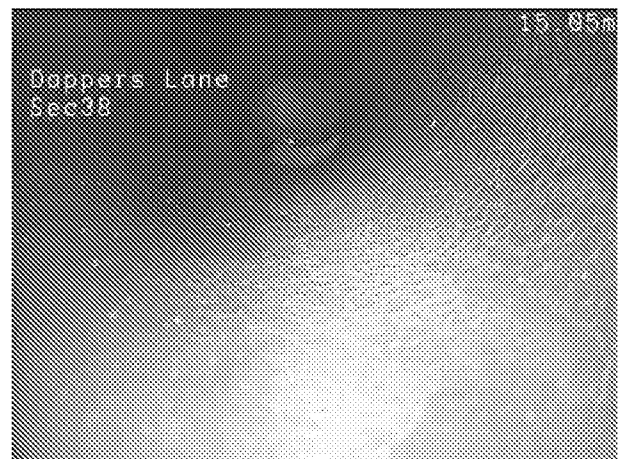
4, 00:00:55, 15.10 m  
Finish node, manhole, reference: SP26

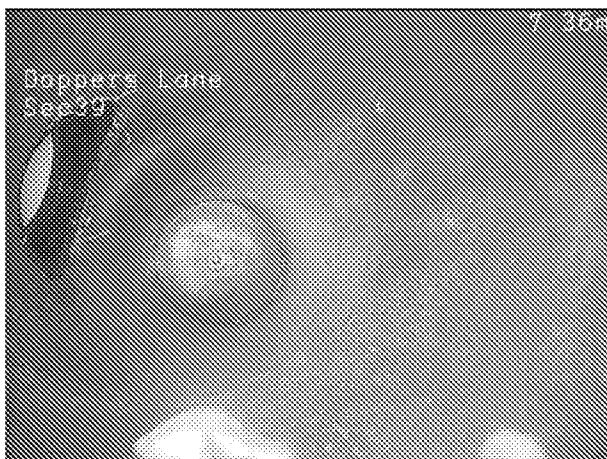
3, 00:00:45, 7.40 m  
Finish node, manhole, reference: SP27

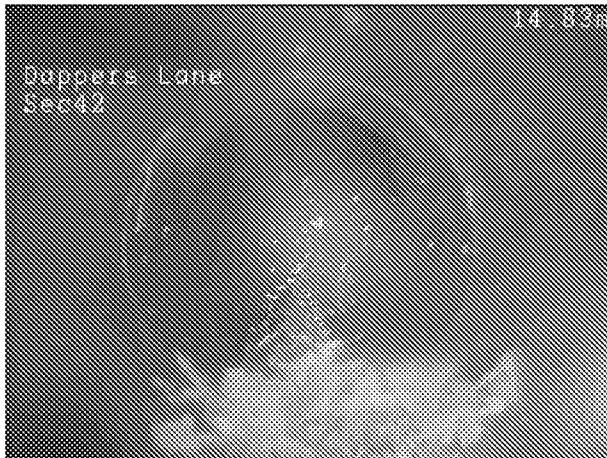
7, 00:01:21, 14.50 m  
Line deviates up

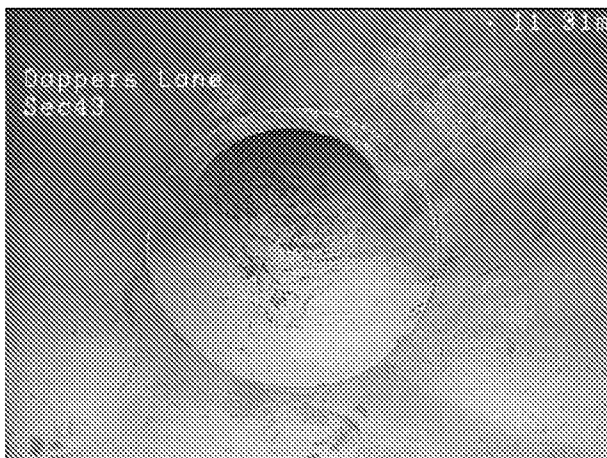
4, 00:00:36, 7.00 m  
Line deviates left

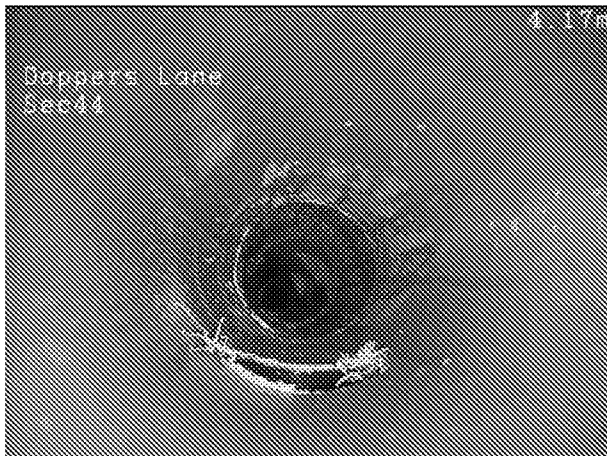
3, 00:00:48, 4.20 m  
Finish node, manhole, reference: SP31

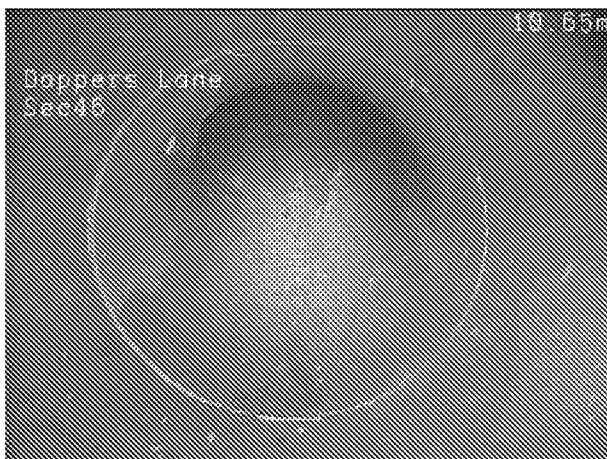
3, 00:00:53, 10.70 m  
Line deviates up

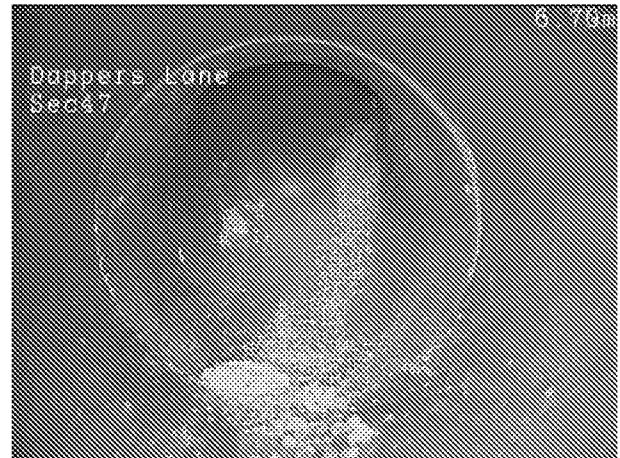
2, 00:00:31, 6.70 m  
Line deviates up

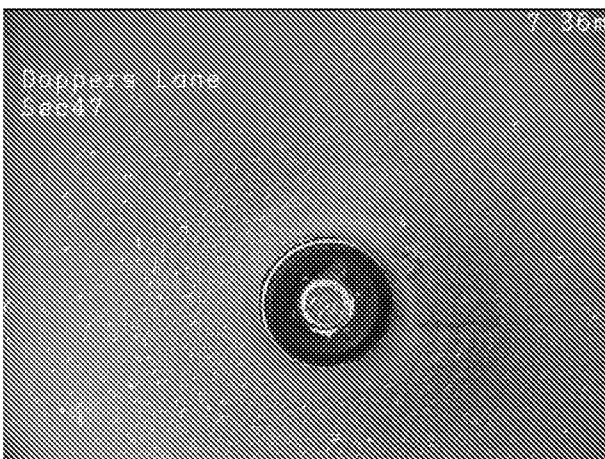
3, 00:00:36, 7.40 m  
Finish node, manhole, reference: SP33

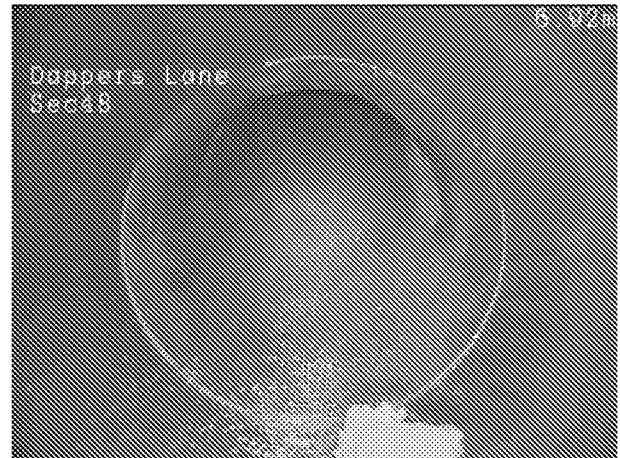
2, 00:00:32, 6.90 m  
Line deviates up

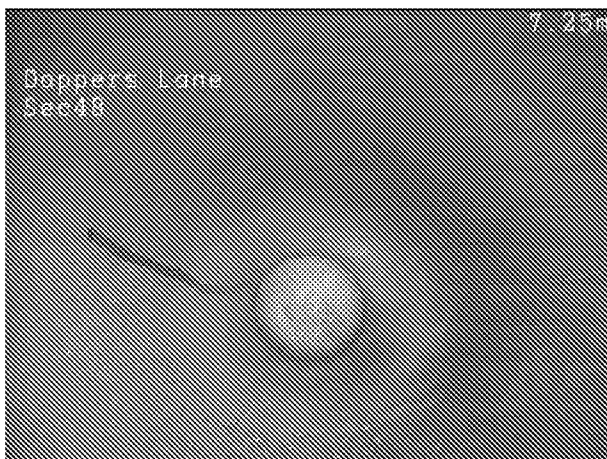
3, 00:00:38, 7.20 m  
Finish node, manhole, reference: SP34

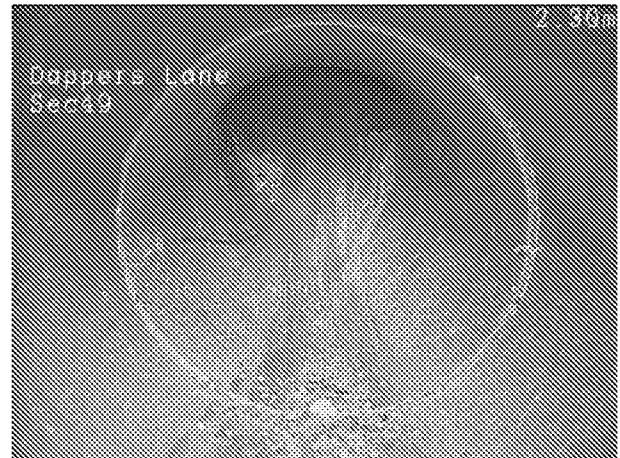
2, 00:00:30, 2.40 m  
Line deviates up

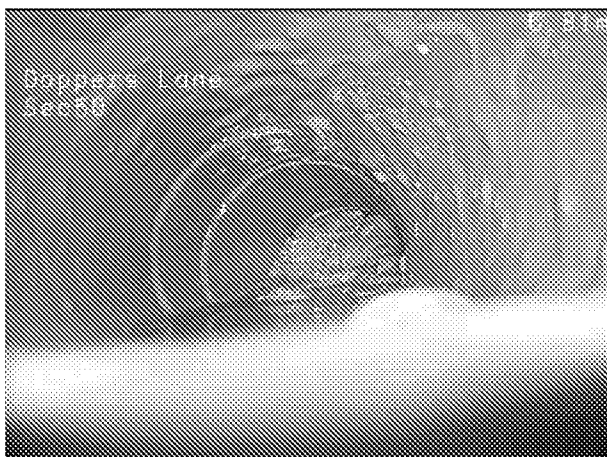
3, 00:00:40, 6.80 m  
Settled deposits, fine, 40% cross-sectional area loss, change
