## Section Inspection - 26/05/2021 - SP36X

| Town or Village: | Angmering | Inspection Direction: | Upstream | Upstream Node: | SP36 |
| Road: | Dappers Lane | Inspected Length: | 4.00 m | Upstream Pipe Depth: | |

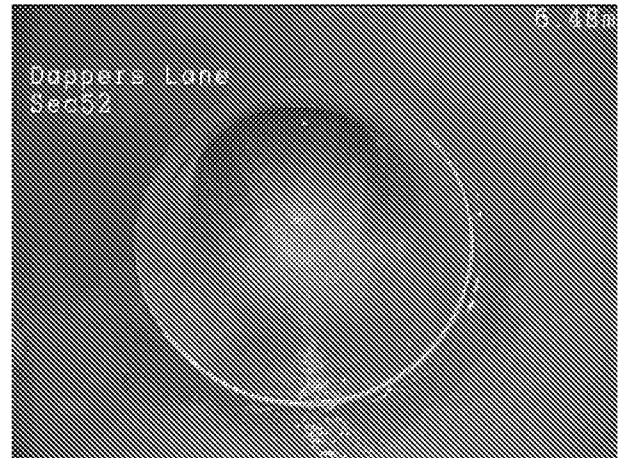
2, 00:00:23, 6.60 m  
Line deviates up

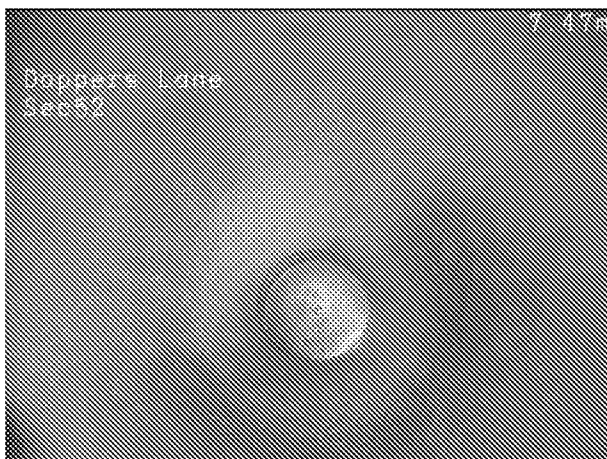
3, 00:00:32, 7.50 m  
Finish node, manhole, reference: SP37

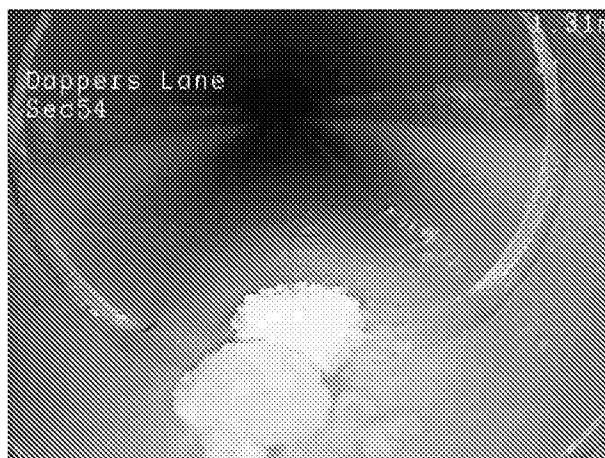
2, 00:00:13, 1.30 m  
Water level, 5% of the vertical dimension

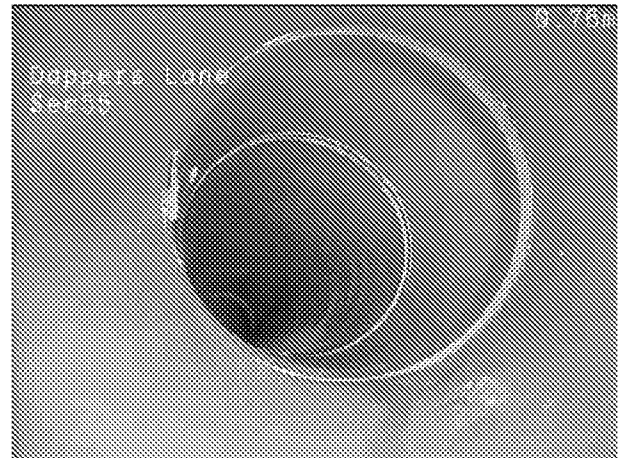
2, 00:00:13, 0.80 m  
Line deviates left

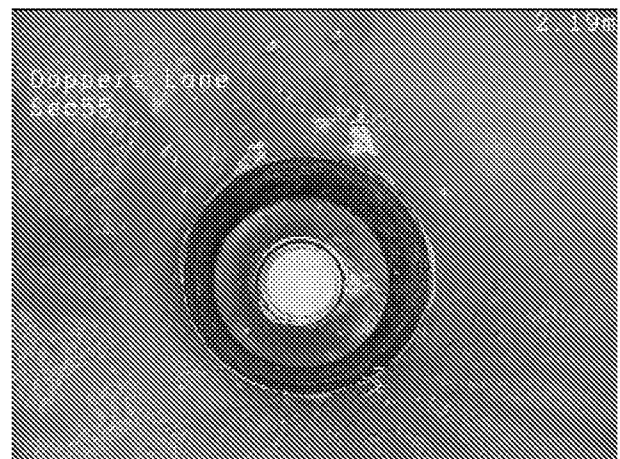
4, 00:00:25, 2.20 m  
Finish node, manhole, reference: SP39

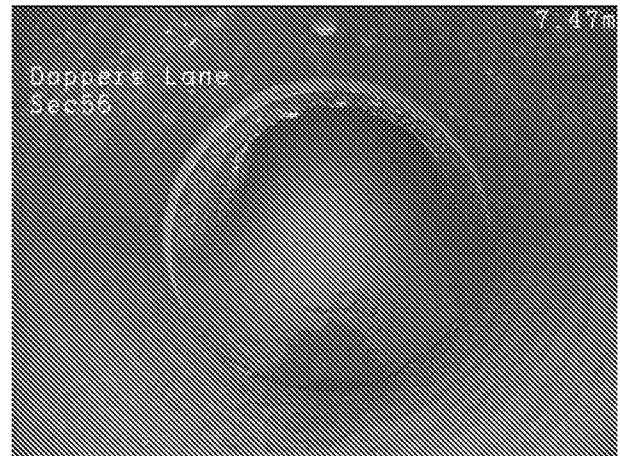
4, 00:00:48, 7.60 m  
Line deviates up

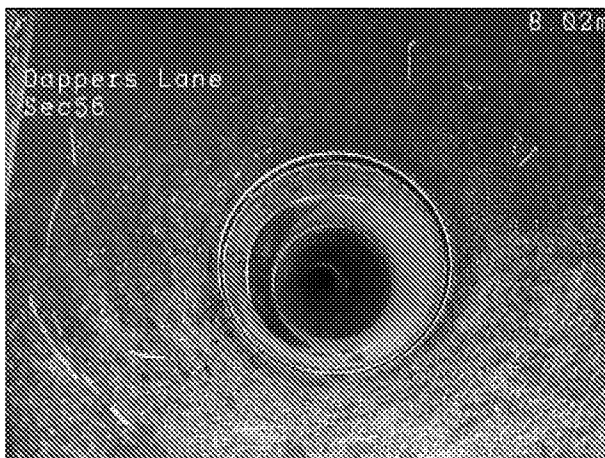
5, 00:00:54, 8.00 m  
Finish node, manhole, reference: SP40

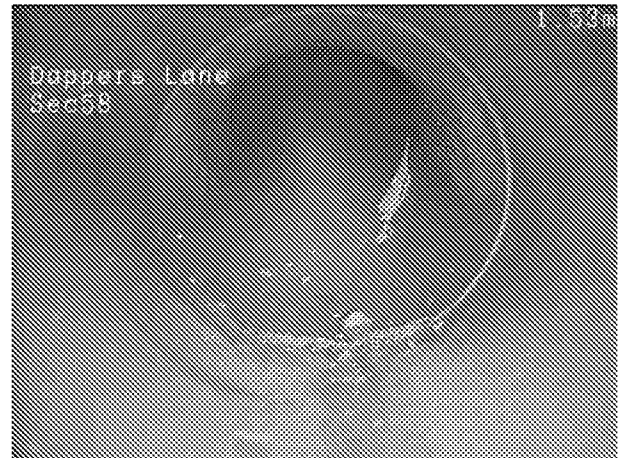
2, 00:00:20, 1.60 m  
Line deviates up

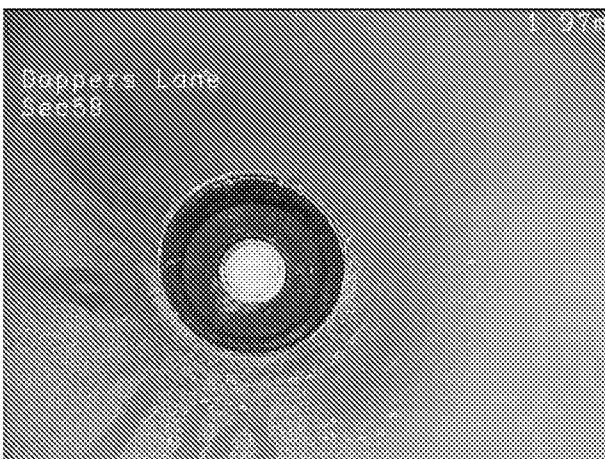
3, 00:00:27, 2.00 m  
Finish node, manhole, reference: SP41

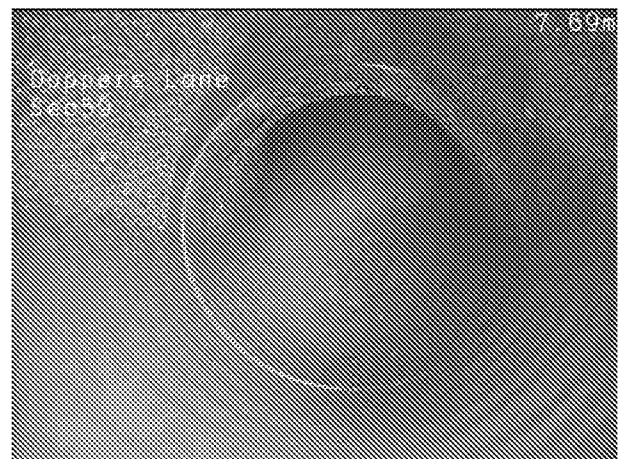
4, 00:00:43, 7.80 m  
Line deviates up

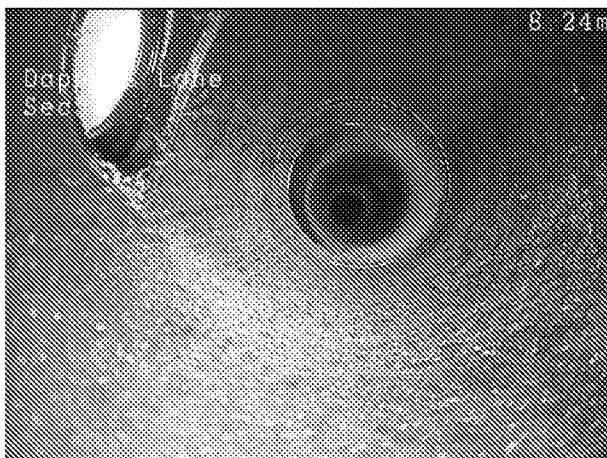
5, 00:00:46, 8.20 m  
Finish node, manhole, reference: SP42

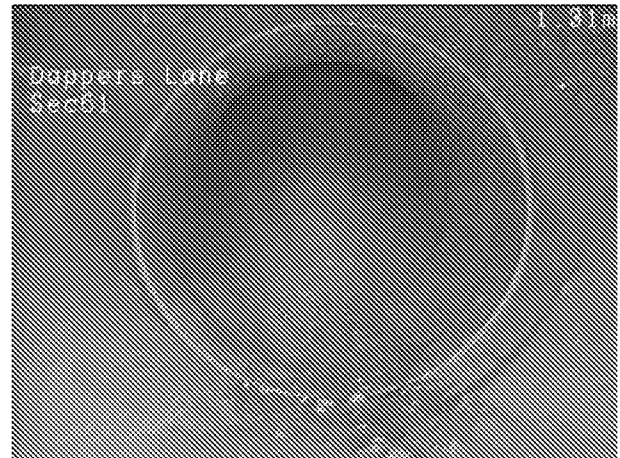
2, 00:00:17, 1.40 m  
Line deviates up

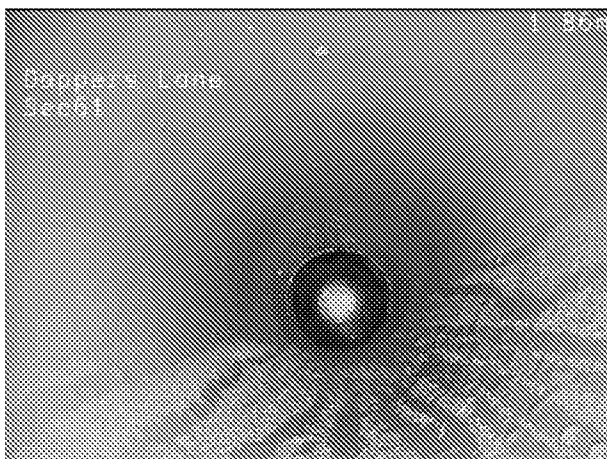
3, 00:00:20, 1.90 m  
Finish node, manhole, reference: SP43

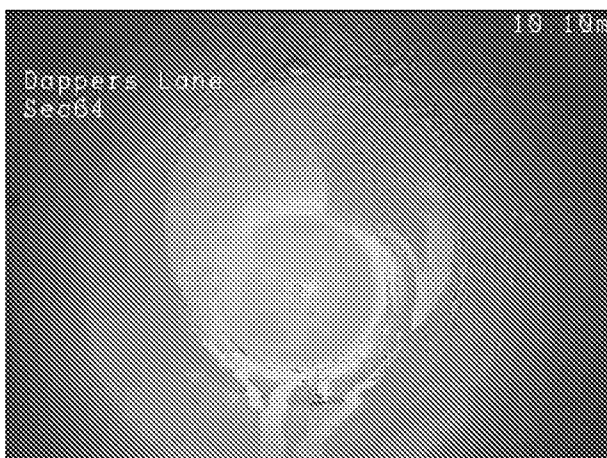
5, 00:01:14, 10.10 m  
Finish node, manhole, reference: RE4

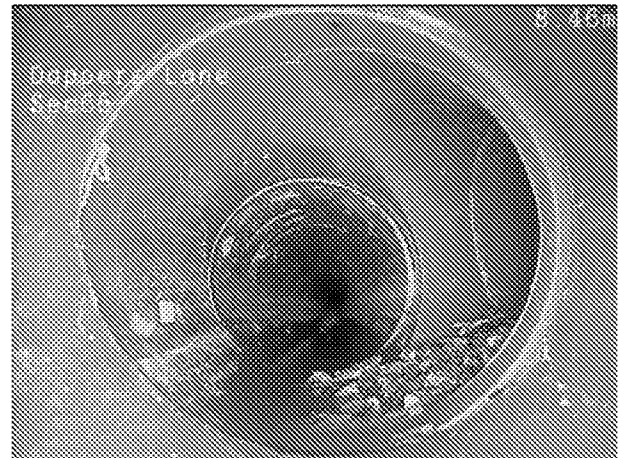
2, 00:00:43, 8.60 m  
Junction at 3 o'clock, 100mm dia

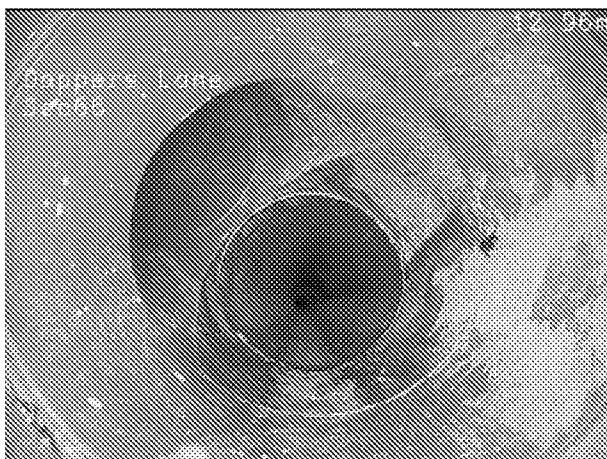
3, 00:01:04, 13.10 m  
Junction at 10 o'clock, 100mm dia

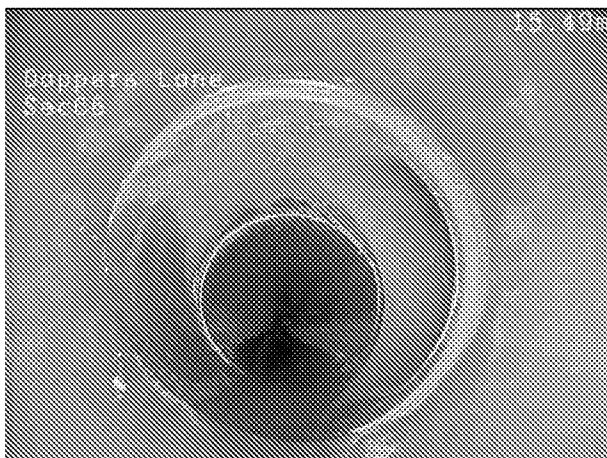
5, 00:01:15, 15.60 m  
Junction at 3 o'clock, 100mm dia

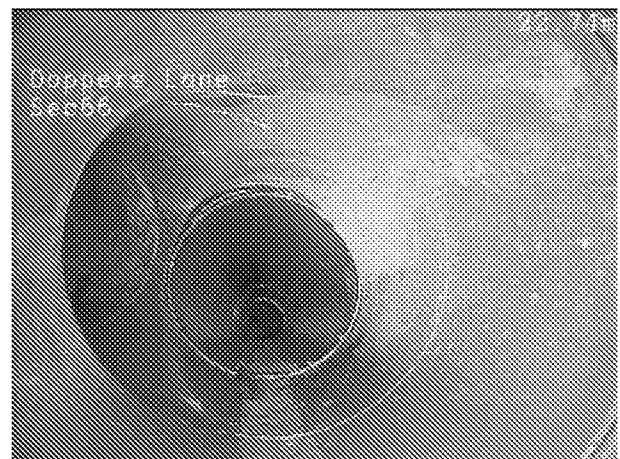
10, 00:02:04, 22.80 m  
Junction at 9 o'clock, 100mm dia

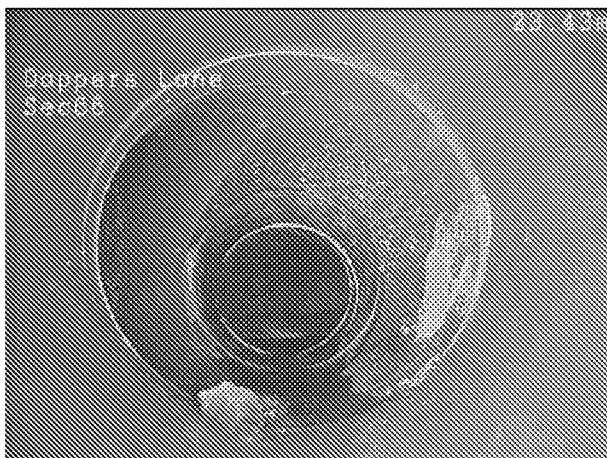
11, 00:02:10, 23.50 m  
Junction at 9 o'clock, 100mm dia

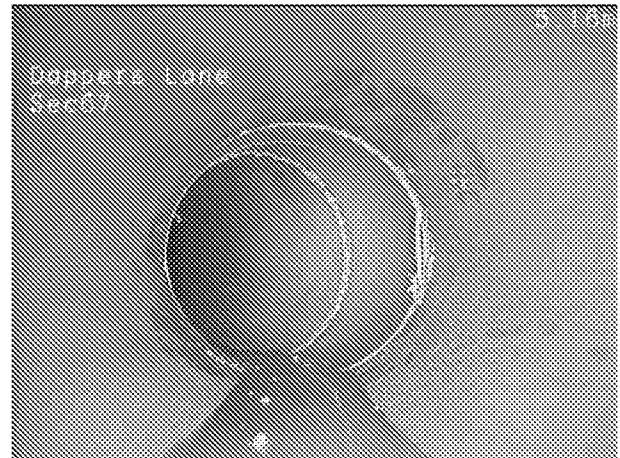
2, 00:00:55, 5.30 m  
Line deviates left

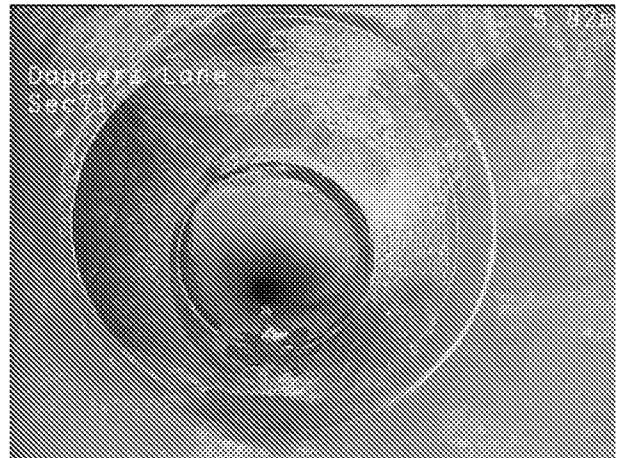
2, 00:00:20, 5.60 m  
Junction at 9 o'clock, 100mm dia

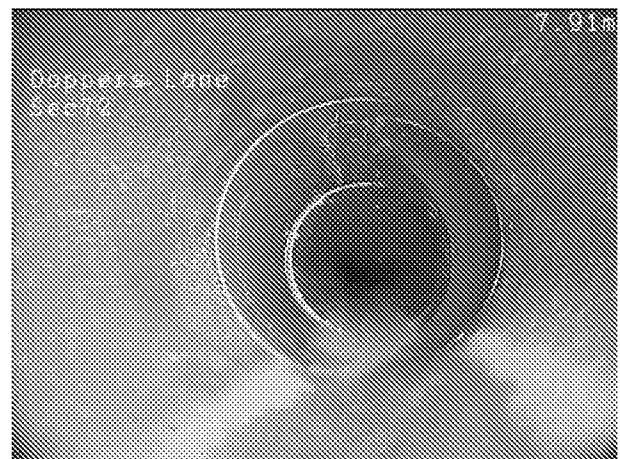
4, 00:01:05, 8.10 m  
Junction at 3 o'clock, 100mm dia

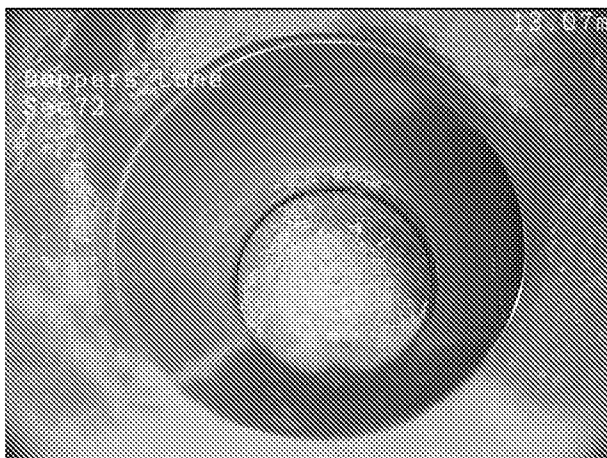
5, 00:01:17, 13.20 m  
Junction at 3 o'clock, 100mm dia

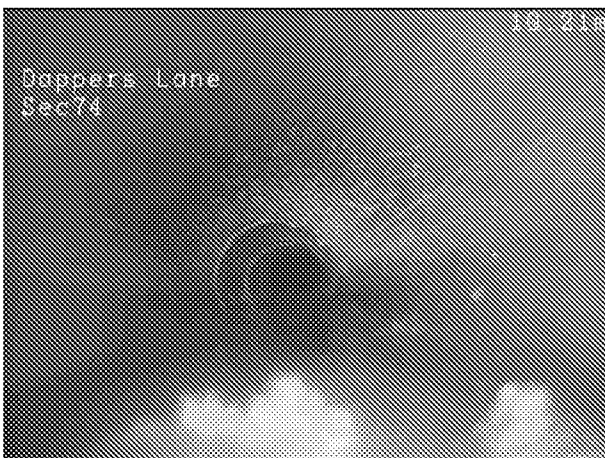
5, 00:01:00, 10.20 m  
Water level, 20% of the vertical dimension, Continuous

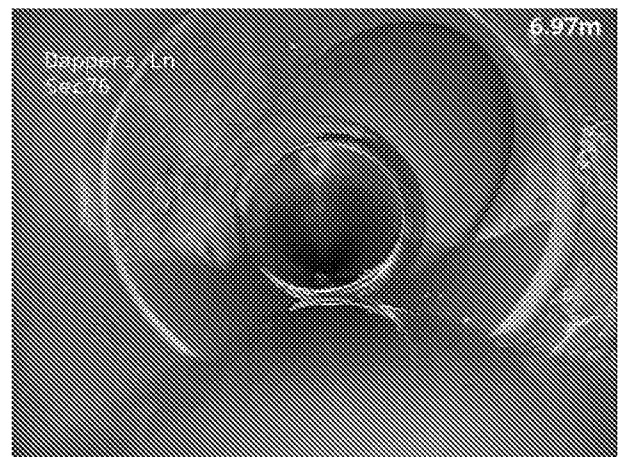
4, 00:00:32, 7.20 m  
Junction at 2 o'clock, 100mm dia

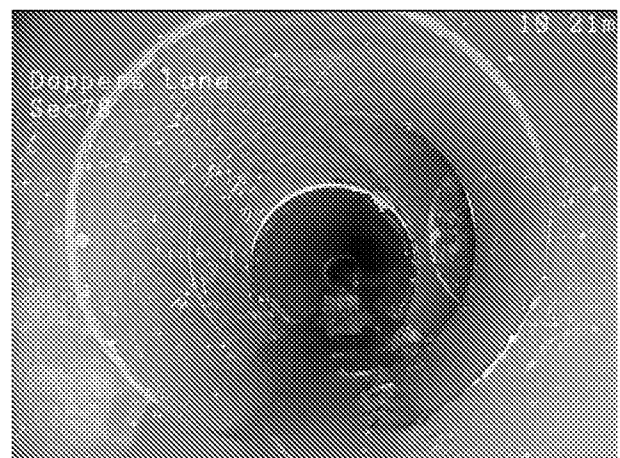
5, 00:00:51, 4.70 m  
Water level, 10% of the vertical dimension
