## Section Inspection - 27/05/2021 - LDX

| Town or Village: | Angmering | Inspection Direction: | Upstream | Upstream Node: | LD |
| Road: | Dappers Lane | Inspected Length: | 14.10 m | Upstream Pipe Depth: | |

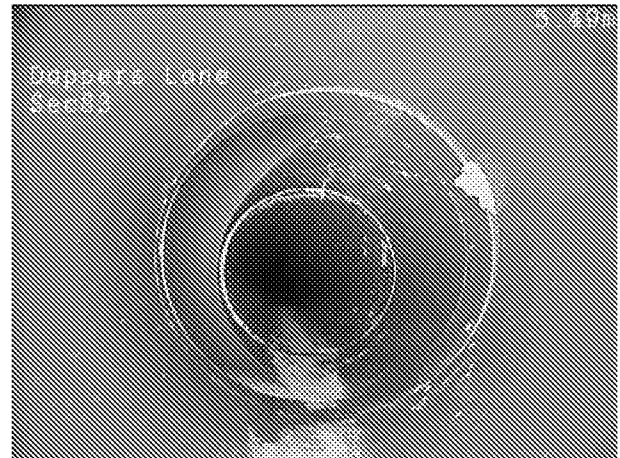
2, 00:00:33, 5.60 m  
Junction at 9 o'clock, 100mm dia

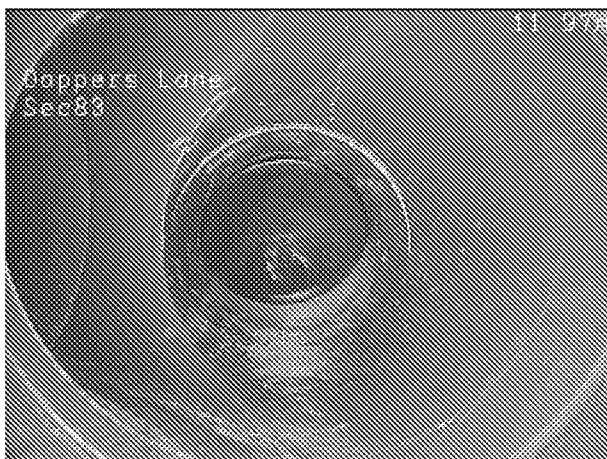
3, 00:00:54, 12.00 m  
Junction at 9 o'clock, 100mm dia

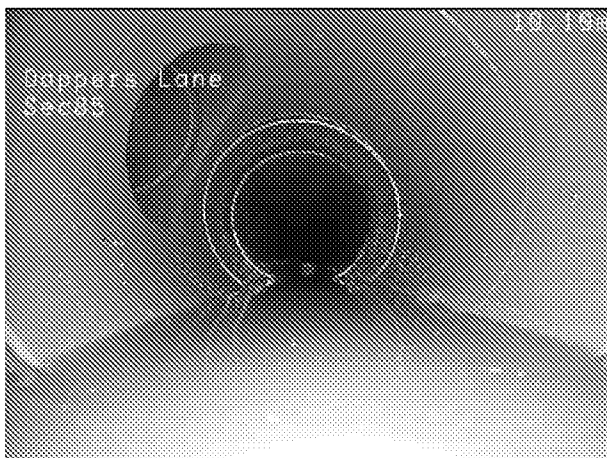
5, 00:00:59, 10.30 m  
Junction at 10 o'clock, 100mm dia

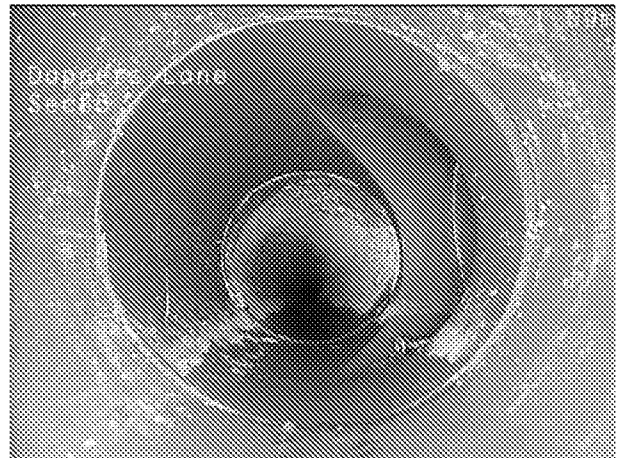
2, 00:00:13, 1.20 m  
Junction at 3 o'clock, 100mm dia

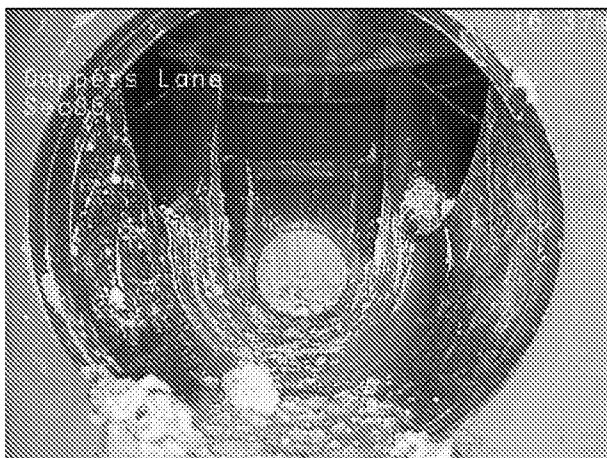
5, 00:01:07, 16.50 m  
Finish node, manhole, reference: S30

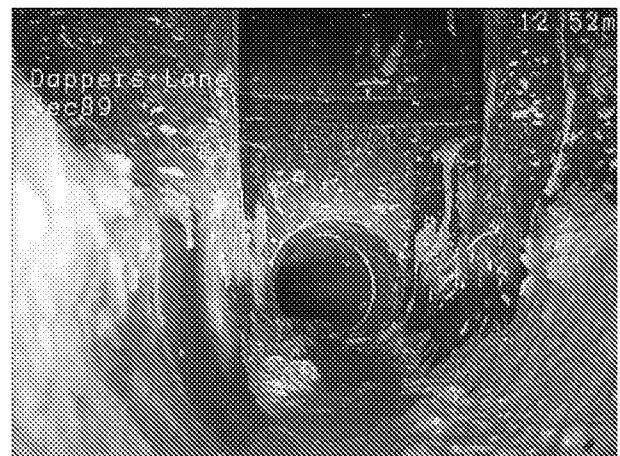
6, 00:01:05, 12.60 m  
Finish node, manhole, reference: S31

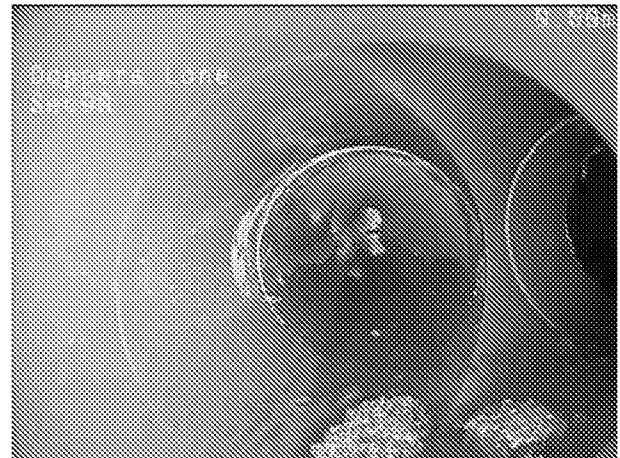
2, 00:00:11, 0.10 m  
Junction at 3 o'clock, 100mm dia

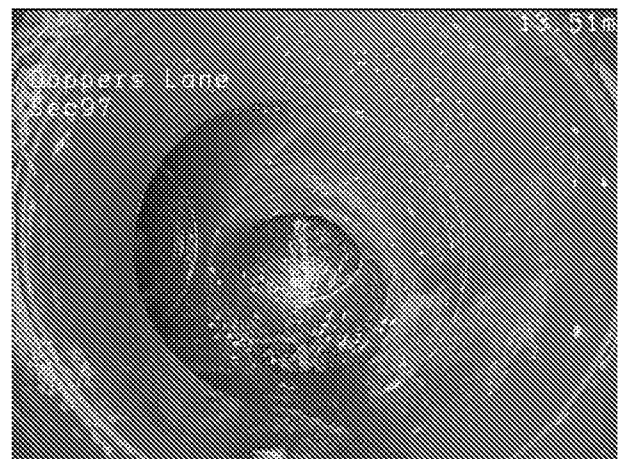
4, 00:00:43, 13.60 m  
Junction at 9 o'clock, 100mm dia
