## Section Inspection - 28/05/2021 - RWPX

| Town or Village: | Angmering | Inspection Direction: | Upstream | Upstream Node: | RWP |
| Road: | Dappers Lane | Inspected Length: | 1.40 m | Upstream Pipe Depth: | |

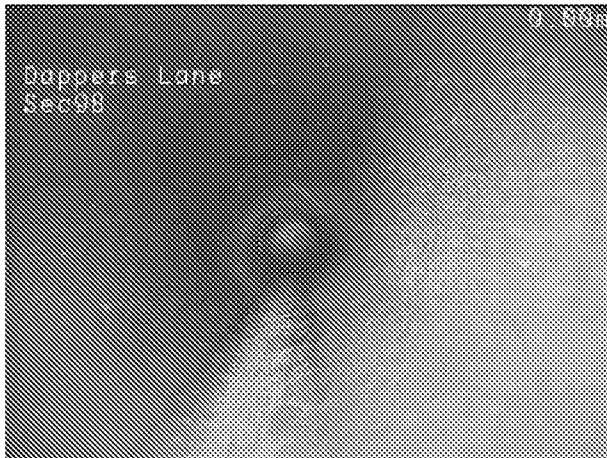
1, 00:00:00, 0.00 m  
Start node, manhole, reference: S32

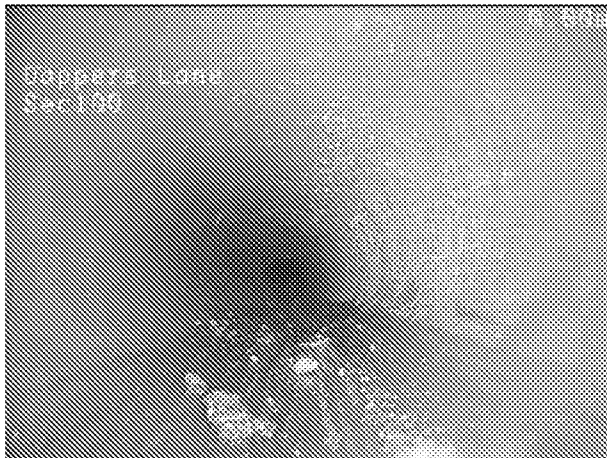
1, 00:00:00, 0.00 m  
Start node, manhole, reference: S32A

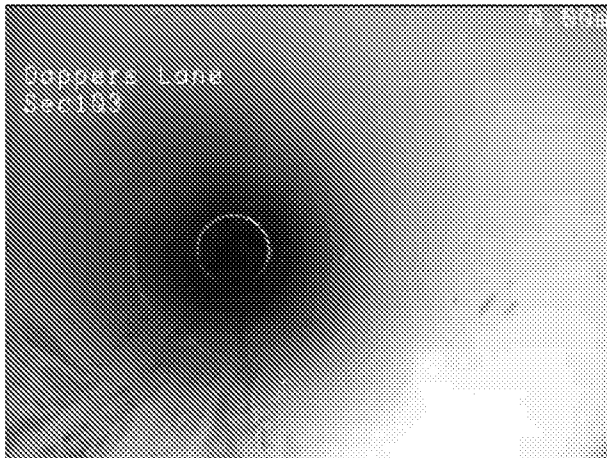
1, 00:00:00, 0.00 m  
Start node, manhole, reference: S6

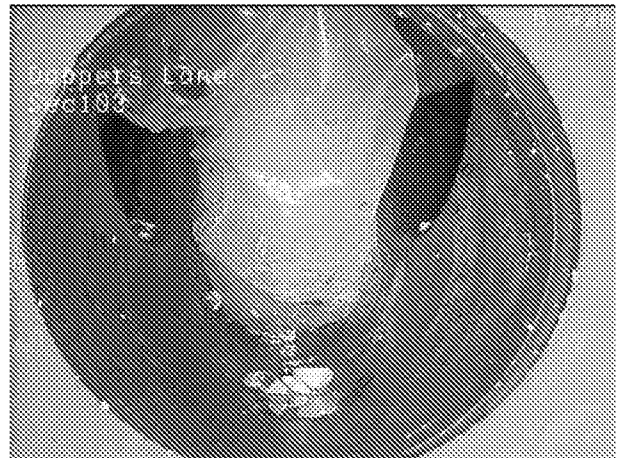
2, 00:00:41, 7.00 m  
Finish node, manhole, reference: S36

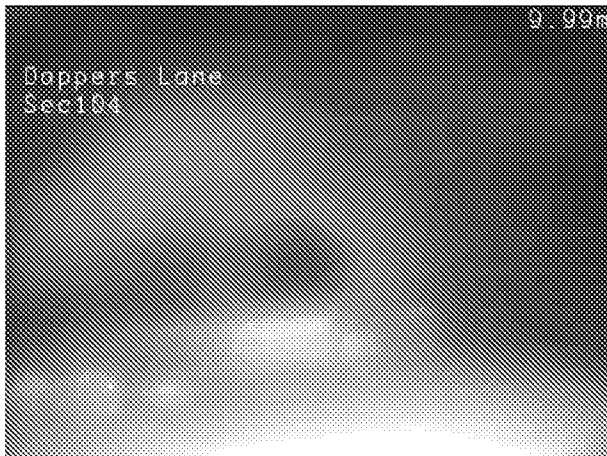
9, 00:01:29, 10.00 m  
Finish node, manhole, reference: S7, Buried under road

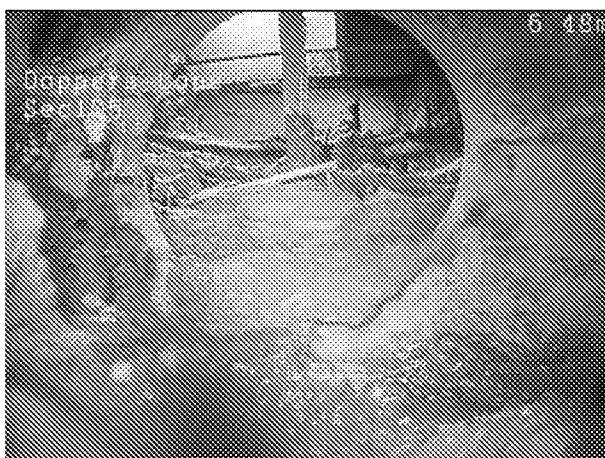
5, 00:00:41, 6.70 m  
Finish node, manhole, reference: RG, Debris in gully

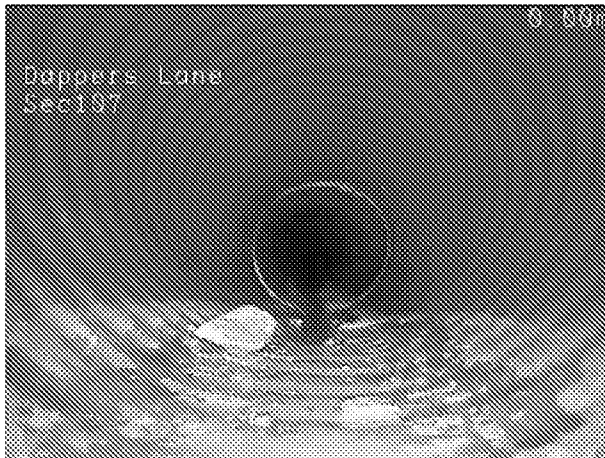
1, 00:00:00, 0.00 m  
Start node, manhole, reference: S8

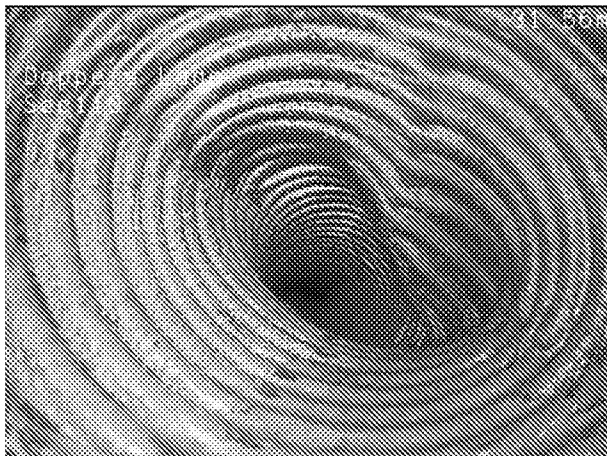
Deformed sewer or drain, 40%

S / 4

3, 00:02:07, 31.20 m  
Deformed sewer or drain, 40%

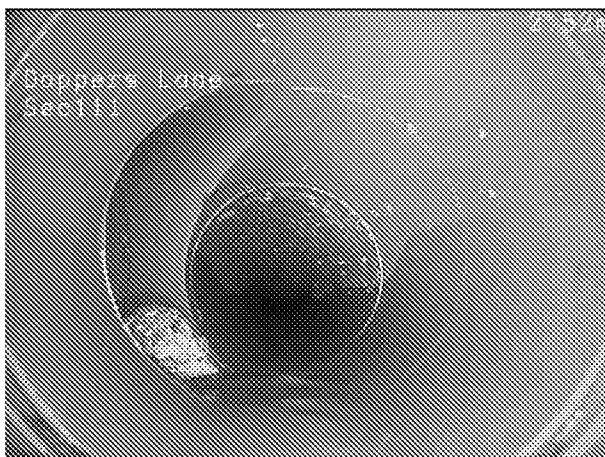
3, 00:00:24, 2.60 m  
Junction at 9 o'clock, 100mm dia

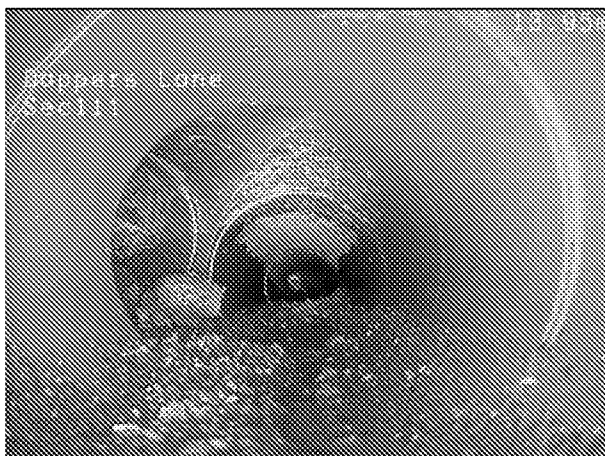
5, 00:02:04, 13.90 m  
Settled deposits, coarse, 15% cross-sectional area loss

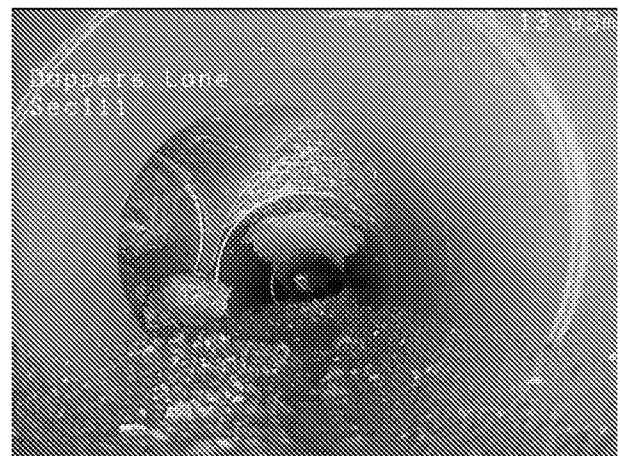
6, 00:02:04, 14.10 m  
Junction at 9 o'clock, 100mm dia

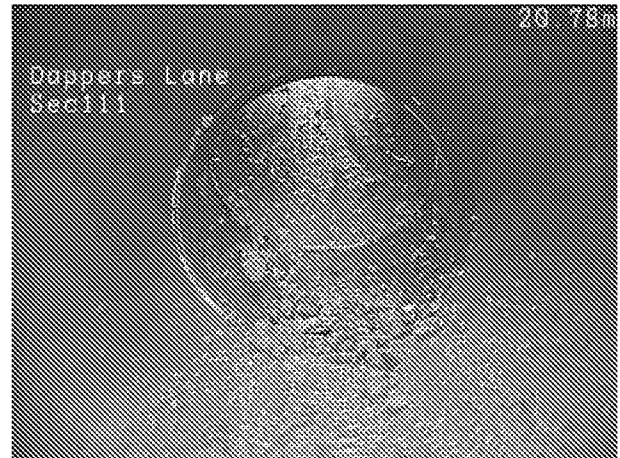
8, 00:01:27, 20.90 m  
Line deviates up

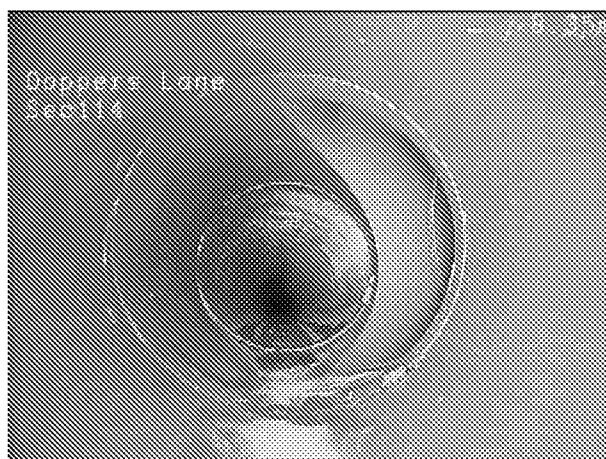
4, 00:00:41, 8.50 m  
Junction at 3 o'clock, 100mm dia

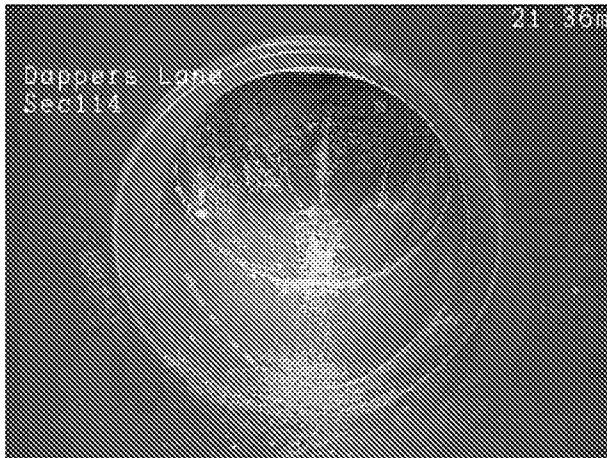
7, 00:01:15, 21.50 m  
Line deviates up

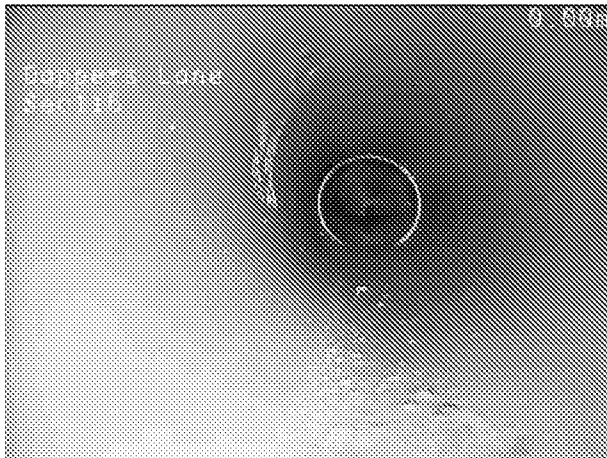
1, 00:00:00, 0.00 m  
Start node, manhole, reference: S37A

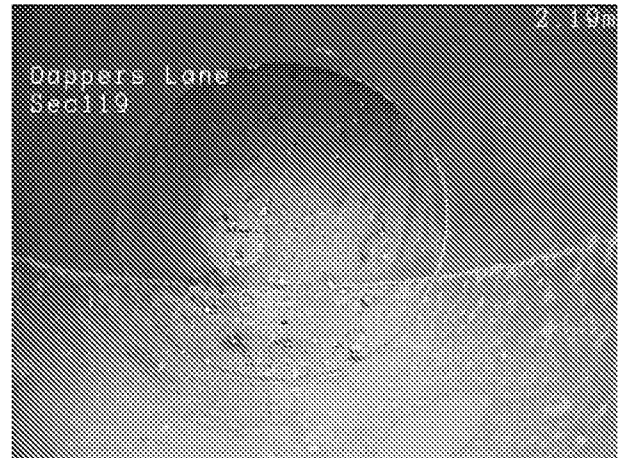
2, 00:00:15, 2.30 m  
Line deviates up
