## Section Pictures - 28/05/2021 - F29AX

| Town or Village: | Angmering | Inspection Direction: | Downstream | Upstream Node: | F29B |
| Road: | Dappers Lane | Inspected Length: | 2.30 m | Upstream Pipe Depth: | |

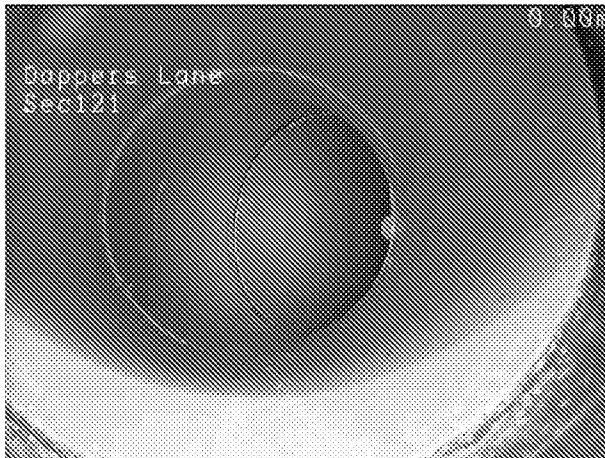
1, 00:00:00, 0.00 m  
Start node, manhole, reference: F29B

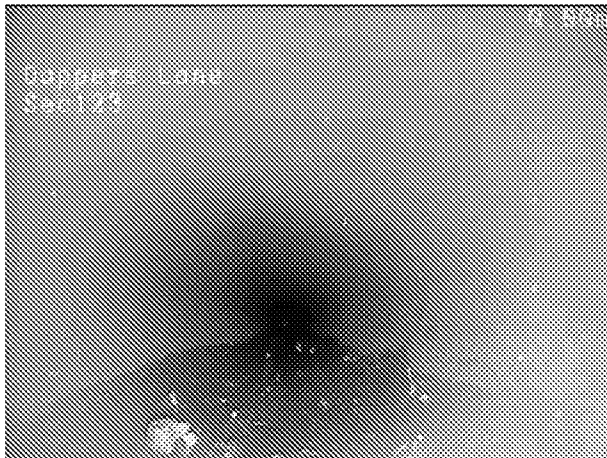
1, 00:00:00, 0.00 m  
Start node, manhole, reference: F29C

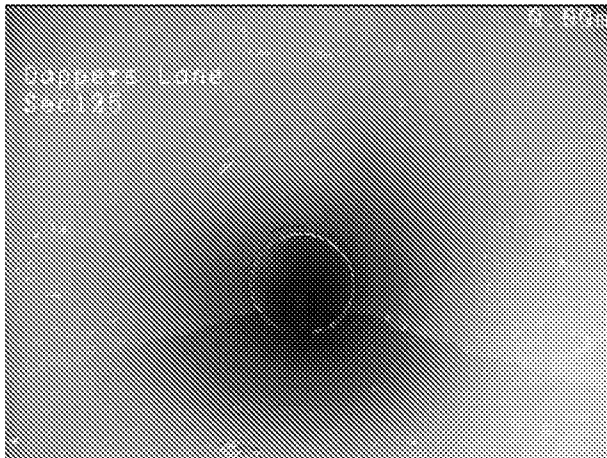
1, 00:00:00, 0.00 m  
Start node, manhole, reference: F29D

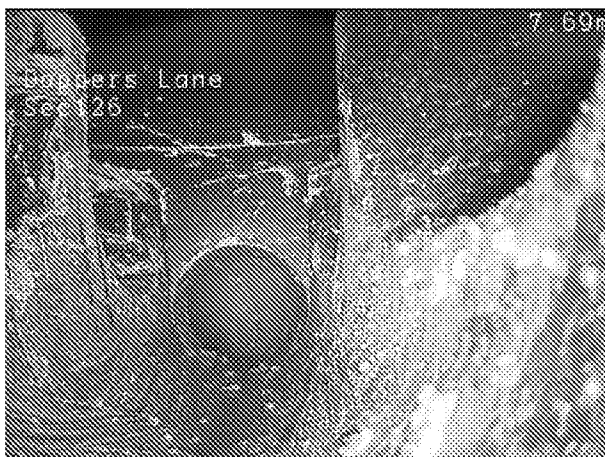
3, 00:00:29, 7.60 m  
Finish node, manhole, reference: F29

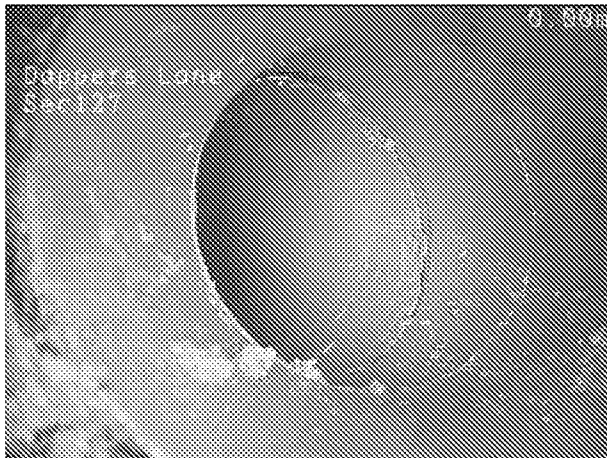
1, 00:00:00, 0.00 m  
Start node, manhole, reference: F29

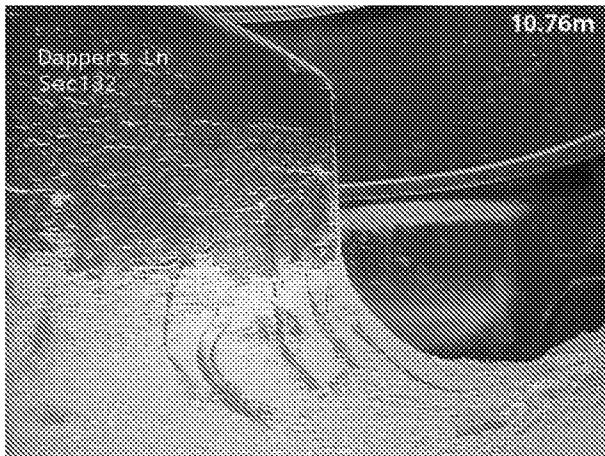
3, 00:00:52, 10.80 m  
Finish node, manhole, reference: S16

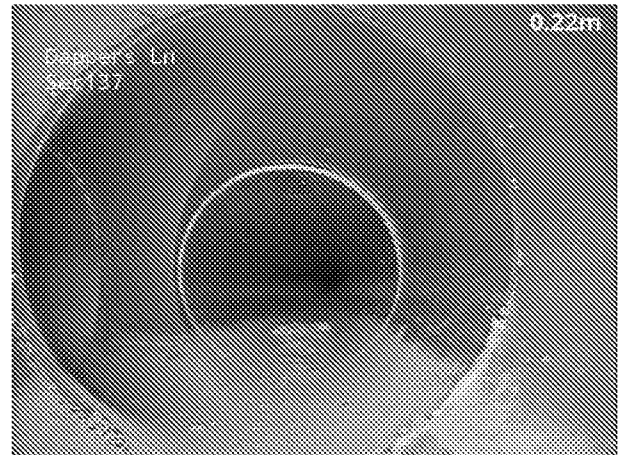
2, 00:00:18, 0.40 m  
Junction at 9 o'clock, 100mm dia

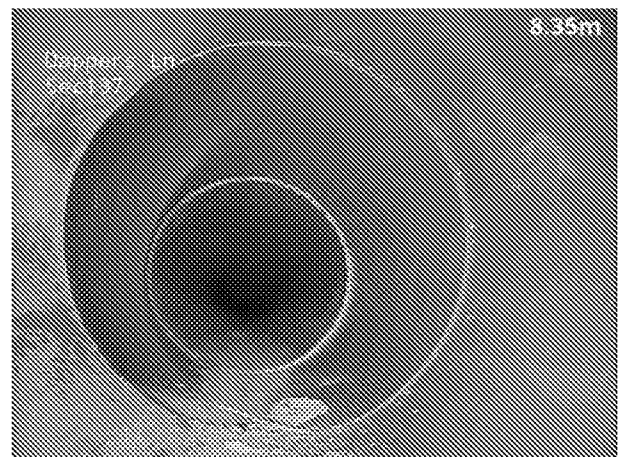
4, 00:00:54, 8.50 m  
Junction at 9 o'clock, 100mm dia

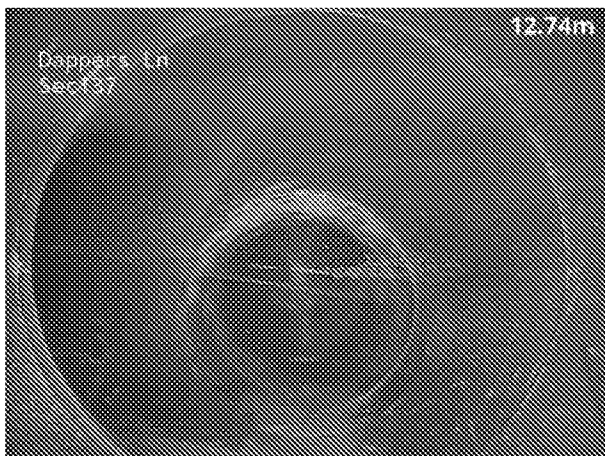
5, 00:01:08, 12.80 m  
Junction at 9 o'clock, 100mm dia

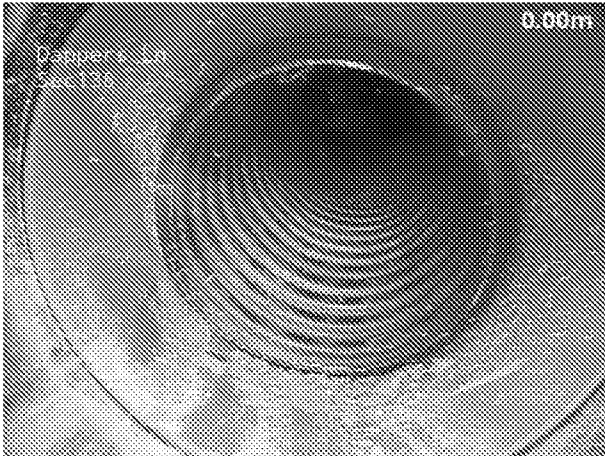
1, 00:00:07, 0.10 m  
Finish node, manhole, reference: LD

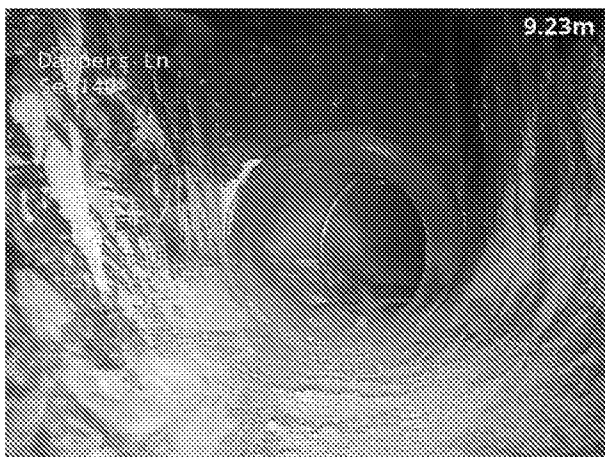
3, 00:00:51, 9.10 m  
Finish node, manhole, reference: F33

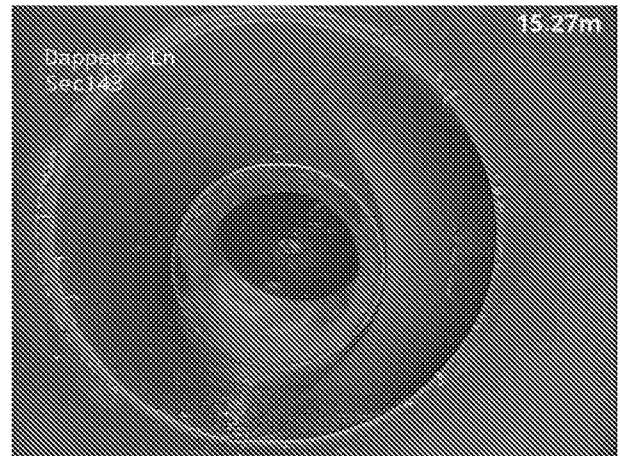
4, 00:01:01, 15.40 m  
Junction at 3 o'clock, 100mm dia
