## Section Inspection - 20/07/2021 - S18X

| Town or Village: | Angmering | Inspection Direction: | Downstream | Upstream Node: | S18 |
| Road: | Dappers Lane | Inspected Length: | 14.00 m | Upstream Pipe Depth: | |

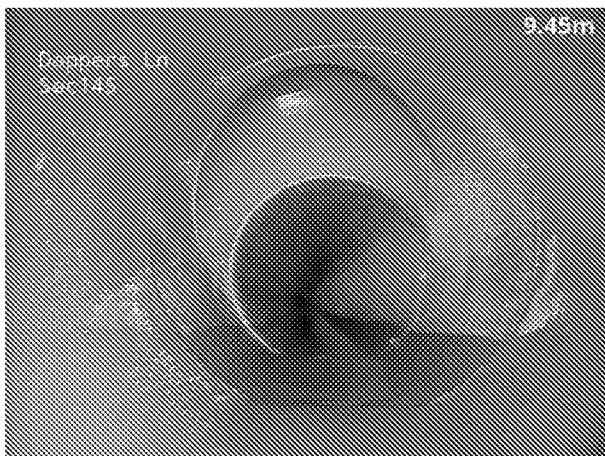
5, 00:01:02, 9.60 m  
Junction at 11 o'clock, 100mm dia

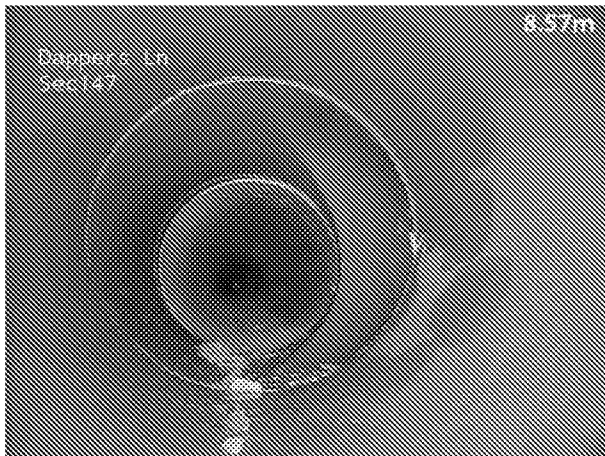
3, 00:00:37, 8.70 m  
Junction at 3 o'clock, 100mm dia

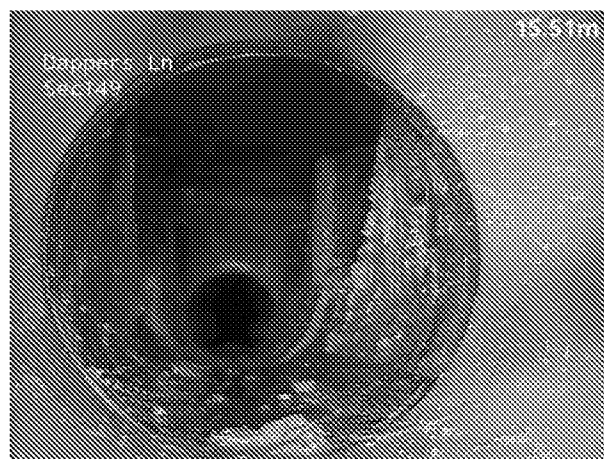
4, 00:00:58, 15.70 m  
Finish node, manhole, reference: S21

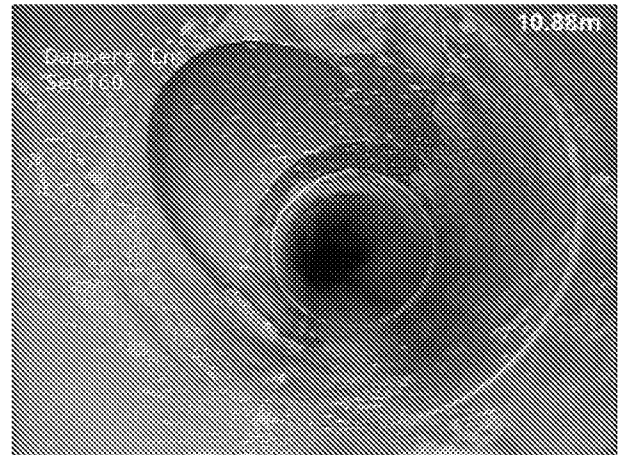
8, 00:00:53, 11.00 m  
Junction at 10 o'clock, 100mm dia

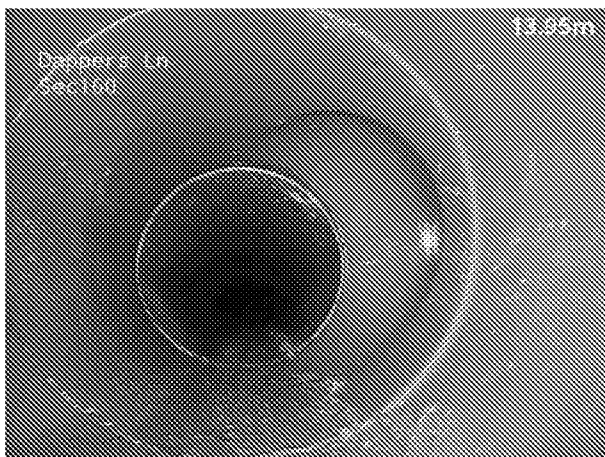
9, 00:01:47, 14.20 m  
Junction at 3 o'clock, 100mm dia

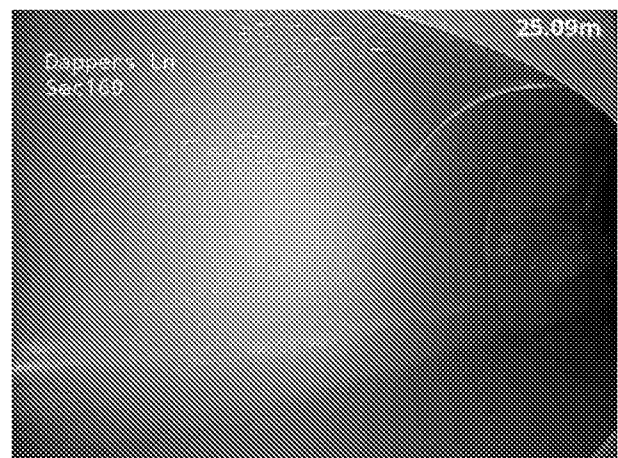
12, 00:01:42, 25.20 m  
Finish node, major connection without manhole, reference: JN

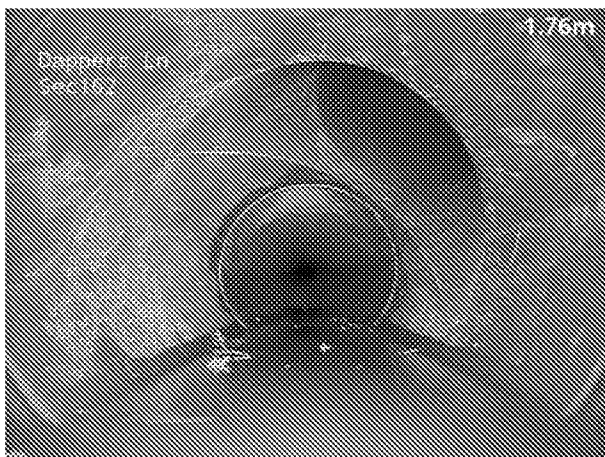
3, 00:00:24, 1.90 m  
Junction at 1 o'clock, 100mm dia

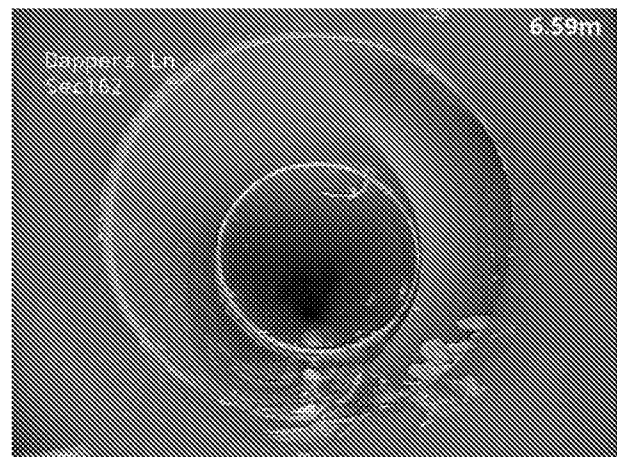
4, 00:00:38, 6.80 m  
Junction at 3 o'clock, 100mm dia

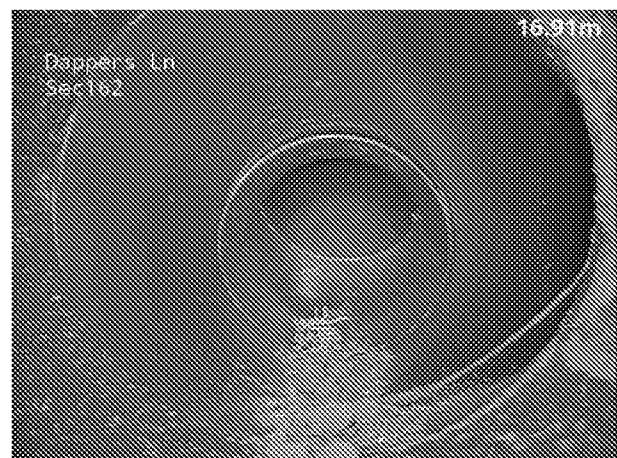
6, 00:01:01, 17.00 m  
Junction at 3 o'clock, 10mm dia
