**Project Name:** Mackoy Ltd - Langmead Place Angmering

**Project Date:** 04/11/2025

**Inspection Standard:** MSCC5 Sewers & Drainage GB (SRM5 Scoring)

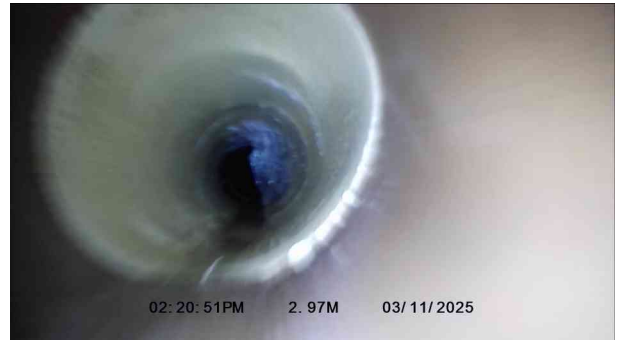
| Scale: | 1:88 | Position [m] | Code | Observation | MPEG | Photo | Grade |
|---|---|---|---|---|---|---|---|
| | 2.97 | S01 | RPL | Point repair, localised lining from 12 o'clock to 11 o'clock, start | 00:00:11 | 2 | |

2, 00:00:11, 2.97 m  
Point repair, localised lining from 12 o'clock to 11 o'clock, start

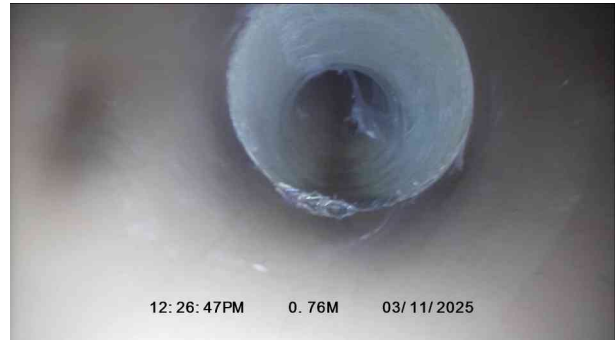
| Scale: | 1:76 | Position [m] | Code | Observation | MPEG | Photo | Grade |
|---|---|---|---|---|---|---|---|
| | 0.76 | S01 | RPL | Point repair, localised lining from 12 o'clock to 11 o'clock, start | 00:00:15 | 2 | |

2, 00:00:15, 0.76 m  
Point repair, localised lining from 12 o'clock to 11 o'clock, start

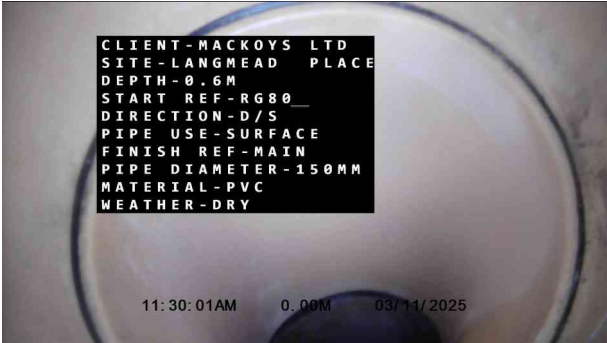
1, 00:00:00, 0.00 m  
Start node, gully, reference: RG80

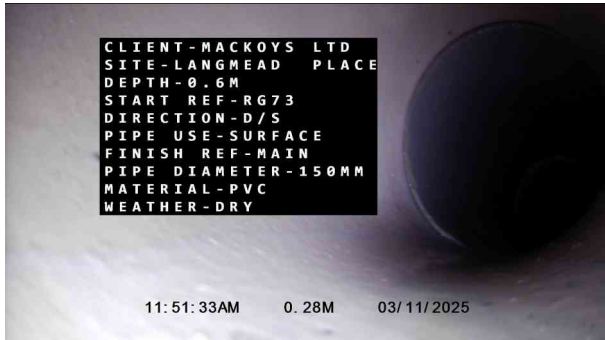
1, 00:00:00, 0.00 m  
Start node, gully, reference: RG73

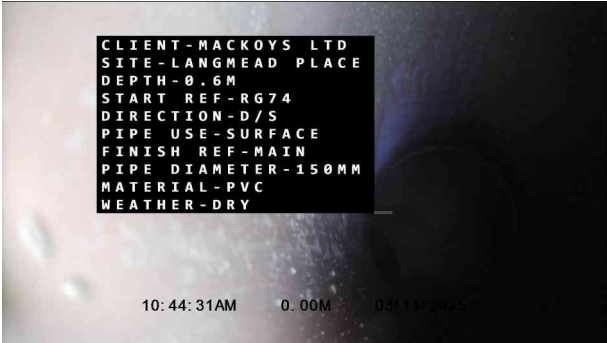
1, 00:00:00, 0.00 m  
Start node, gully, reference: RG74

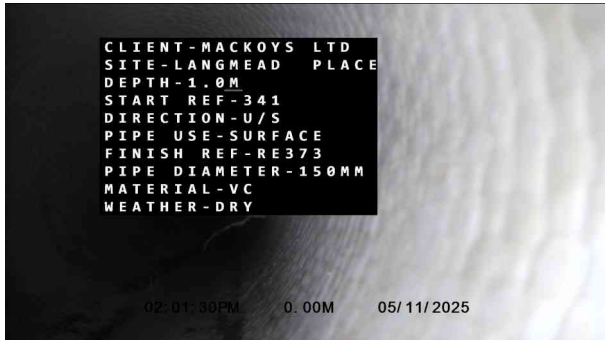
1, 00:00:00, 0.00 m  
Start node, manhole, reference: 341

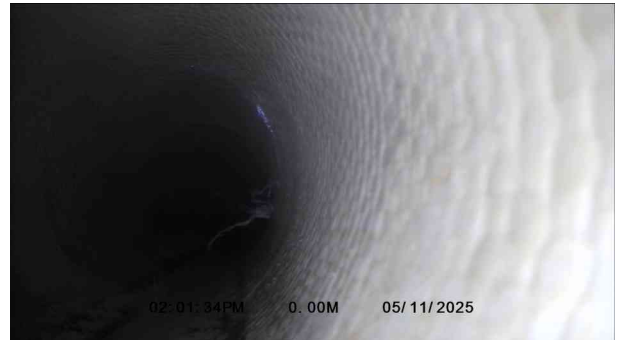
| Scale: | 1:80 | Position [m] | Code | Observation | MPEG | Photo | Grade |
|---|---|---|---|---|---|---|---|
| 0.00 | S01 | RPL | | Point repair, localised lining from 12 o'clock to 11 o'clock, start | 00:00:07 | 2 | |
| 0.86 | F01 | RPL | | Point repair, localised lining from 12 o'clock to 11 o'clock, finish | 00:00:14 | | |

2, 00:00:07, 0.00 m  
Point repair, localised lining from 12 o'clock to 11 o'clock, start

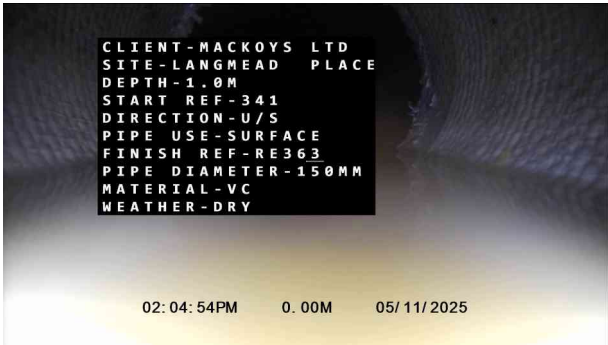
1, 00:00:00, 0.00 m  
Start node, manhole, reference: 341

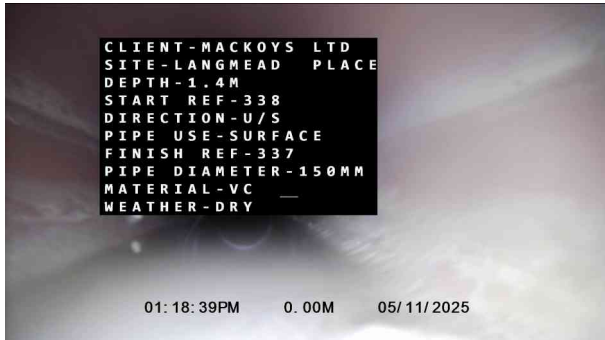
1, 00:00:00, 0.00 m  
Start node, manhole, reference: 338

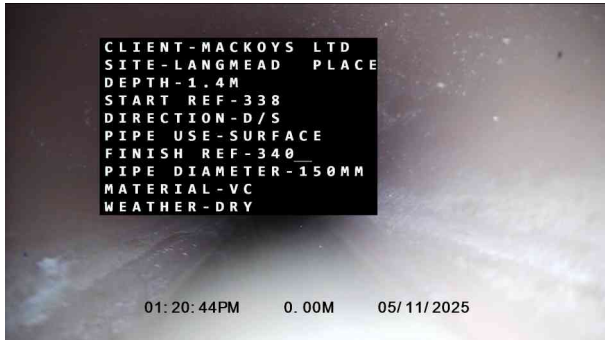
1, 00:00:00, 0.00 m  
Start node, manhole, reference: 338

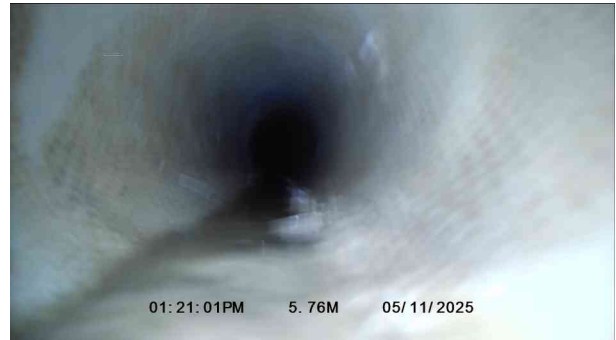
<table><tr><th>Code</th><th>Observation</th><th>MPEG</th><th>Photo</th><th>Grade</th></tr><tr><td>S01</td><td>RPL Point repair, localised lining from 12 o'clock to 11 o'clock, start</td><td>00:00:19</td><td>2</td><td></td></tr><tr><td>F01</td><td>RPL Point repair, localised lining from 12 o'clock to 11 o'clock, finish</td><td>00:00:22</td><td></td><td></td></tr></table>

2, 00:00:19, 5.76 m  
Point repair, localised lining from 12 o'clock to 11 o'clock, start

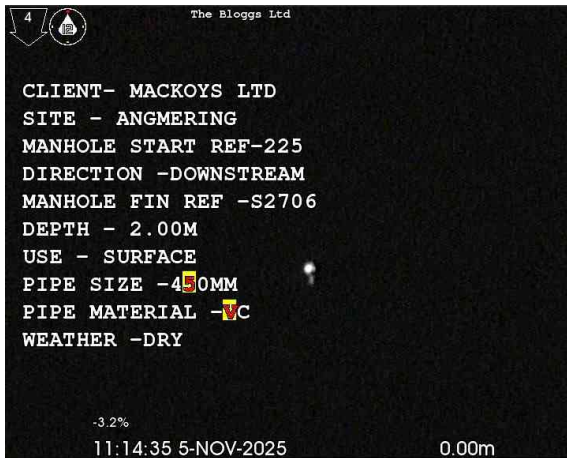
1, 00:00:00, 0.00 m  
Start node, manhole, reference: 225

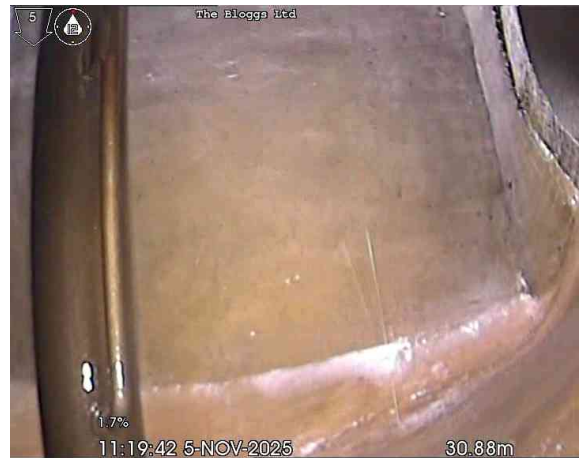
2, 00:03:04, 30.88 m  
Finish node, manhole, reference: S2706

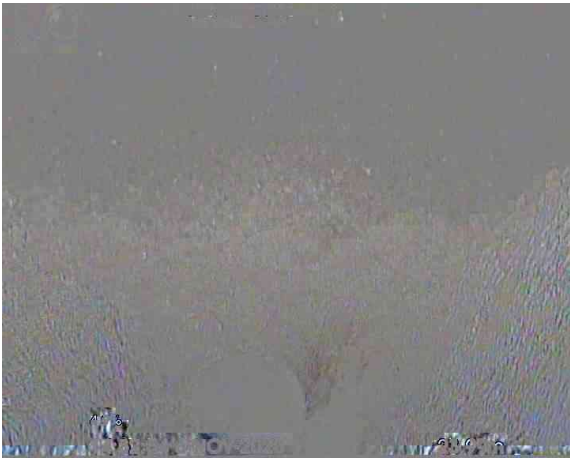
2, 00:01:32, 24.05 m  
Finish node, manhole, reference: F24

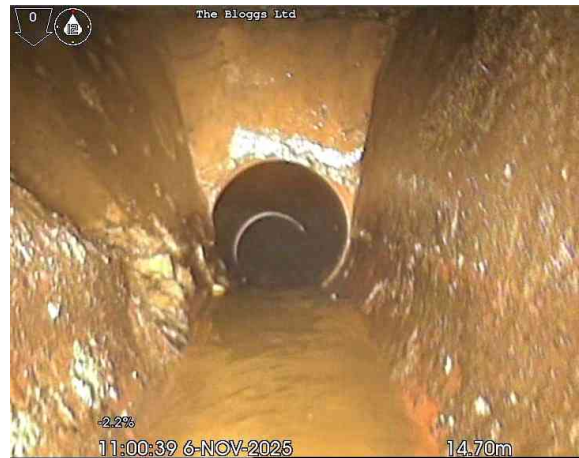
2, 00:01:59, 14.70 m  
Finish node, manhole, reference: F43

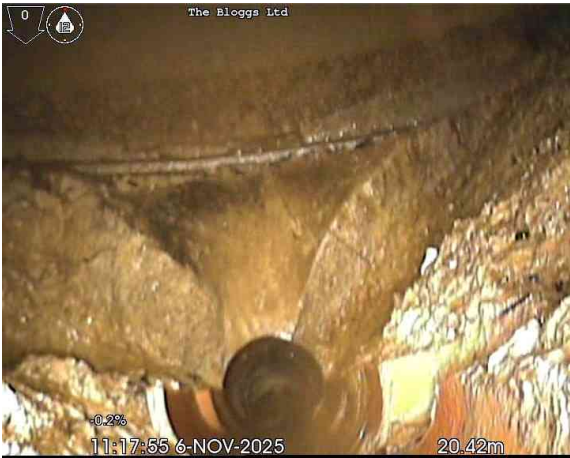
2, 00:02:25, 20.42 m  
Finish node, manhole, reference: F47

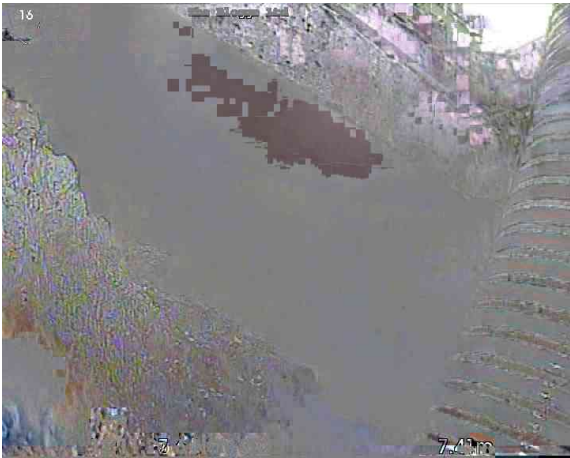
2, 00:01:04, 7.41 m  
Finish node, manhole, reference: F19

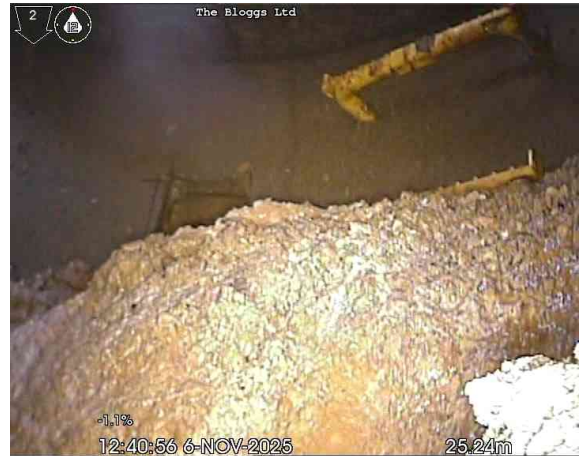
2, 00:02:49, 25.24 m  
Finish node, manhole, reference: F20

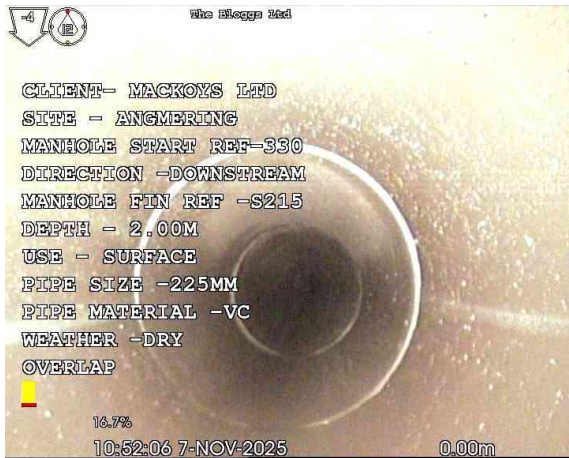
1, 00:00:00, 0.00 m  
Start node, manhole, reference: 330

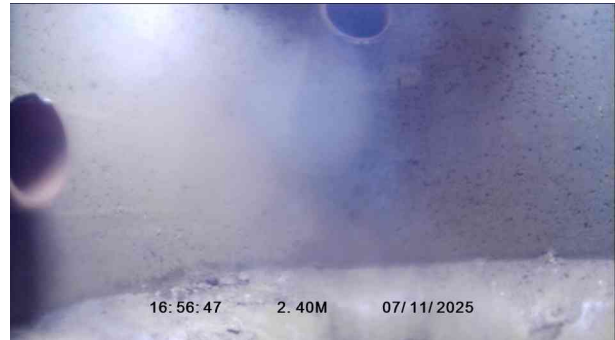
2, 00:00:41, 2.40 m  
Finish node, manhole, reference: F41

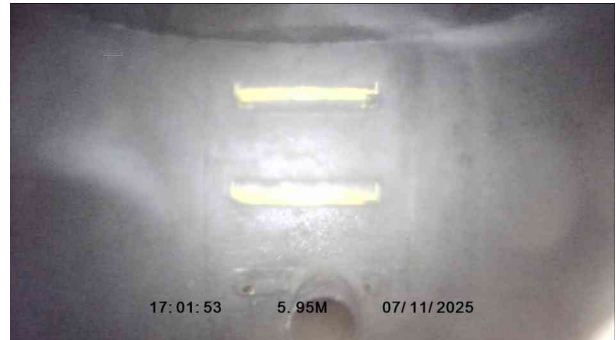
2, 00:00:25, 5.95 m  
Finish node, manhole, reference: F41

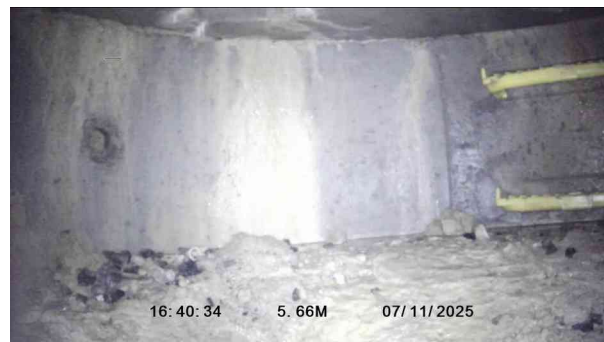
2, 00:00:36, 5.66 m  
Finish node, manhole, reference: F18

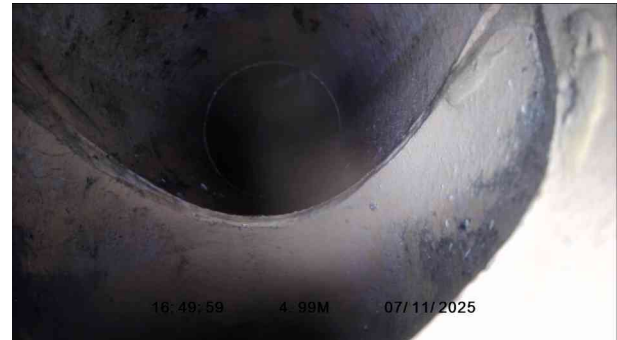
2, 00:00:31, 4.99 m  
Finish node, manhole, reference: F39

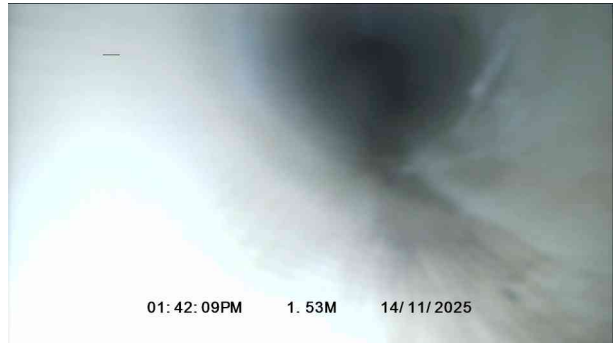
| Scale: | 1:74 | Position [m] | Code | Observation | MPEG | Photo | Grade |
|---|---|---|---|---|---|---|---|
| | 1.53 | S01 | RPL | Point repair, localised lining from 12 o'clock to 11 o'clock, start | 00:00:10 | 2 | |

2, 00:00:10, 1.53 m  
Point repair, localised lining from 12 o'clock to 11 o'clock, start
