## RICS Home Surveys Building Survey

Dormouse Cottage  
The Square  
Angmering  
LITTLEHAMPTON  
BN16 4EA

2nd February 2021

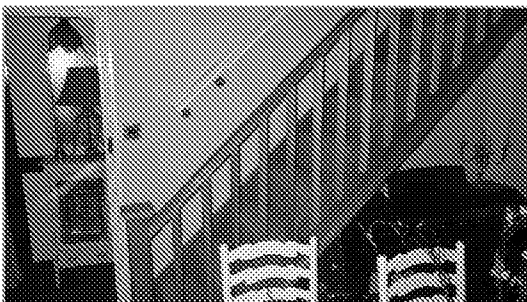
Photo - 38

The property has a timber staircase which is carpeted on the upper surface and enclosed beneath. Treads and risers appear to be firm and level and within normal tolerances, with no signs of any significant spring or undulation noted.

Condition rating 1. No repair is currently needed. The property must be maintained in the normal way.

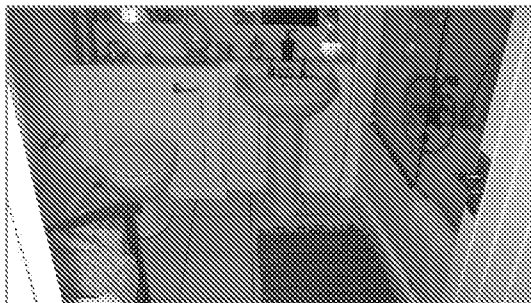
Photo - 39

The kitchen is provided with a range of basic units which appeared serviceable although individual units were not inspected in detail there is some wear and tear. There are a good range of base and wall units with a stainless steel sink and laminate worktops. The kitchen should be provided with a mechanical extractor fan.

Condition rating 1. No repair is currently needed. The property must be maintained in the normal way.

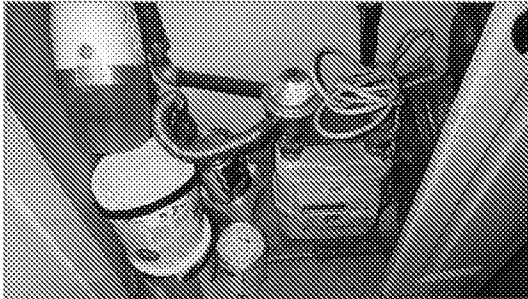
Photo - 42

Condition rating 3. These investigations should be carried out immediately.
