**Bellamy Wallace Partnership**  
Consulting Structural Engineers

**REPORT ON VISUAL INSPECTION OF  
CONDITION OF EXISTING BUILDINGS AT  
SITE OF PROPOSED REDEVELOPMENT**

**Arundel Road  
Angmering,  
Littlehampton,  
BN16 4ET**

Date: 01 March 2023

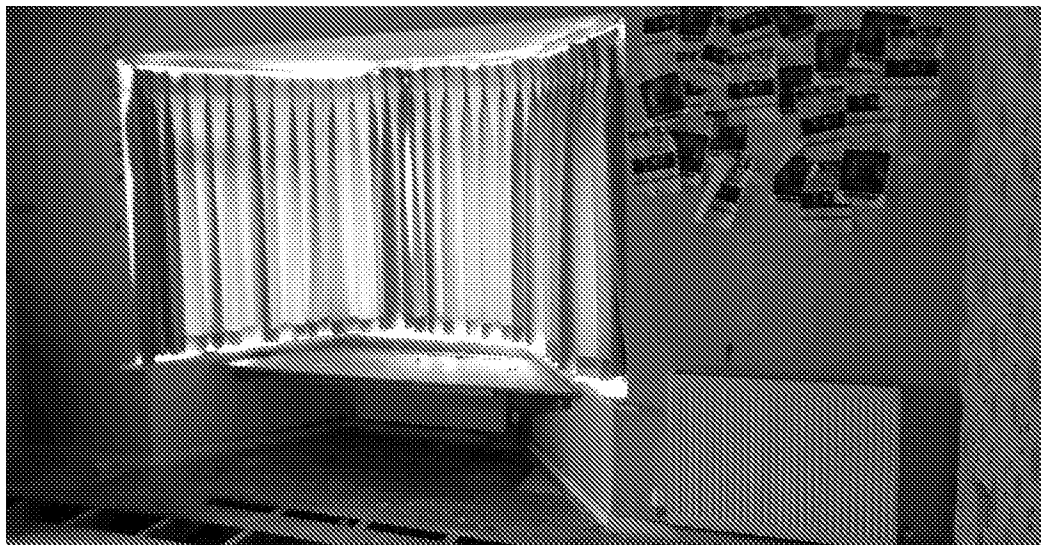
Photo 8 - Block A - front bay window

- 3.1.1 The ground bearing slab appears to be settling unevenly as evidenced by the cracking shown in the photos 6 to 10 and 13 and may be subject to heave.
- 3.1.2 Cracking of the ground bearing slab outside the house and in the drive would appear to be indicative of further settlement.
- 3.1.3 The beam propping the roof of the garage appears to have inadequate restraint.
- 3.1.4 Cracks to the walls within the building would appear to be consistent with settlement of the ground bearing slab.

Given the uneven settlement of the ground bearing slab and the cracking that this appears to have caused to the walls of the house and garage it is recommended that the house and garage be demolished.

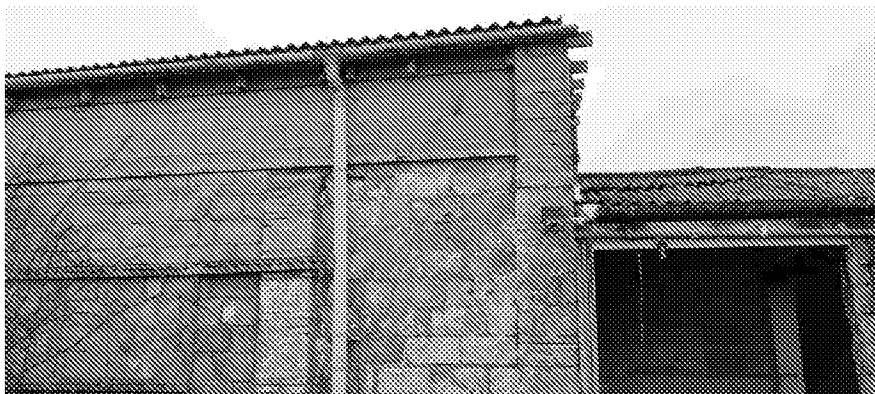
- 4.1.1 The wall detail in photo 17 with a concrete block vertical extension on top is not of robust construction and the quality of construction cannot be verified.
- 4.1.2 Photo 21 shows a prop to support the roof beam and trusses. This would appear not to meet the requirements of robustness and has the potential for collapse as the removal of this prop could cause the roof to become unsafe.
- 4.1.3 The extension at the end in rendered block is cracking in the gable wall.

Photo 17 – Block B - Side elevation – vertical extension in concrete block above the stone block

The vertical wall extension is potentially unsafe, the gable end of the extension is cracking and the roof would appear to be unsafe. Given these factors it is recommended that the building be demolished.

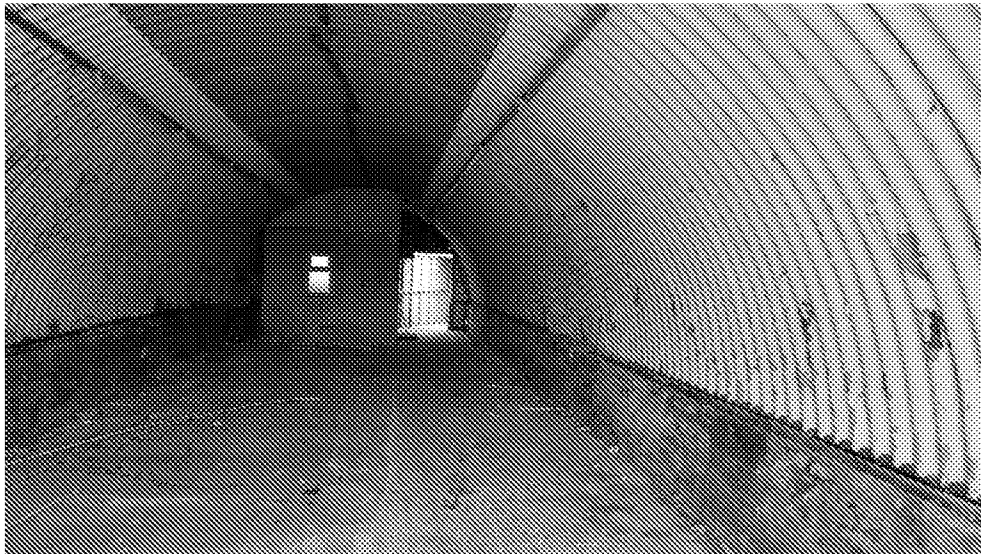
- 5.0.1 Block C comprises 5no. Nissen style huts comprising concrete block walls with a curved corrugated iron roof. The gable walls are concrete block.
- 5.0.2 In front of hut C5 there appears to be an oil storage bund or petrol interceptor. There was oil present at the site.
- 5.0.3 Photos 29 and 30 show cracking in the ground bearing slab.
- 5.0.4 Photo 35 shows damage and cracking to the gable wall of one of the huts.
- 5.0.5 Photo 36 shows cracking to the gable wall of one of the huts.
- 5.0.6 Photo 37 shows cracking to the ground bearing slab.
- 5.0.7 Photo 38 shows a steel column and beam supporting the roller shutter door in the gable wall of one of the huts. The column is in poor condition.

- 5.1.1 There is cracking and some damage to the gable walls of the huts.
- 5.1.2 There is cracking indicative of settlement in some of the ground bearing slabs.
- 5.1.3 There was a smell of oil in some of the huts and an oil storage bund or petrol interceptor in front of hut C5. Therefore, there is potentially oil contamination in the ground which might necessitate removing and replacing the ground as part of remediation.

Photo 29 – Block C - Internal view of Hut C5

- A) The ground bearing slabs show cracking, the gable walls are cracking and damaged and there is the potential of oil contamination in the ground. Given these factors it is recommended that the buildings be demolished.
- B) The existing petrol interceptor should be further inspected in order to ascertain its setting out and extent i.e. depth and form of construction.

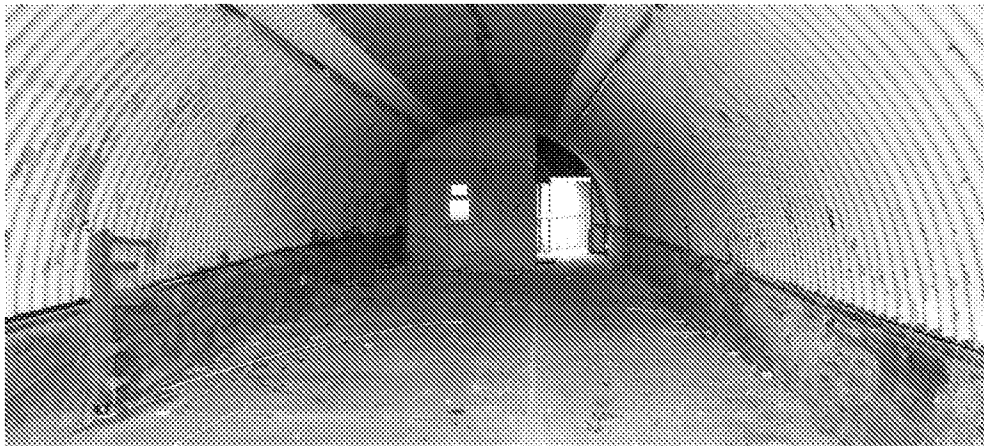
Photo 30 – Block C – Internal view of Hut C5

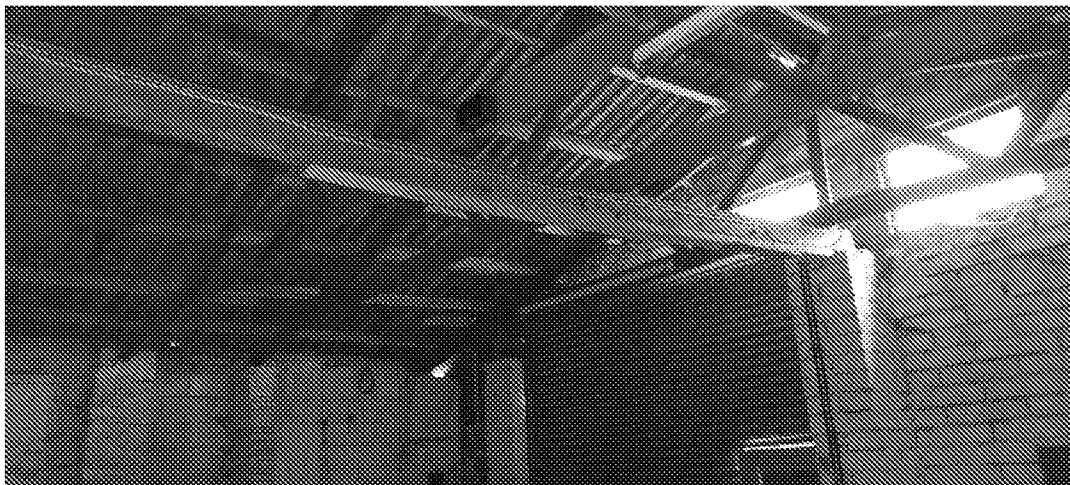
- 6.1.1 The roof is sagging and the props supporting the roof appear to be temporary props rather than permanent construction.
- 6.1.2 There is cracking indicative of settlement in the ground bearing slab.
- 6.1.3 The rear wall is leaning outwards in which could be spread from the roof load above.

Photo 47 – Block D – Roof beam propping roof trusses

The ground bearing slab is cracking and the rear wall and roof are non-robust and potentially unsafe. The ground bearing slab is cracking, which implies some ground movement and subject to further soils investigation should be removed. The existing roof structure would appear to be of a sub-standard form of construction and is propped temporarily throughout. Spread of the roof at the eaves would appear to have affected the perimeter walls, which now appear out of tolerance. Given these factors it is recommended that the buildings be demolished.

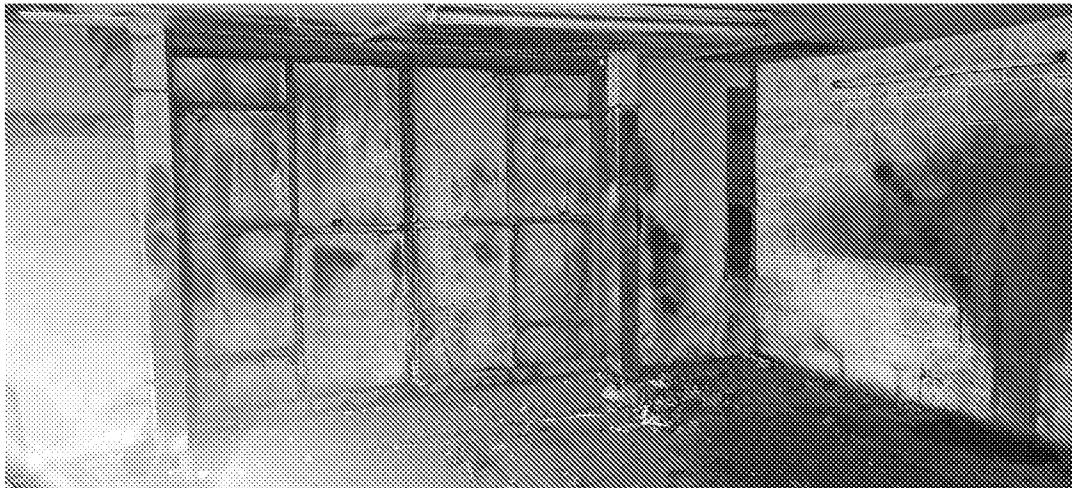
- 7.1.1 The roof is sagging.
- 7.1.2 The gable wall is cracked.
- 7.1.3 The construction method of propping the wall laterally is not robust and is in poor condition. Precast concrete posts are strapped to the wall to provide lateral propping to the blockwork wall panels. This does not appear to be a robust method of propping, which could leave the wall panel without adequate lateral support.

Photo 53 – Block E – Gable entrance

Given the factors listed in 7.1 is recommended that the buildings be demolished.

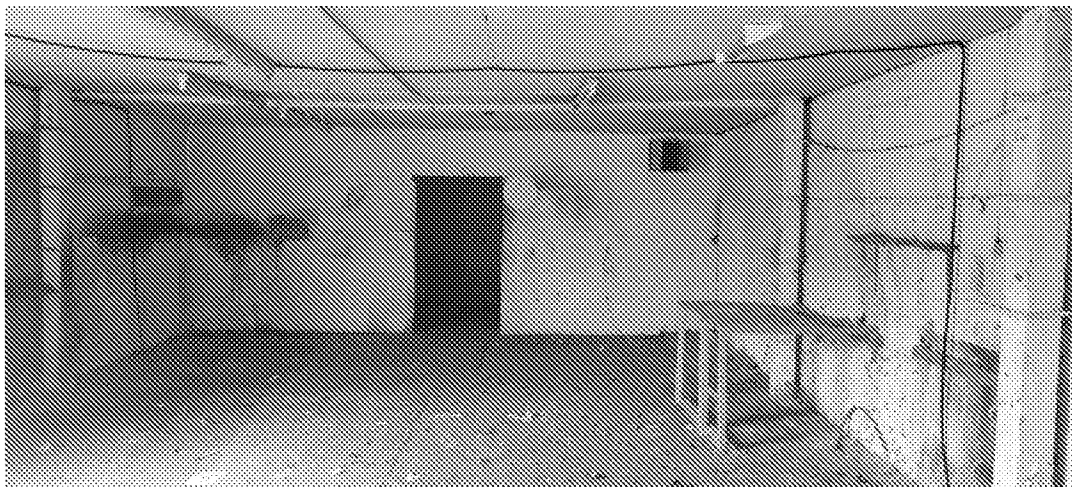
Photo 54 – Block E – Internal view

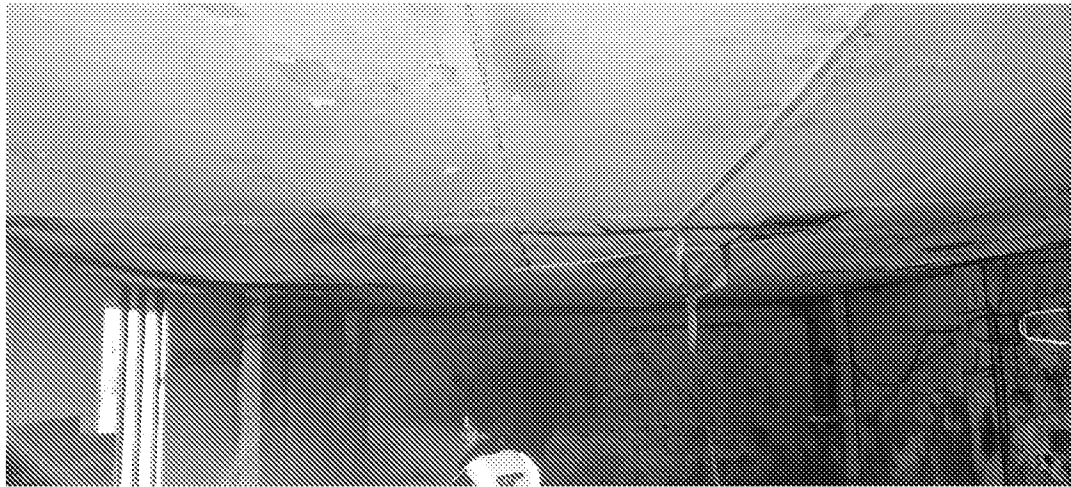
- 7.0.1 Block E comprises a single building in load bearing rendered blockwork with a corrugated iron roof.
- 7.0.2 Photo 48 shows the roof to be sagging unevenly.
- 7.0.3 Photo 51 shows cracking in the entrance gable wall.
- 7.0.4 Photo 52 shows the walls propped laterally using precast concrete posts that are strapped to the wall to provide lateral propping to the blockwork wall panels.

Photo 55 – Block E – View of roof

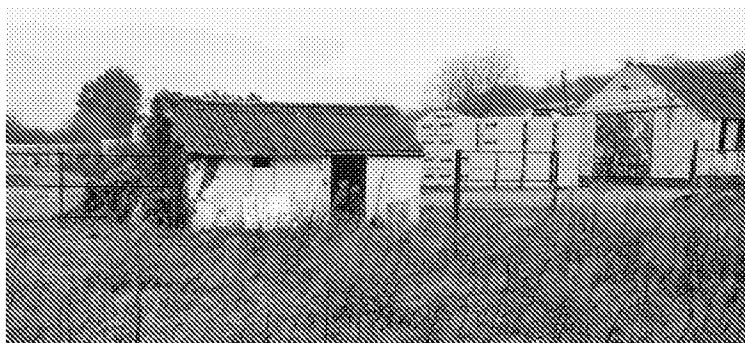
Photo 57 – Block F – Side elevation

Given the factors listed in 8.1 is recommended that the building be demolished.

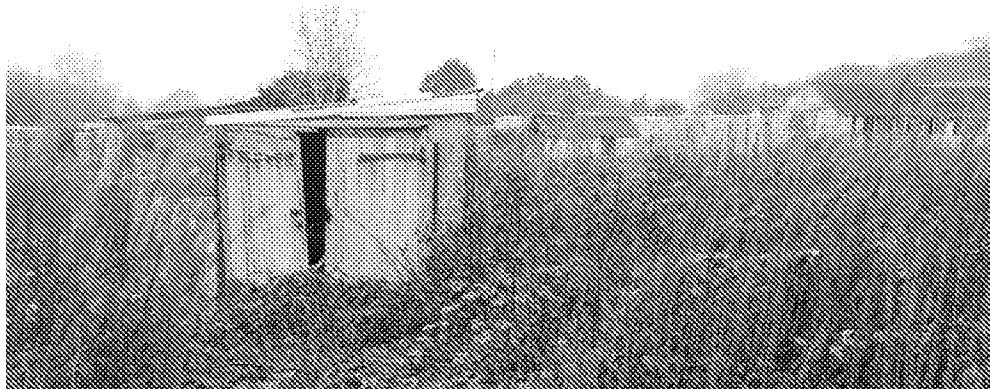
10.0.3 Above the doorway at the gable end the blocks over the lintel were loose.

Photo 61 – Block H – Gable end

Given the factors listed in 10.1 it is recommended that the building be demolished.

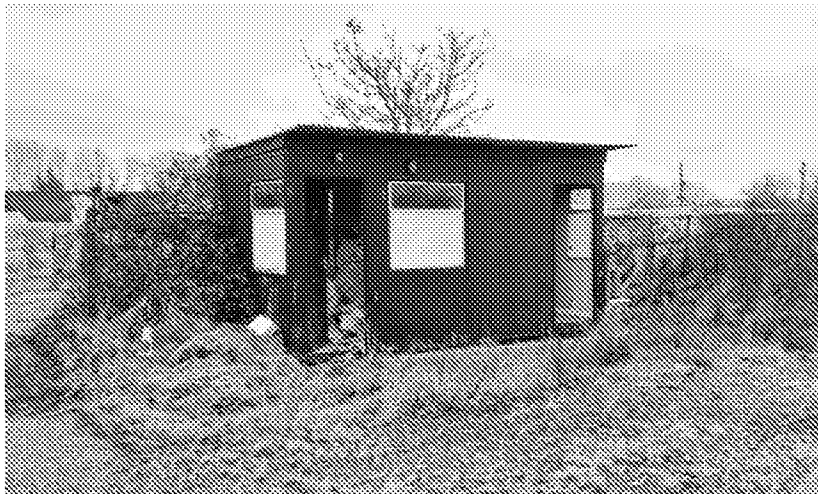
11.1.1 The hut is more of a temporary structure akin to a portacabin or caravan than a permanent structure.

Photo 62 – Block J – View of the hut

Given the factor listed in 11.1 it is recommended that the hut be demolished and removed.
