# Damp Survey

The Vestry Cottage  
Arundel Road  
Angmering  
West Sussex BN16 4JS

6 January 2026

Our Reference: 2601050126DW

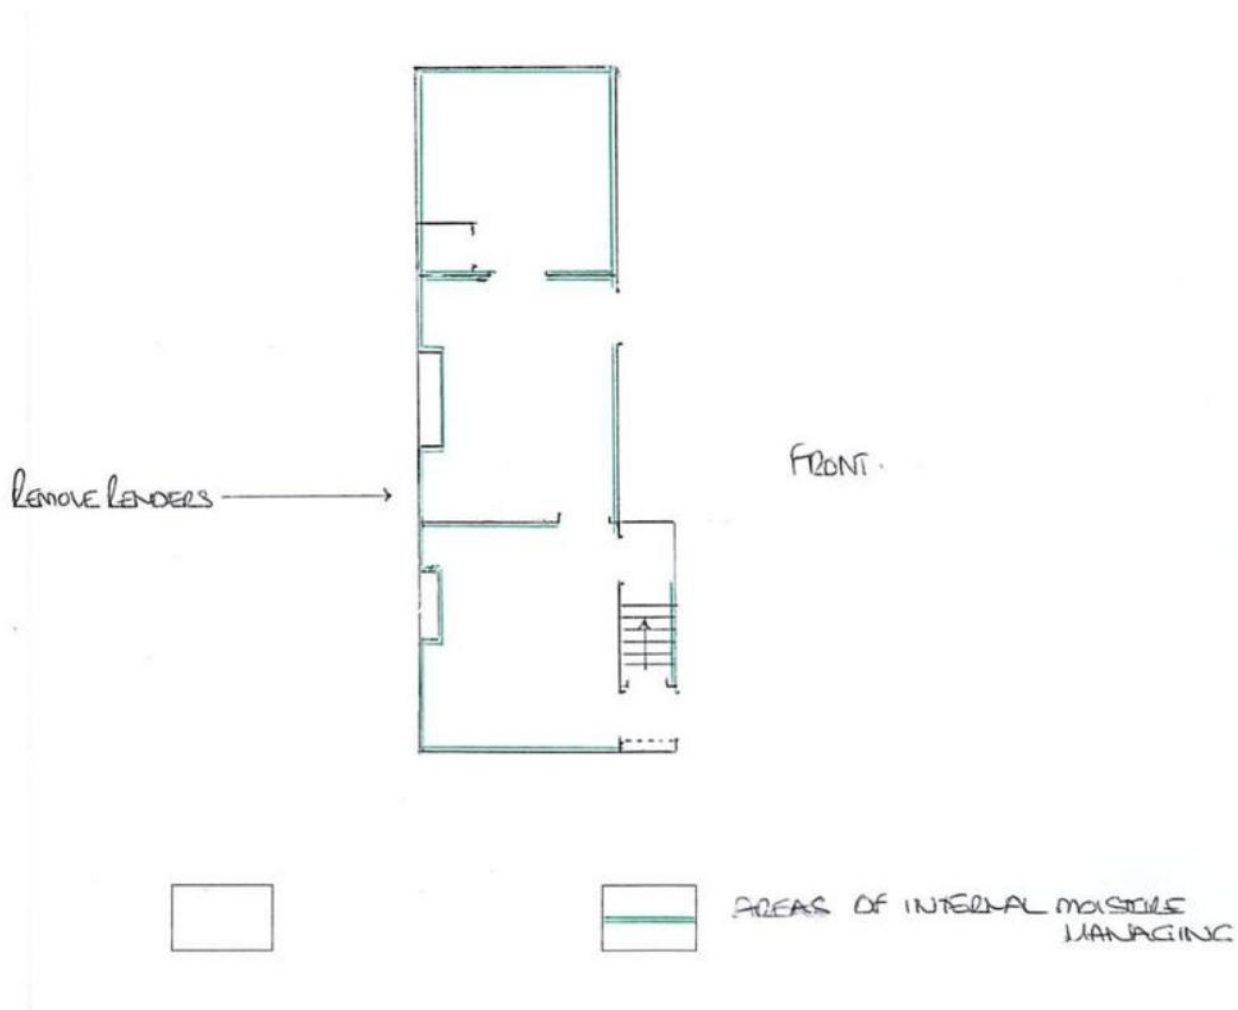
Inspection of the ground floor walls where accessible and using a dual mode protimeter surveymaster moisture meter and visual evidence in our opinion revealed evidence of rising damp to the walls indicated on the sketch plan.
