**Tree Survey, Appraisal  
and  
Arboricultural Impact Assessment**  
in accordance with BS 5837 : 2012  
Trees in relation to design, demolition and construction - Recommendations.

Trees in relation to  
**Proposed highway improvement works**  
**Manor Nursery, High Street, Angmering,  
West Sussex.**

Prepared for  
Hanbury Properties.  
March 2014

**ARBORTECH** (Consultancy)

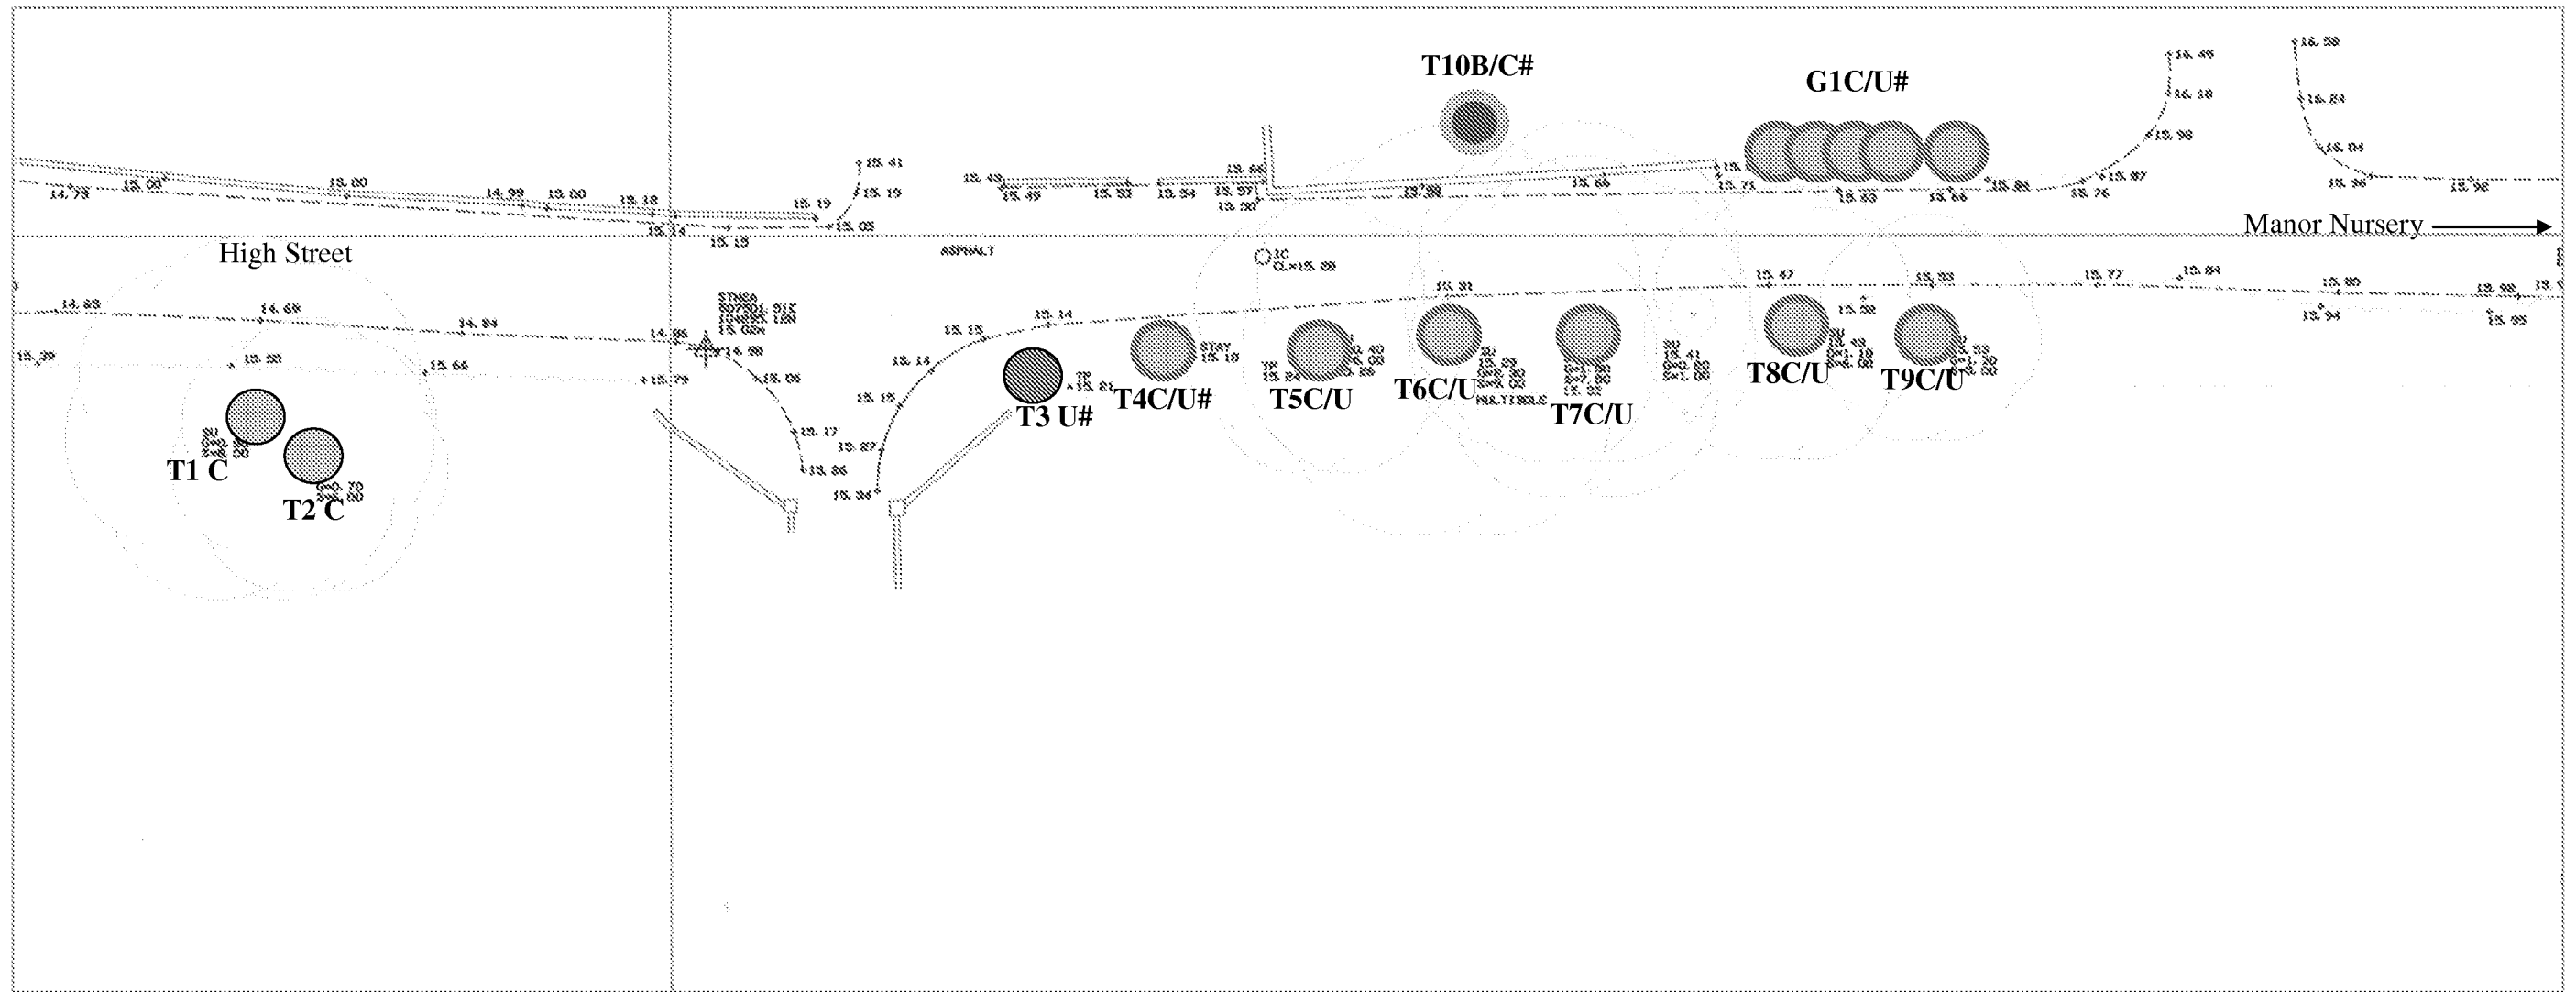
### TREE SURVEY PLAN

To be read in conjunction with Appendix 4 'Tree Survey Notes'.

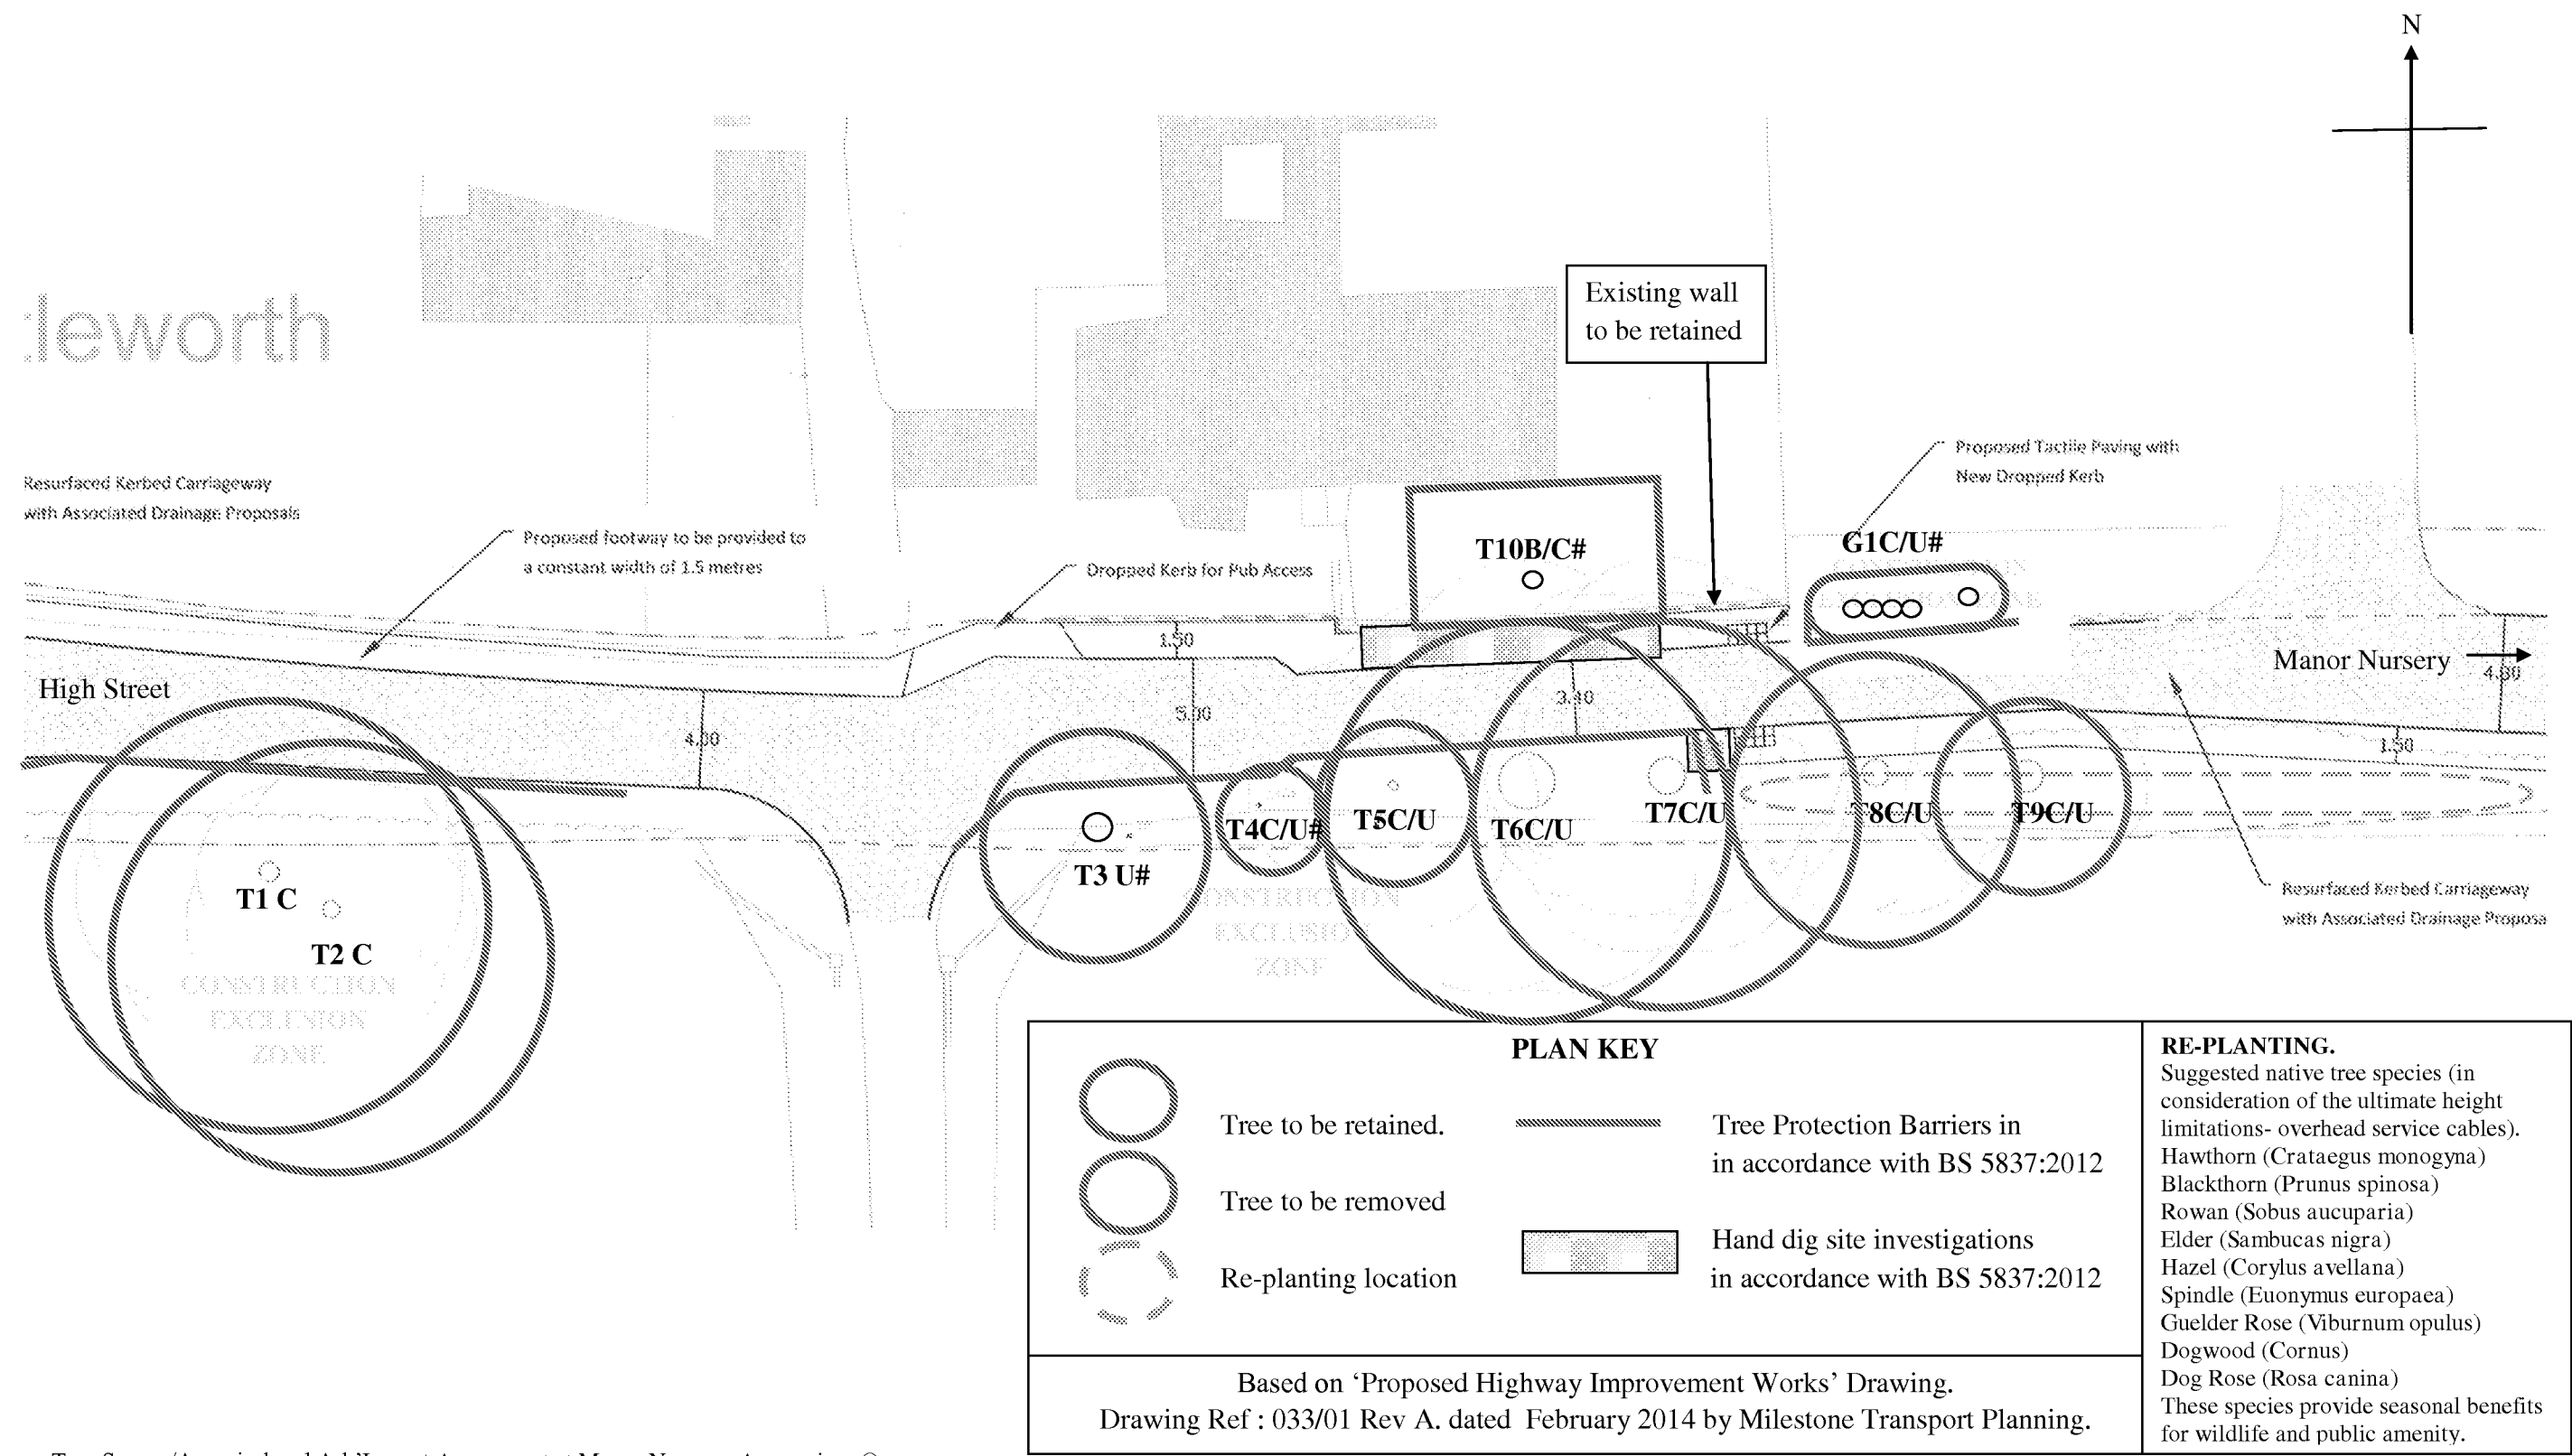
APPENDIX 3  
**TREE RETENTION / REMOVAL PLAN**  
Indicating proposed re-planting  
and proposed tree protection measures.

| BS5837:2012<br>Tree Quality Category | Trees to be retained | Trees to be removed. | Tree Protection<br>Barriers in accordance<br>with BS 5837:2012 |
|---|---|---|---|
| <p><u>Tree Retention :</u><br/>Trees T1-T6, T10 and G1 are to be retained and protected in accordance with BS 5837 : 2012 as per Appendix 3..</p> <p><u>Tree Removal :</u><br/>Trees to be removed are of low quality, which in the context of the current land use are unlikely to be retained for longer than 10 years. They are to be removed and replaced by an improved planting scheme.</p> <p><u>Planting Scheme.</u><br/>A new and improved planting scheme is proposed to mitigate for any tree loss. The location of the proposed planting is indicated at Appendix 3, together with species selection. Further detail is also included within the ‘Tree Appraisal’ at Section 3</p> <p><u>Tree Protection :</u><br/>Where necessary retained trees are to be protected in accordance with BS 5837:2012 ‘Trees in relation to design, demolition and construction - Recommendations’. The proposed tree protection measures are indicated at Appendix 3.</p> | | | |
