St. Margaret's

ANGMERING

**Re: St Margaret's Angmering, Tree works (Section 211 notification)**

## Tree safety inspection at St Margaret's churchyard, Angmering

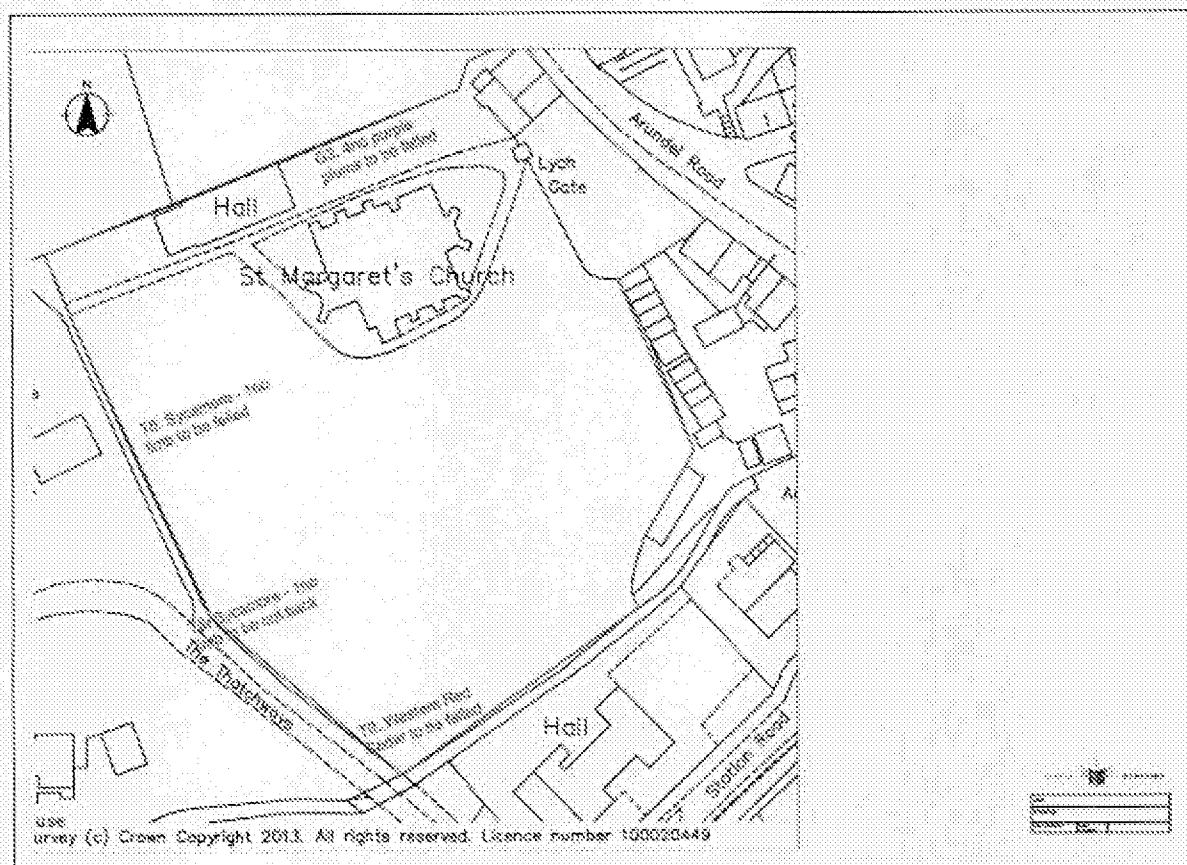
(T9) Western Red Cedar to the west boundary  
Leaning limb to be felled (on safety grounds) where this is leaning at a dangerous angle over the road.

T9 Western red cedar – the tree has two main limbs, one of which leans over the adjacent road at a steep angle. **The leaning limb represents a potential hazard and should be removed.**
