**Project Name:** Mackoy Ltd - Langmead Place Angmering

**Project Date:** 04/11/2025

**Inspection Standard:** MSCC5 Sewers & Drainage GB (SRM5 Scoring)

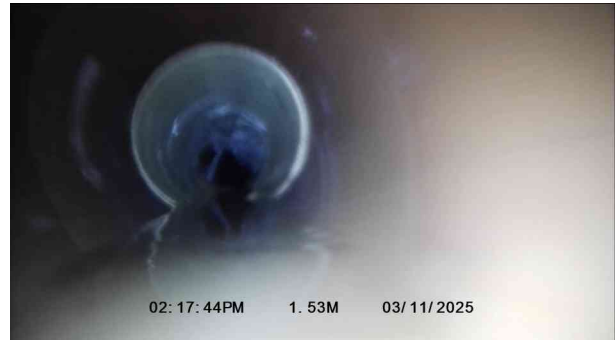
2, 00:00:18, 1.53 m  
Point repair, localised lining from 12 o'clock to 11 o'clock, start

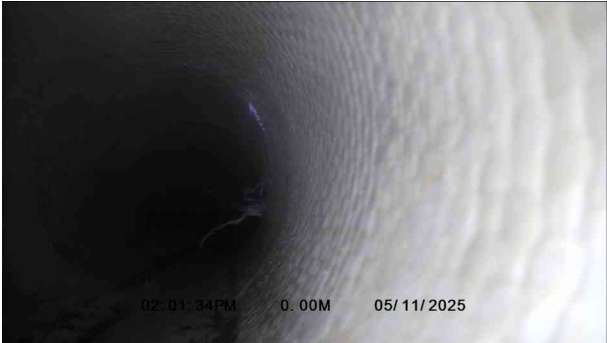
2, 00:00:07, 0.00 m  
Point repair, localised lining from 12 o'clock to 11 o'clock, start

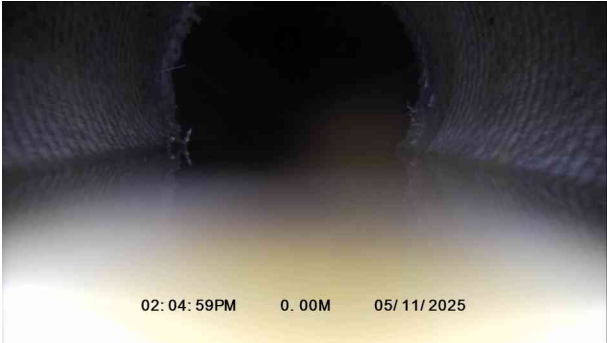
2, 00:00:08, 0.00 m  
Point repair, localised lining from 12 o'clock to 11 o'clock, start

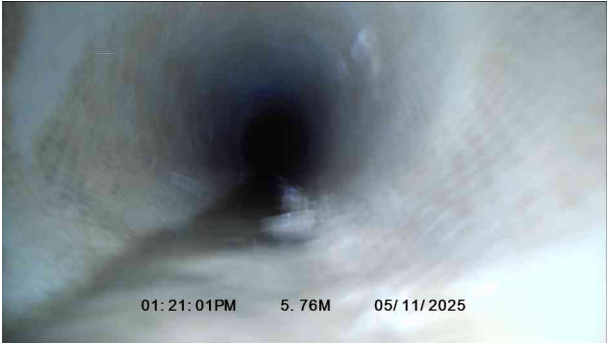
2, 00:00:19, 5.76 m  
Point repair, localised lining from 12 o'clock to 11 o'clock, start

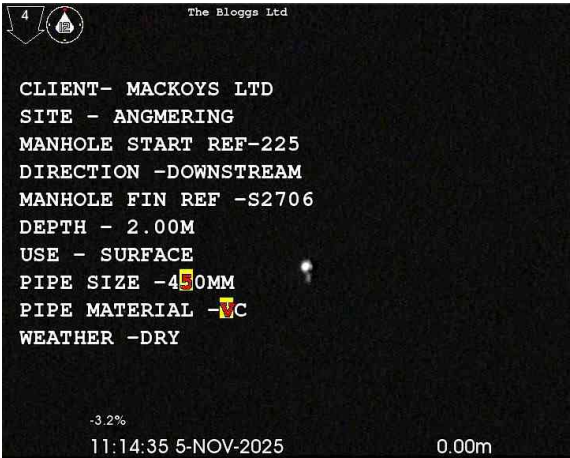
1, 00:00:00, 0.00 m  
Start node, manhole, reference: 225

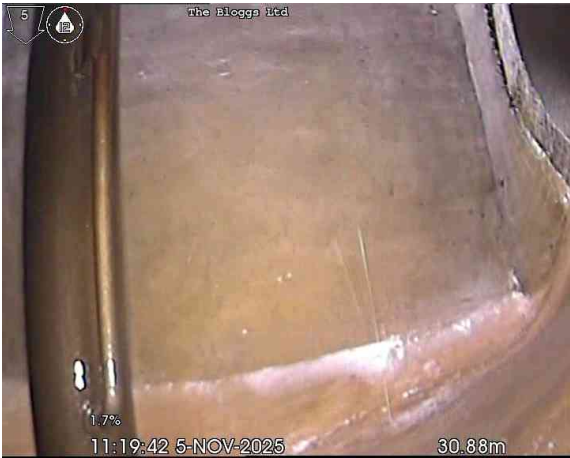
2, 00:03:04, 30.88 m  
Finish node, manhole, reference: S2706

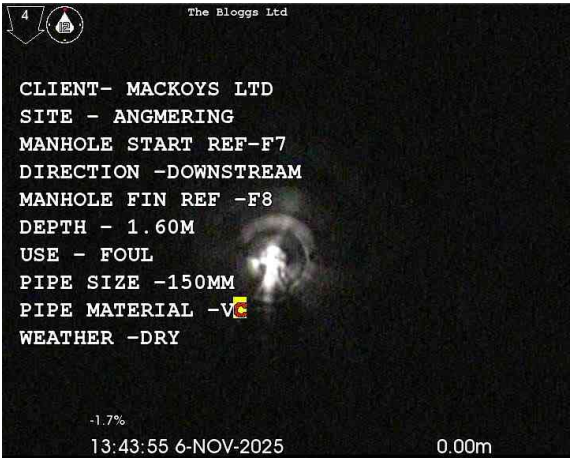
1, 00:00:00, 0.00 m  
Start node, manhole, reference: F7

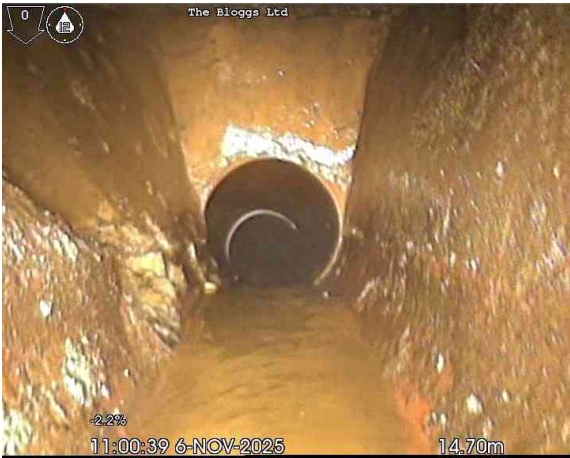
2, 00:01:59, 14.70 m  
Finish node, manhole, reference: F43

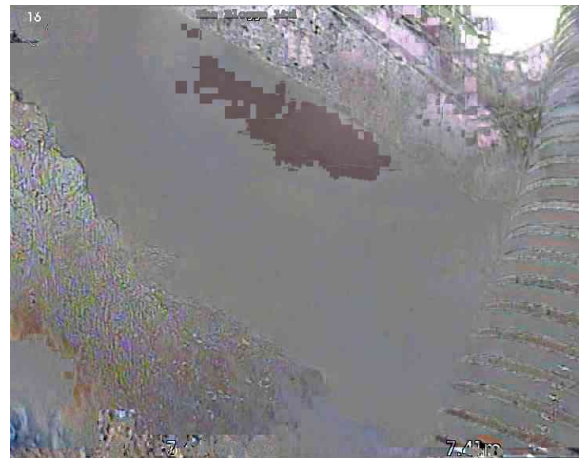
2, 00:01:04, 7.41 m  
Finish node, manhole, reference: F19

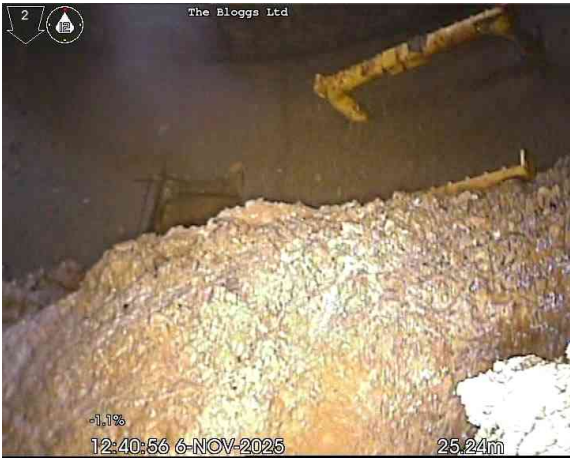
2, 00:02:49, 25.24 m  
Finish node, manhole, reference: F20

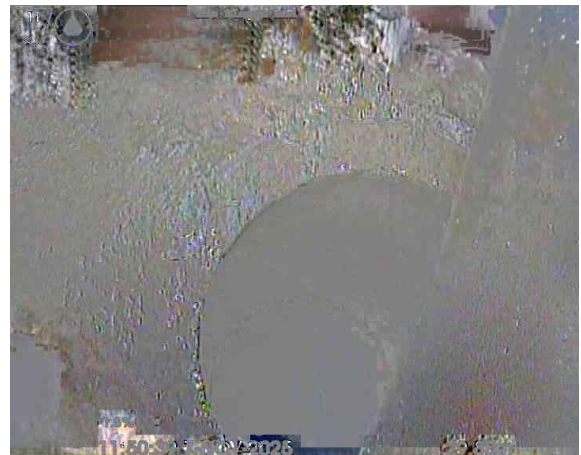
2, 00:02:20, 29.80 m  
Finish node, manhole, reference: 326

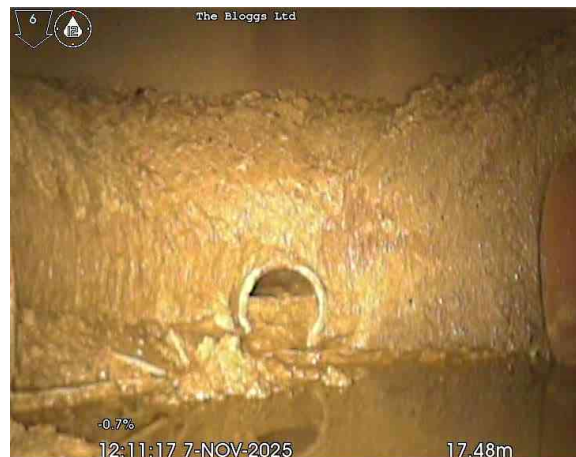
2, 00:01:28, 17.48 m  
Finish node, manhole, reference: 323A

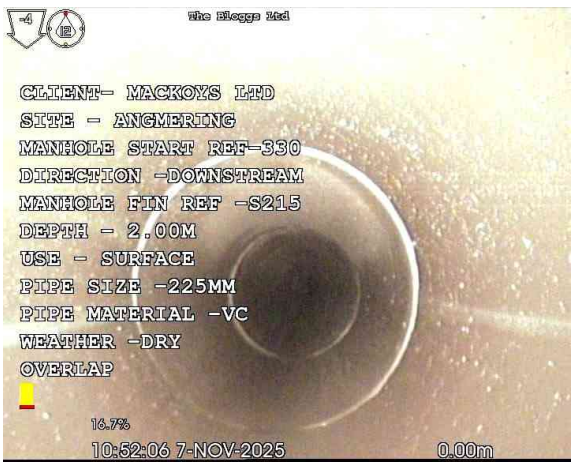
1, 00:00:00, 0.00 m  
Start node, manhole, reference: 330

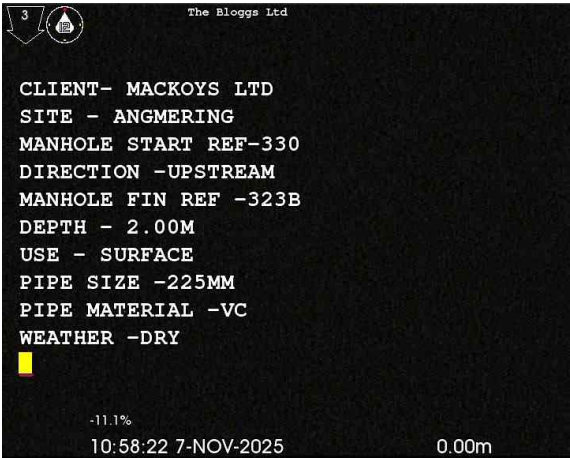
1, 00:00:00, 0.00 m  
Start node, manhole, reference: 330

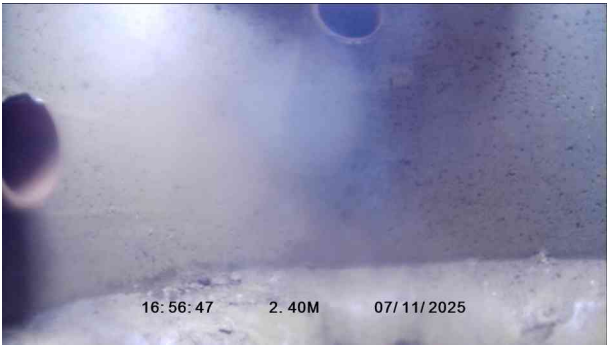
2, 00:00:41, 2.40 m  
Finish node, manhole, reference: F41

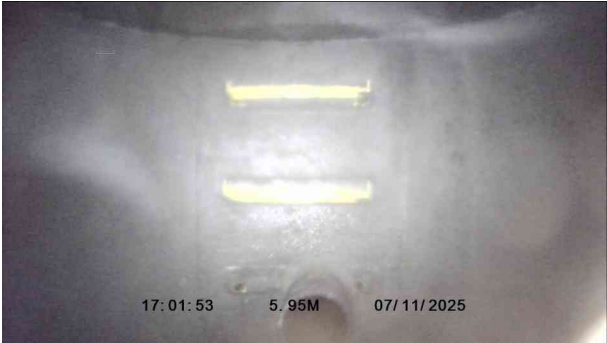
2, 00:00:25, 5.95 m  
Finish node, manhole, reference: F41

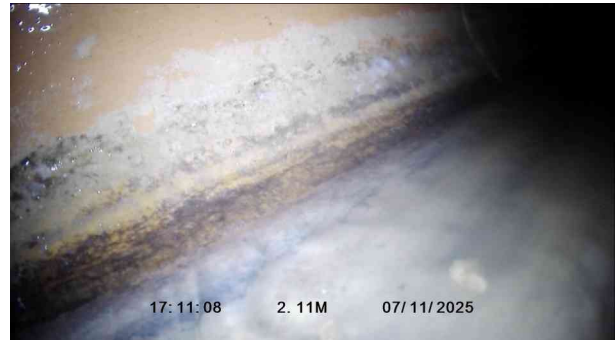
2, 00:00:15, 2.11 m  
Finish node, major connection without manhole, reference:  
MAIN

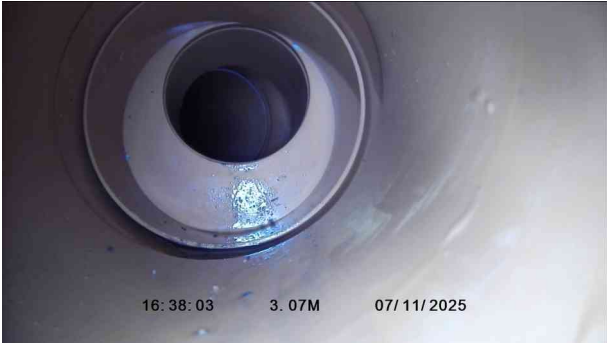
3, 00:01:02, 3.07 m  
Finish node, manhole, reference: FW230

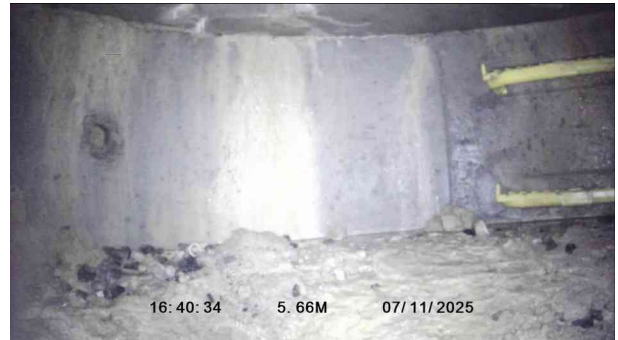
2, 00:00:36, 5.66 m  
Finish node, manhole, reference: F18

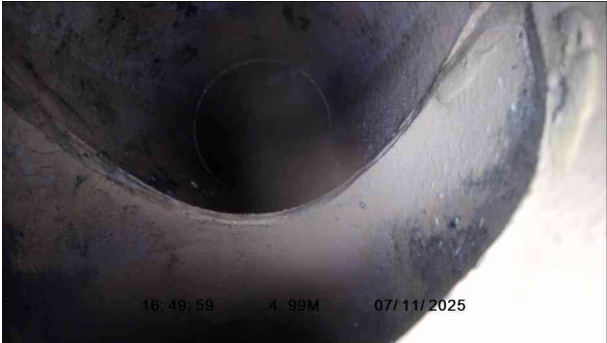
2, 00:00:31, 4.99 m  
Finish node, manhole, reference: F39

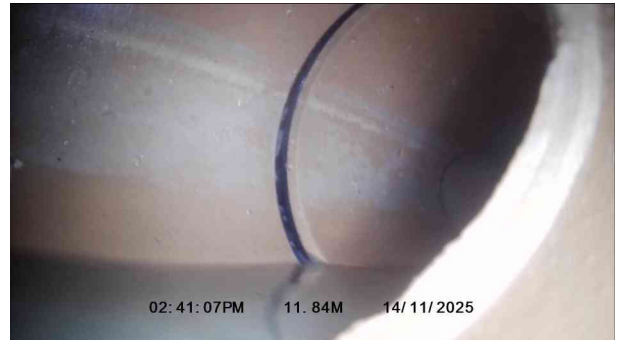
2, 00:00:56, 11.84 m  
Finish node, major connection without manhole, reference:  
MAIN

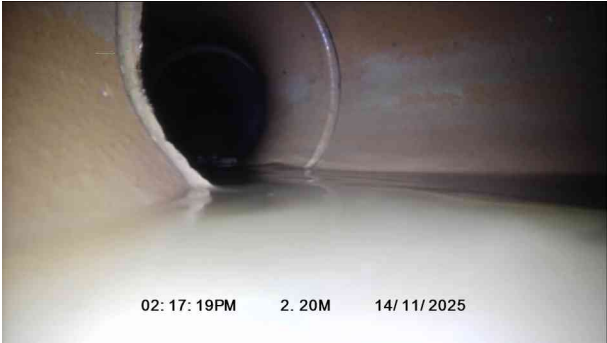
2, 00:00:13, 2.20 m  
Finish node, major connection without manhole, reference: MAIN

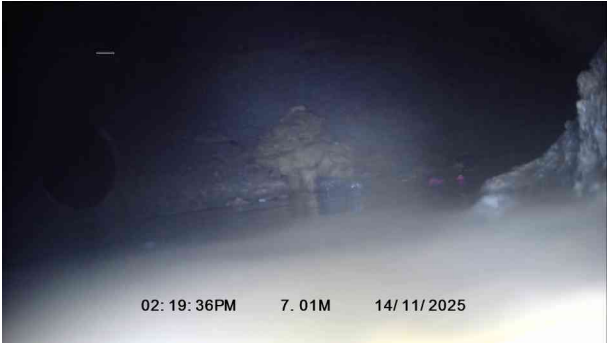
2, 00:00:27, 7.01 m  
Finish node, manhole, reference: 323A

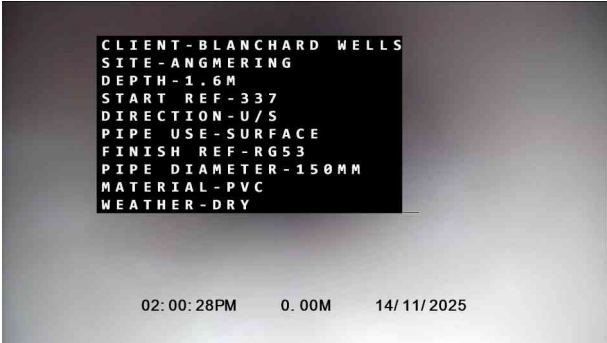
1, 00:00:00, 0.00 m  
Start node, manhole, reference: 337

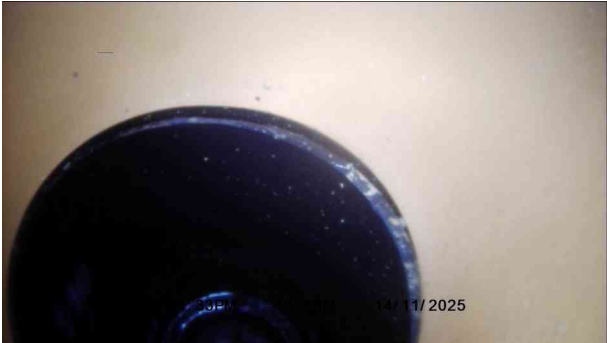
2, 00:01:04, 15.56 m  
Finish node, gully, reference: RG53

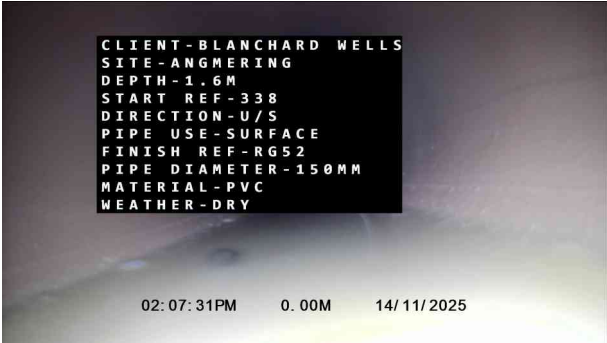
1, 00:00:00, 0.00 m  
Start node, gully, reference: 338

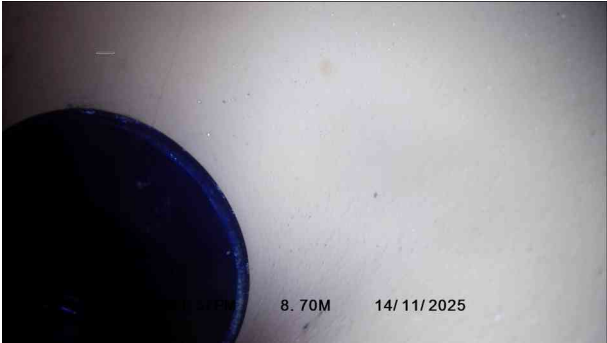
2, 00:01:07, 8.70 m  
Finish node, gully, reference: RG52

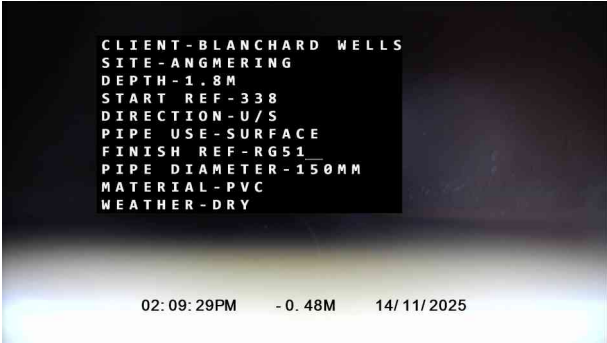
1, 00:00:00, 0.00 m  
Start node, manhole, reference: 338

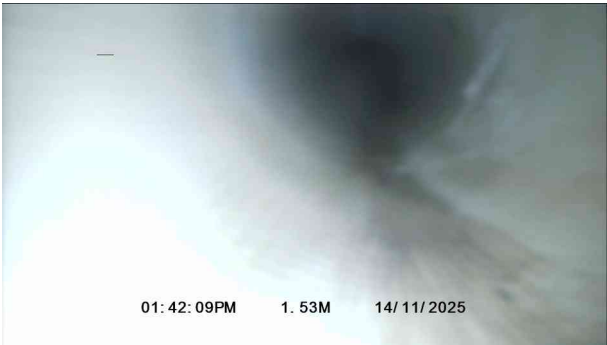
2, 00:00:10, 1.53 m  
Point repair, localised lining from 12 o'clock to 11 o'clock, start

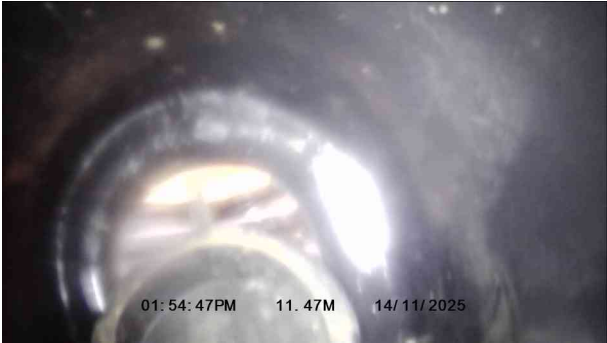
2, 00:00:49, 11.47 m  
Finish node, gully, reference: RG54
