# Surface Water Drainage Verification Report

Former Bartons Infant School, North Bersted Bognor  
Regis PO22 9BD

Lovell Partnerships

Ref: 11642

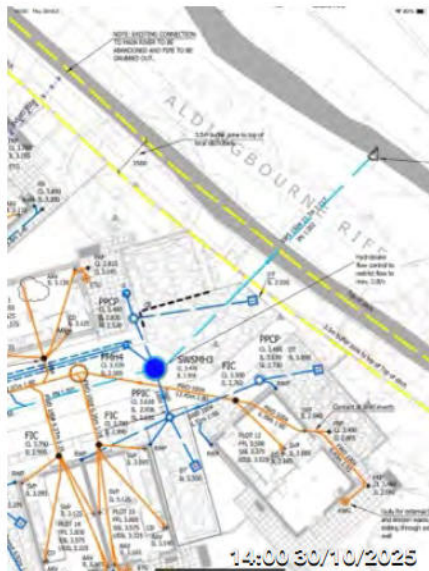
Hydro Break, Flow Control  
Assigned To Lovells  
SWSMH3  
Storm manhole housing the hydro break.

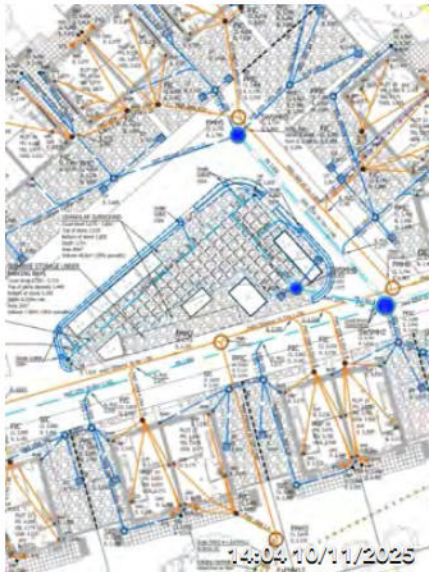
Swale On The outside of The Attenuation Tank  
Assigned To Lovells  
Drawing ref:11642 1601 C6 , showing the layout of  
the land drain and the swale.

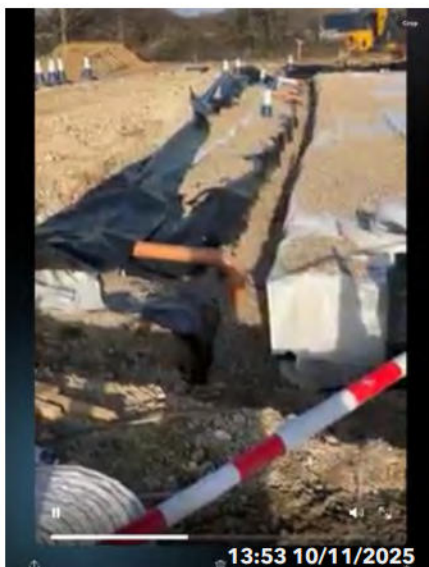
Swale On The outside of The Attenuation Tank  
Assigned To Lovells  
Membrane laid out to the kerb, shingle fill.

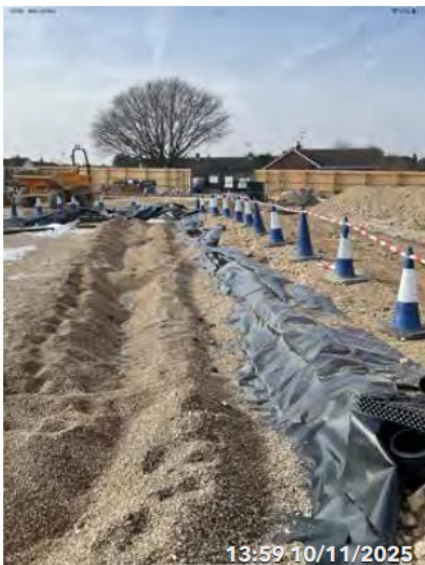
Swale On The outside of The Attenuation Tank  
Assigned To Lovells  
Membrane laid out to the kerb, shingle fill.  
.100mm land drain wrapped in terram,

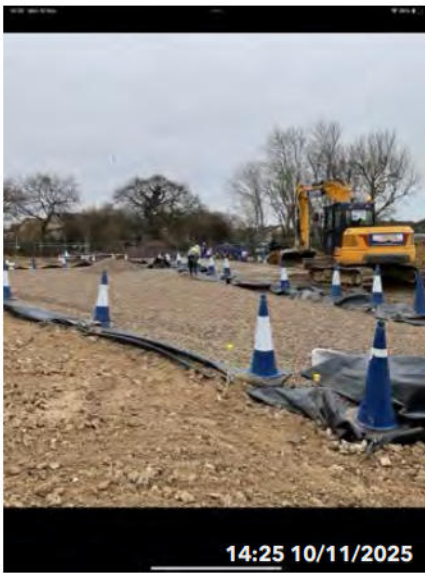
Swale Outside Of The Attenuation Tank  
Assigned To Lovells  
Back fill over the wraparound.  
Level with stone.
