**RE: 2-4 Waterloo Square, Bognor Regis PO21 1SU**

#### BRIEF

On 17<sup>th</sup> May 2018, H J Concepts Ltd were contacted and instructed by Mr R Brooks of B5 Ltd for the purpose attending site to review the structural condition of the buildings (where access is available) and more specifically the exposed structural steel support beams at 2-4 Waterloo Square, Bognor Regis PO21 1SU

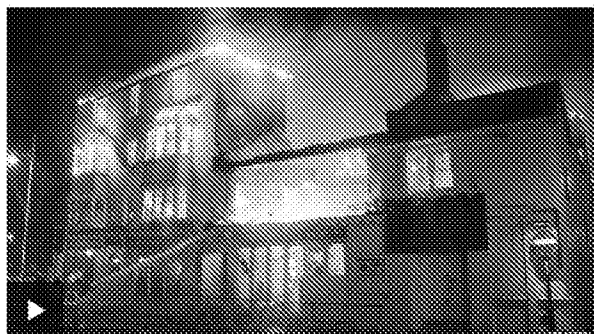
It should be noted that the adjoining buildings were the subject of a very serious fire in November 2016 and subsequently collapsed with the remaining being demolished and the site cleared. Due to the intensity of the fire it is inevitable that water had entered the subject buildings
